**Inspection Photos**  
**Location Name: Lewton Company F Unit 1**  
**Location ID: 001-08920**

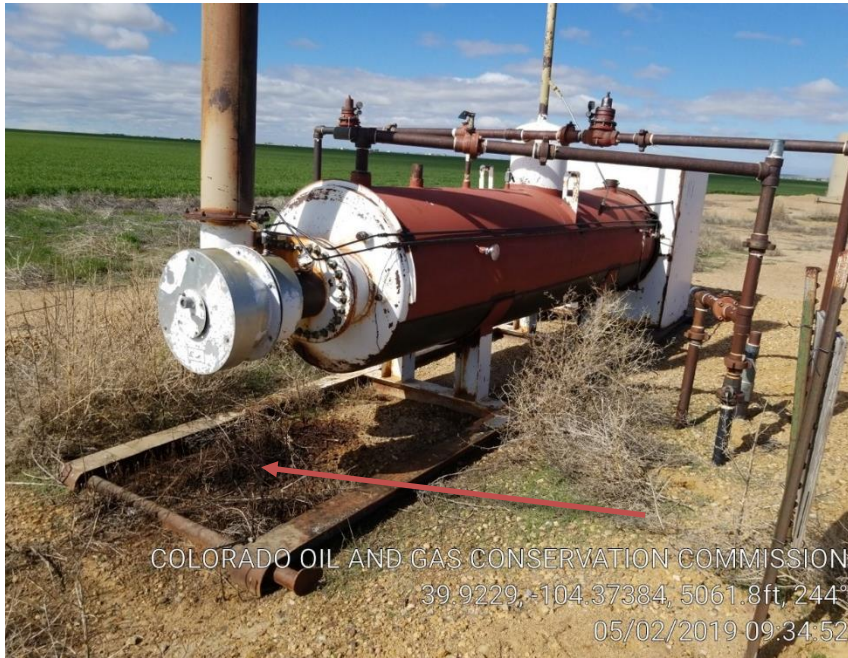
**Pic 3. Separator possible leak. Stained soil**

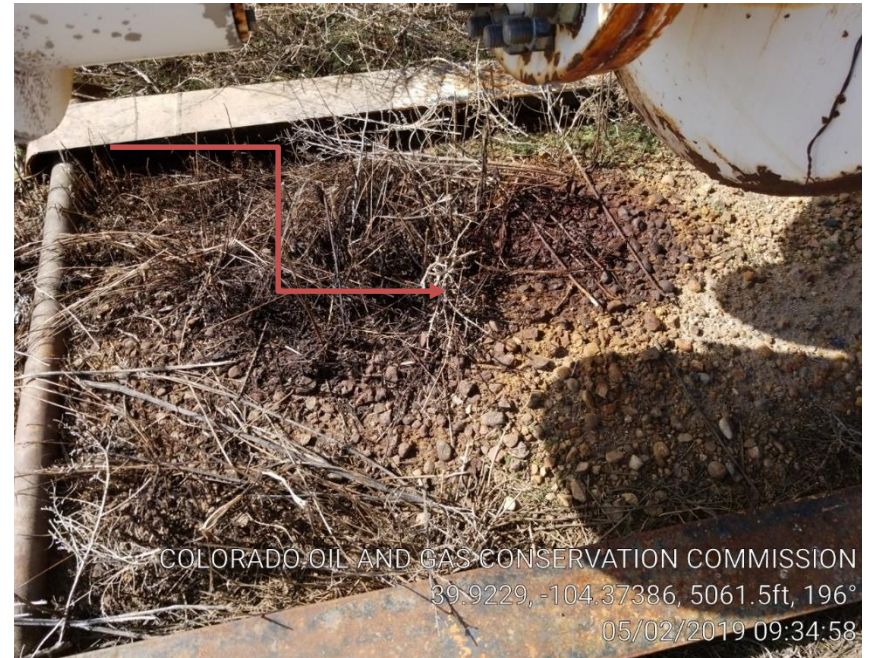
**Pic 4 possible leak stained soil.**

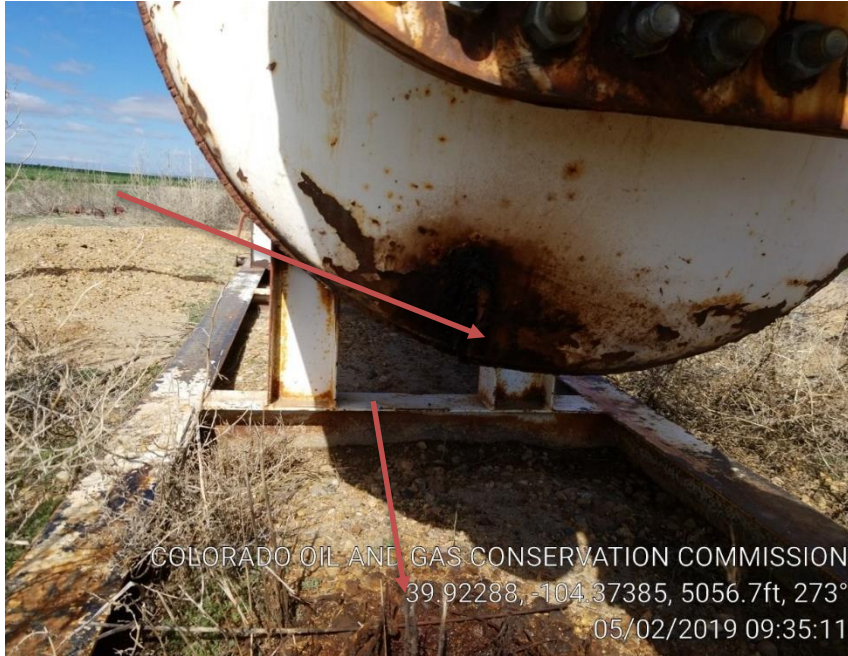
**Pic 5 stained soil possible leak**

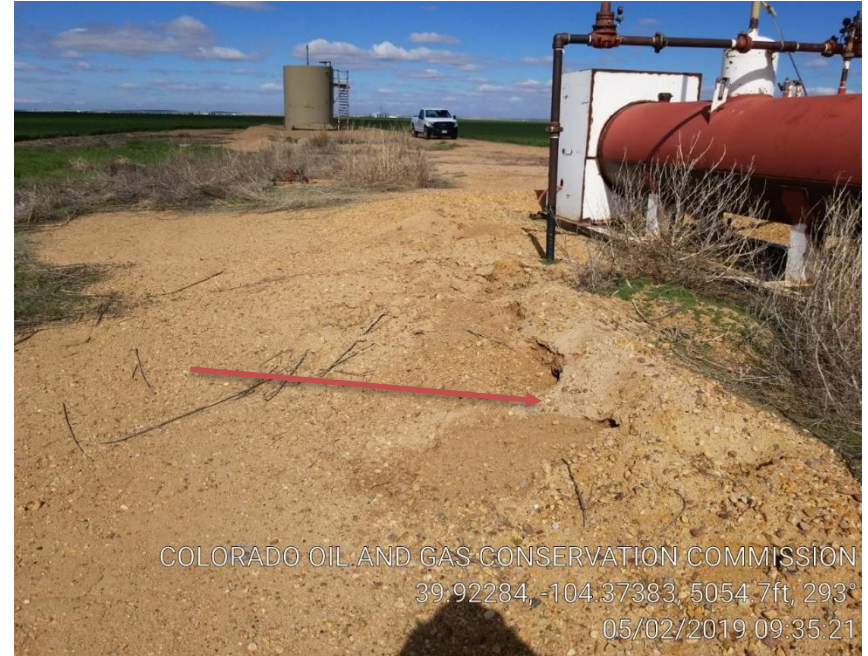
**Pic 6 separator berm appears to have burrowed through by animals.**

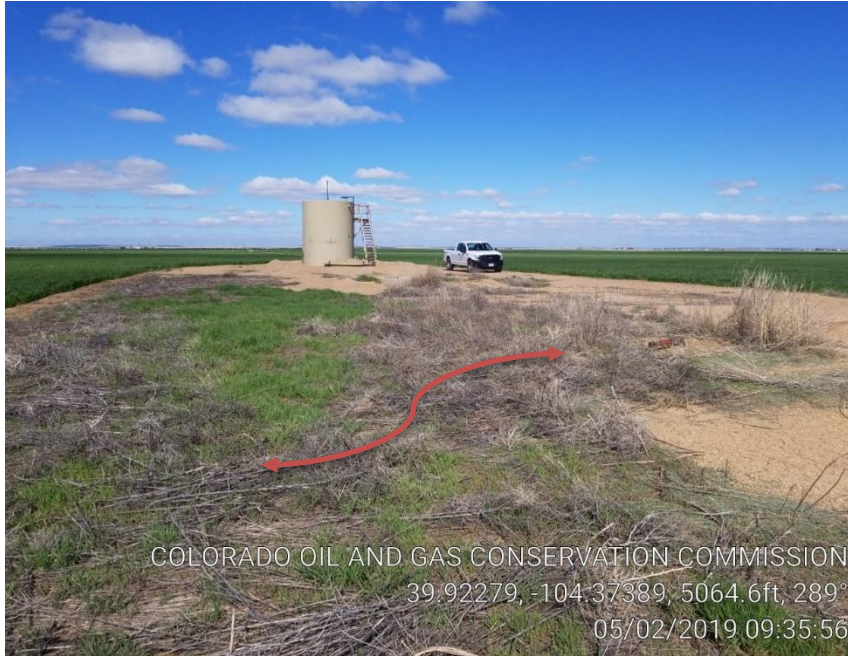
**Pic 7 weeds on location.**

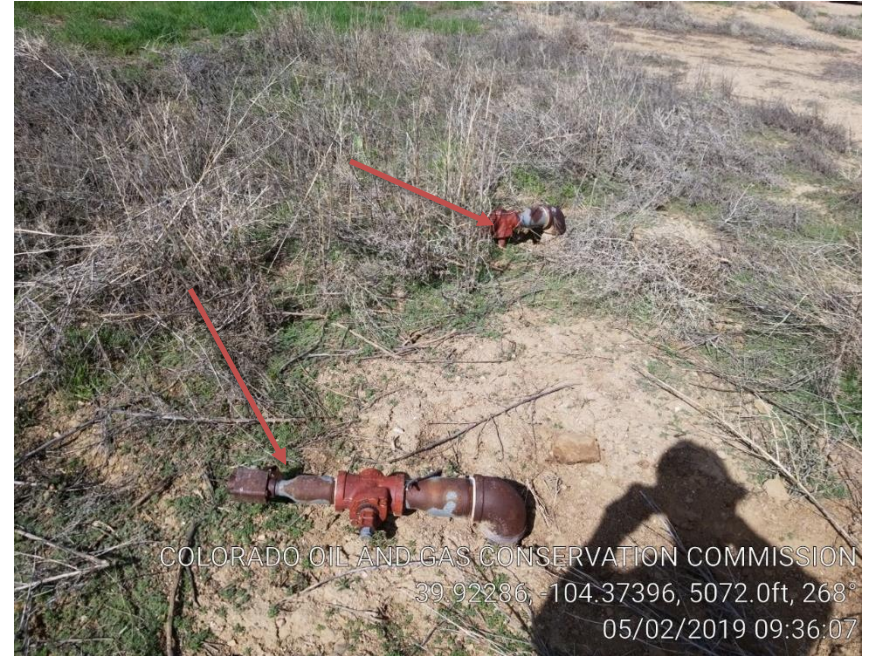
**Pic 8 unmarked risers in weeds.**

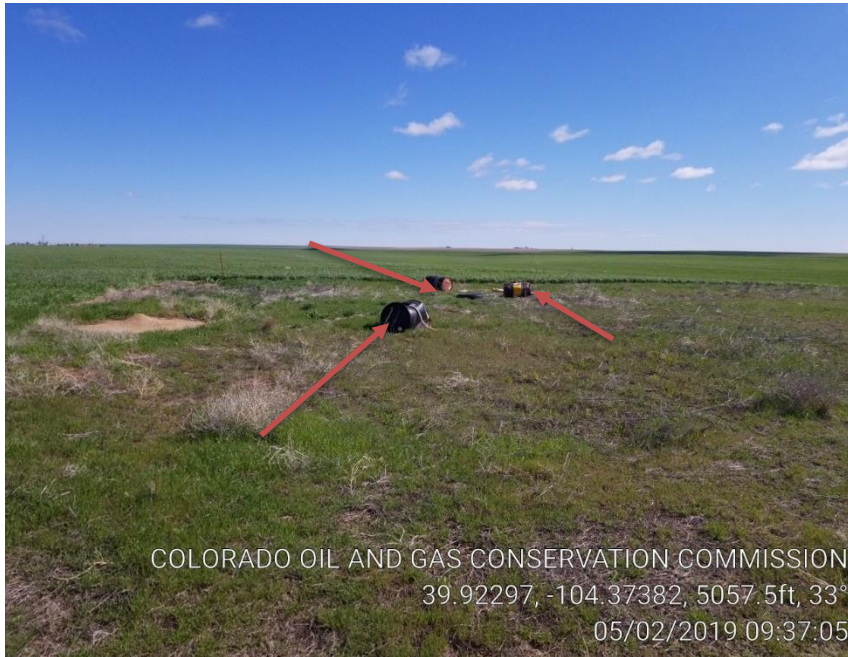
**Pic 9 trash on location.**

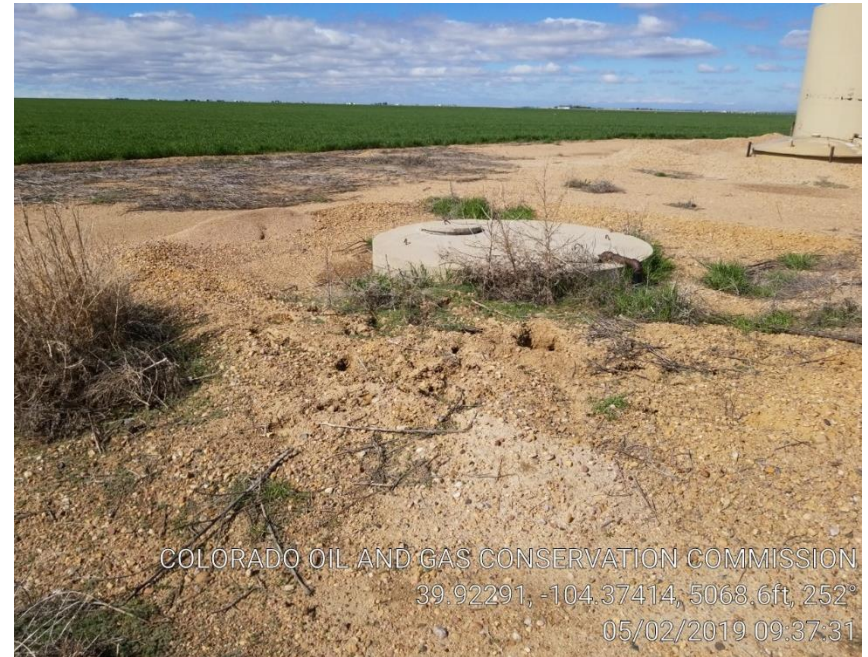
**Pic 10 unmarked buried concrete vault.**

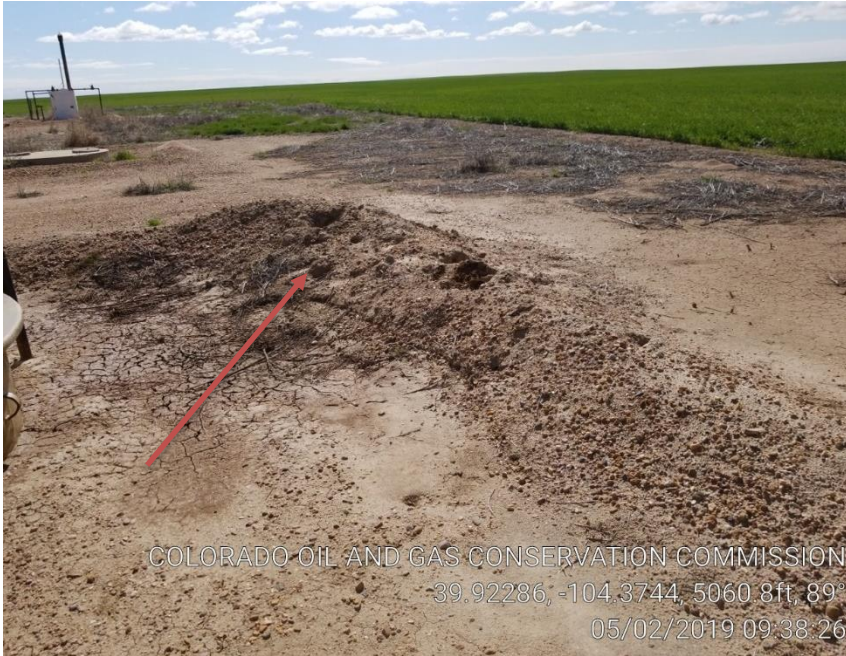
**Pic 11 berm appears to have been burrowed through by animals.**

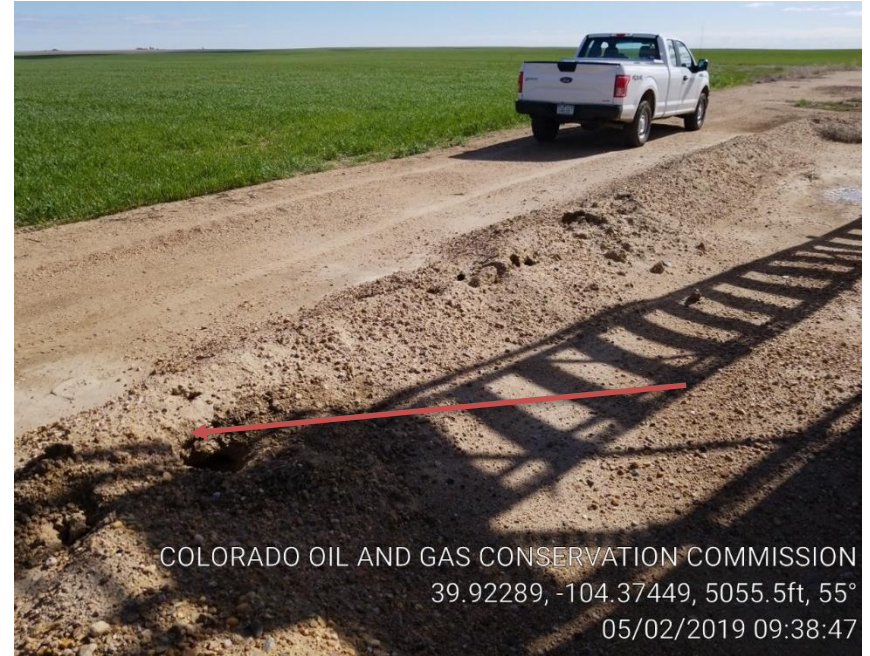
**Pic 11 berm appears to have been burrowed through by animals**
