Inspection Photos
Location Name: Comanche Creek 2-14
Location ID: 320321

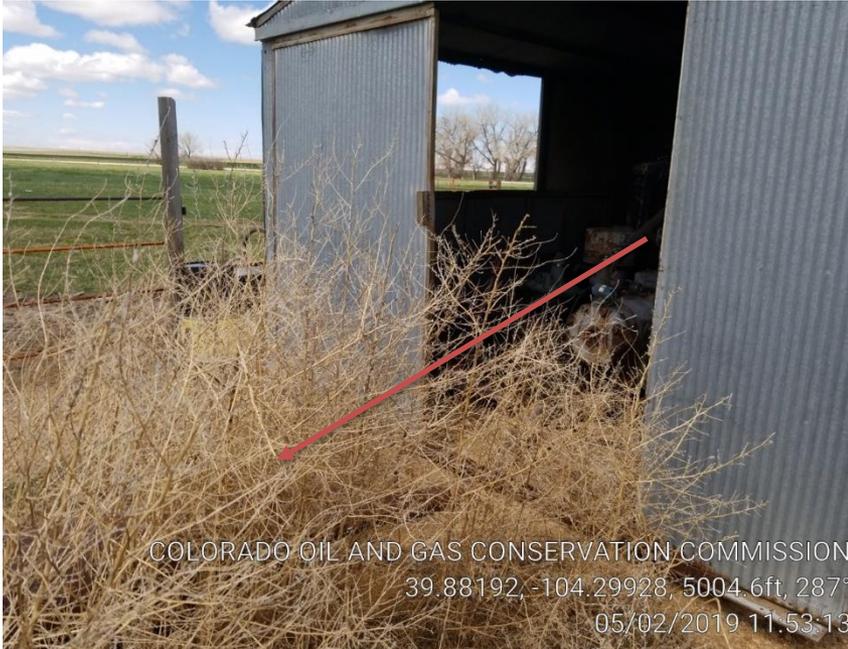
Pic 1 weeds around motor house

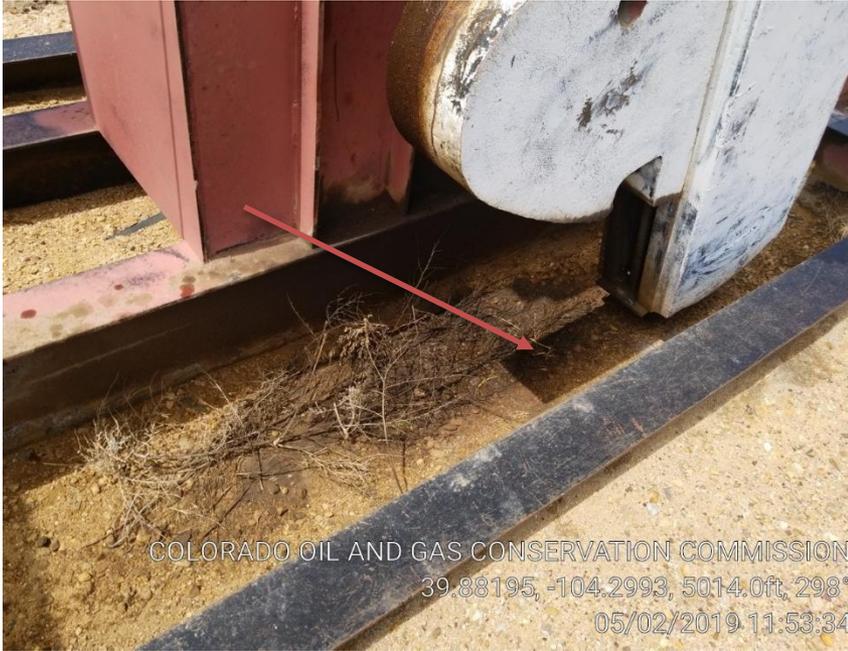
Pic 3 stained soil below counterweight.

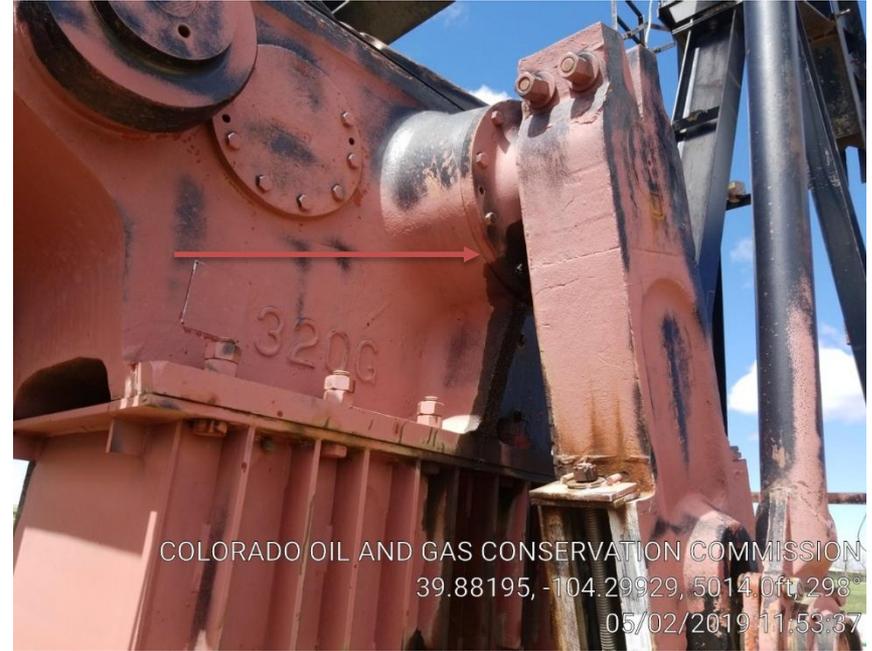
Pic 4 what appears to be leak on pumping unit.

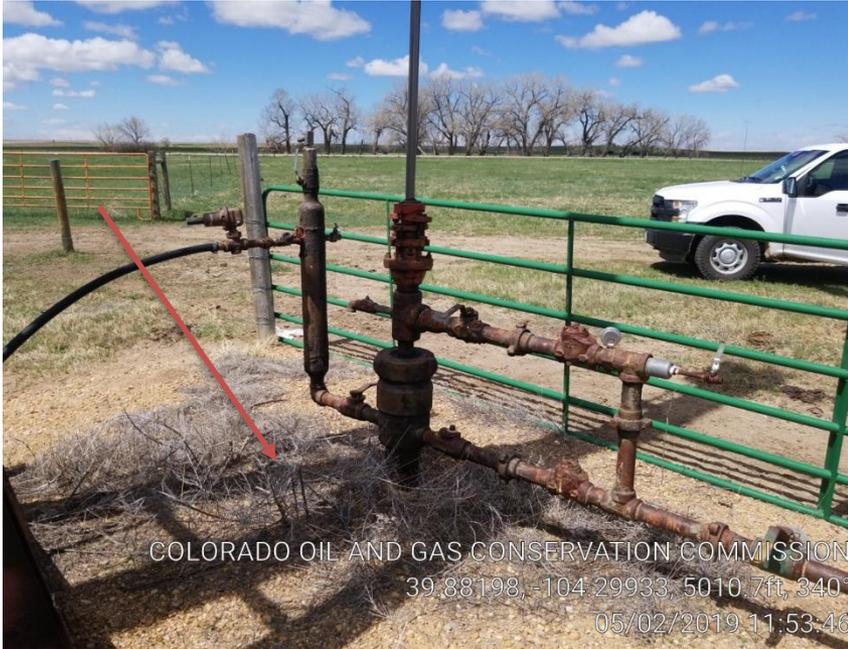
Pic 5 weeds around wellhead.

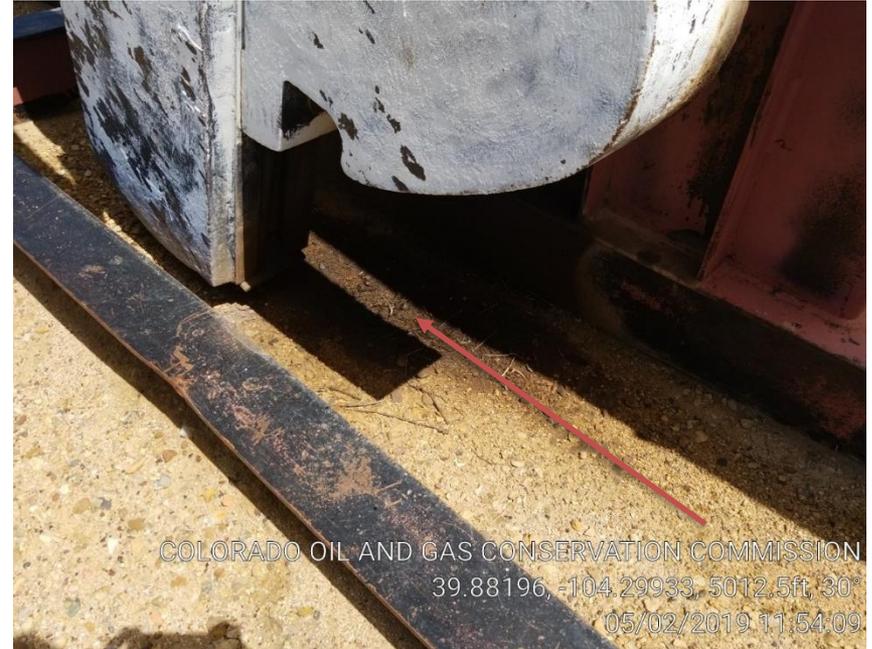
Pic 6 stained soil below other counterweight.

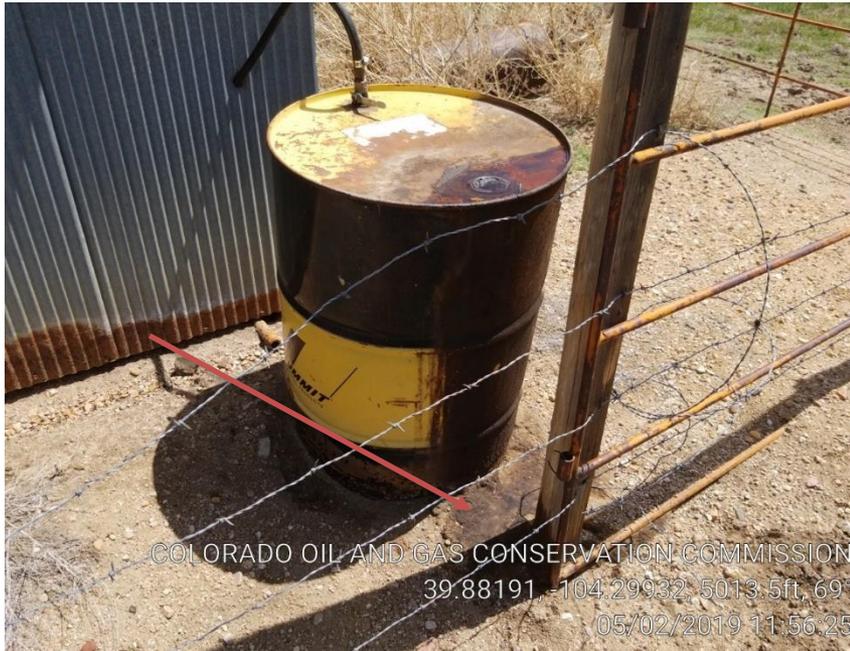
Pic 7 unknown barrel contents, no containment, appears to be leaking stained soil
