Inspection Photos

API: 05-061-06471

Operator: MARATHON OIL COMPANY

Inspection Date: 5/15/2019

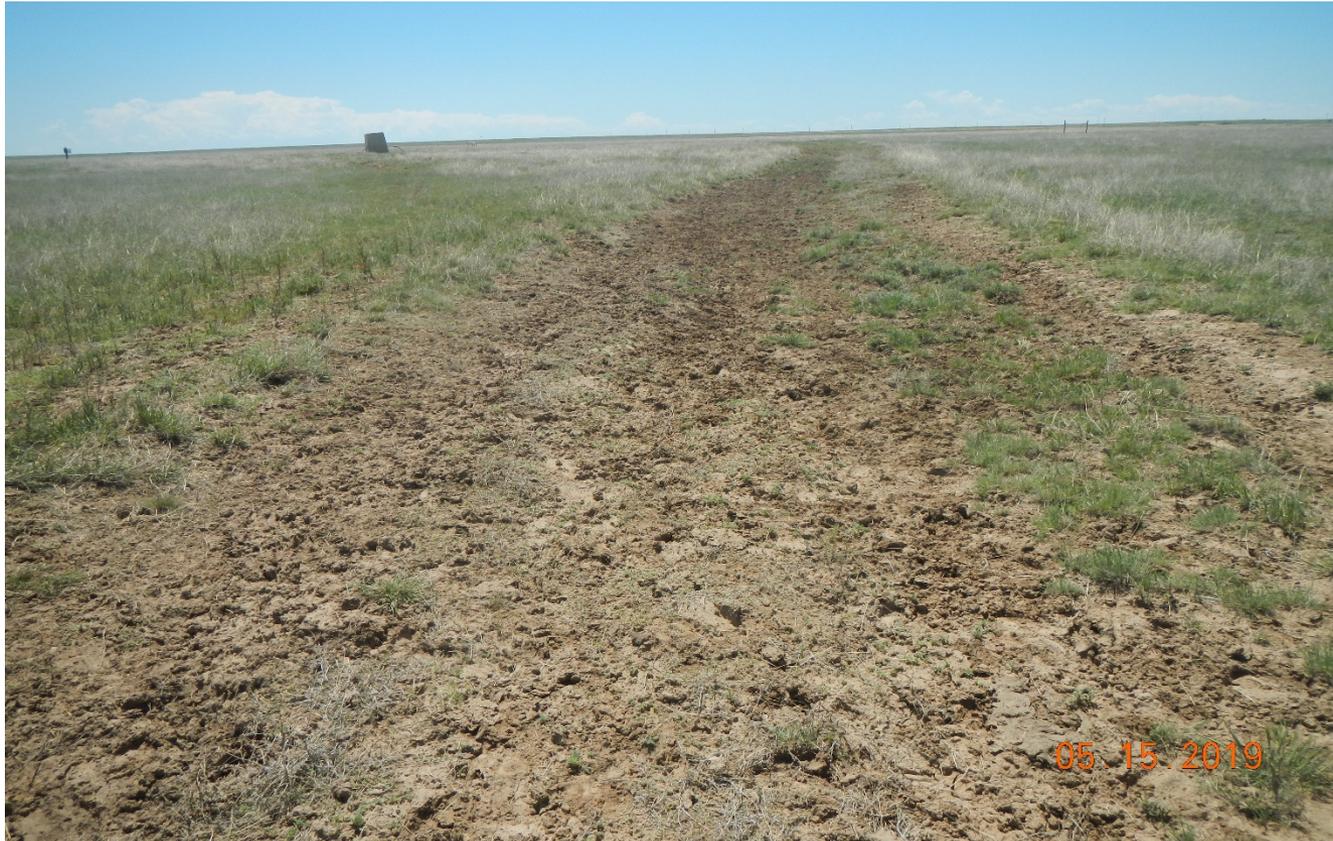
Photo 1. Facing north along the access road. The old road is has mostly turned into a two track. This area has been heavily used by cattle.

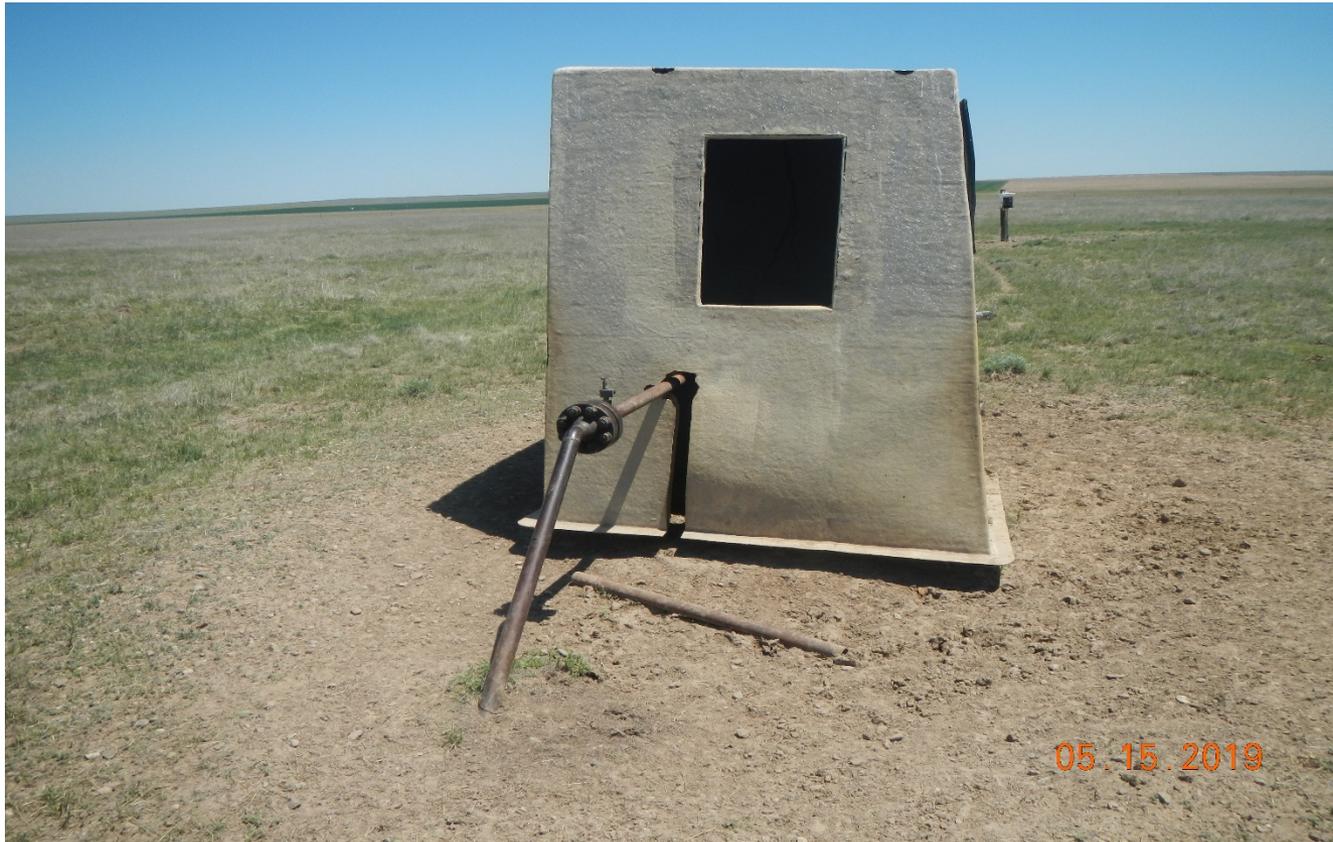
Photo 2. There is a riser shed at the location.

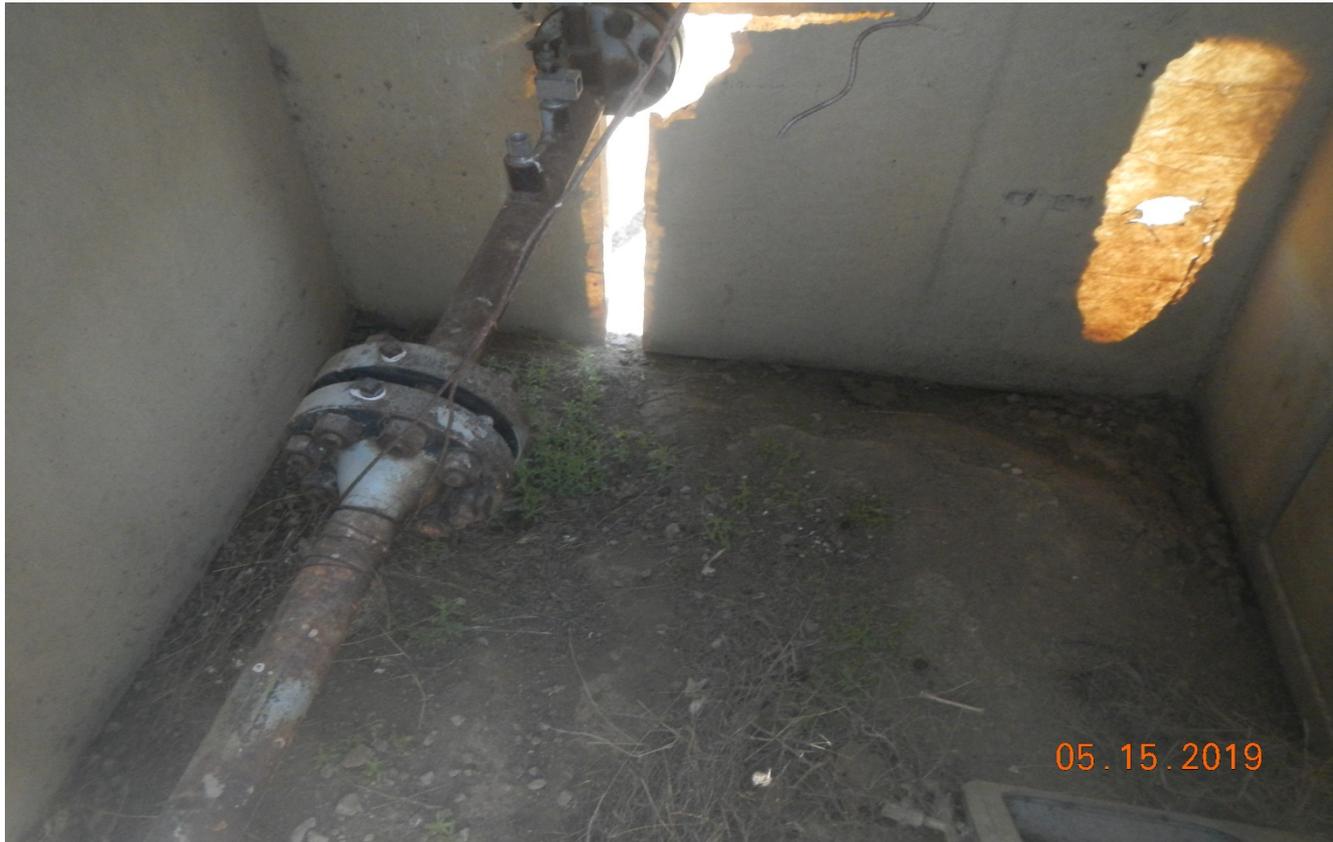
Photo 3. View of inside shed.

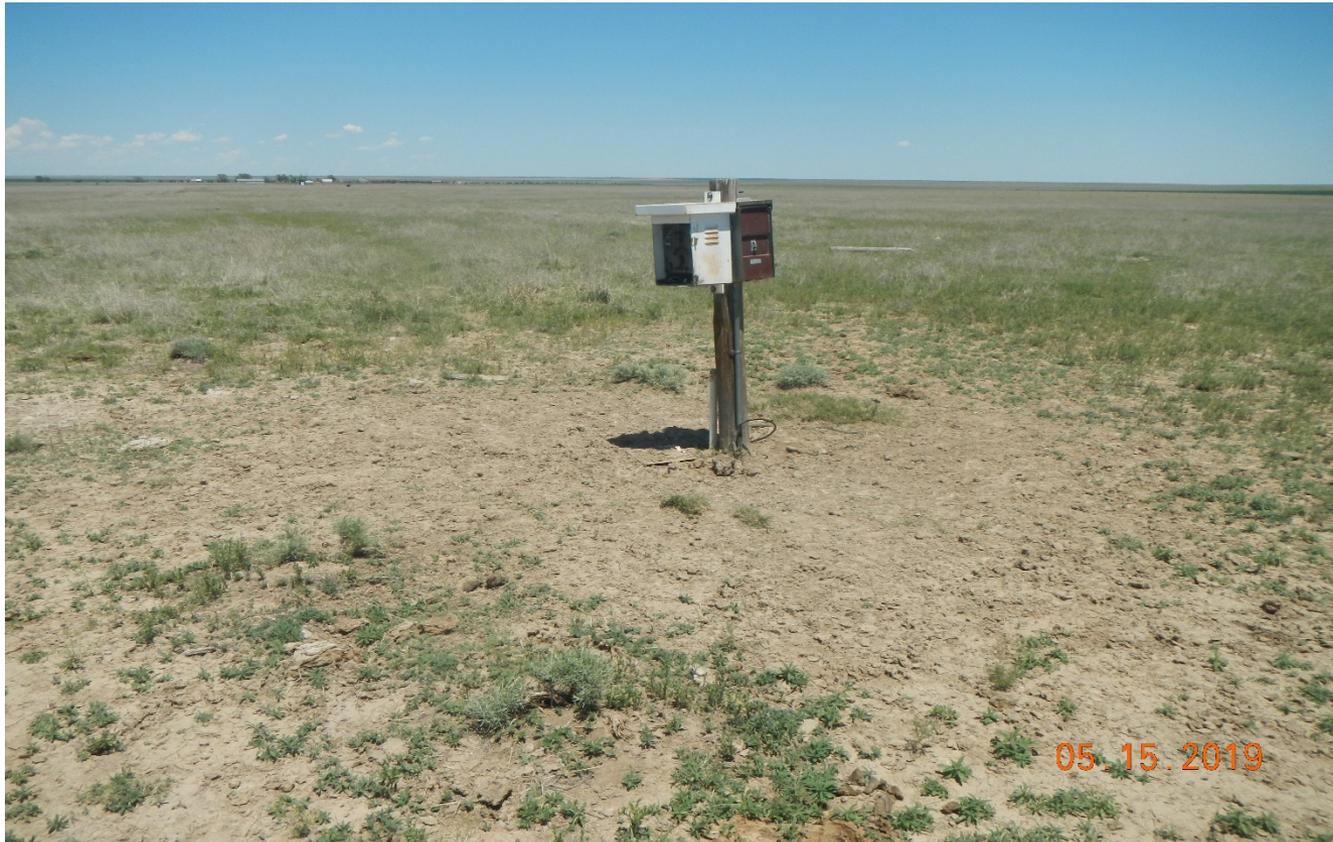
Photo 4. There is a disconnected electric bos close to well coordinates.

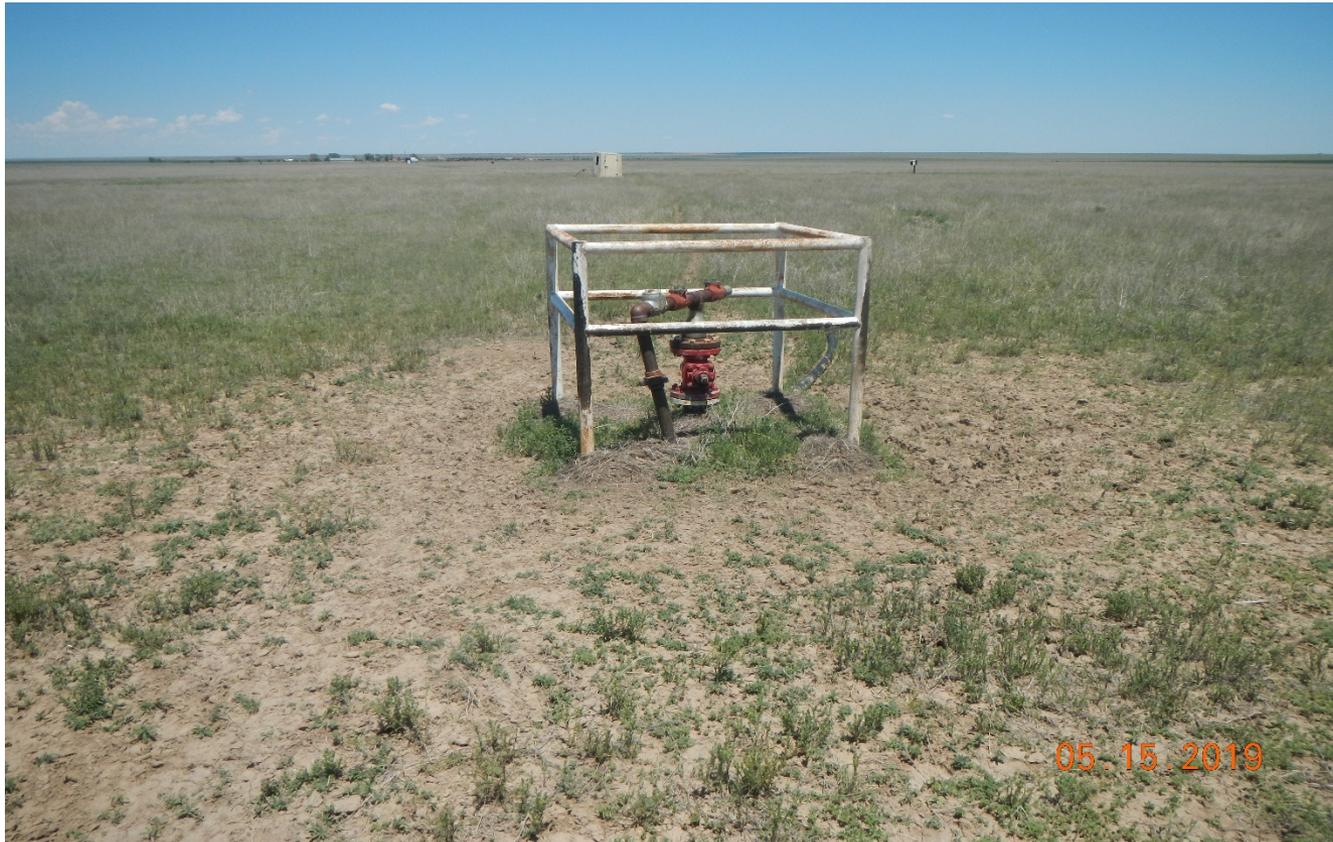
Photo 5. South of the location facing north. There is equipment in place.

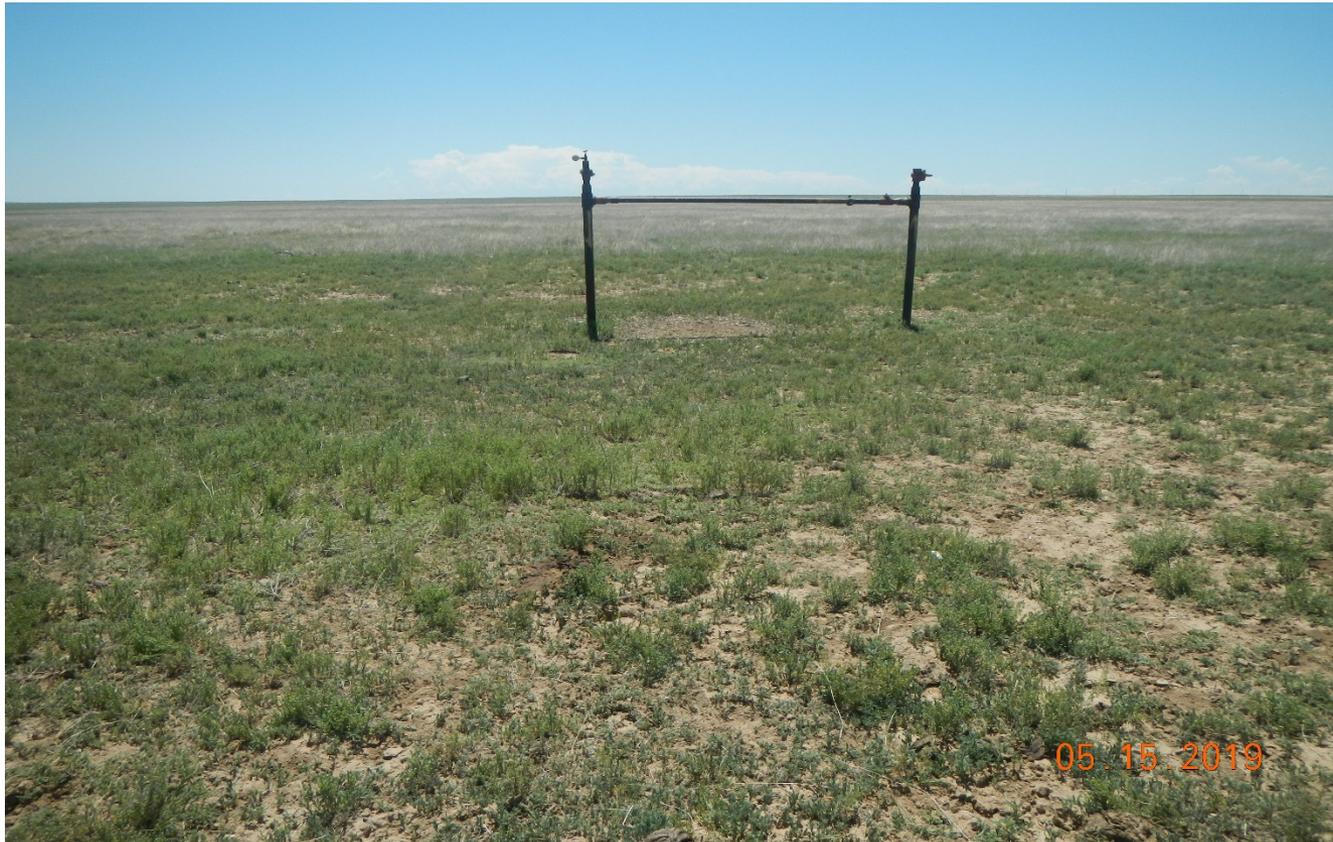
Photo 6. Approximately 300ft. West of the location is this pipe riser.
