Inspection Photos
Location Name: Federal 6-25
API: 05-081-06745

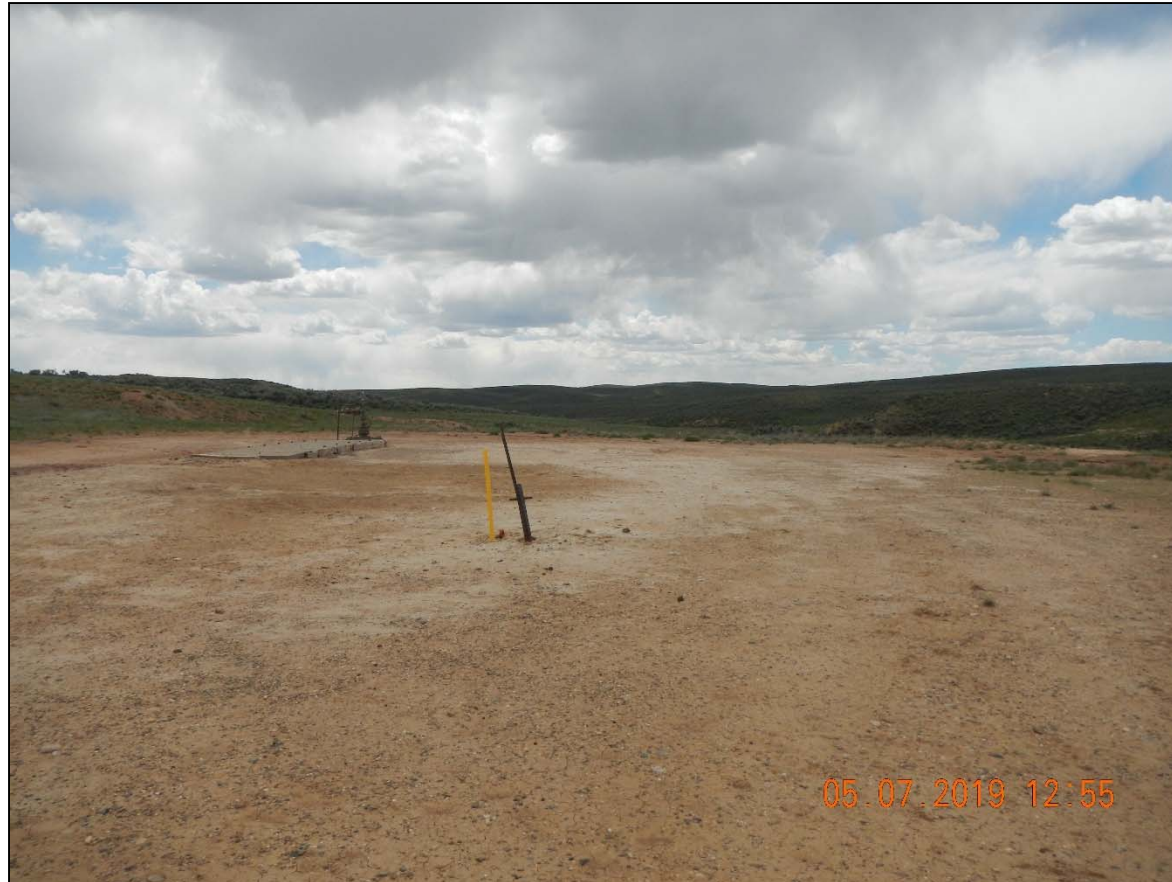
Photo 1. Overview of location taken at entrance facing south.

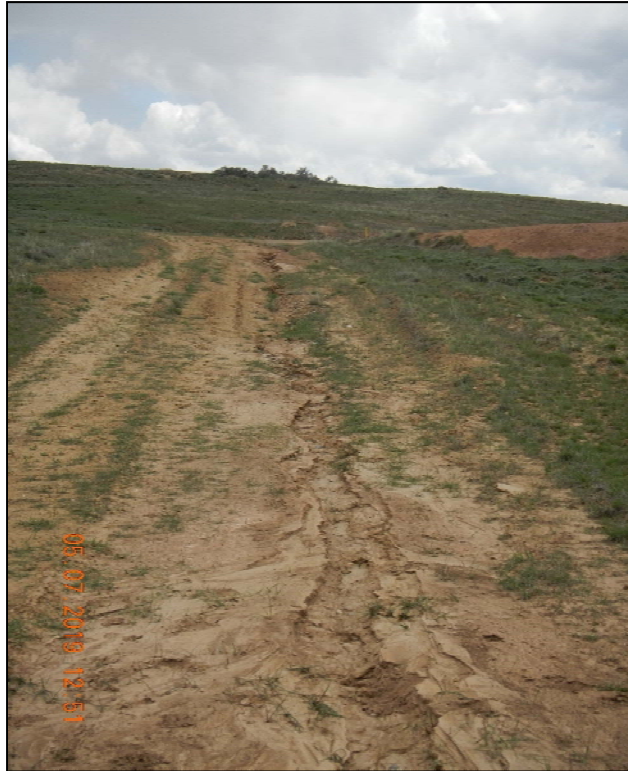
Photo 2. Sediment moving off location onto access road.

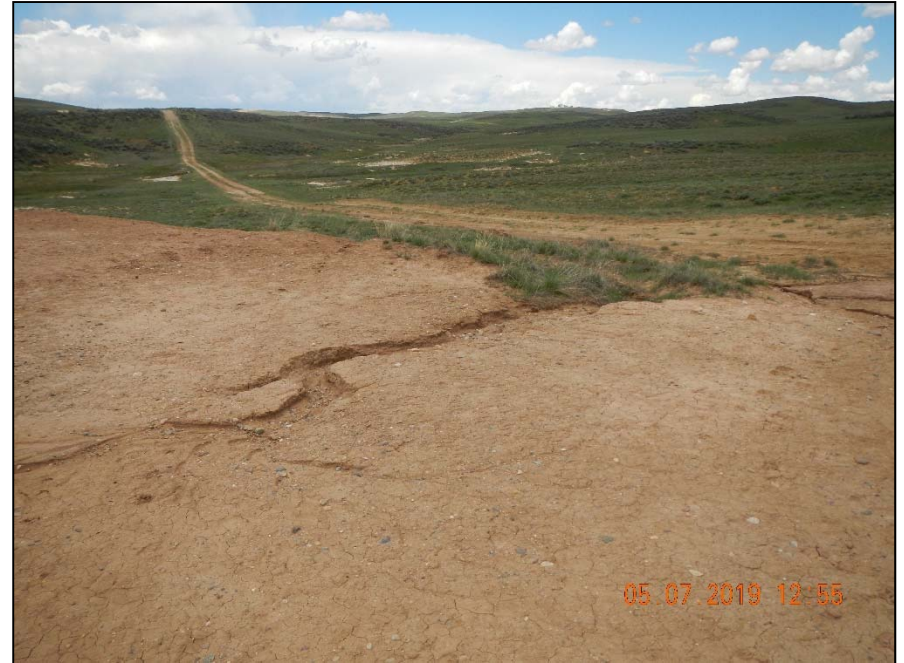
Photo 3. Erosion gully leaving location.

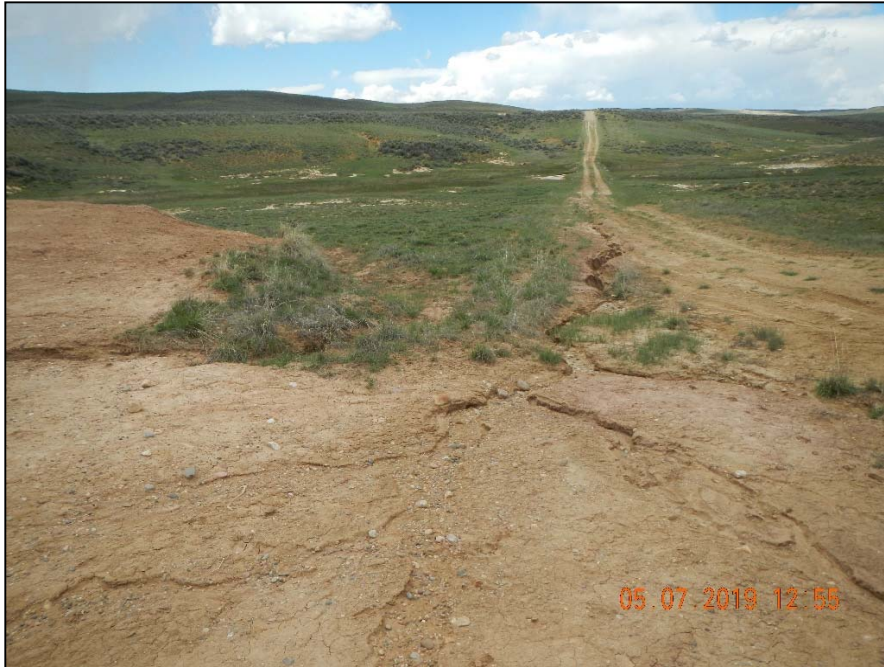
Photo 4. Erosion gullies leaving location and transporting sediment onto access road.

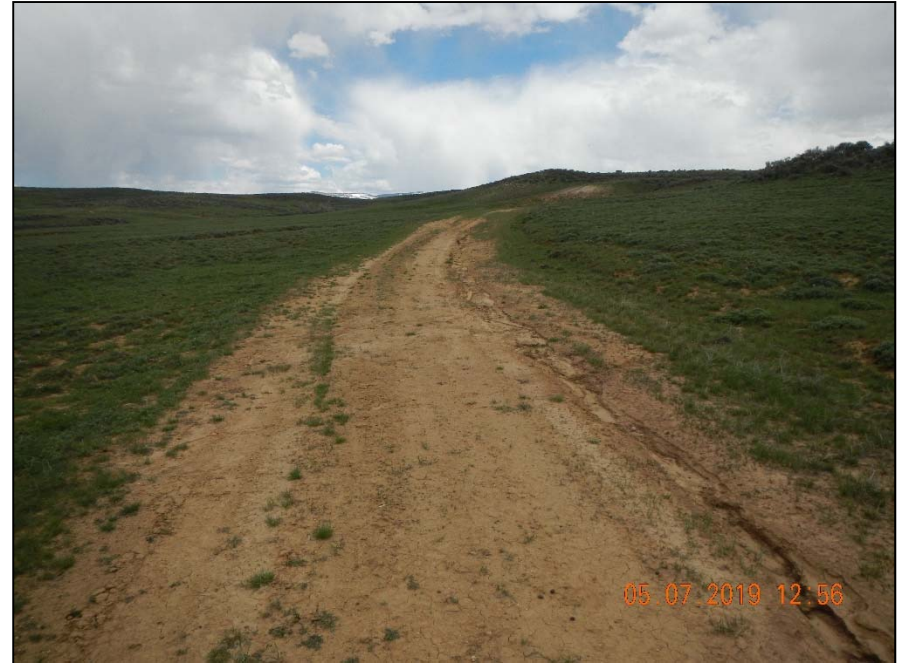
Photo 5. Sediment migration on access road.

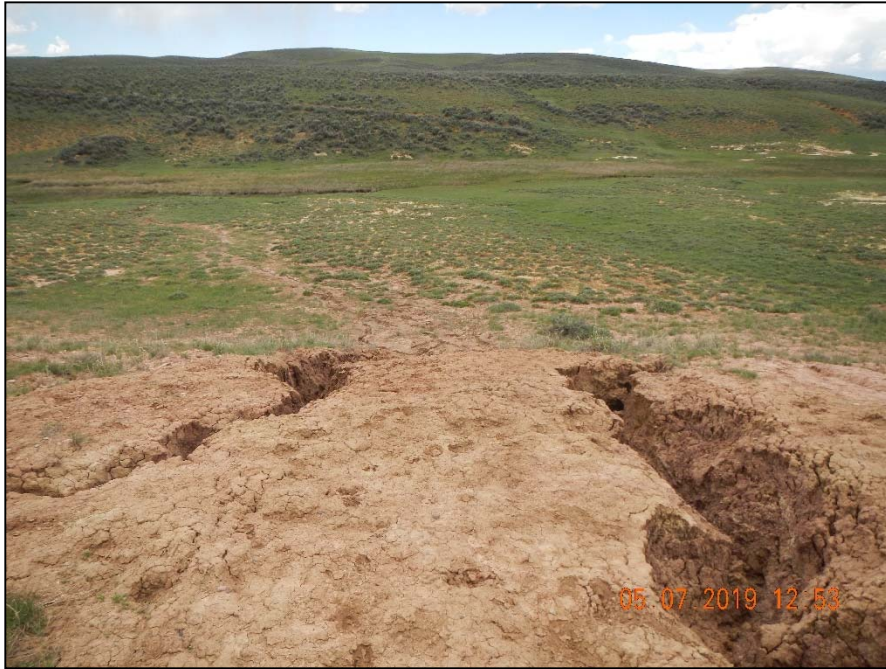
Photo 6. Erosion gullies leaving location and transporting sediment towards drainage in background.

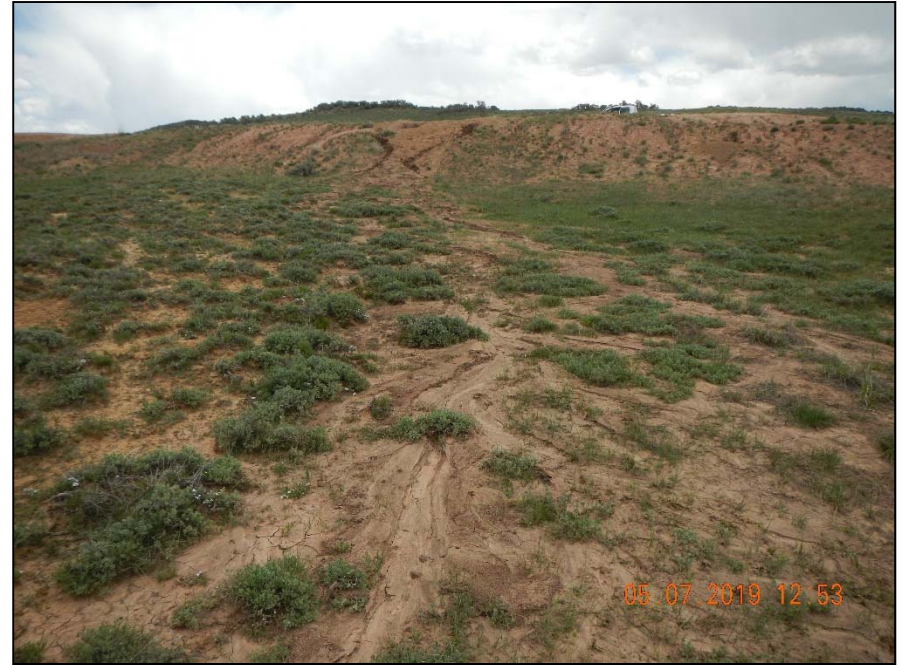
Photo 7. Sediment path of migration from location.
