Federal 11-90-35 #1 —API—051-06059 - Inspection Doc 693900462 -6/19/19

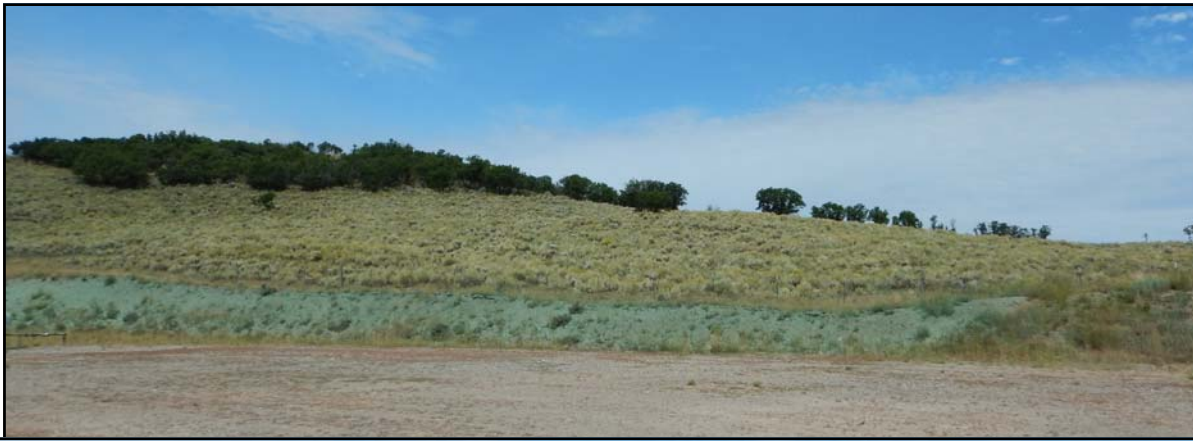
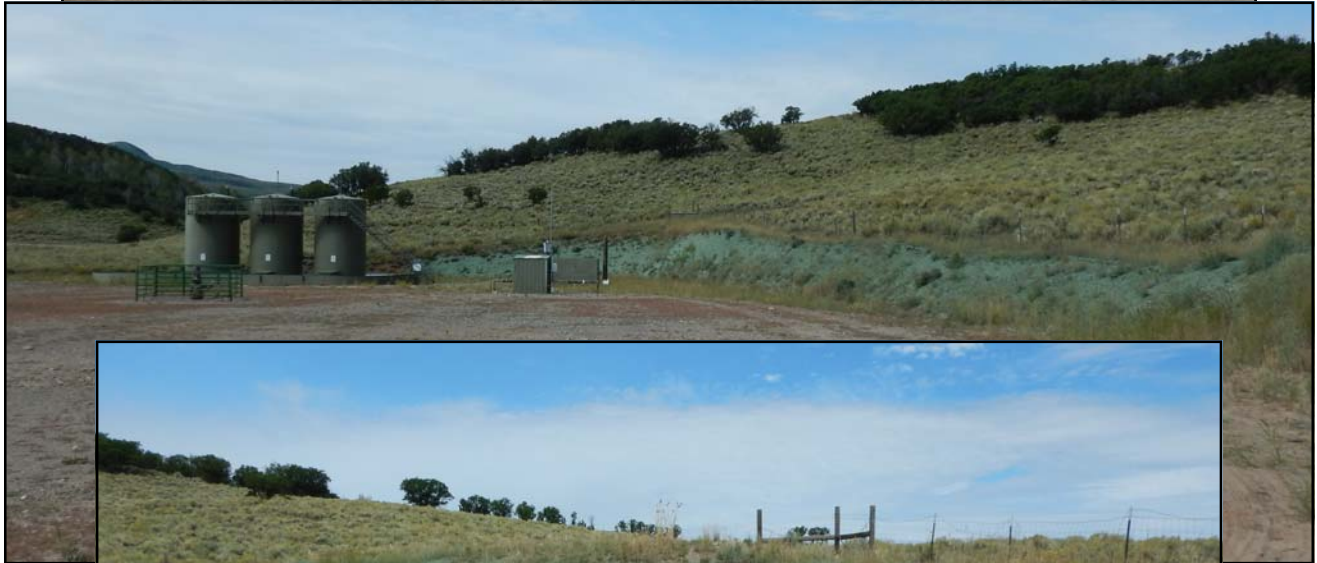
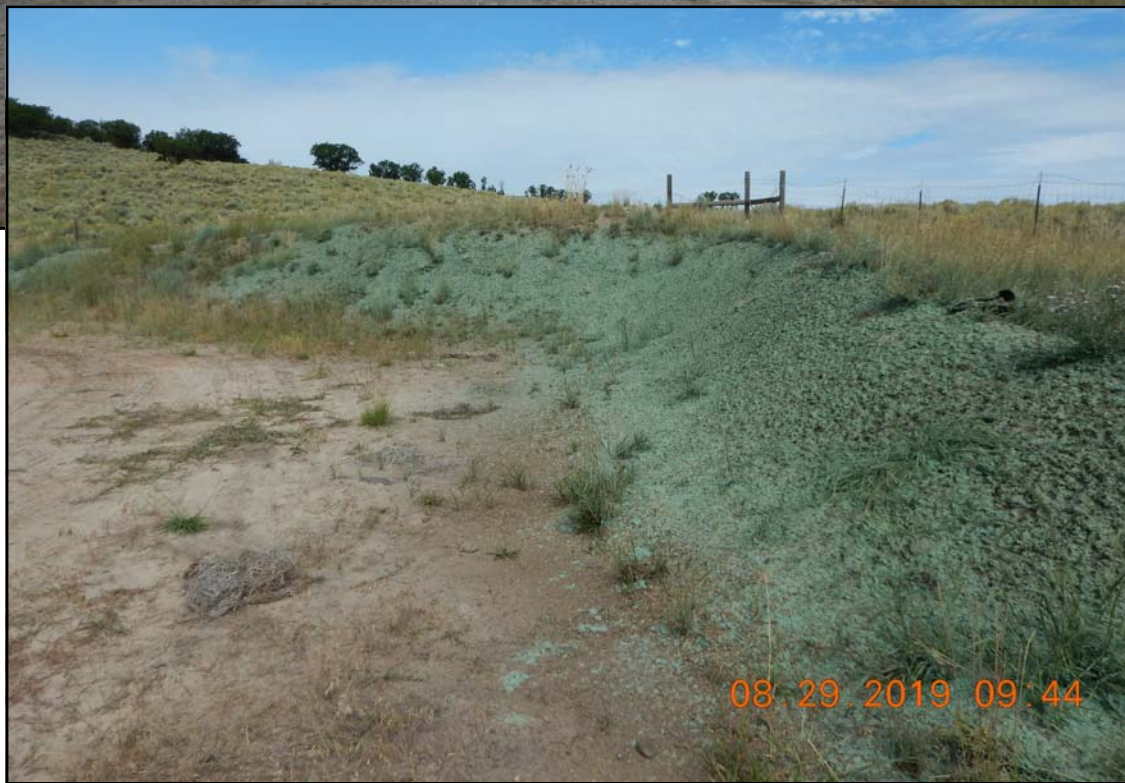
CA #1 of 1—Repair/replace erosion control blanket, additional slope stabilization measures are needed on all well pad cut-slopes.

Erosion Control Blankets acted as designed and have been removed. Additional slope stabilization measures were added.
