Inspection Photos

API: 05-061-06293

Operator: CHEMCO INC

Inspection Date: 10/7/2019

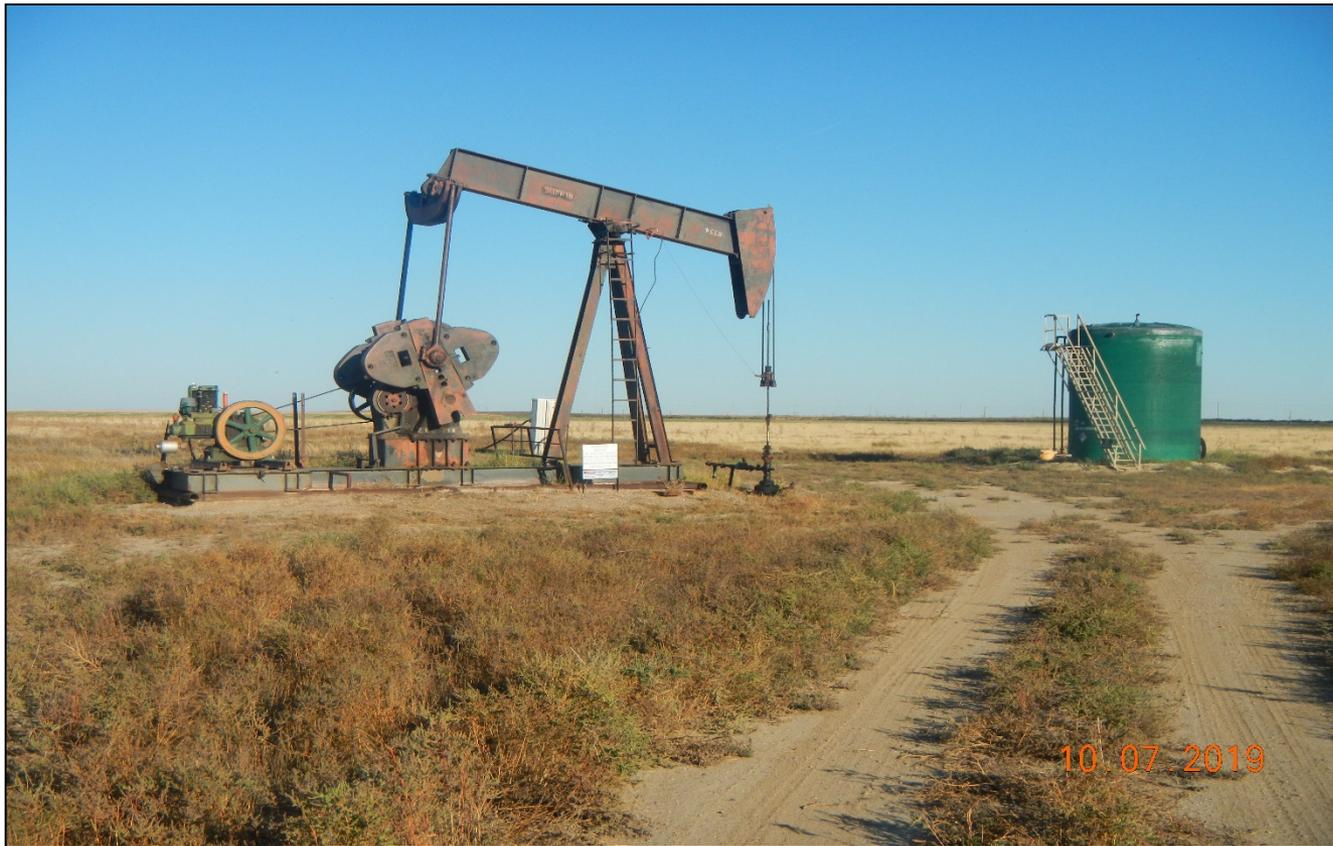
Photo 1. Facing southwest toward the location.

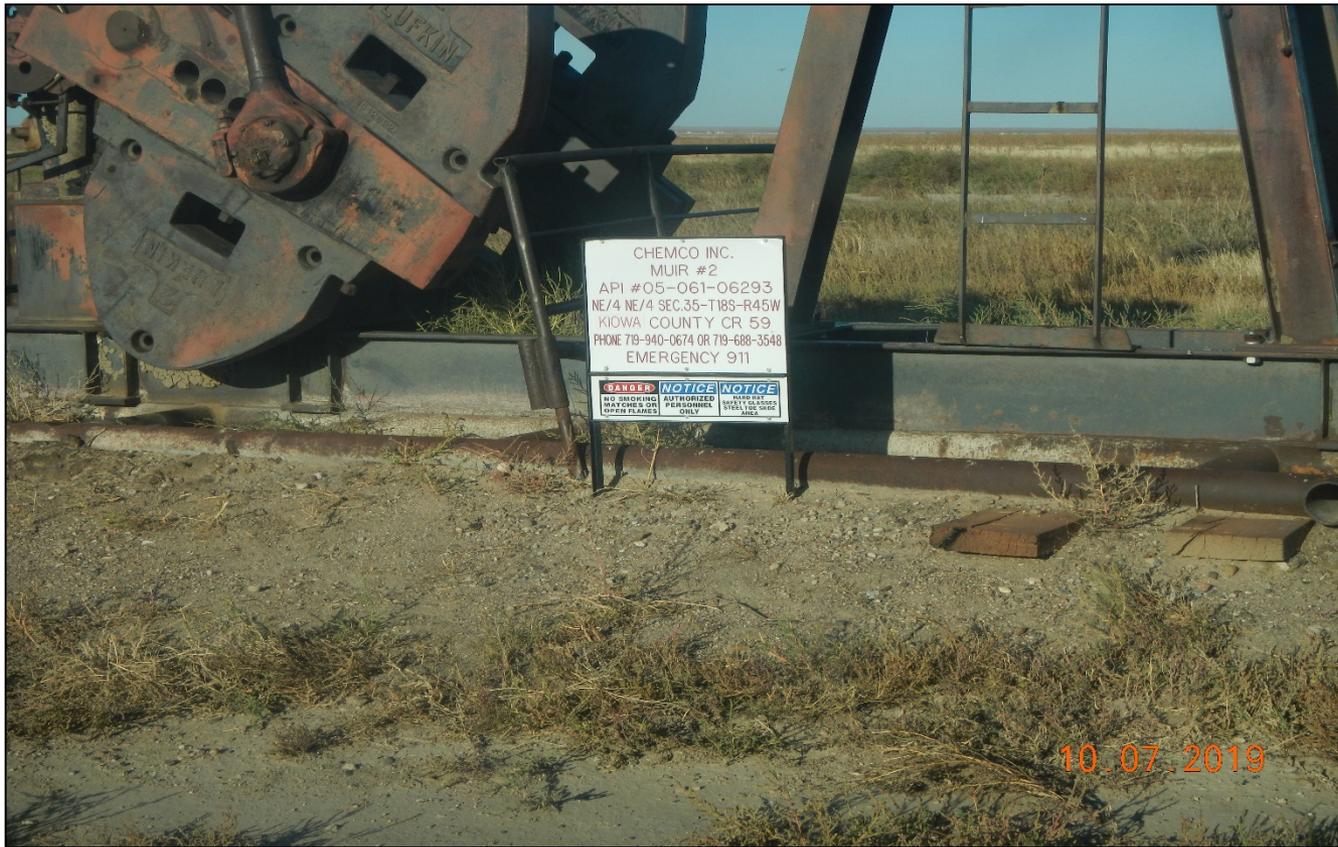
Photo 2. Well sign is posted at the wellhead.

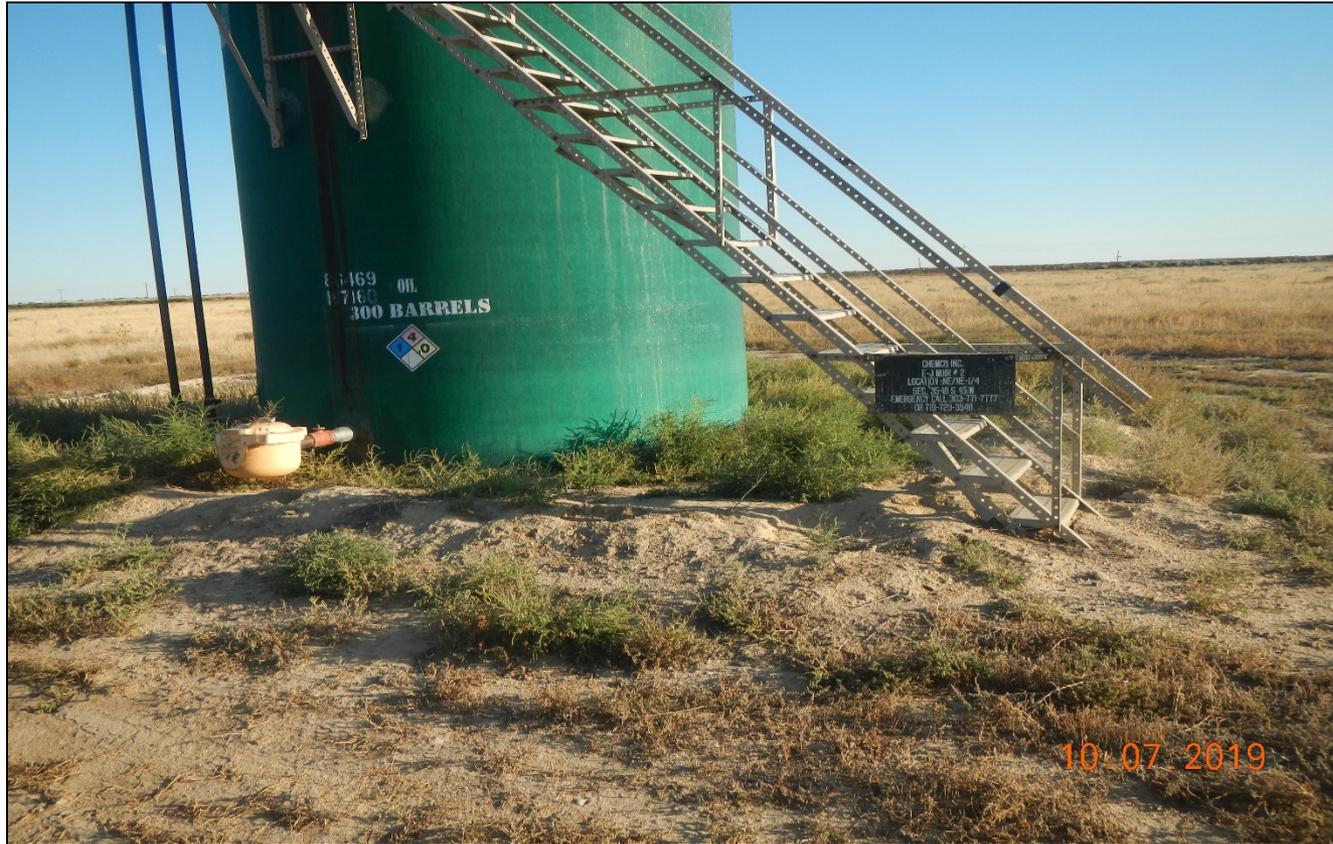
Photo 3. The berm around the tank is degraded and not sufficient to contain a spill.

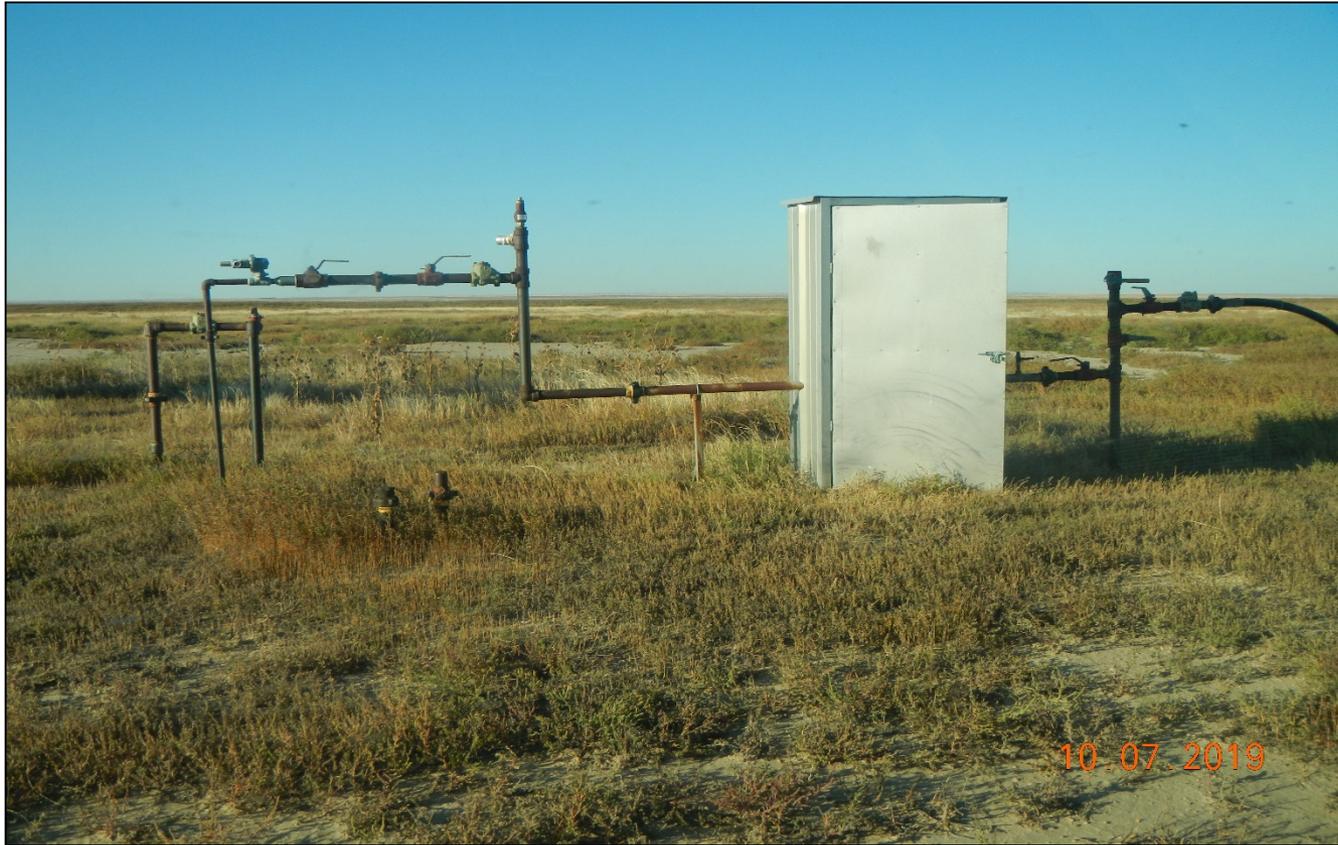
Photo 4. Pipe risers at the location have no LO/TO.

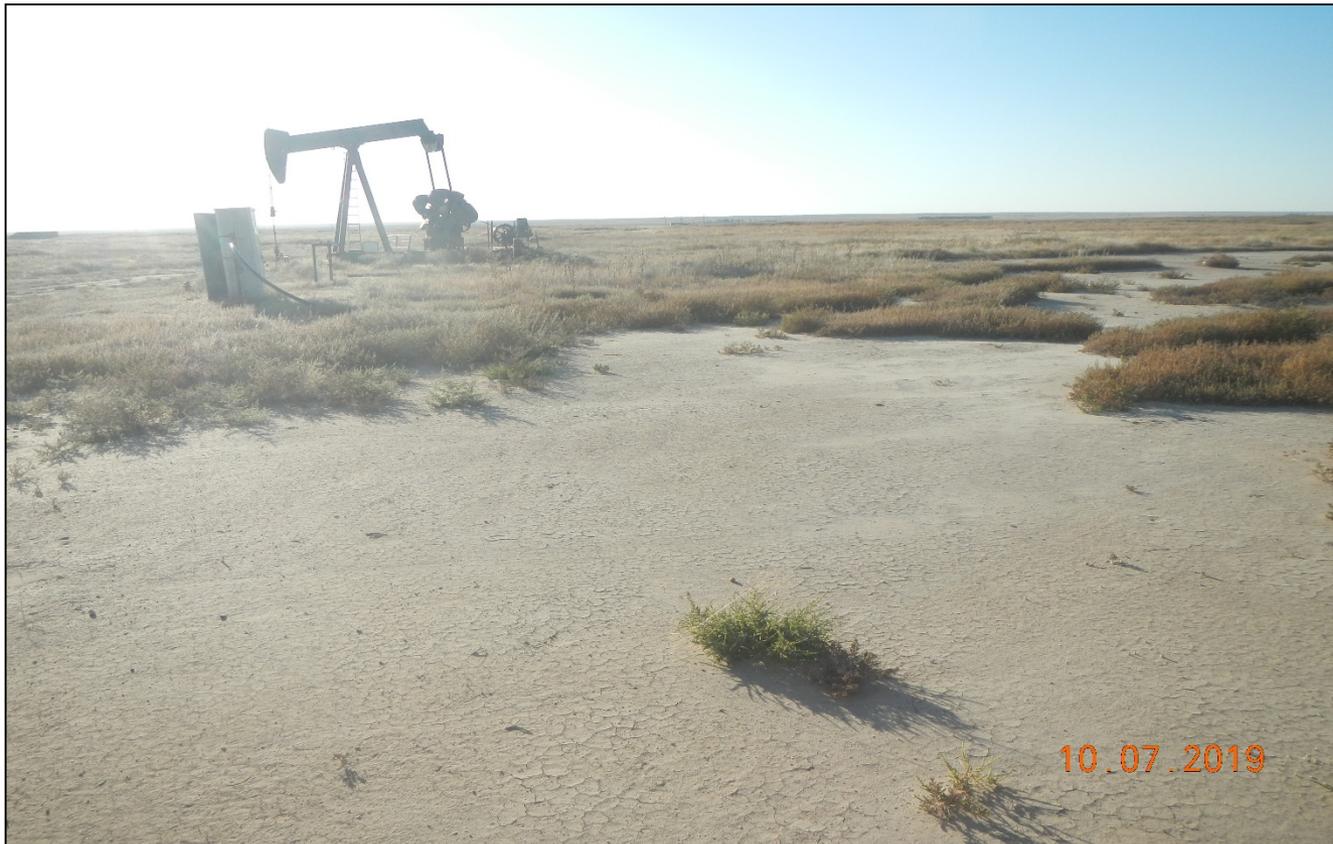
Photo 5. Facing west toward the wellhead. The area northeast of the well is bare of vegetation and appears to be a result of a spill.

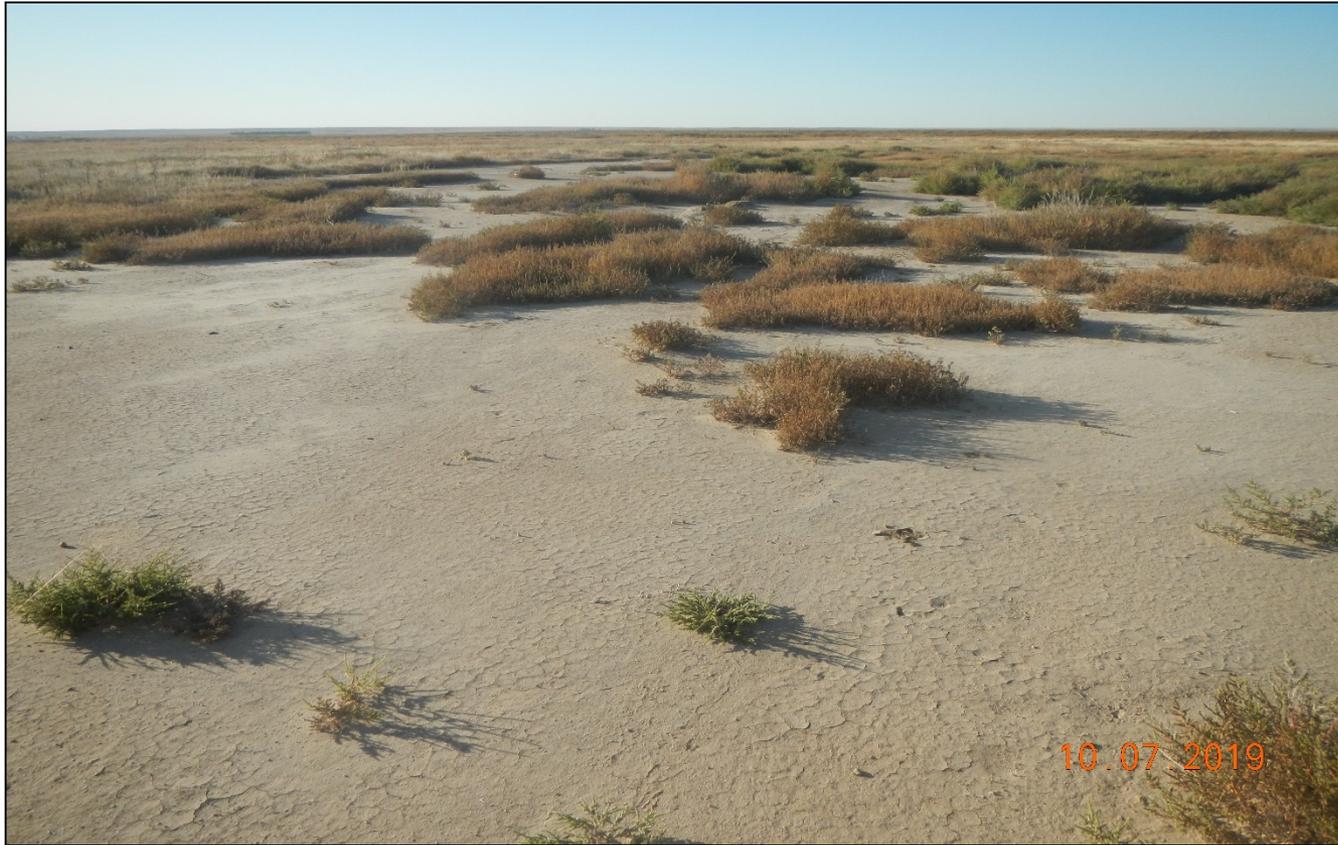
Photo 6. Facing north at the location which appears to have been impacted by a spill.

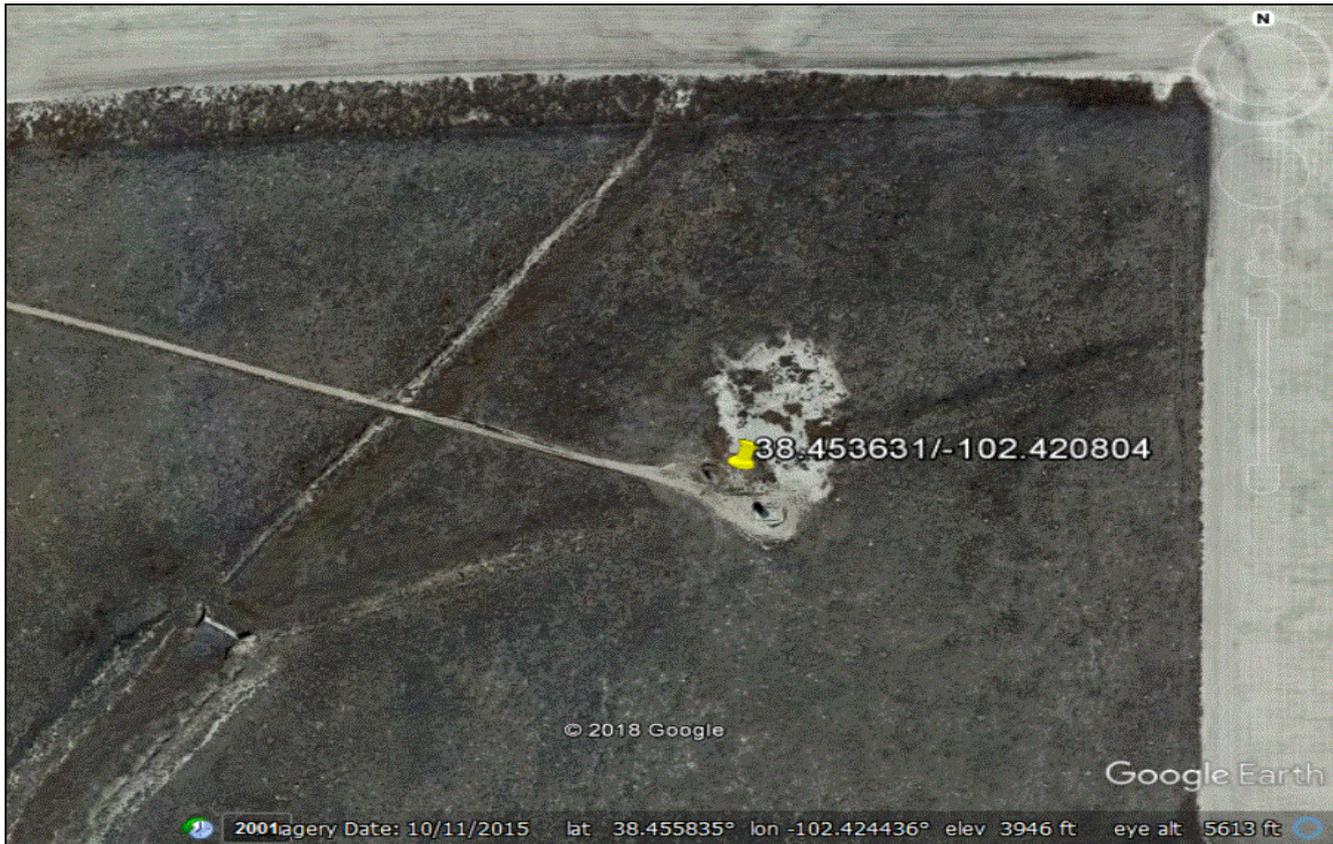
Photo 7. View of aerial image shows area north of the location bare of vegetation which may be the result of a former spill.
