Inspection Photos

Location Name: FIRWHAWK 34-26 FOLLOWUP

API#: 05-071-08389

INSP. #: 695101752

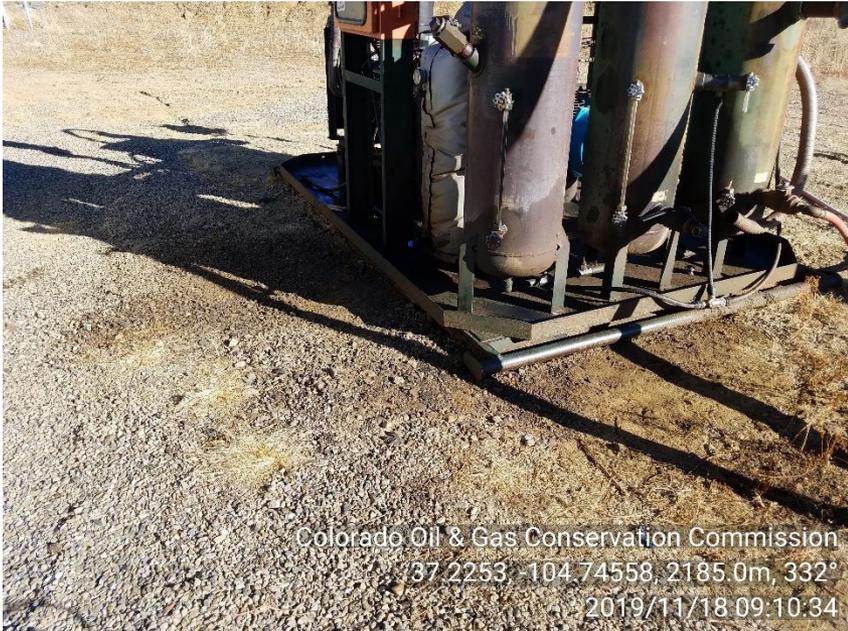
PHOTO 3: AREA OF IMPACTED SOIL AROUND COMPRESSOR SKID. Remove and dispose impacted material in approved manner, service and maintain equipment and self inspect to prevent recurrence of conditions per 1002.f(2) and 907. 12-03-19
