LEAK LOCATION SERVICES, INC.

Subject: Report for the Geomembrane Leak Location Survey of the Pond 2 Water
Impoundment at the Harrison Creek Water Treatment Facility in
Mesa County, Colorado
LLSI Project 2935

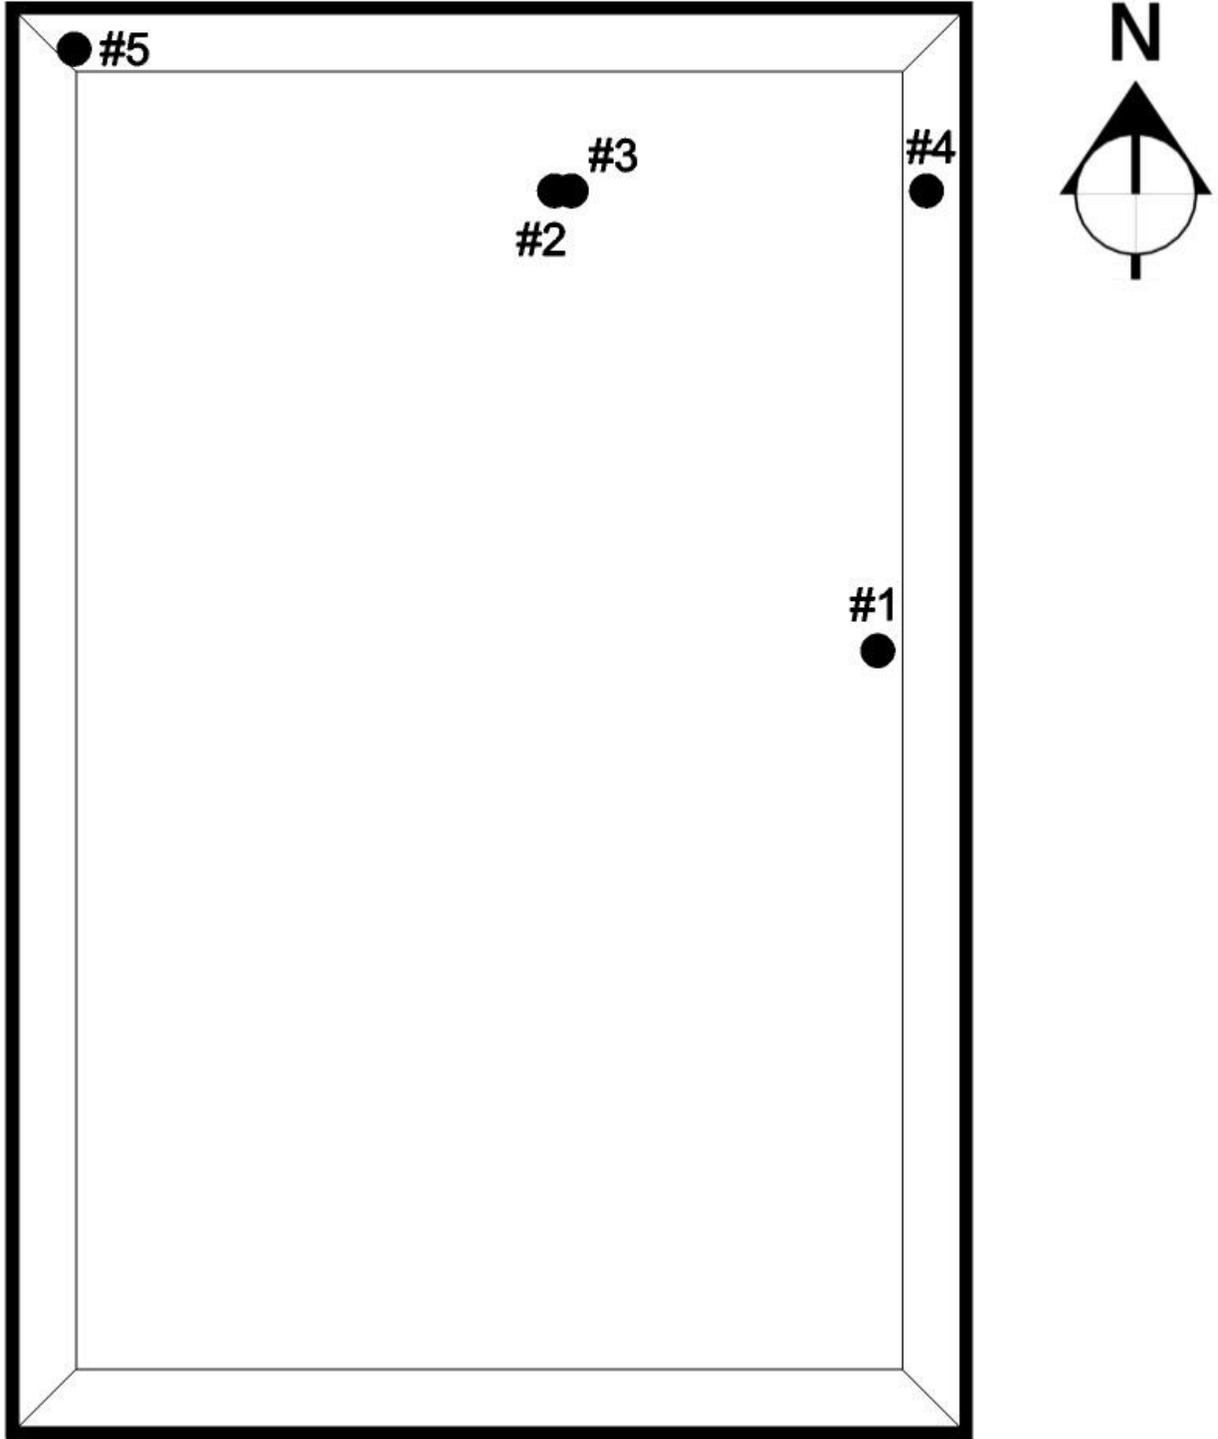
FIGURE 1. APPROXIMATE LOCATIONS OF LEAKS IN POND 2

Five leaks were found in the primary geomembrane of Pond 2. Figure 1 shows the approximate locations of the leaks and Table 1 lists the approximate locations of the leaks found in Pond 2.

LEAK	LOCATION
1	Approximately 25 feet west from the mark at line 230, which is 230 feet north of the south slope.
2	Approximately 124 feet west from the mark at line 370, which is 370 feet north of the south slope.
3	Approximately 121 feet west from the mark at line 370, which is 370 feet north of the south slope.
4	Approximately 10 feet west from the mark at line 370, which is 370 feet north of the south slope.
5	Approximately 15 feet south from the mark at line 290, which is 290 feet west of the east slope.

To relocate the leaks, stretch a string line between the corresponding survey line markers on the opposite sides of the lagoon and then lower the line onto the geomembrane. Use a tape measure to measure the distance from the mark on the geomembrane along the string line to the leak. The tape measure should go down the slope to the toe of the slope and then along the floor to the leak. Draw a short line perpendicular to the end of the tape measure. The leak should be close to the perpendicular line. If two measurements are provided, repeat this process from the second mark. The leak will be close to the intersection of the lines perpendicular to the end of the tape measures.
