Interim Reclamation Inspection

June 8, 2020

Operator: ROCKY MOUNTAIN MIDSTREAM LLC #10716

Facility ID: 476934

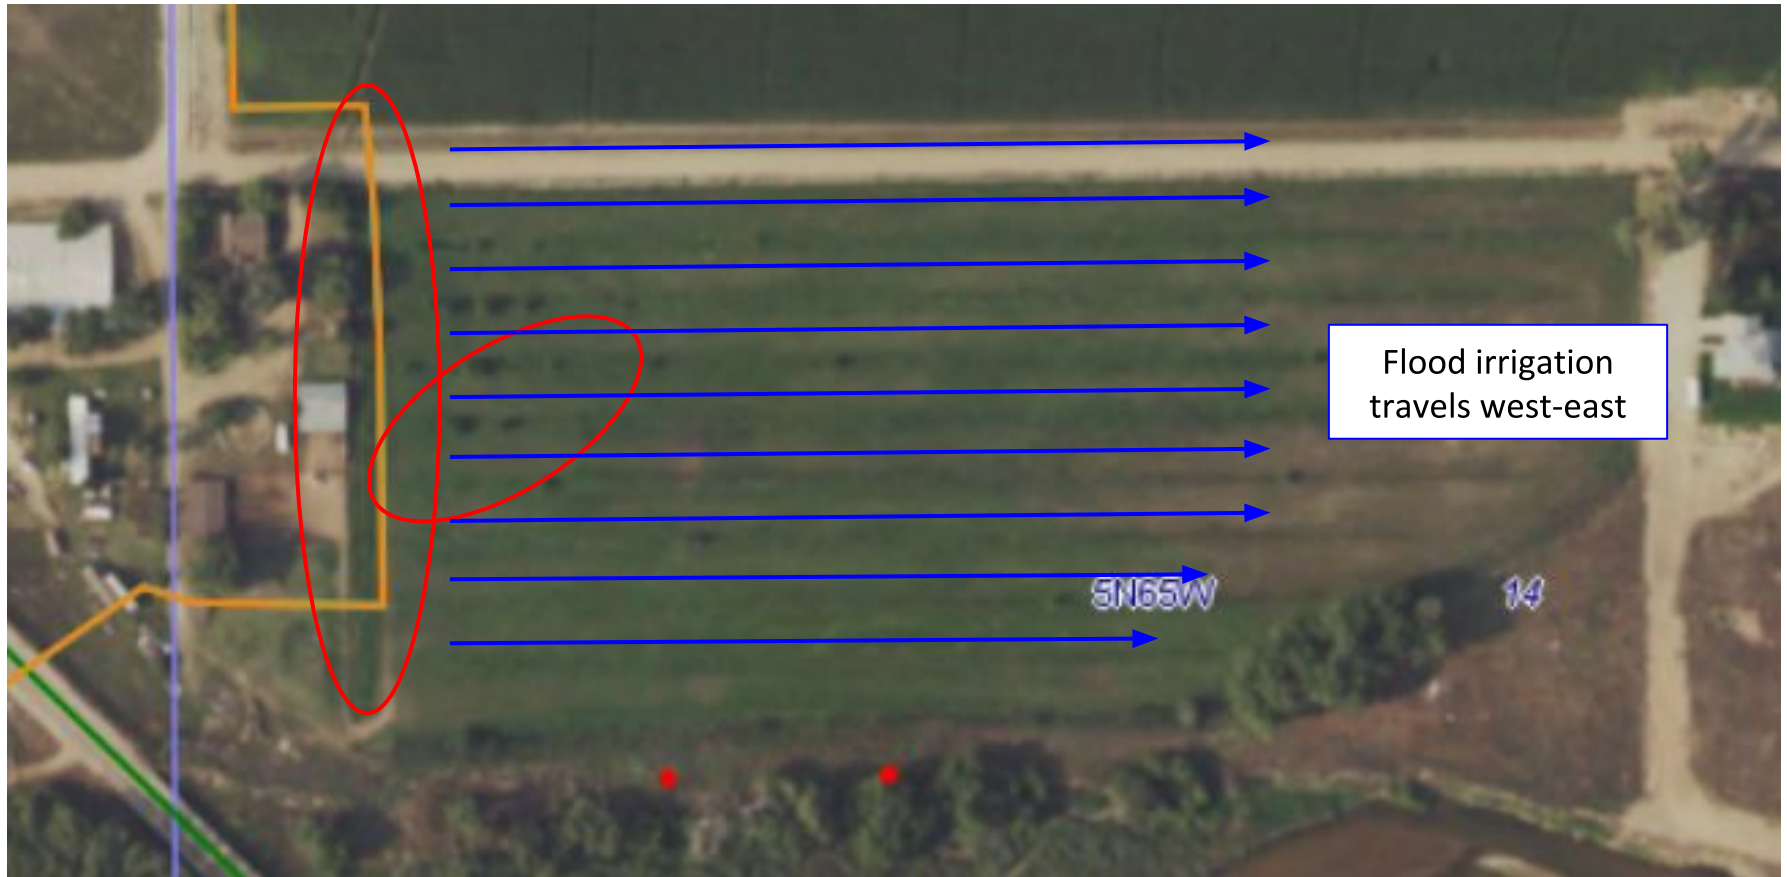
Photo 1. COGCC COGIS 2017 aerial imagery illustrates approximate areas concerning a complaint filed by the surface owner. An active crude oil line (orange line) was first installed and then a second line (gas) was installed later. The second line is associated with the complaint issues.

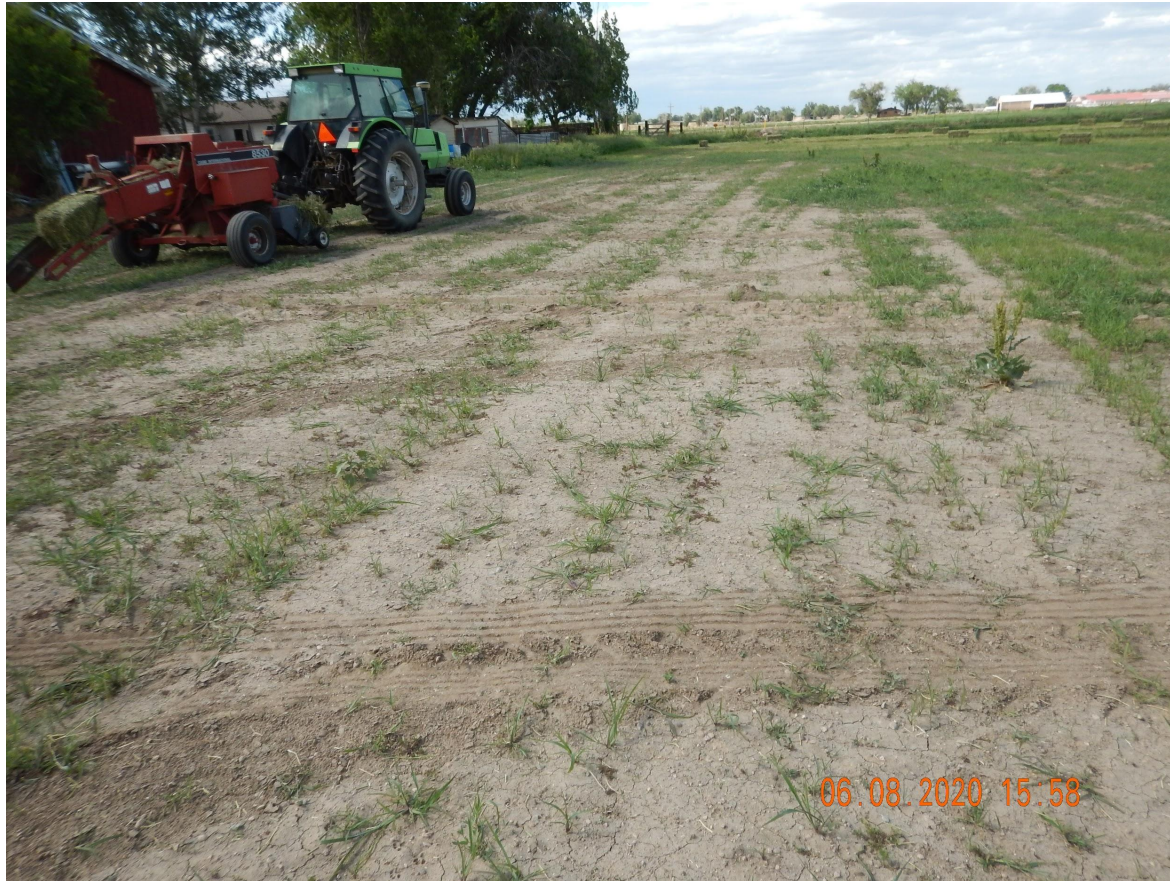
Photo 2. Photo taken from a portion of the line, facing North. Photo illustrates vegetation along the line is not reflective of reference areas. It appears the line has not been properly contoured to allow successful flood irrigation. Complainant indicated that irrigation water ponds along the line which should continue to flow east. Vegetative growth has been negatively affected along the line which is a likely result of ponding water.

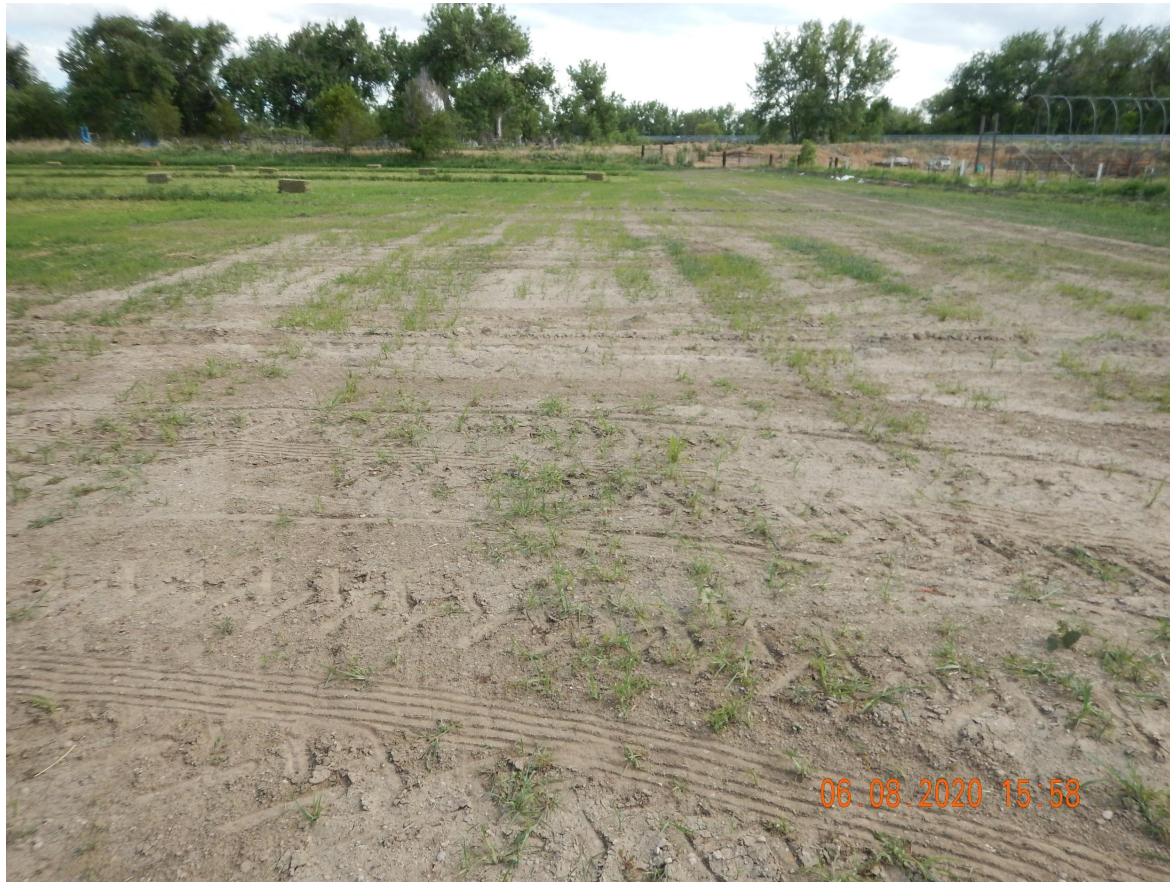
Photo 3. Photo taken from a portion of the line, facing South. See comments under Photo 2.

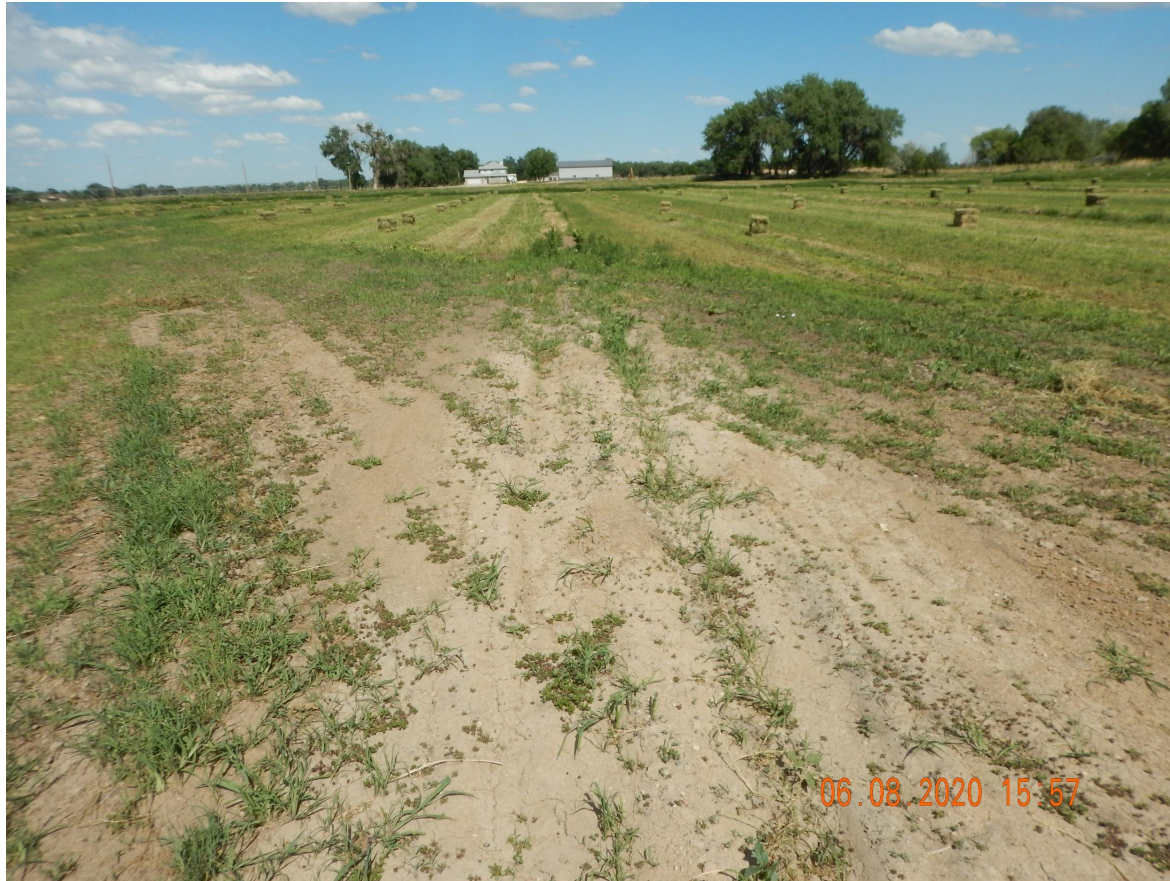
Photo 4. Photo taken from a section just east of the line, facing East. Photo illustrates an area where “topsoil” was imported. Based on field observations, there is no desirable vegetative growth throughout this section which indicates this imported “topsoil” is not suitable for vegetative growth.

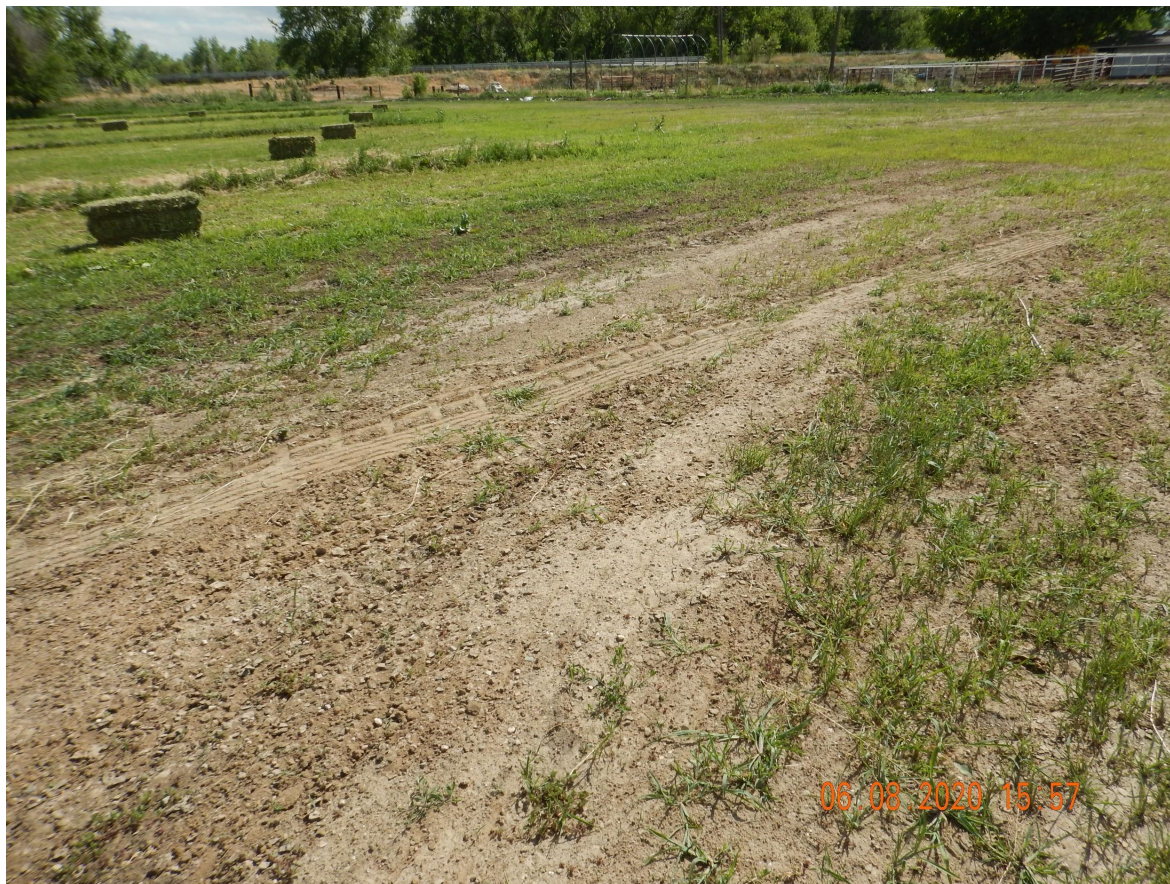
Photo 5. Photo taken from the same section from Photo 4, facing South. See comments under Photo 4.

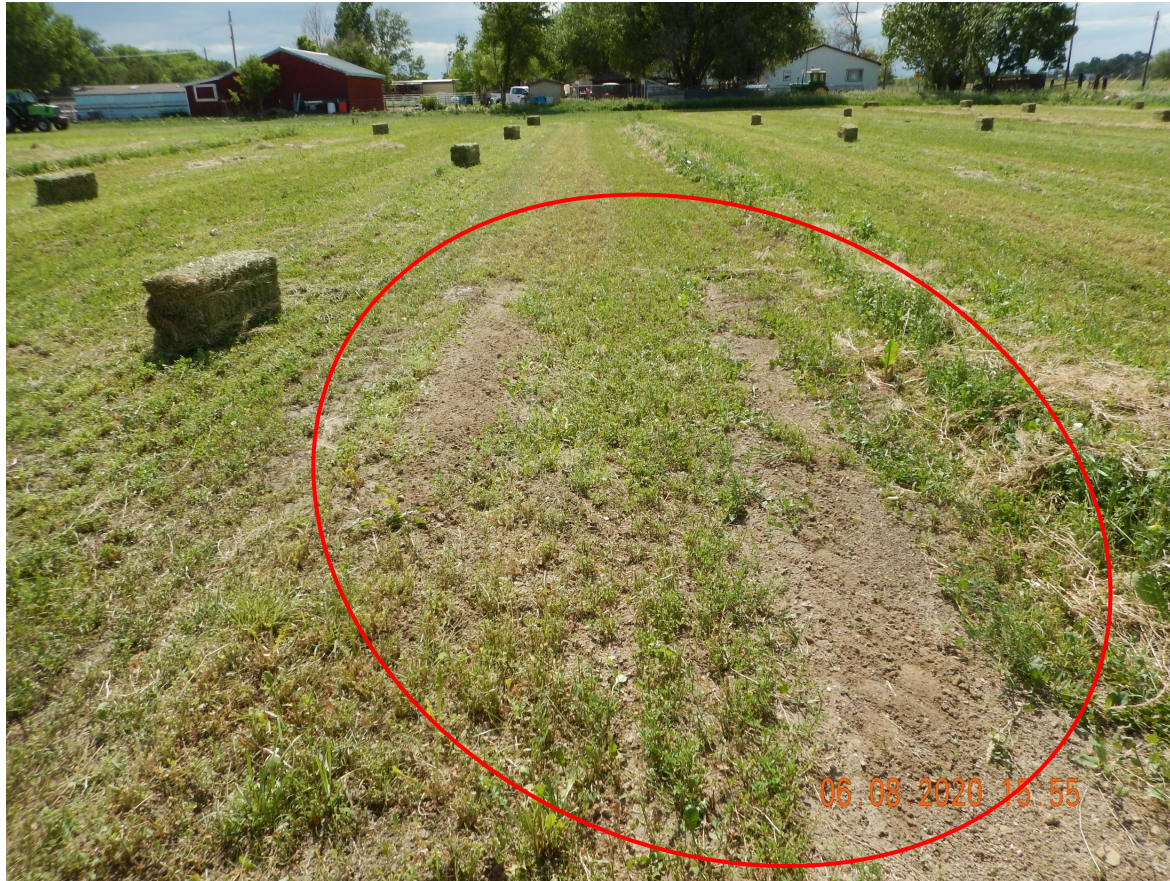
Photo 6. Photo taken from a section east of the line, facing West. Photo illustrates an area where an Operator was observed, by the complainant, who was off the easement and caused damage a portion of the irrigation system and damaged the field.

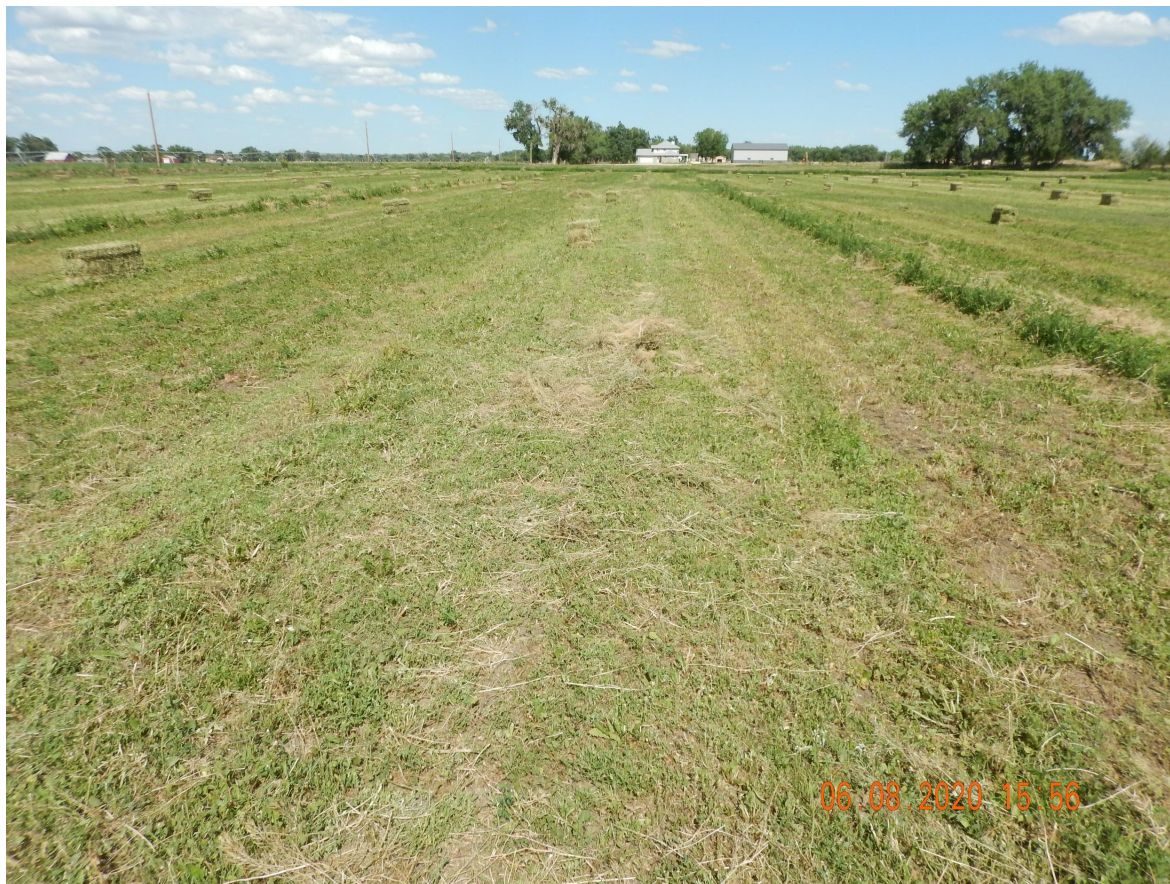
Photo 7. Reference photo taken east of the line, facing East. Photo illustrates the line areas and other sections shown in Photos 4-6 are not reflective of reference areas.
