Inspection Photos
Operator: BP America
API: 067-08507
Date: 8/3/2020

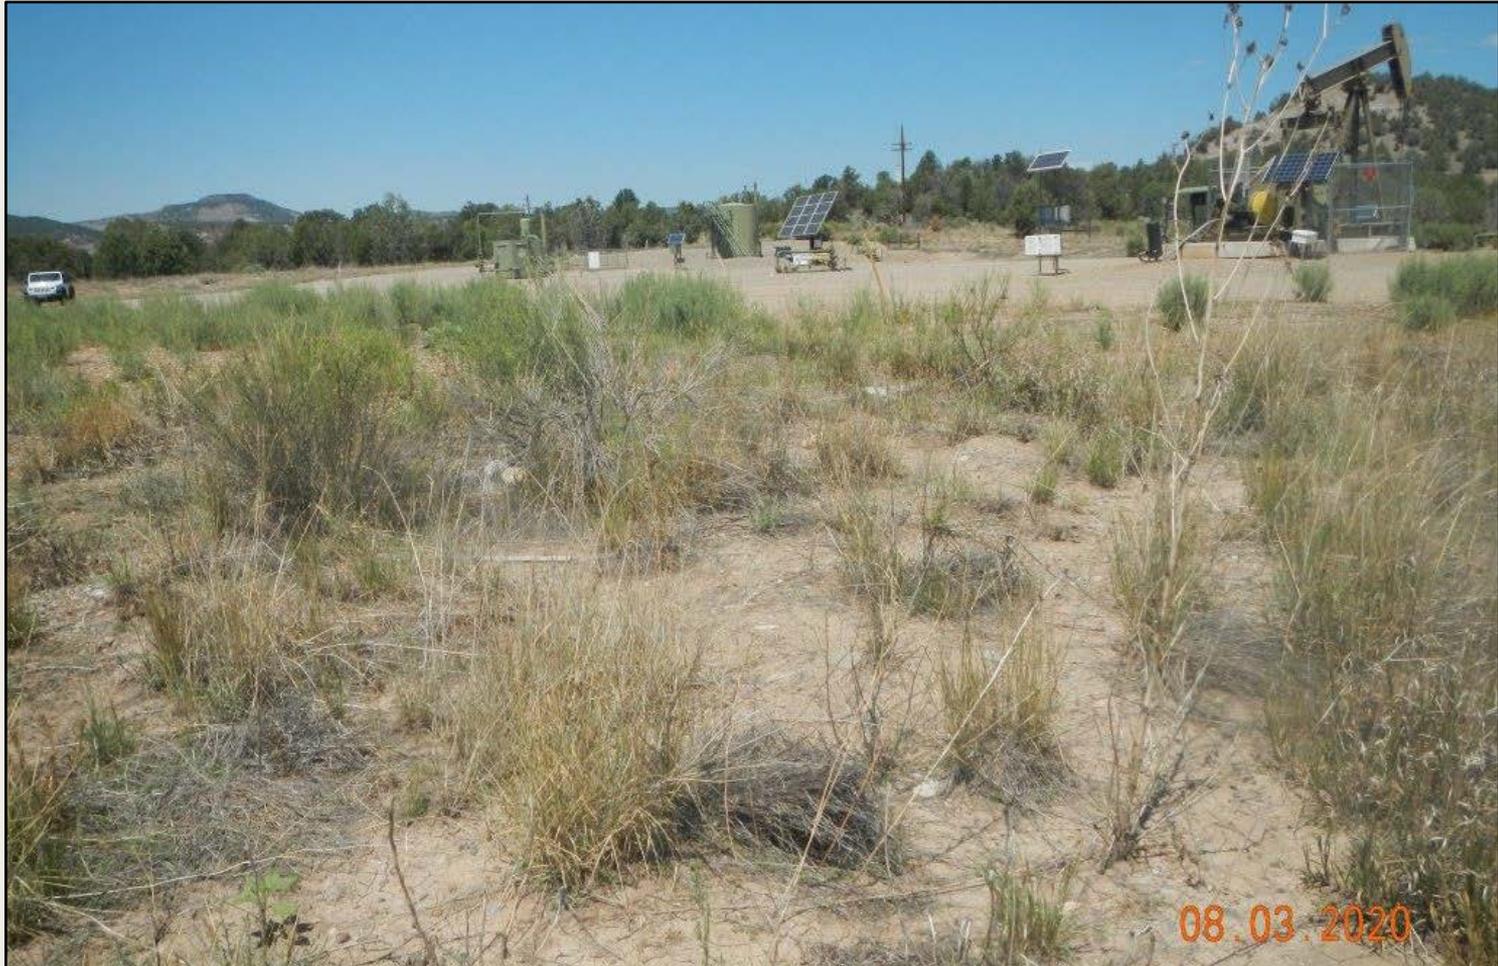
Photo 1. View of the project area from the southeastern corner facing center.

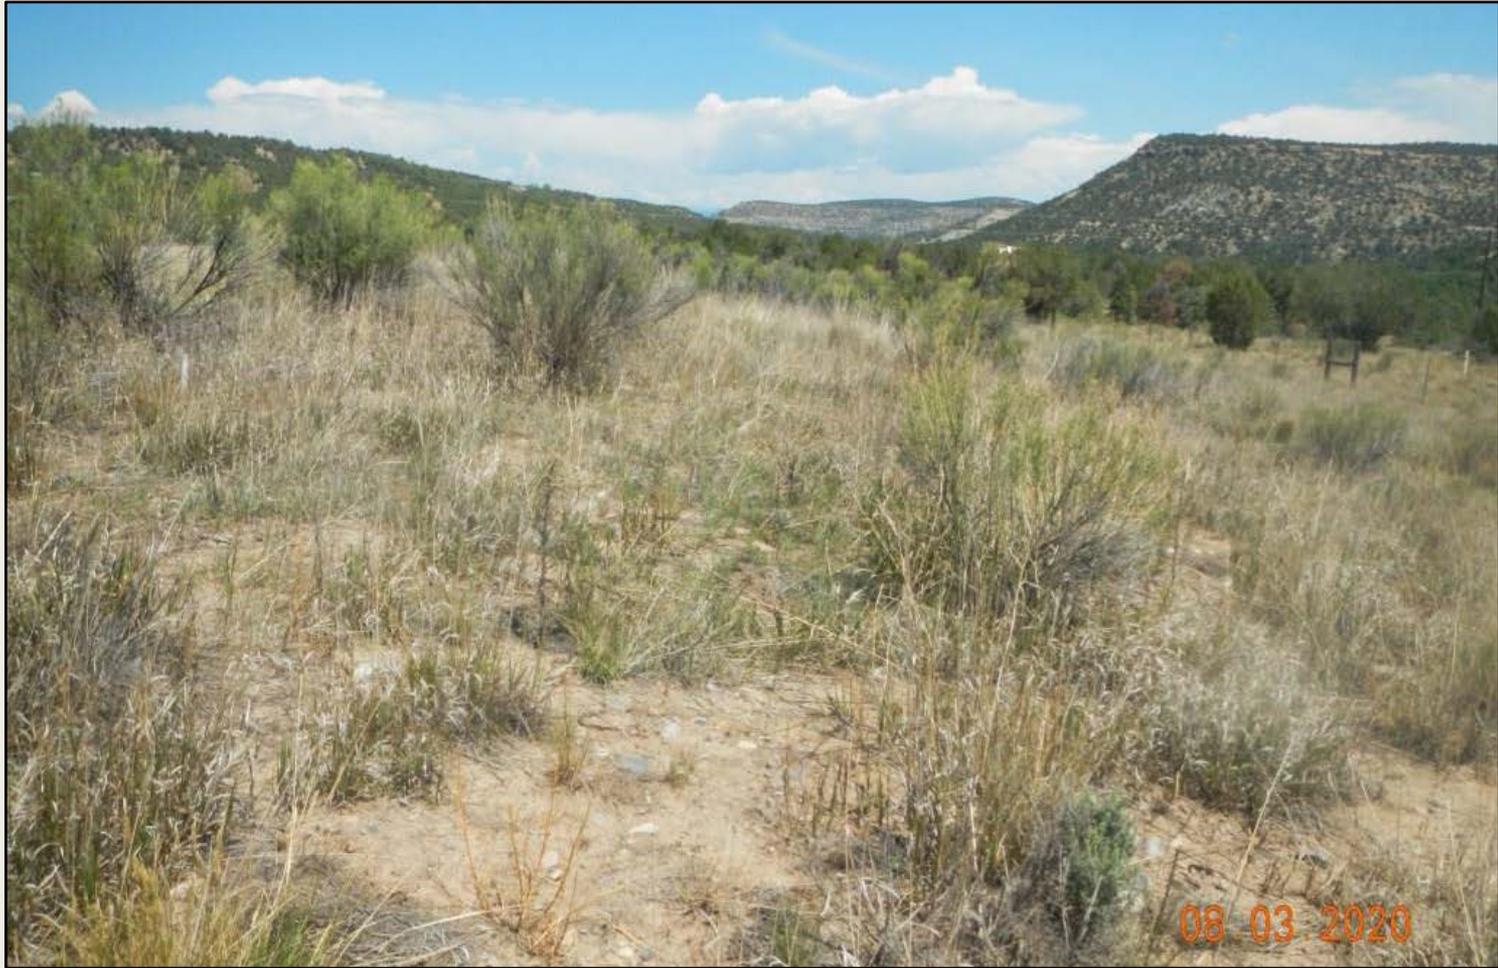
Photo 2. View of the eastern project area from the southeastern corner facing northward. Revegetation is progressing with smooth brome, crested wheatgrass, western wheatgrass, and rubber rabbitbrush.

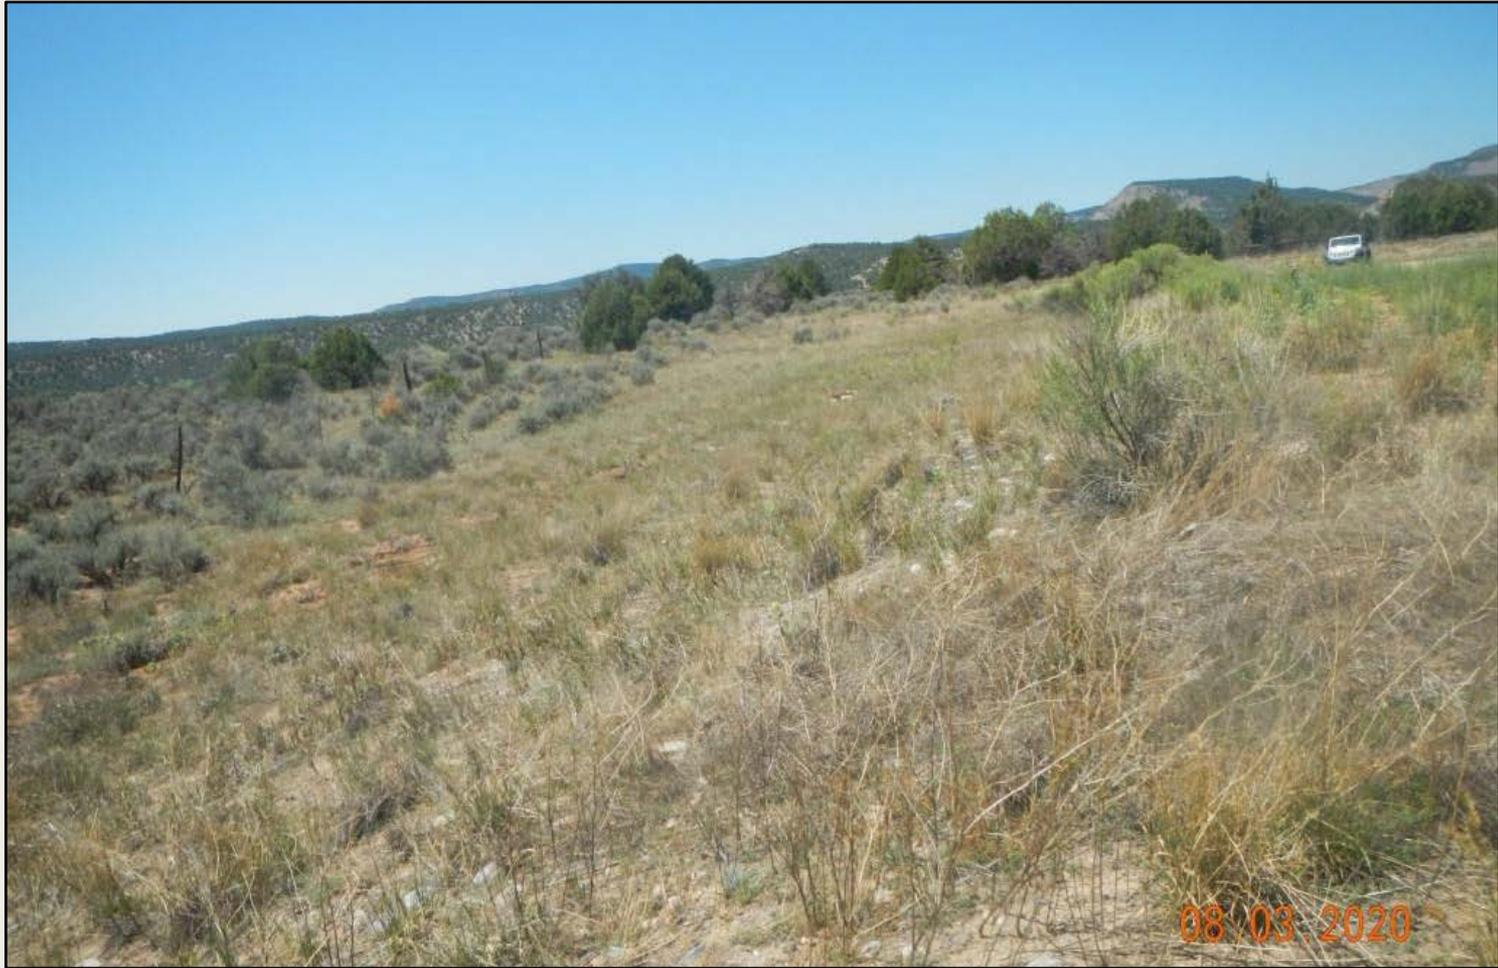
Photo 3. View of the southern project area from the southeastern corner facing northward.

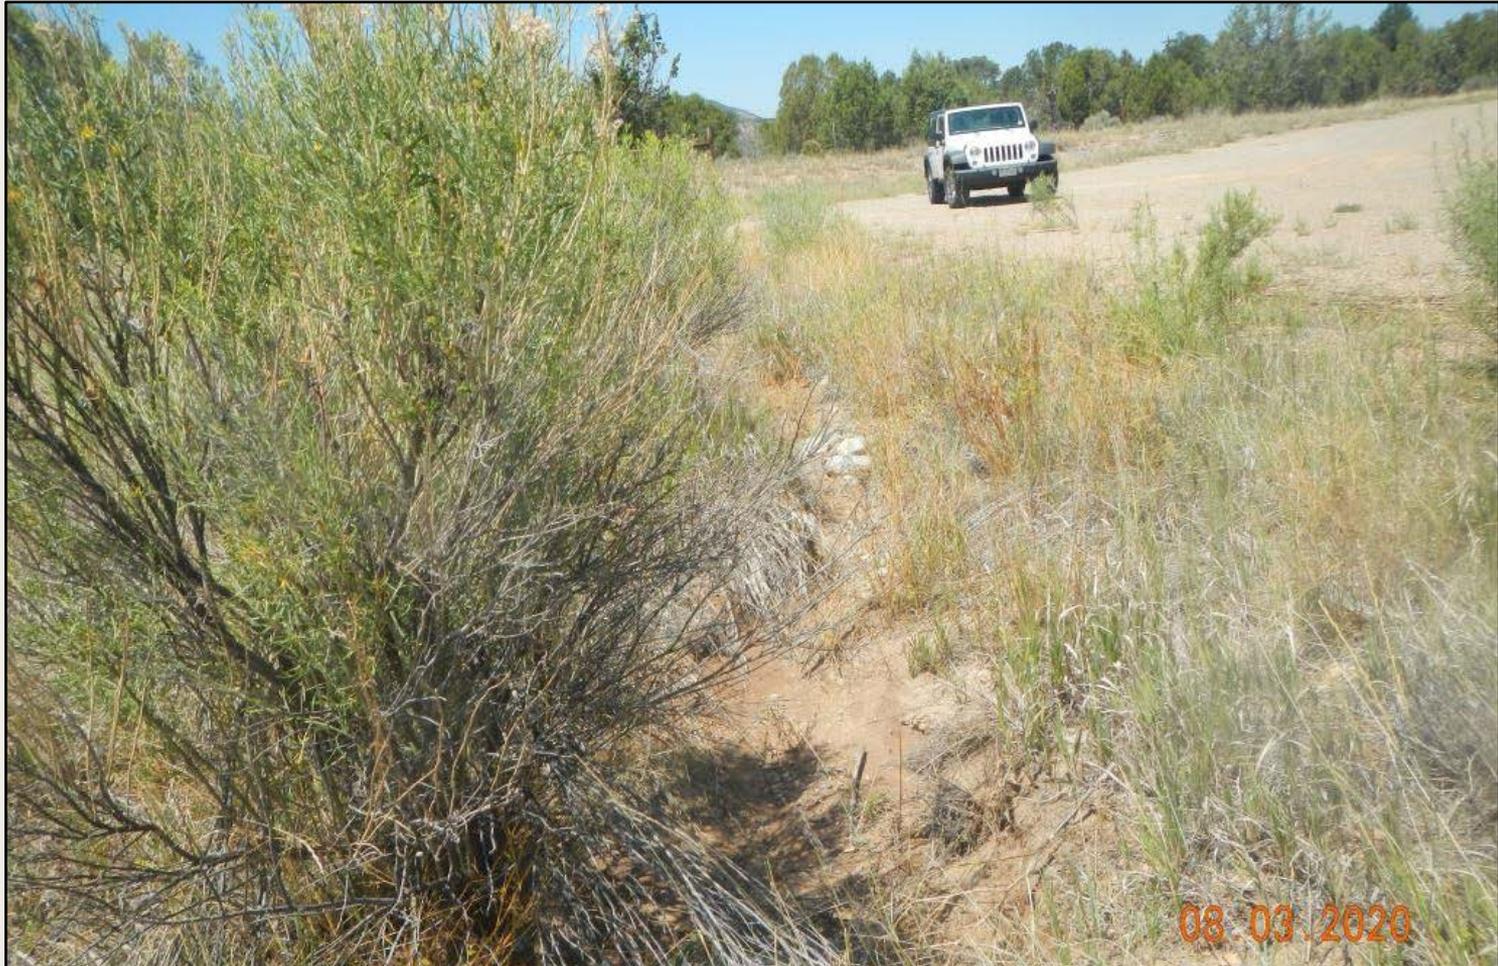
Photo 4. View of erosional channel approximately 2 feet wide and 1.5 feet deep, starting along the southwestern edge and flowing through the southern interim reclamation area.

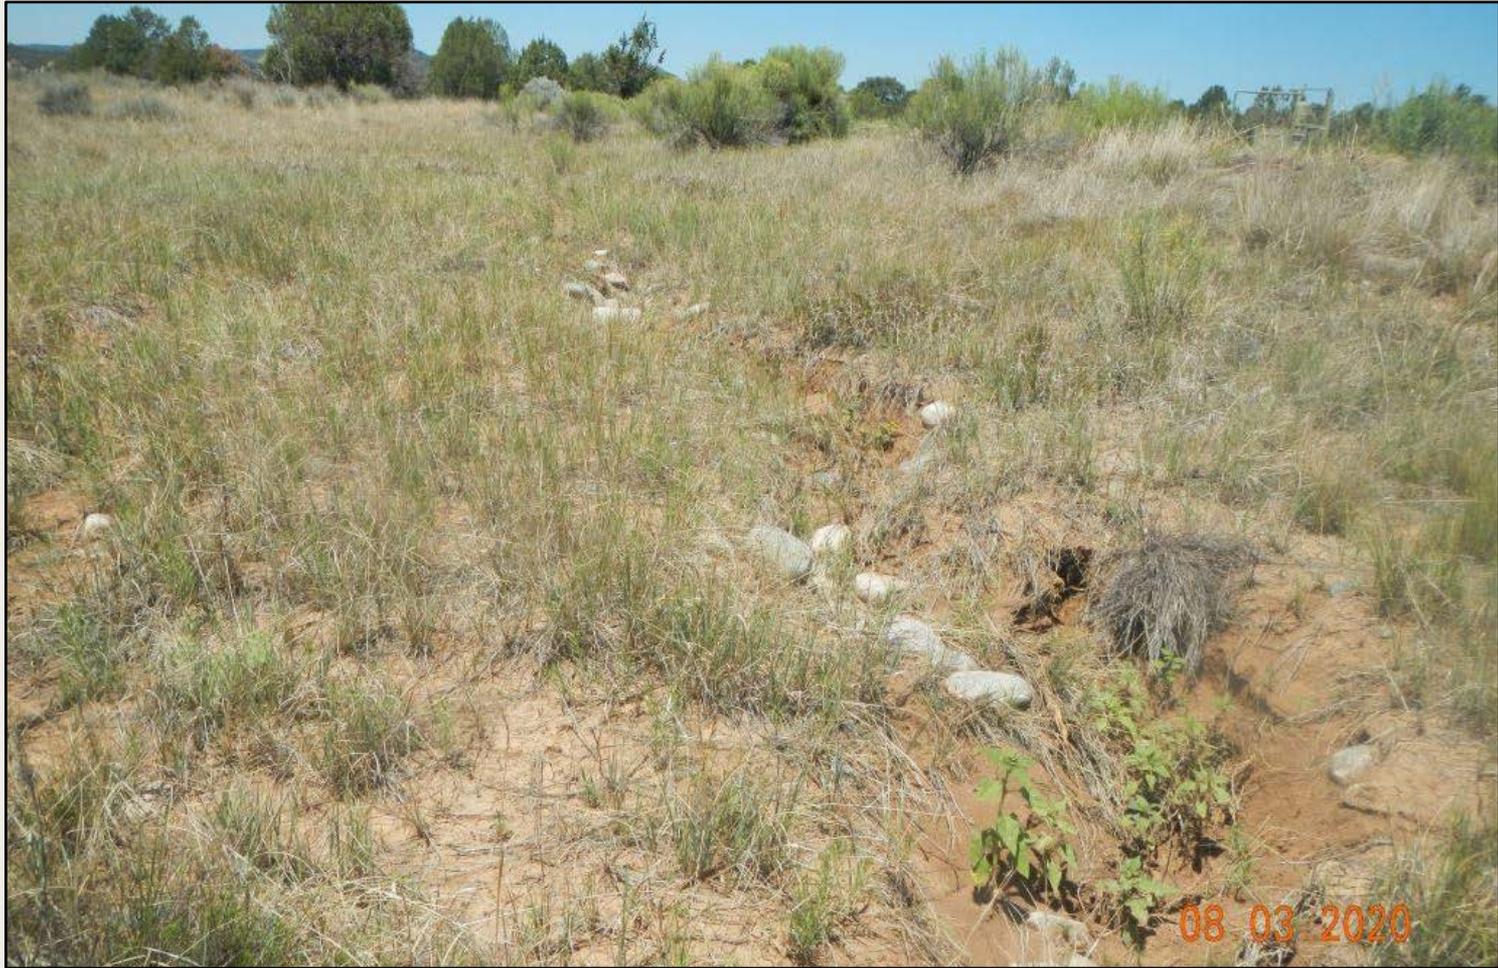
Photo 5. Another view of erosional channel in the southern project area. Cobble BMPs are not sufficient here and no longer functioning.

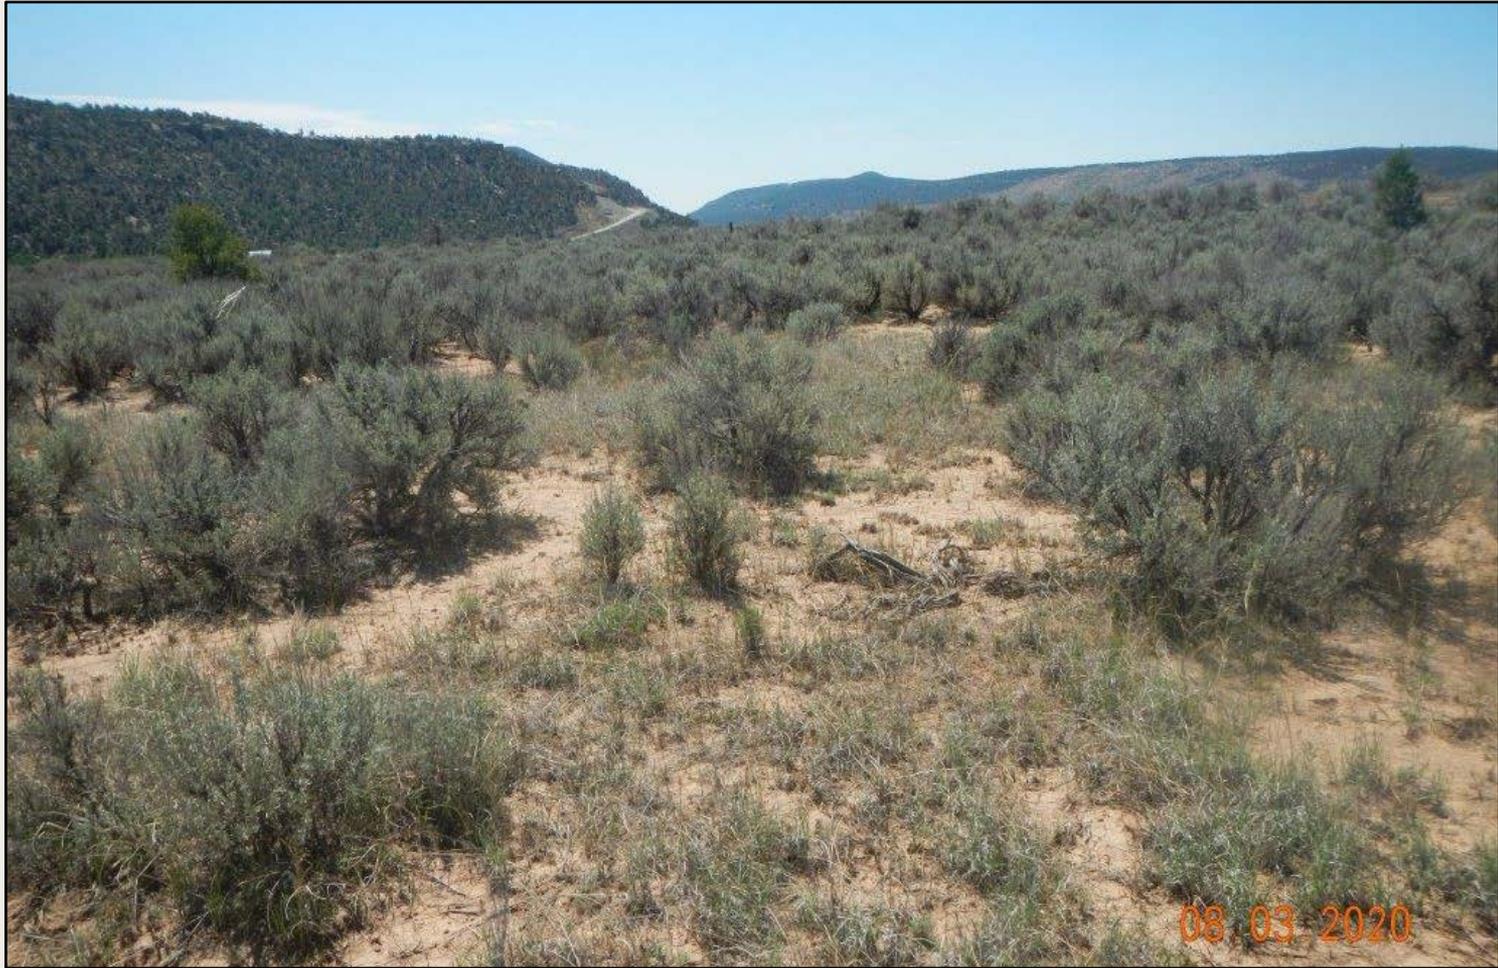
Photo 8. View of reference area vegetation comprised of sagebrush shrubland with understory of blue grama, sand dropseed, and hedgehog cactus.
