Inspection Photos

Operator: Hilcorp Energy
API: 067-08409
Date: 10/15/2020

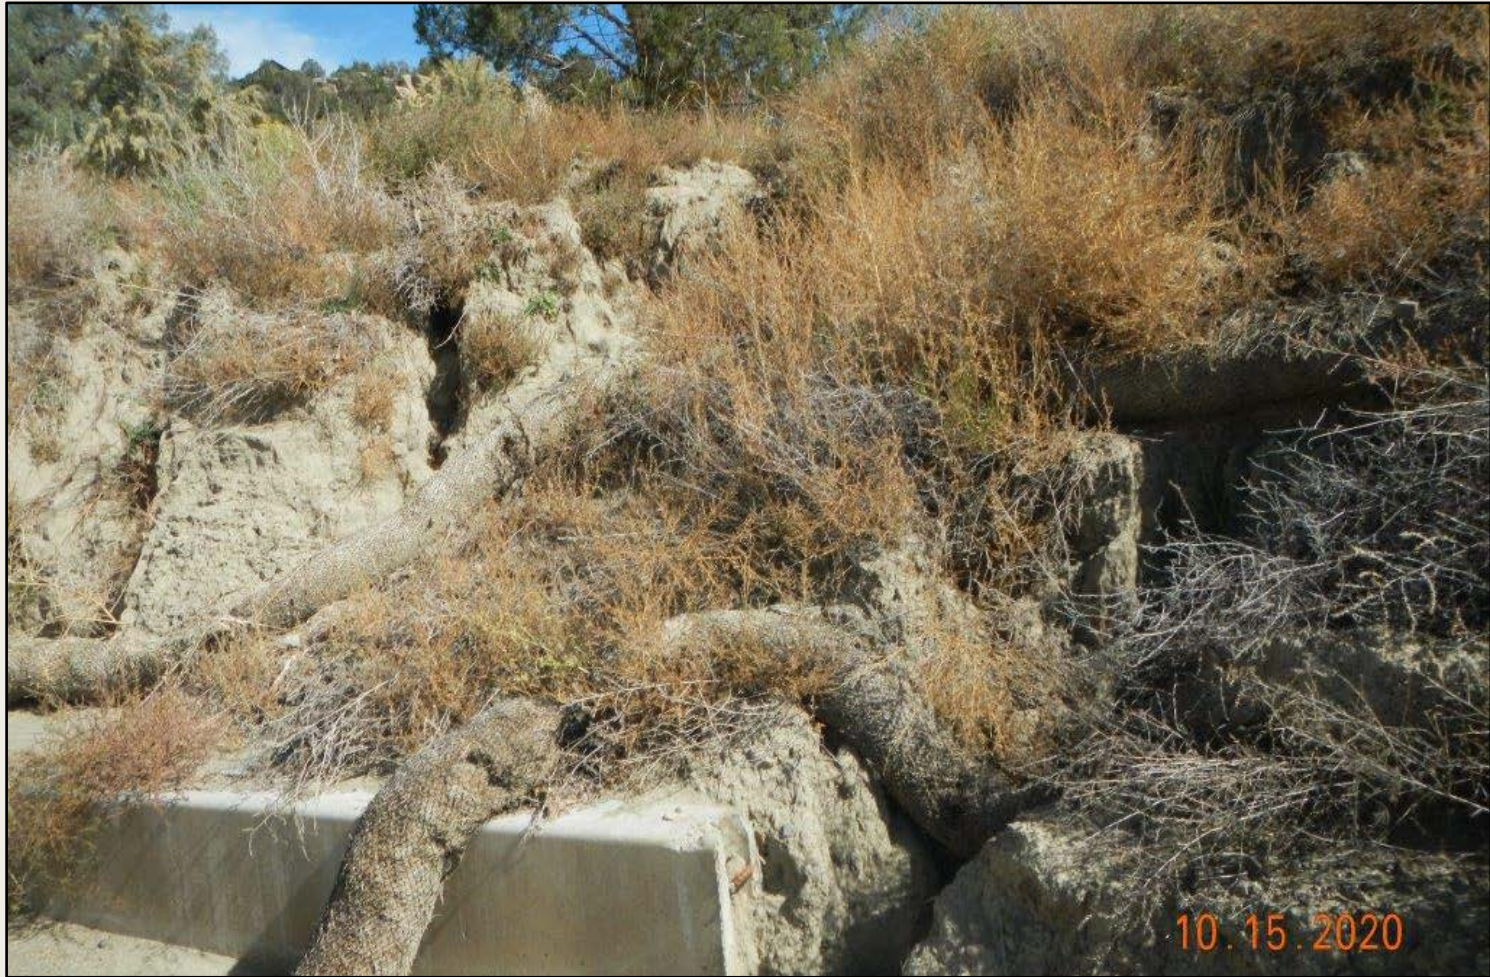
Photo 2. View of erosional channels and failed wattles within the southeastern project area. Erosional channels up to approximately 4 feet deep present here.

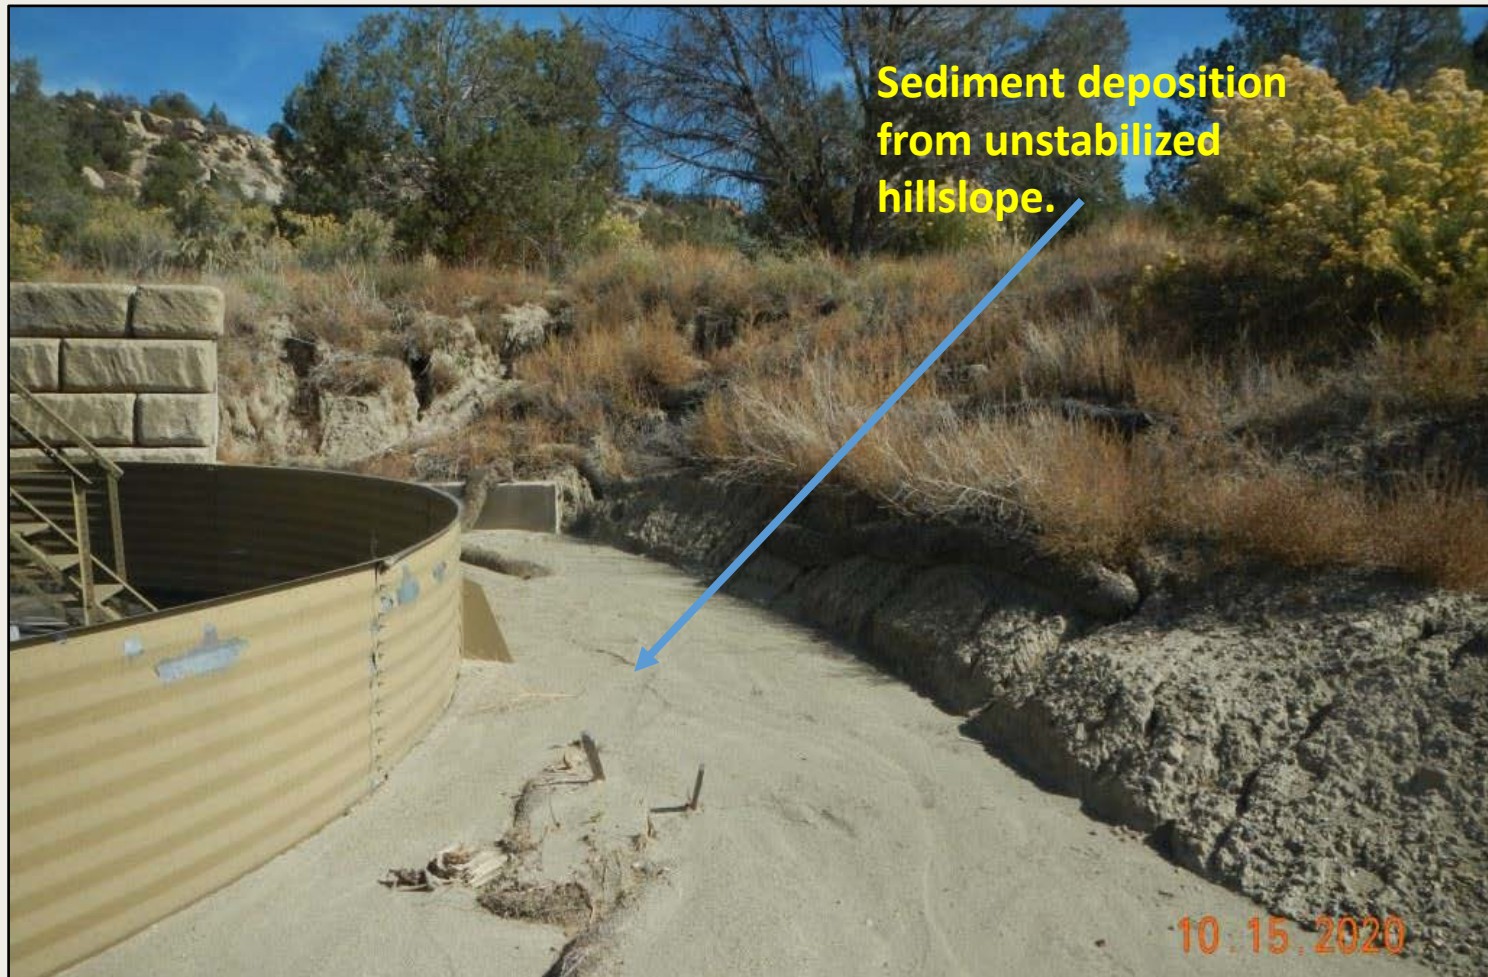
Photo 3. View of sediment deposition within the southeastern project area.

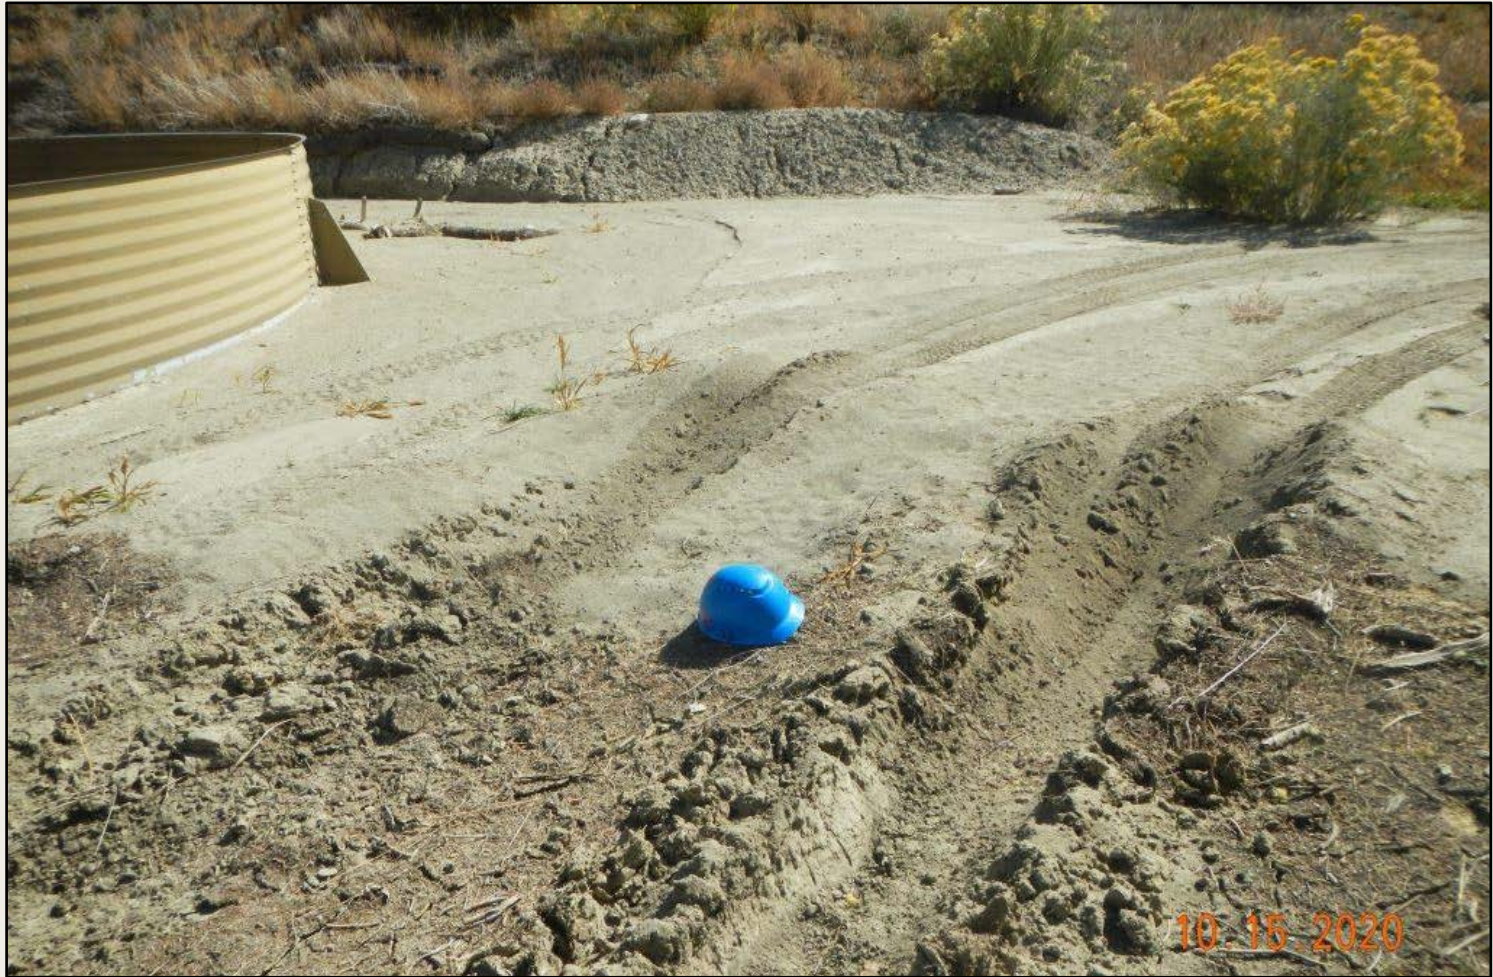
Photo 4. View of sediment deposition, up to 2.5 feet deep within the southern project area.

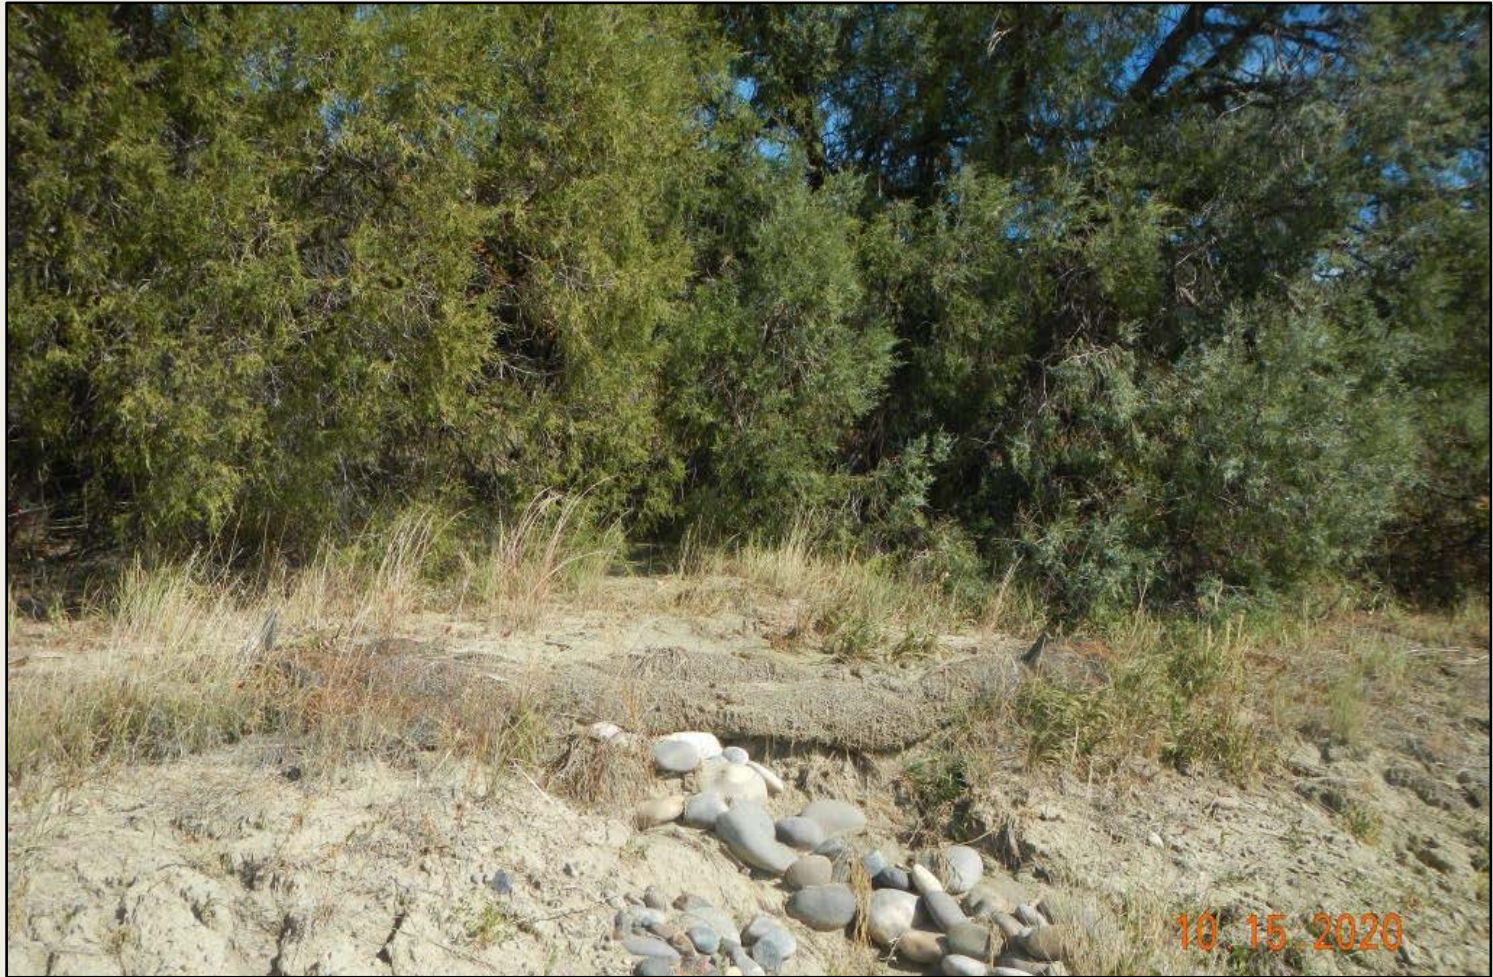
Photo 5. View of the northeastern project area where wattles are full of sediment and rilling is occurring.
