Inspection Photos

API: 071-07414

Operator: TIMBER CREEK OPERATING
OGRIS OPERATING LLC

Inspection Date: 11/19/2020

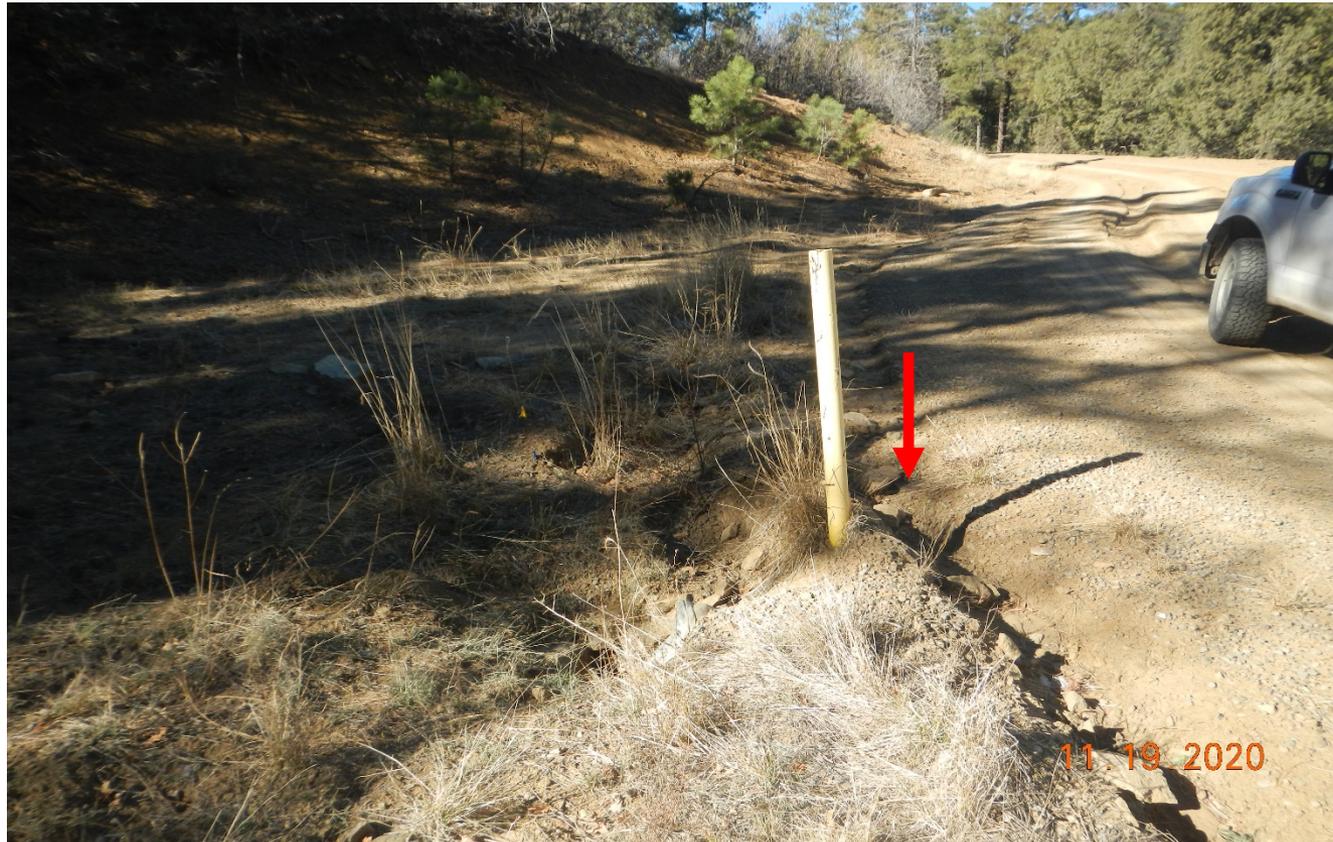
Photo 1. Stormwater is not being diverted toward the culvert which is causing erosion further down the road. Culverts need to be maintained for stormwater diversion.

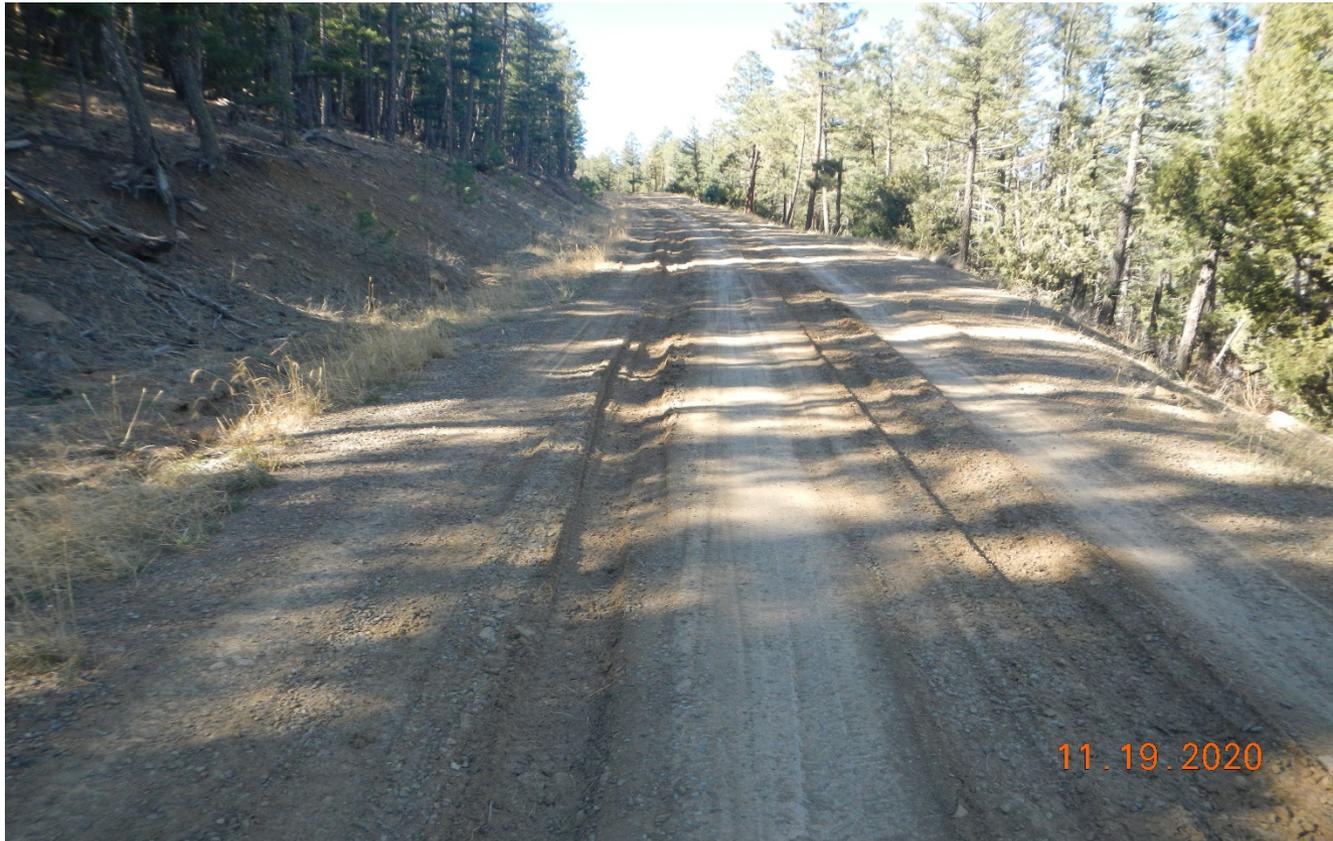
Photo 2. There is vehicle rutting occurring along the road which will only worsen if not repaired. The roads need to be maintained.

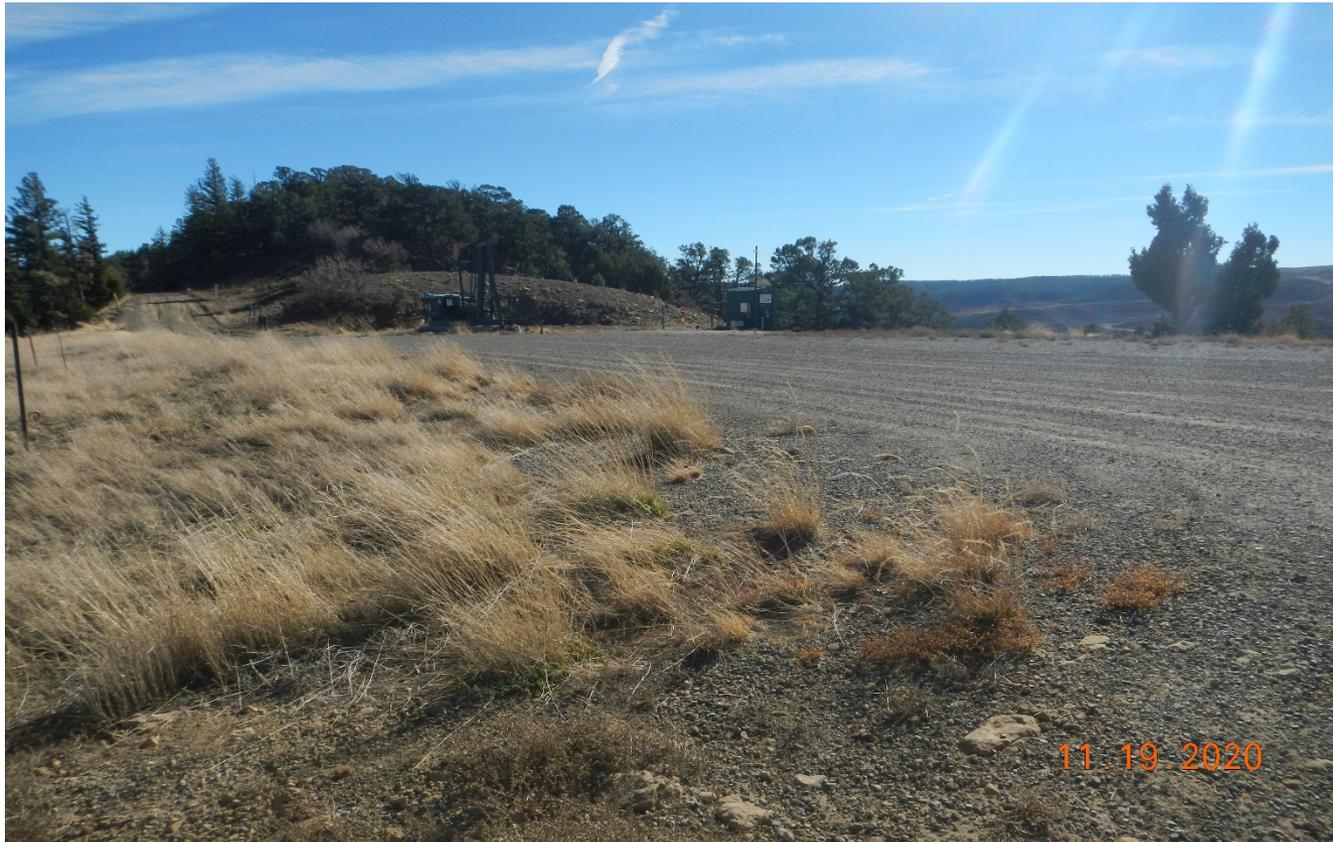
Photo 3. Facing toward the location.
