Inspection Photos
Operator: Hilcorp Energy
API: 067-07794
Date: 12/1/2020

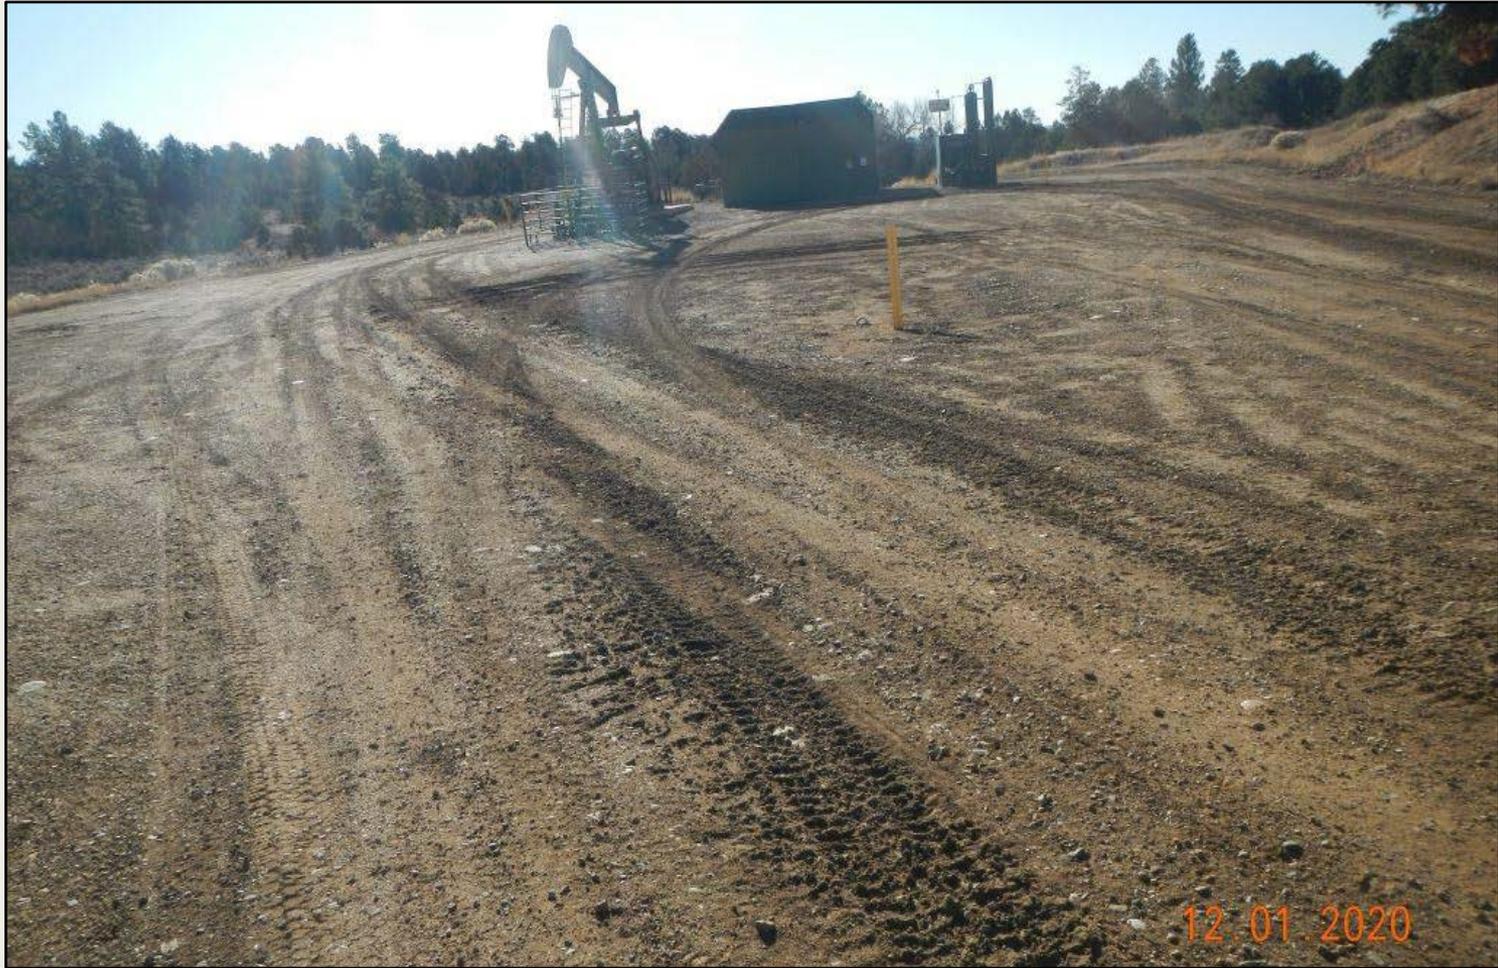
Photo 1. View of the project area from the well pad entrance facing center.

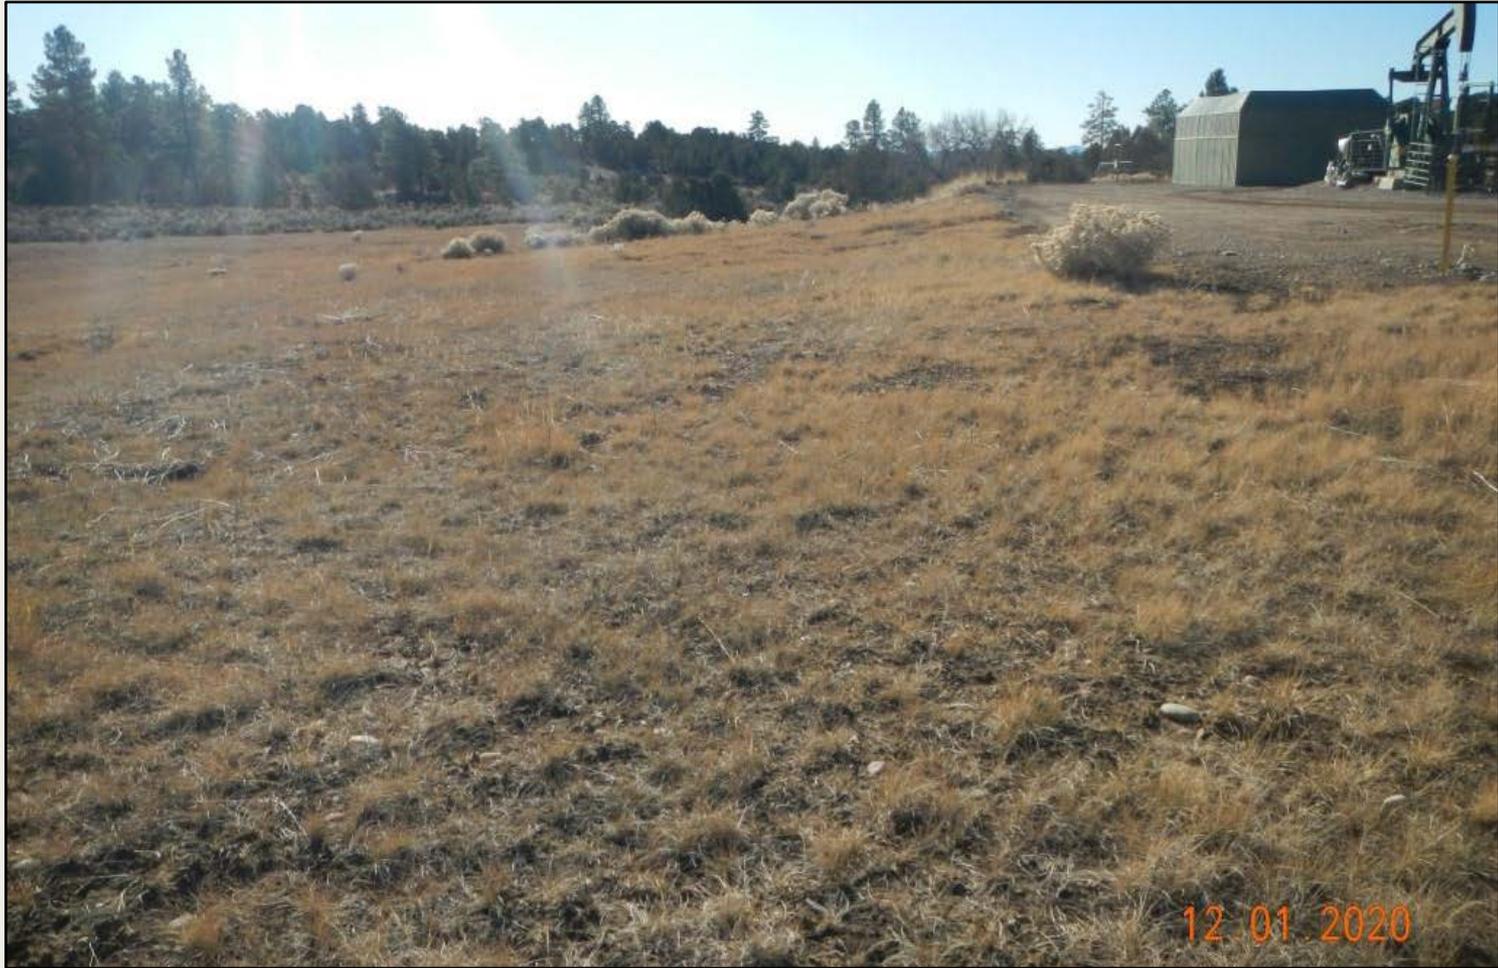
Photo 2. View of the eastern project area from the northeastern corner, facing southward. Revegetation is progressing with western wheatgrass, thickspicke wheatgrass, and sand dropseed.

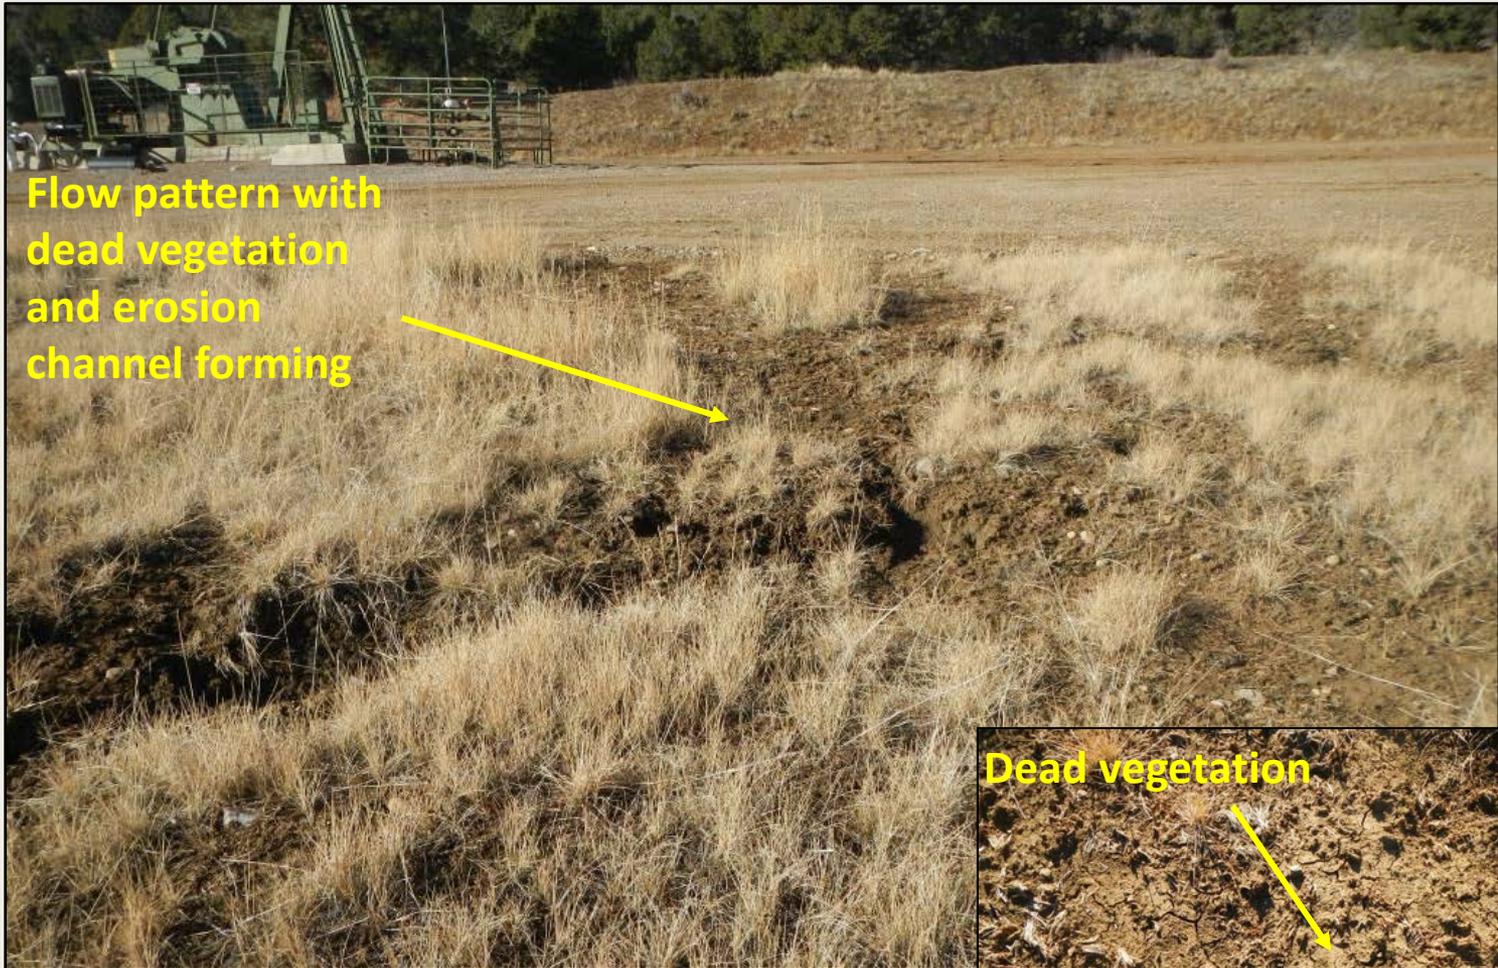
Flow pattern with
dead vegetation
and erosion
channel forming

Dead vegetation

Photo 3. View of area in the eastern project area where stormwater pattern from the well pad is resulting in vegetation die-off and erosion. Channel is approx. 10 inches wide and deep. Inset in right hand corner shows vegetation killed in flow pattern.

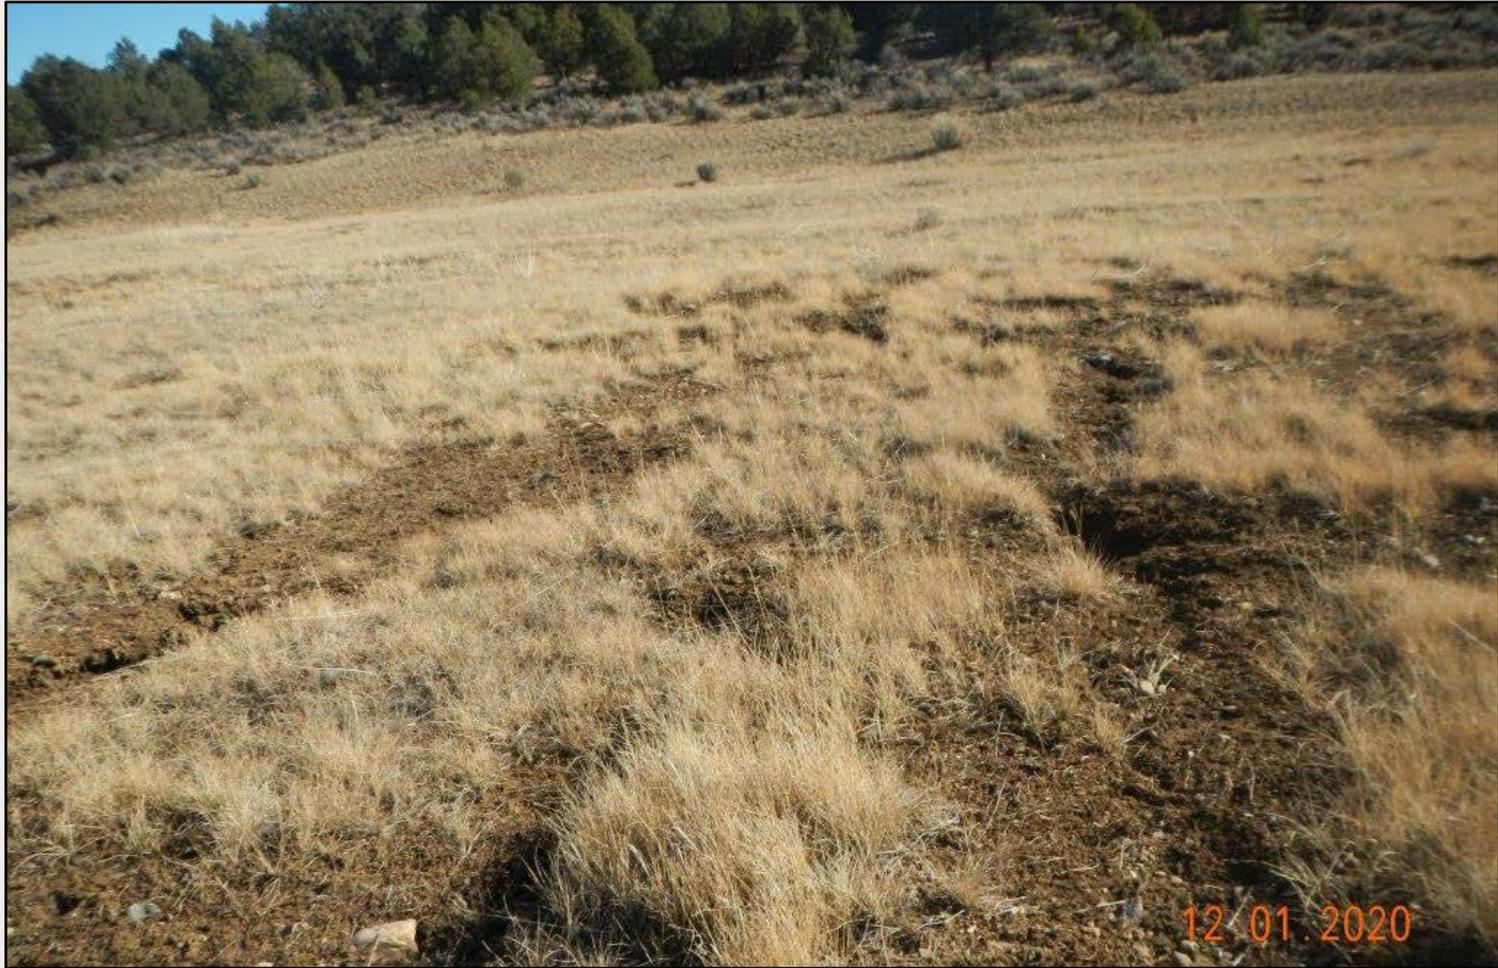
Photo 4. View of more flow patterns facing down slope from the edge of the well pad. Dead vegetation observed in areas where soil is exposed.

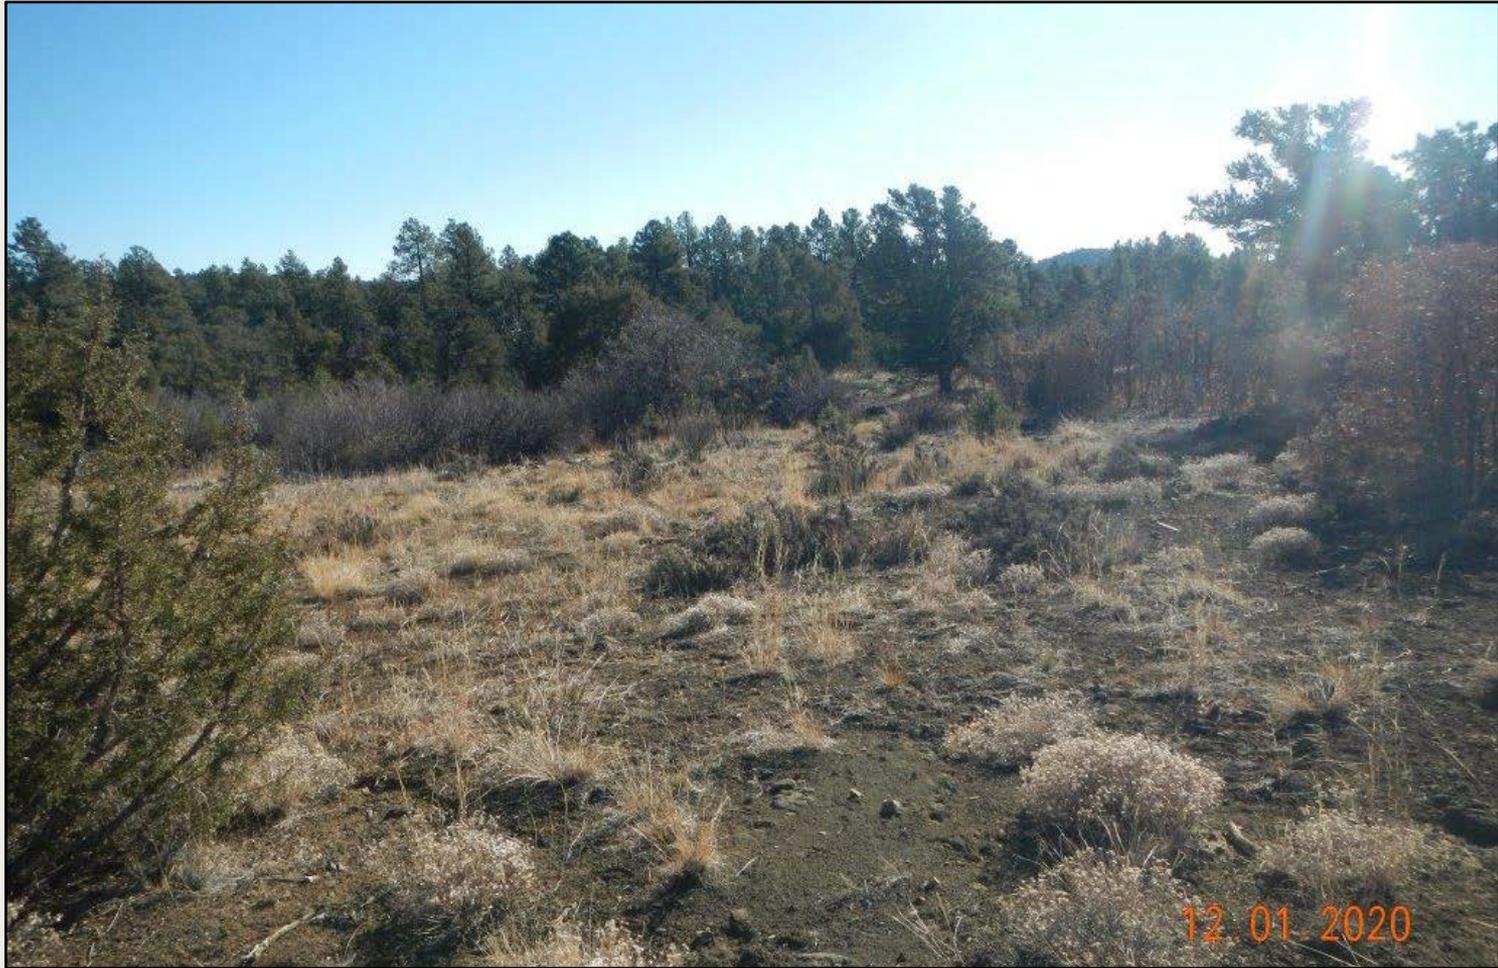
Photo 5. View of reference area vegetation comprised of pinyon and juniper woodland with gambel oak, sagebrush, and and antelope bitterbrush shrubs, along with *Heterotheca villosa*, western wheatgrass, sand dropseed, and Indian ricegrass in the understory.
