**CAERUS PICEANCE LLC**  
**Chevron 42-5D**  
**Location # 435733**

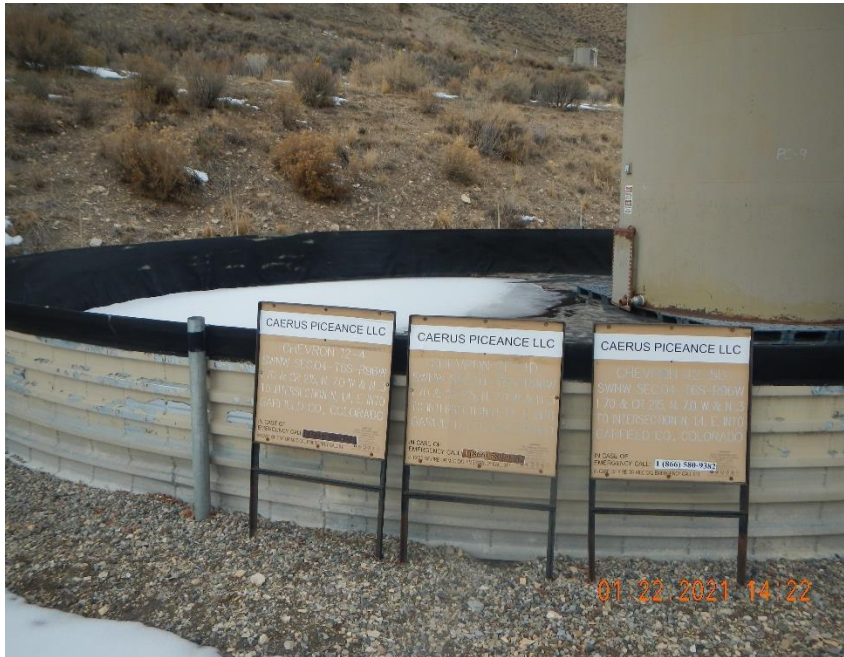
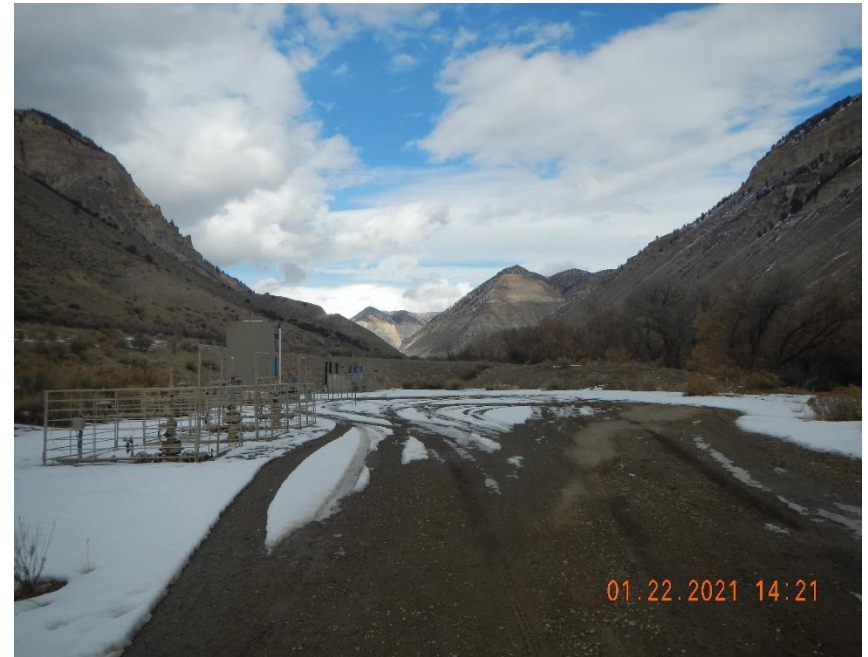
**No evidence of tracking control BMP's**

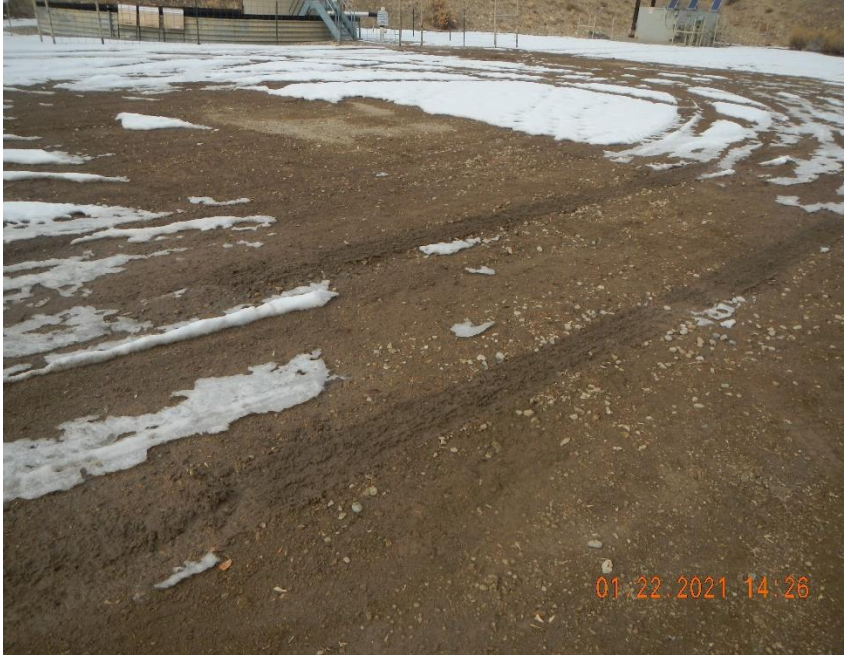
**Location shows signs of lack of stabilization BMPs**

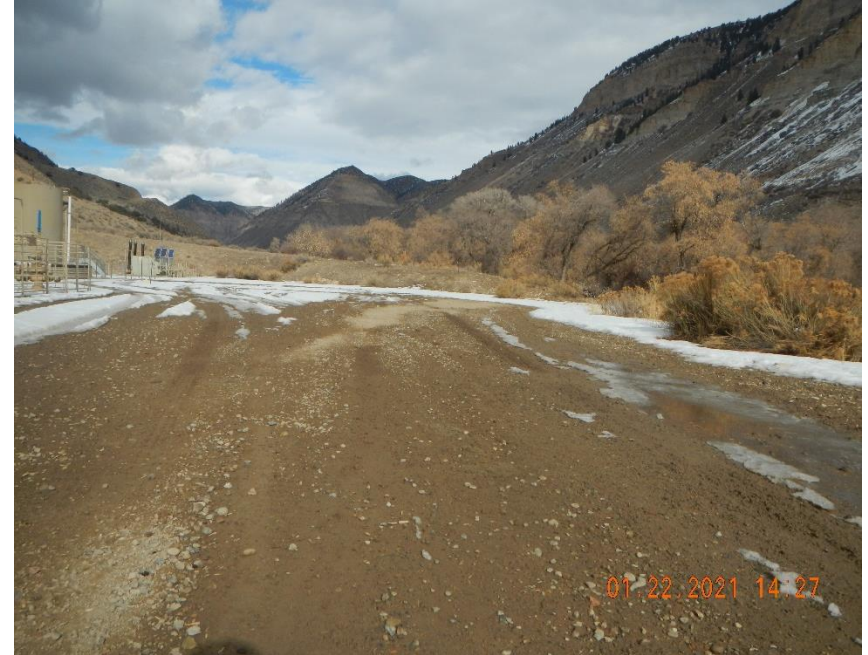
**Location shows signs of lack of stabilization BMPs**

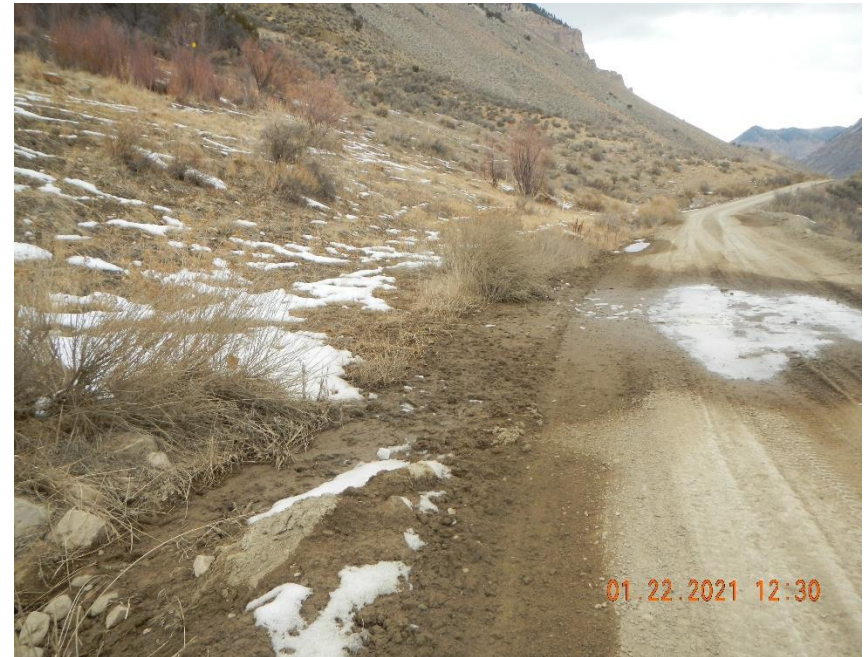
**Sediment blockage in ditch.**

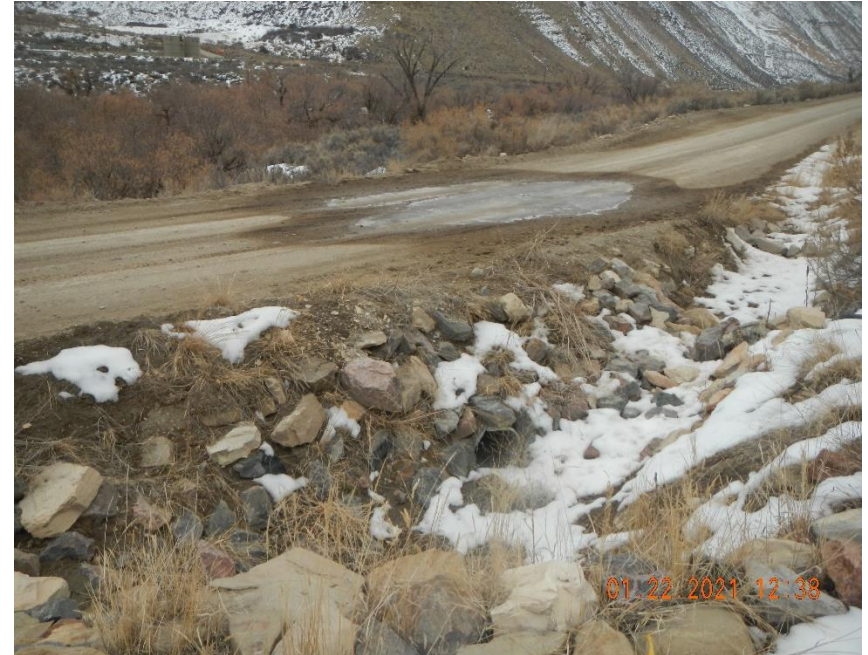
**Water not draining off road.**

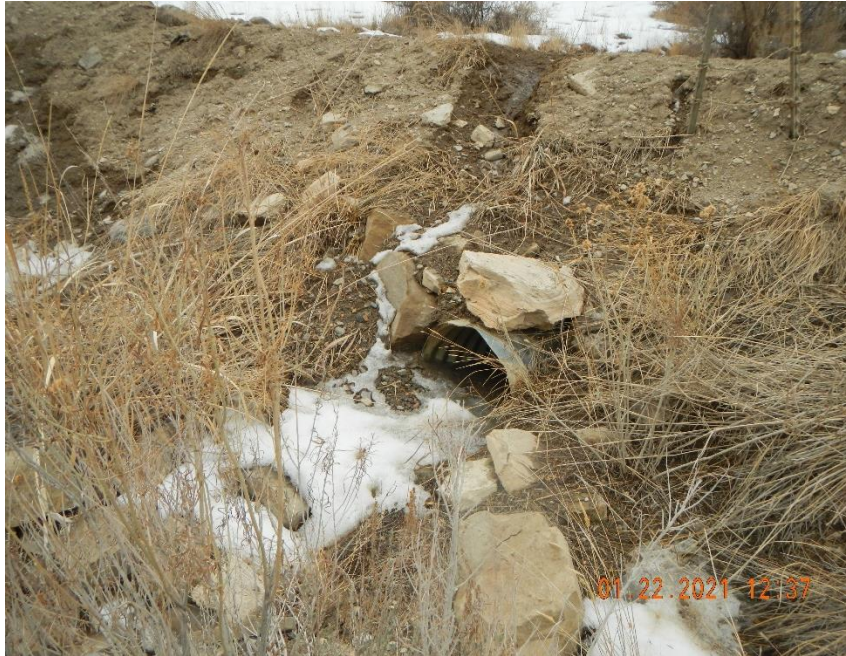
**Sediment build up in culvert outlet.**

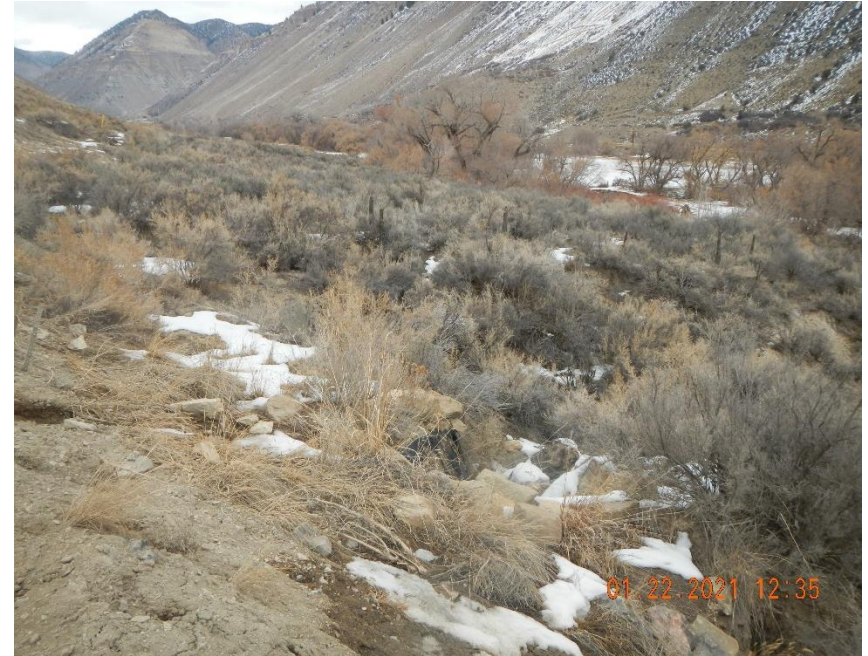
**Erosion damage from culvert outlet.**

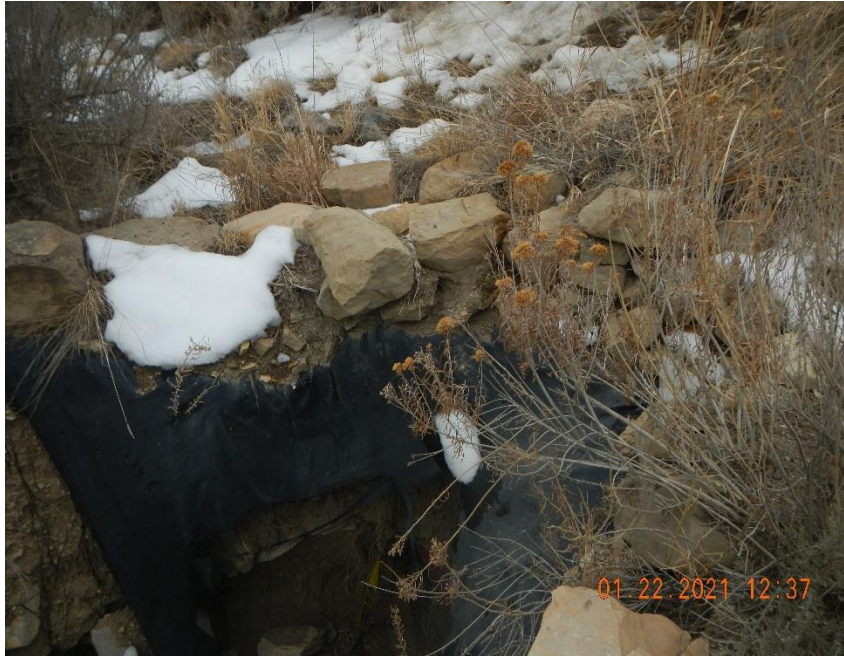
**Erosion damage from culvert outlet.**

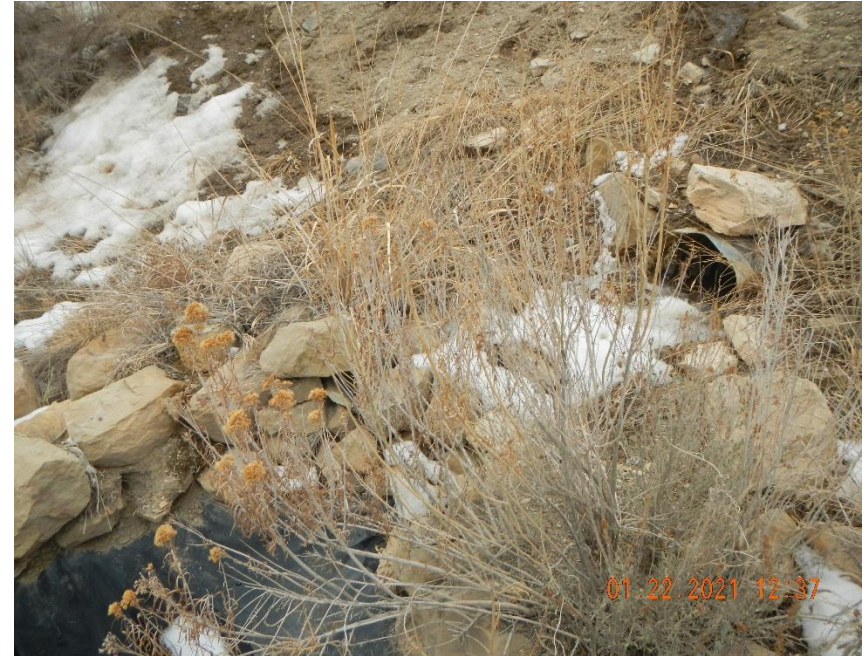
**Erosion damage from culvert outlet.**
