Inspection Photos
Operator: Enduring
API: 067-08734
Date: 1/22/2021

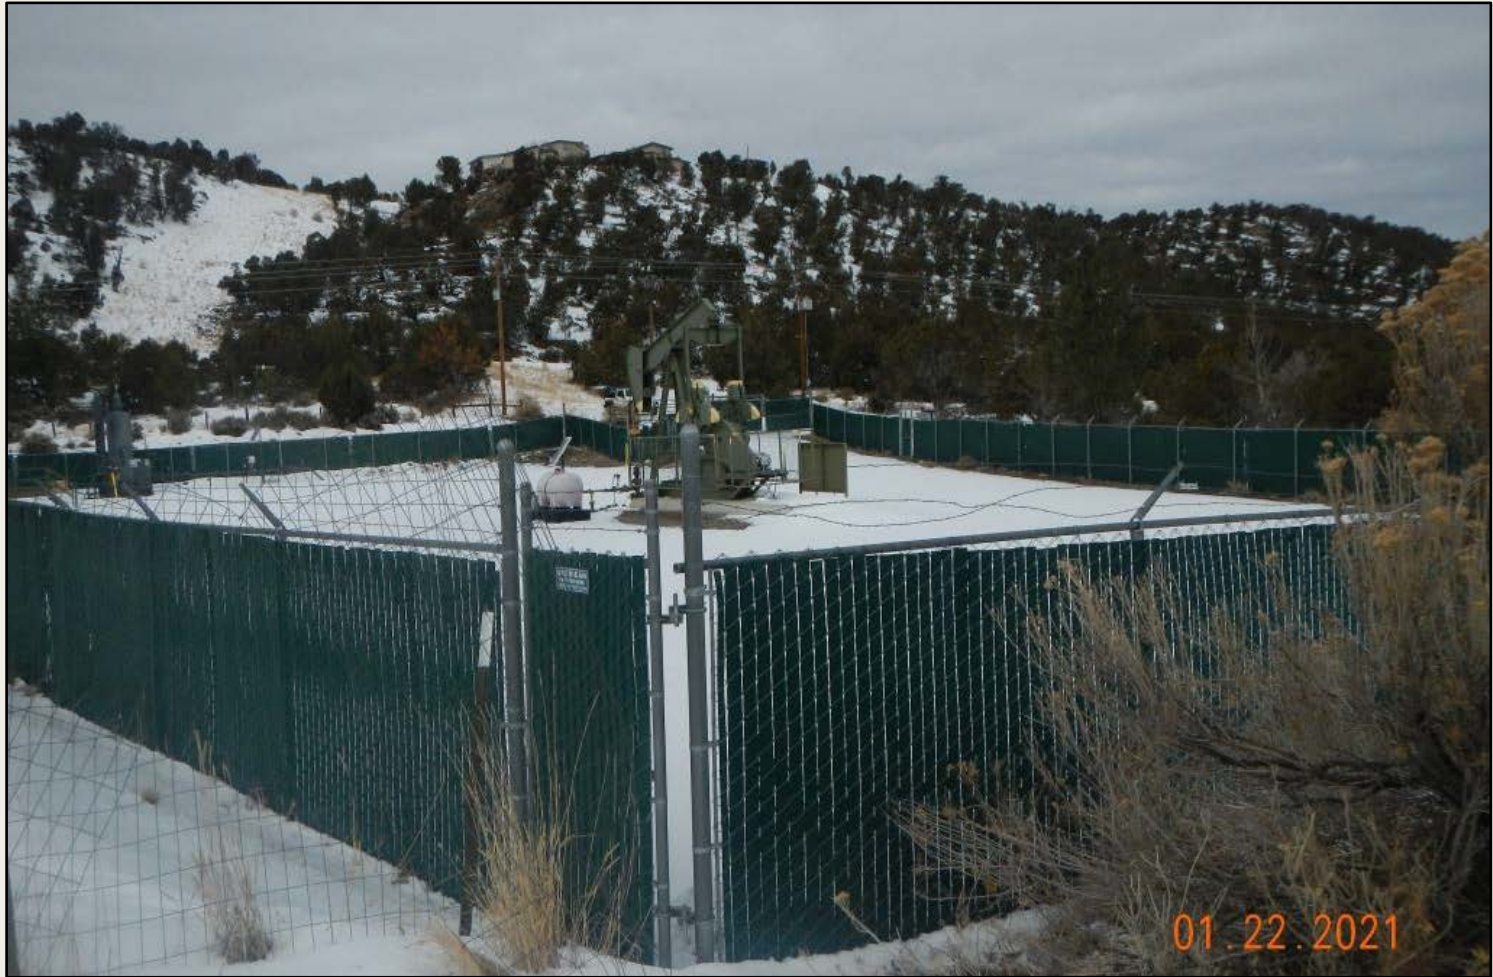
Photo 1. View of the project area from the southeastern corner facing center.

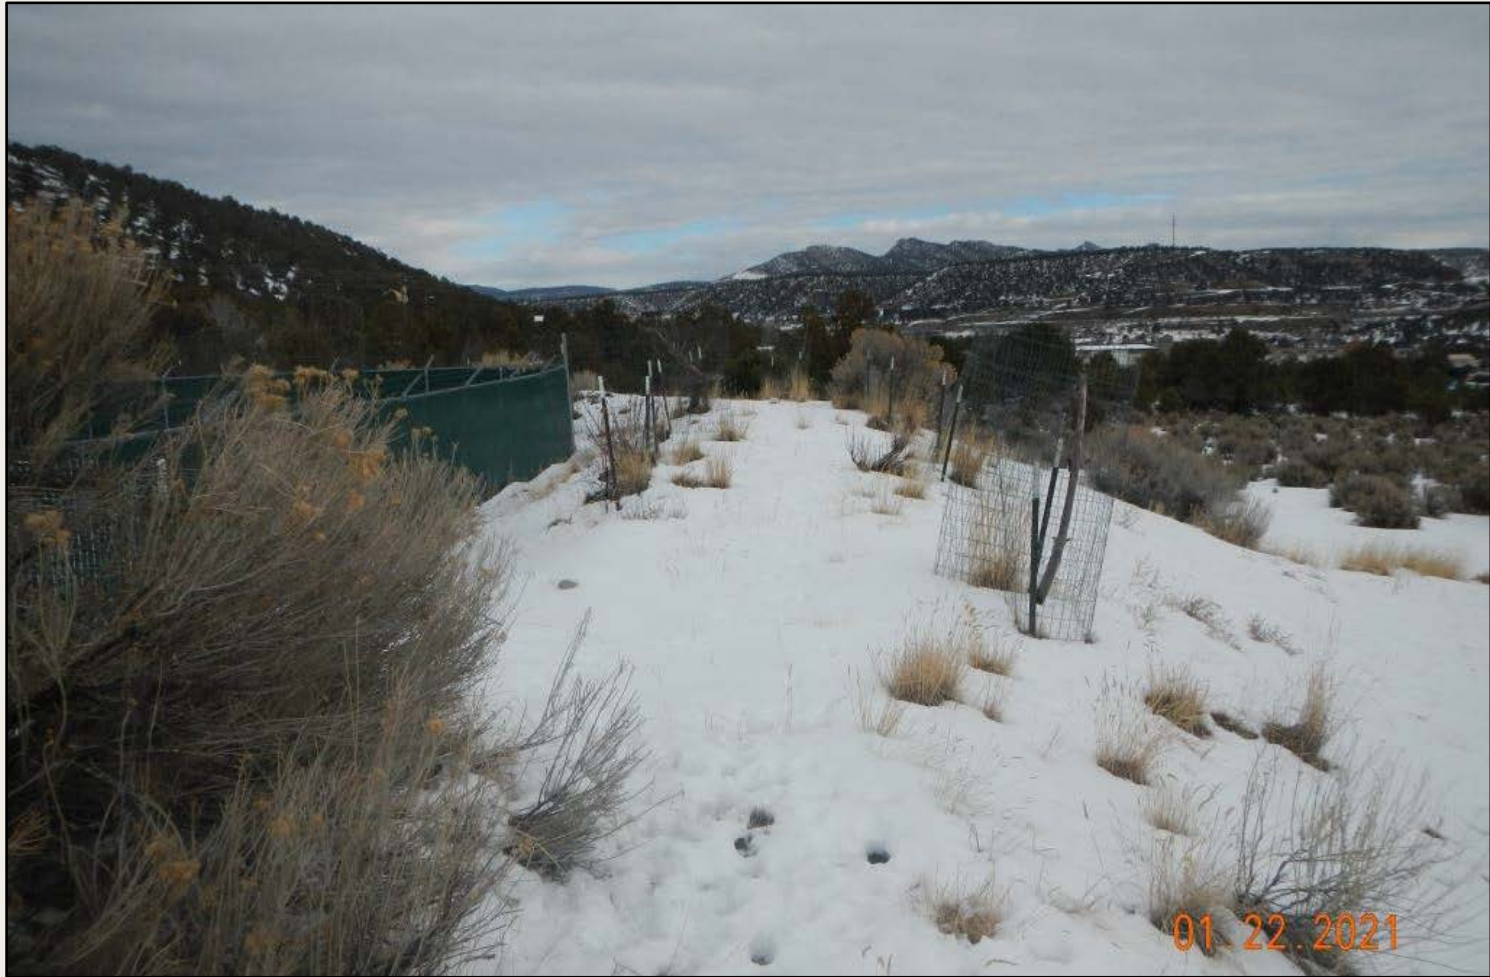
Photo 2. View of the eastern project area from the southeastern corner facing northward. Location largely snow covered. Taller perennial vegetation such as crested wheatgrass, western wheatgrass, and sand dropseed observable through the snow. Planted trees are largely dead.

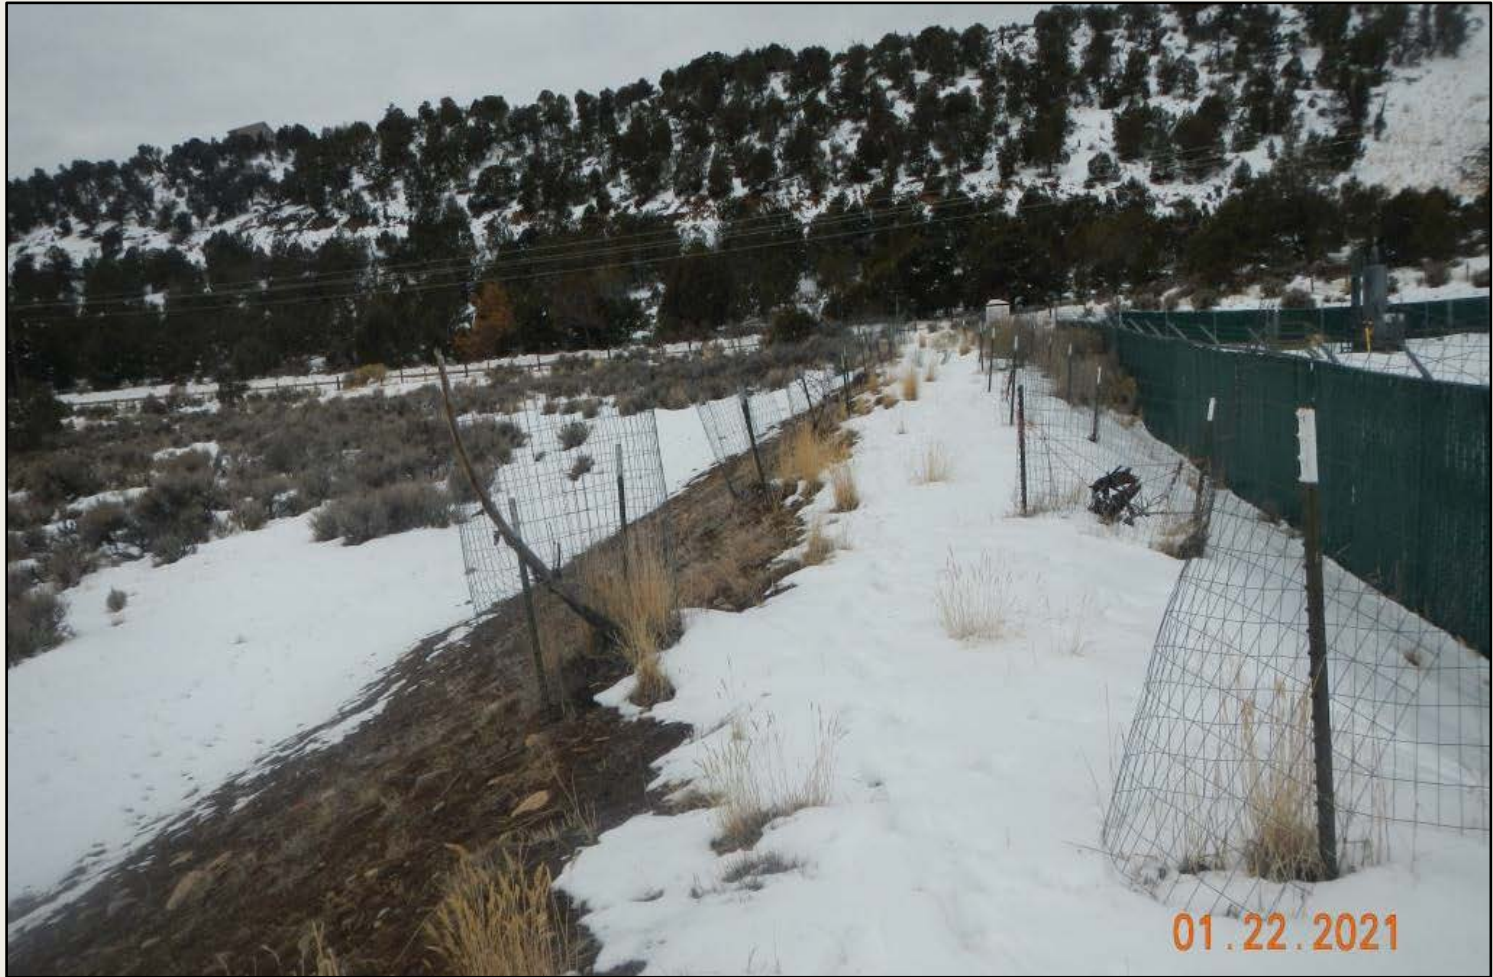
Photo 3. View of the southern project area from the southeastern corner facing eastward.

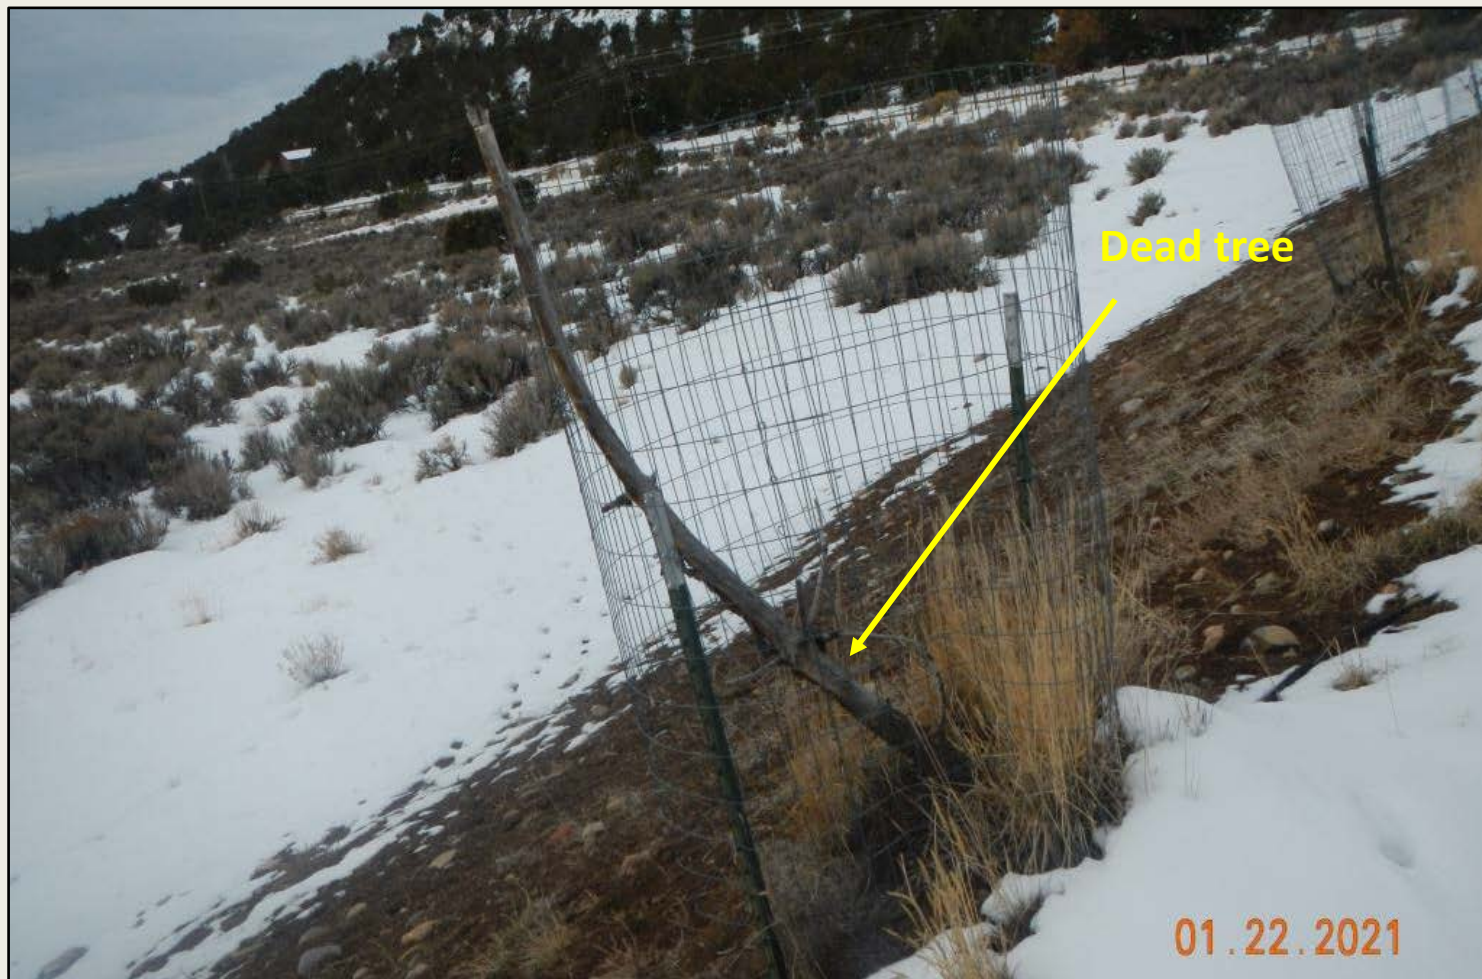
Photo 4. View of dead tree within the project area, fencing and staking present and only dead wood remains.
