# Inspection Photos

2/17/2021

Operator: TEP ROCKY MOUNTAIN LLC - 96850

Location ID: 334721

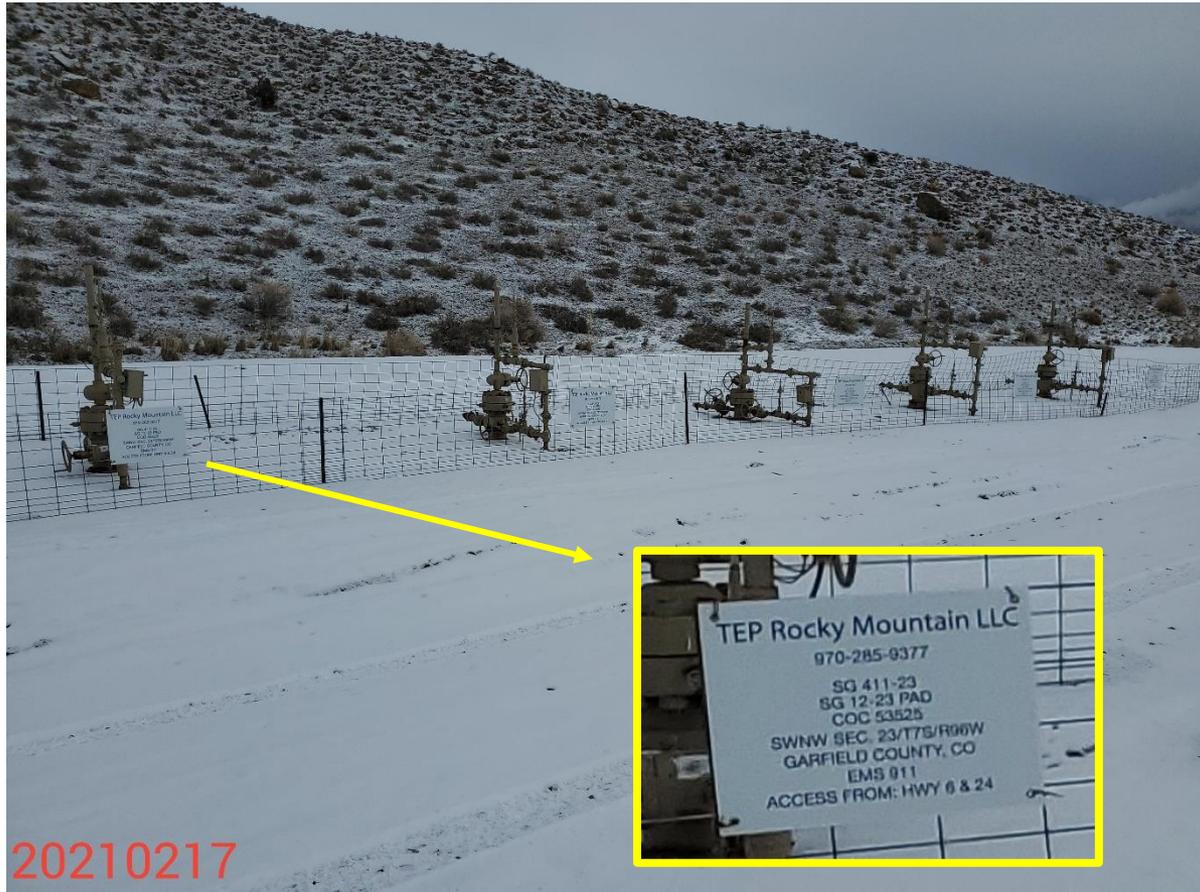
**Photo 1:** Photo of producing wells on Location. Photo also shows signage at wells.

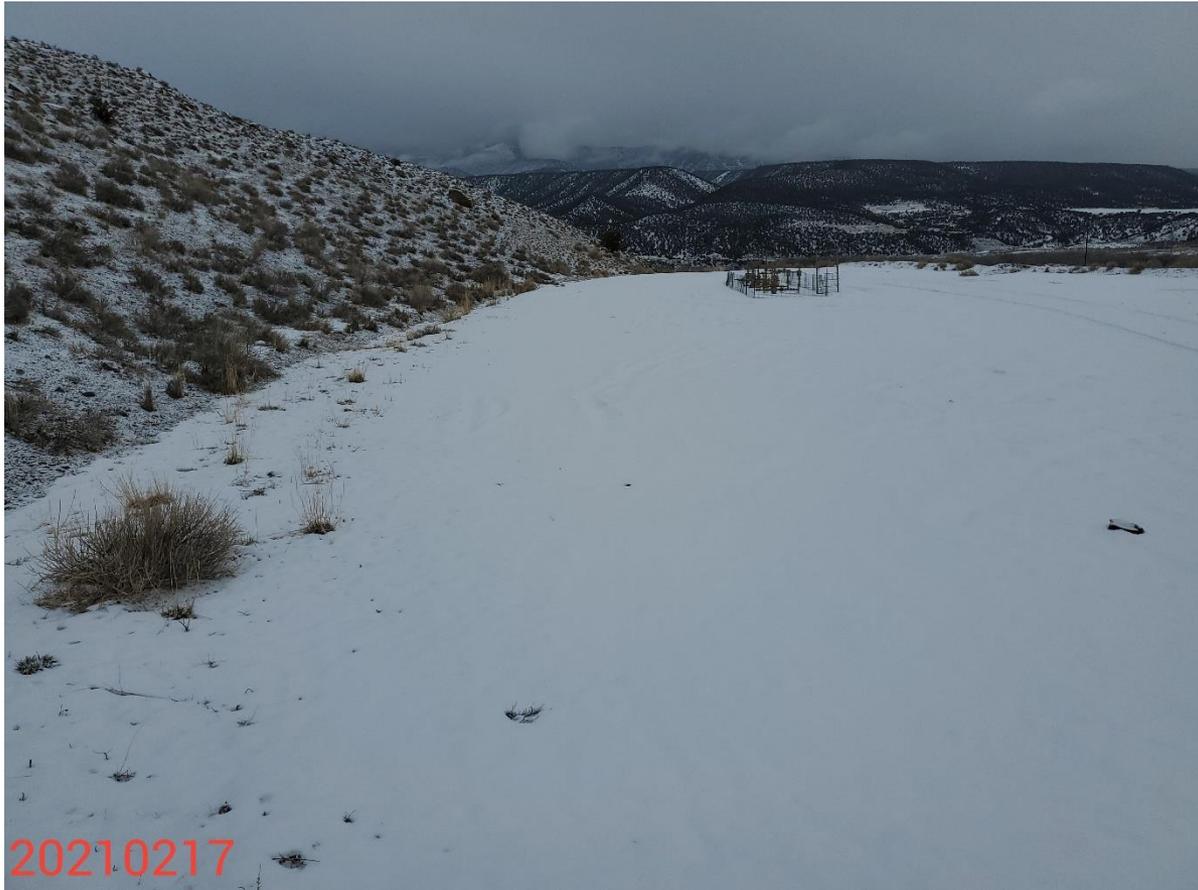
**Photo 2:** Photo taken from the northern corner of the Location, facing east. Photos 1-3 provide an overview of the Location from east, southeast to south.

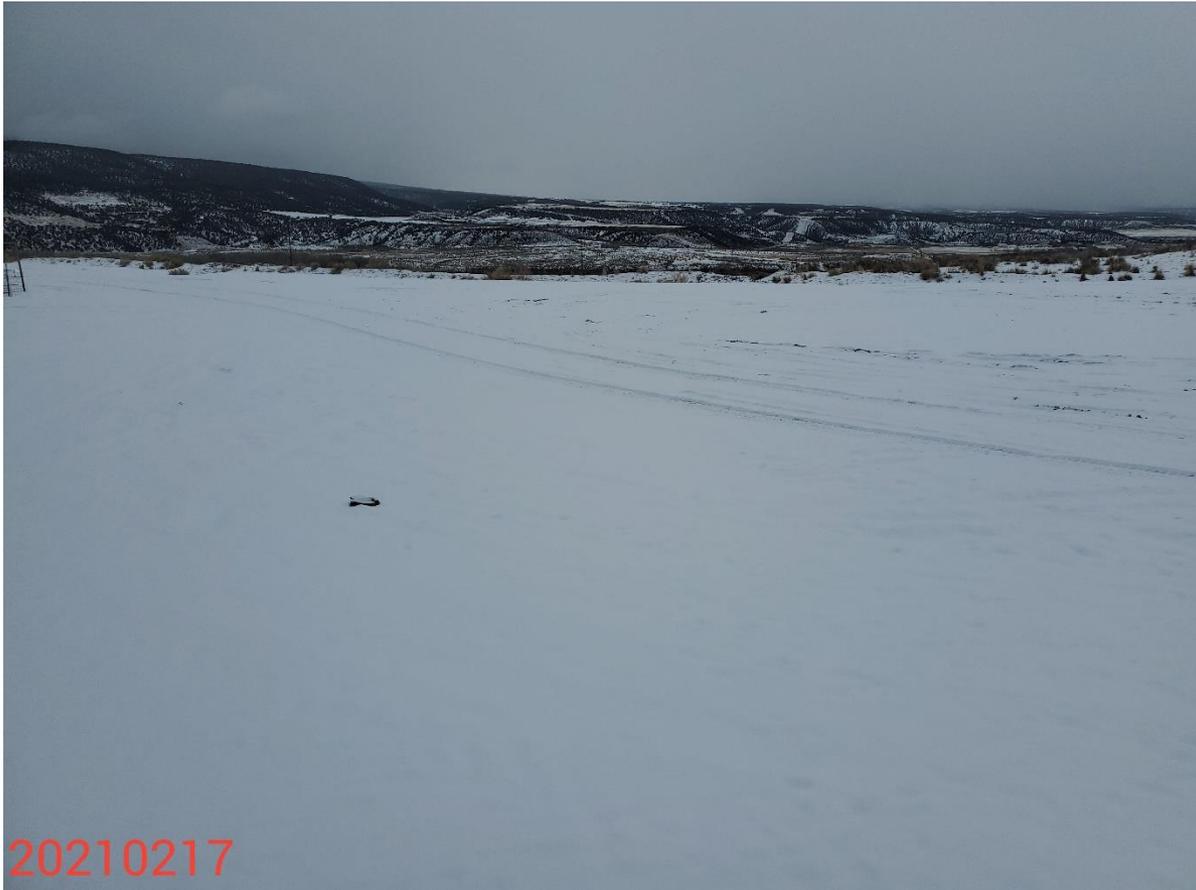
**Photo 3:** See comments under photo 1.

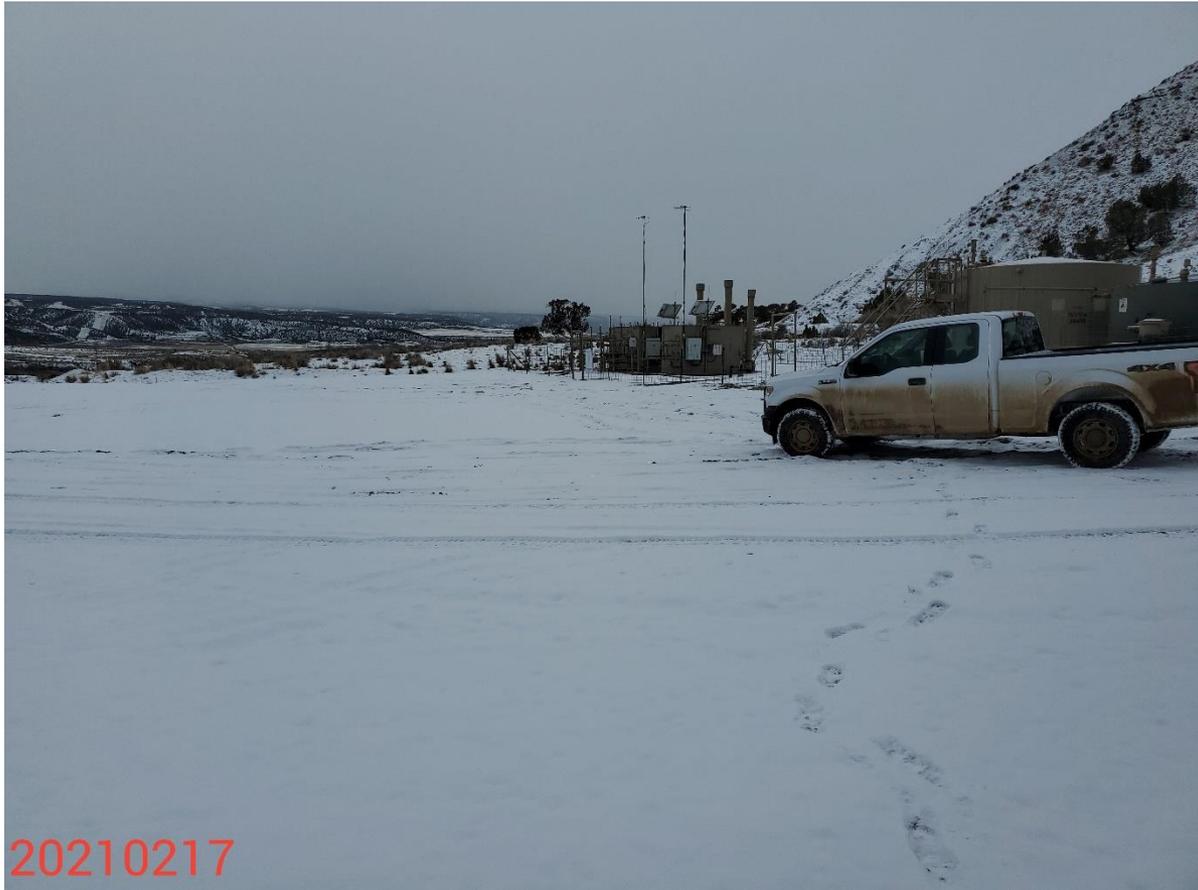
**Photo 4:** See comments under photo 1.

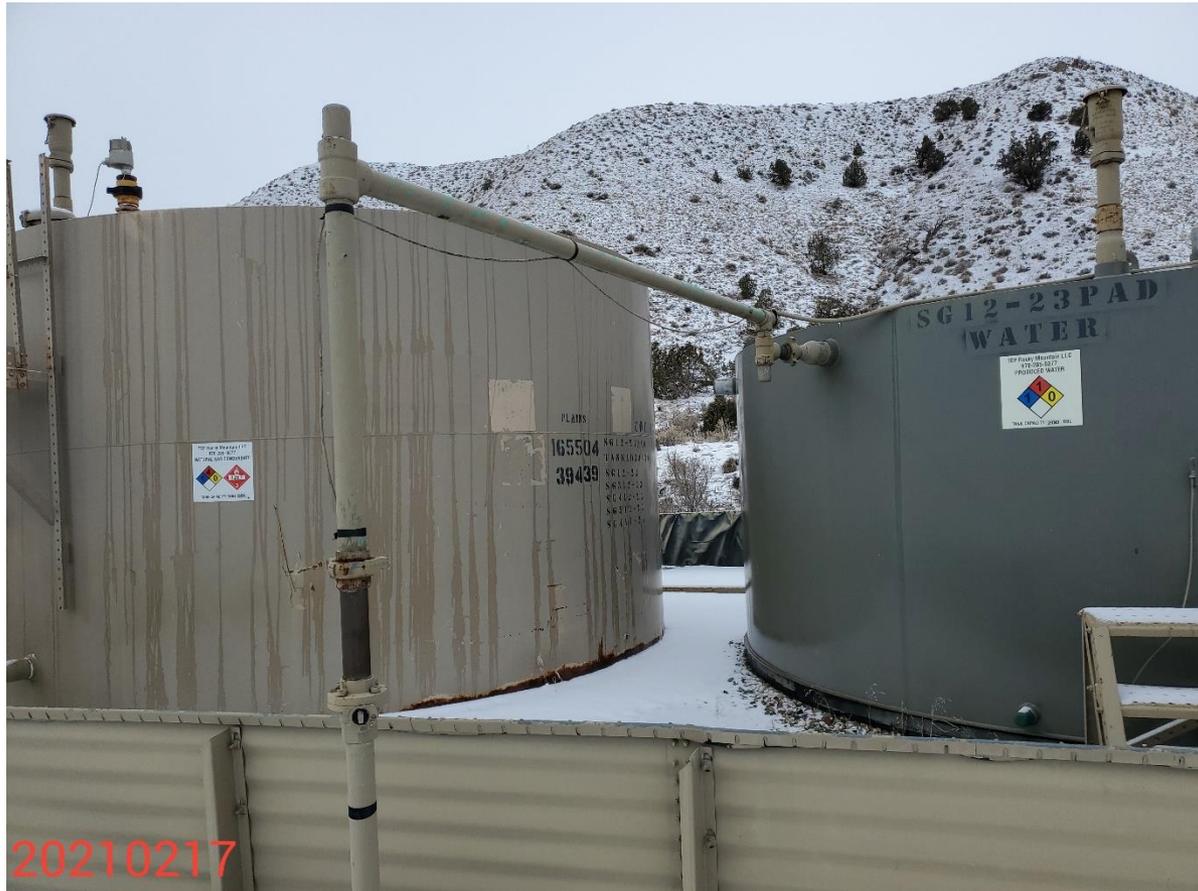
**Photo 5:** Photo shows 300 bbl “natural gas condensate” and 200 bbl “produced water” tanks and containment bmp on the north end of the Location.

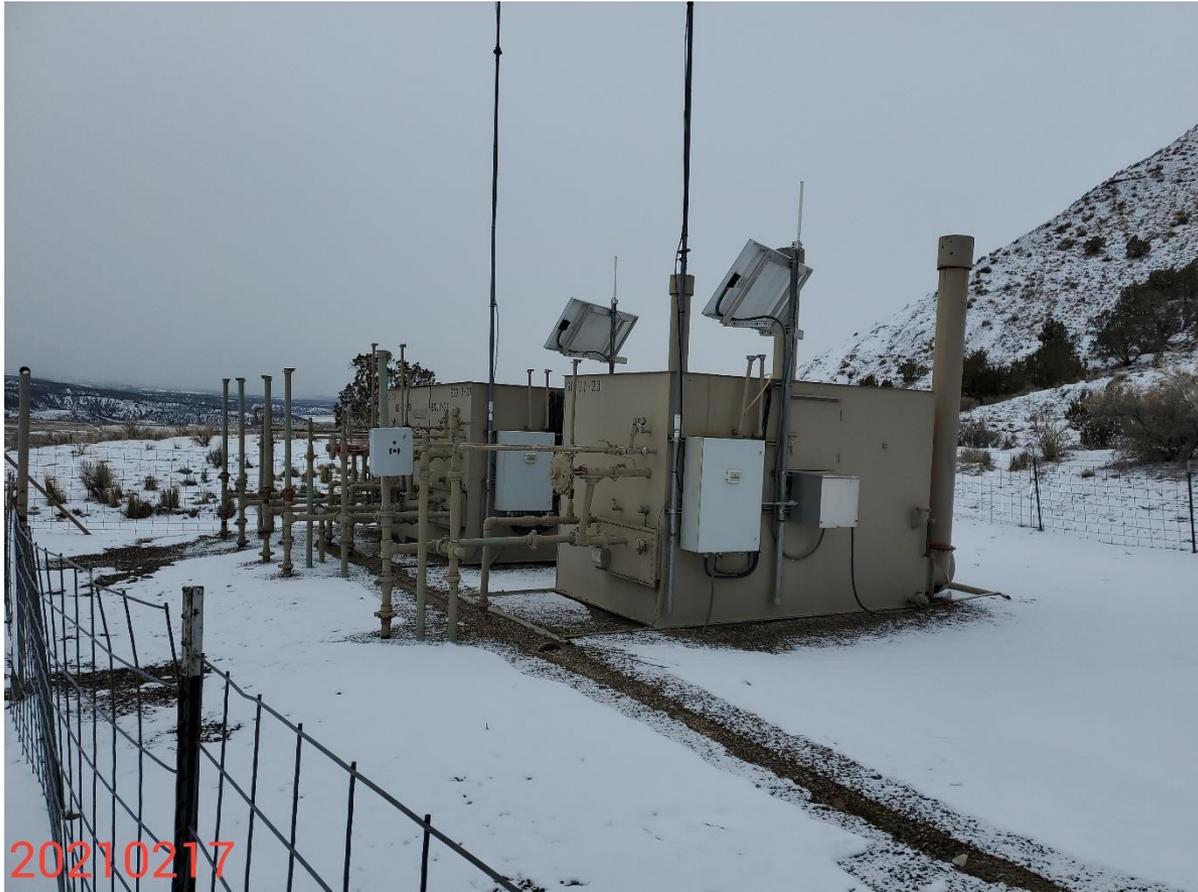
**Photo 6:** Photo shows separator equipment on the north end of the Location.

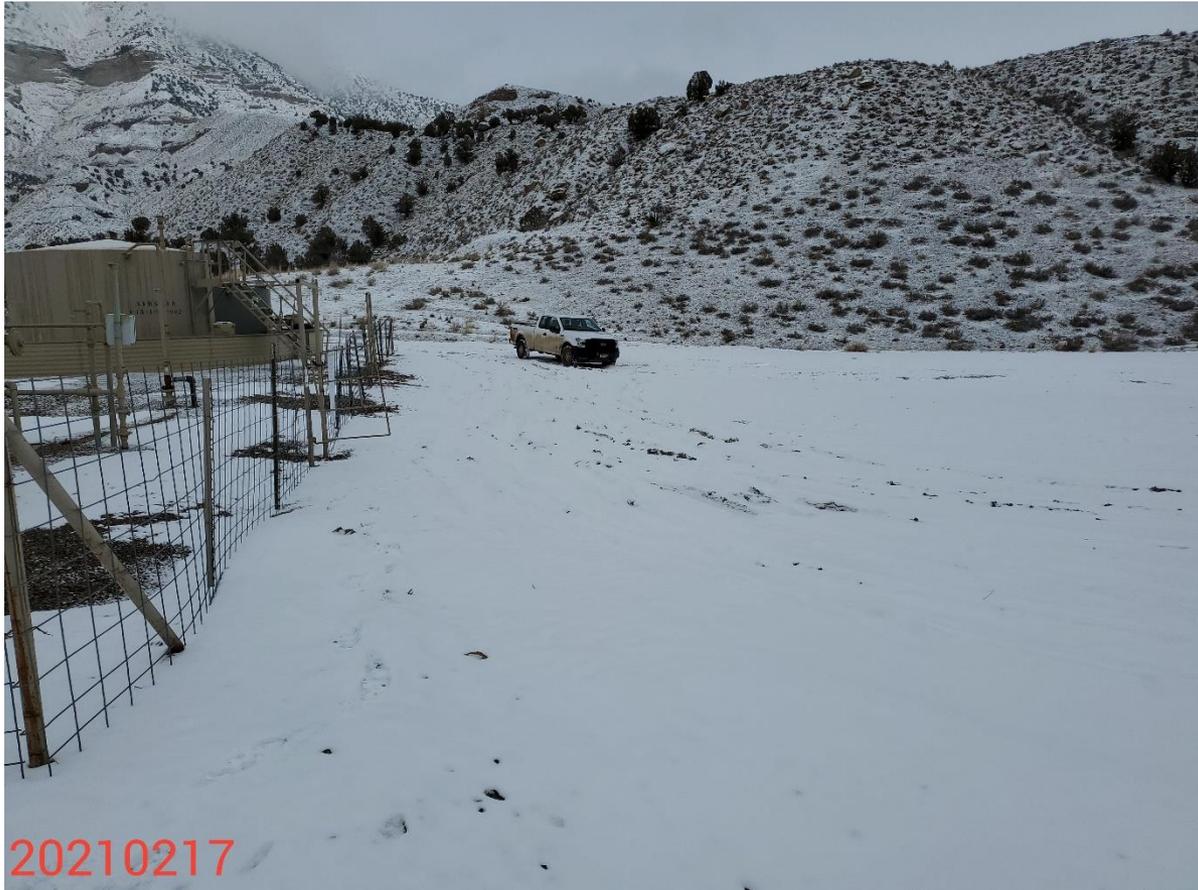
**Photo 7:** Photo taken from the southwest end of the Location, facing north. Photos 7-9 provide an overview of the Location from north, east to southeast.

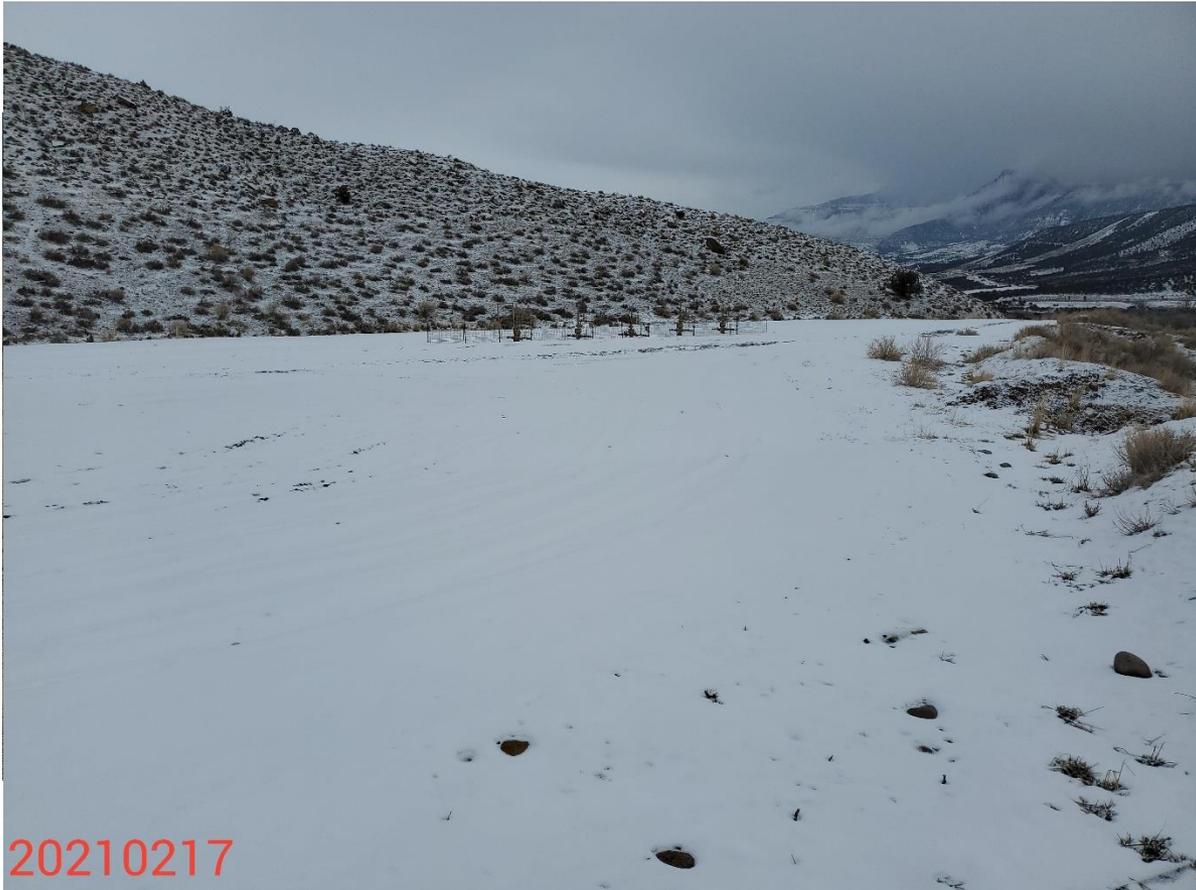
**Photo 8:** See comments under photo 7

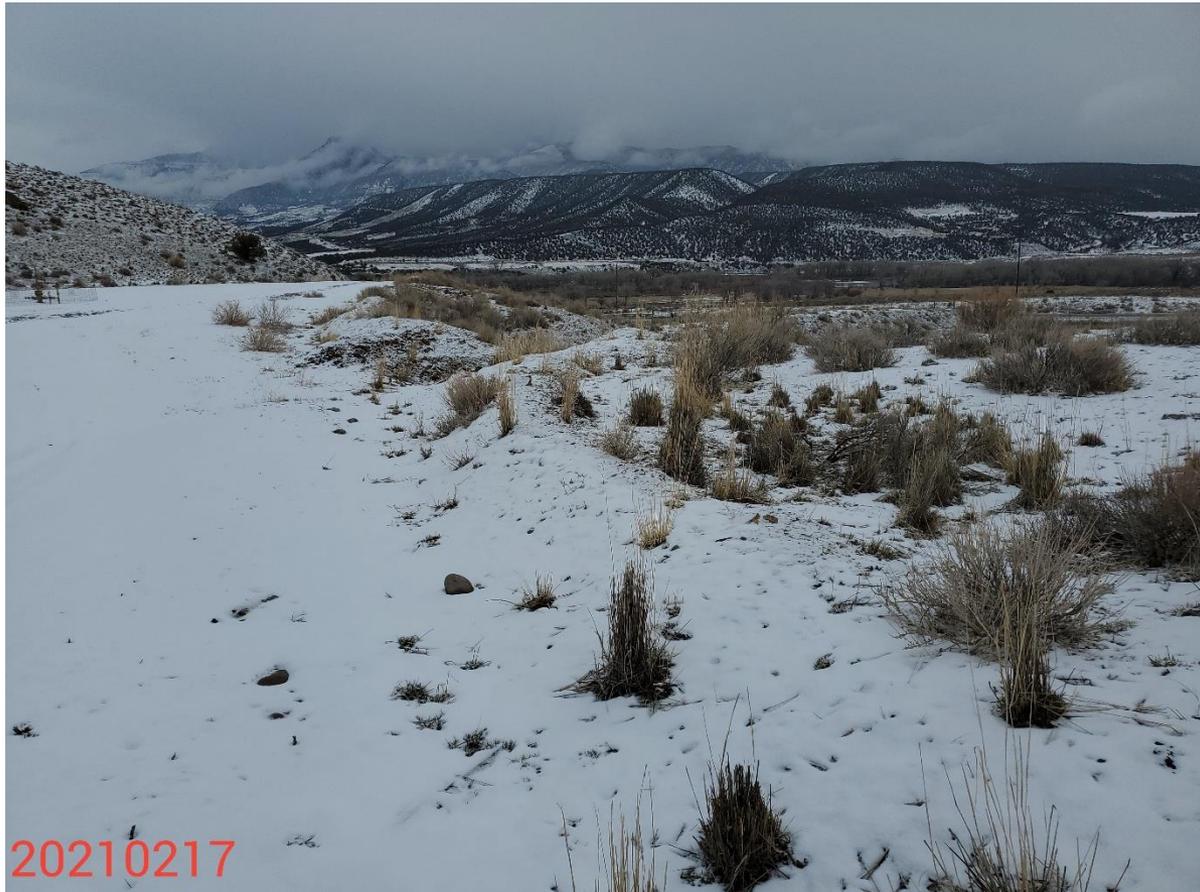
**Photo 9:** See comments under photo 7

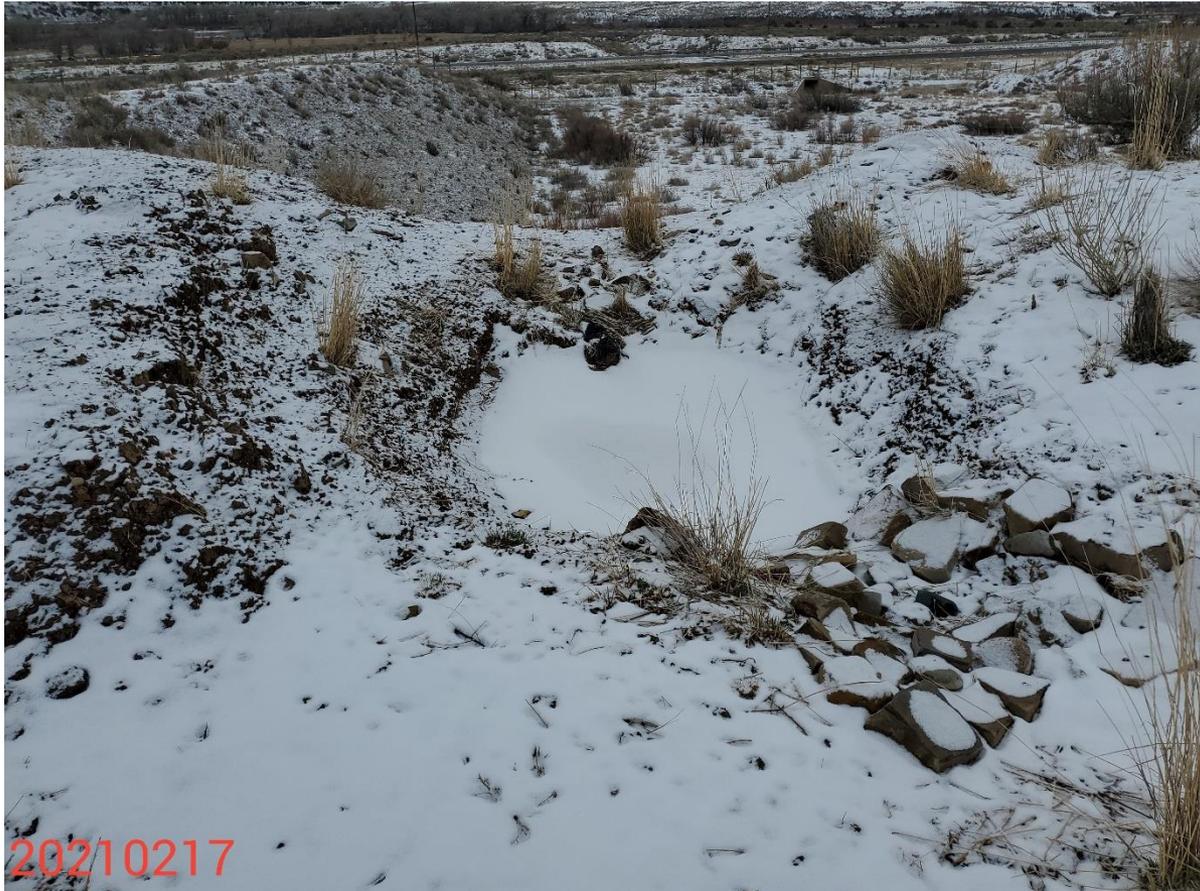
**Photo 10:** Photo shows the western-most sediment trap on the south end of the Location. BMP has been constructed with a slope-drain.

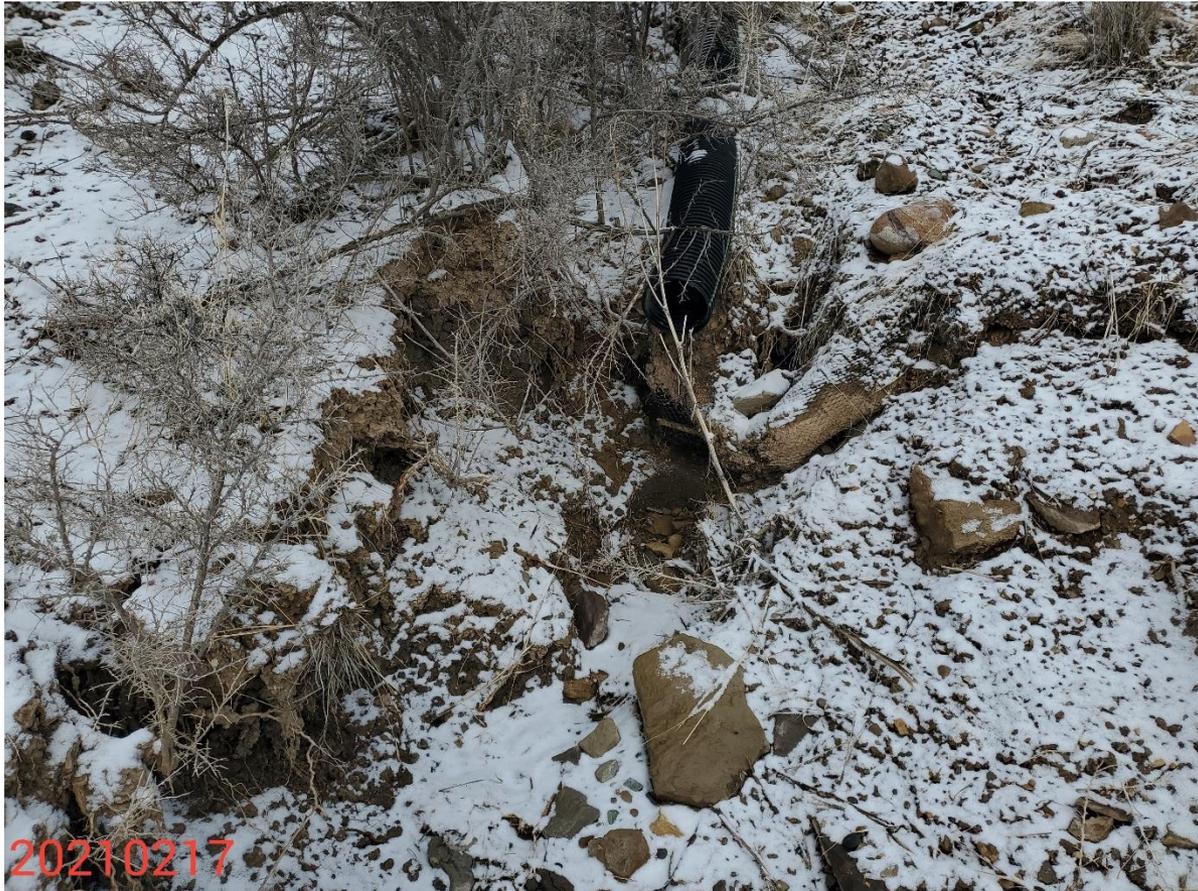
**Photo 11:** Continued from photo 11. Photo shows outlet of slope drain. Photo shows outlet has not been constructed in accordance with good engineering practice; erosion degradation evident.

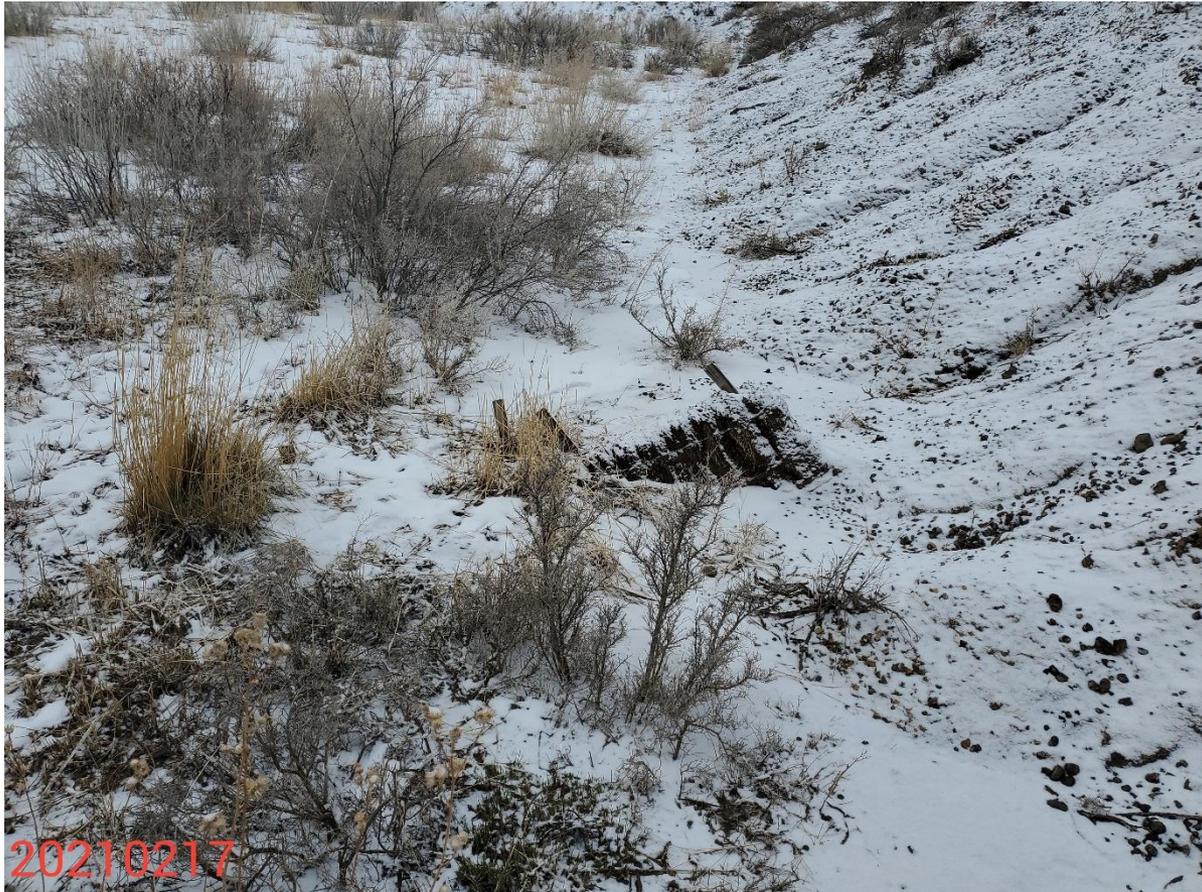
**Photo 12:** Photo taken from west of the drain outlet (photo 11), facing west. Photo shows hay bale control measure; BMPs has not been maintained in proper functioning condition.

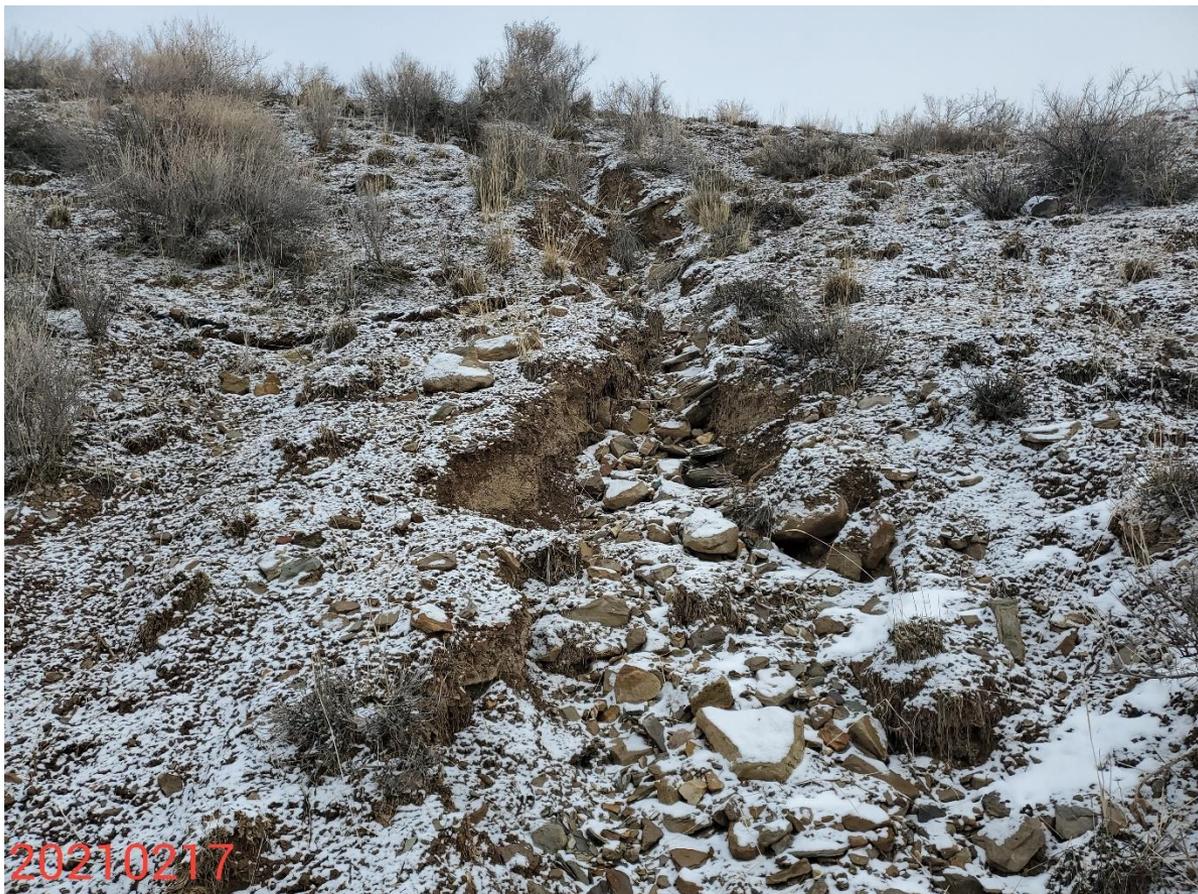
**Photo 13:** Photo taken from the slopes on the south end of the Location. Photo shows gully erosion. BMPs missing or insufficient to stabilize slopes.

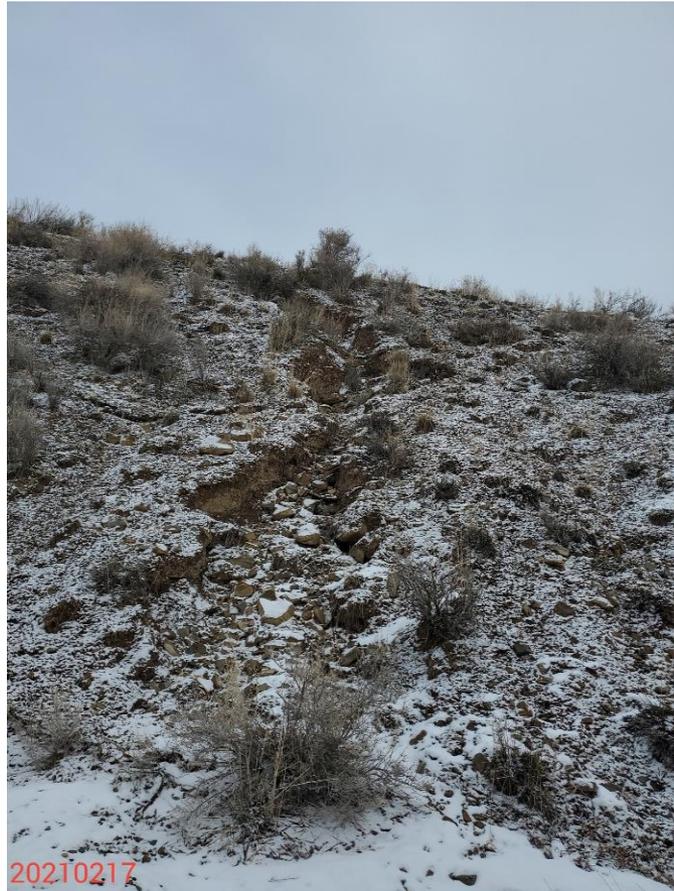
**Photo 14:** See comments under photo 13.

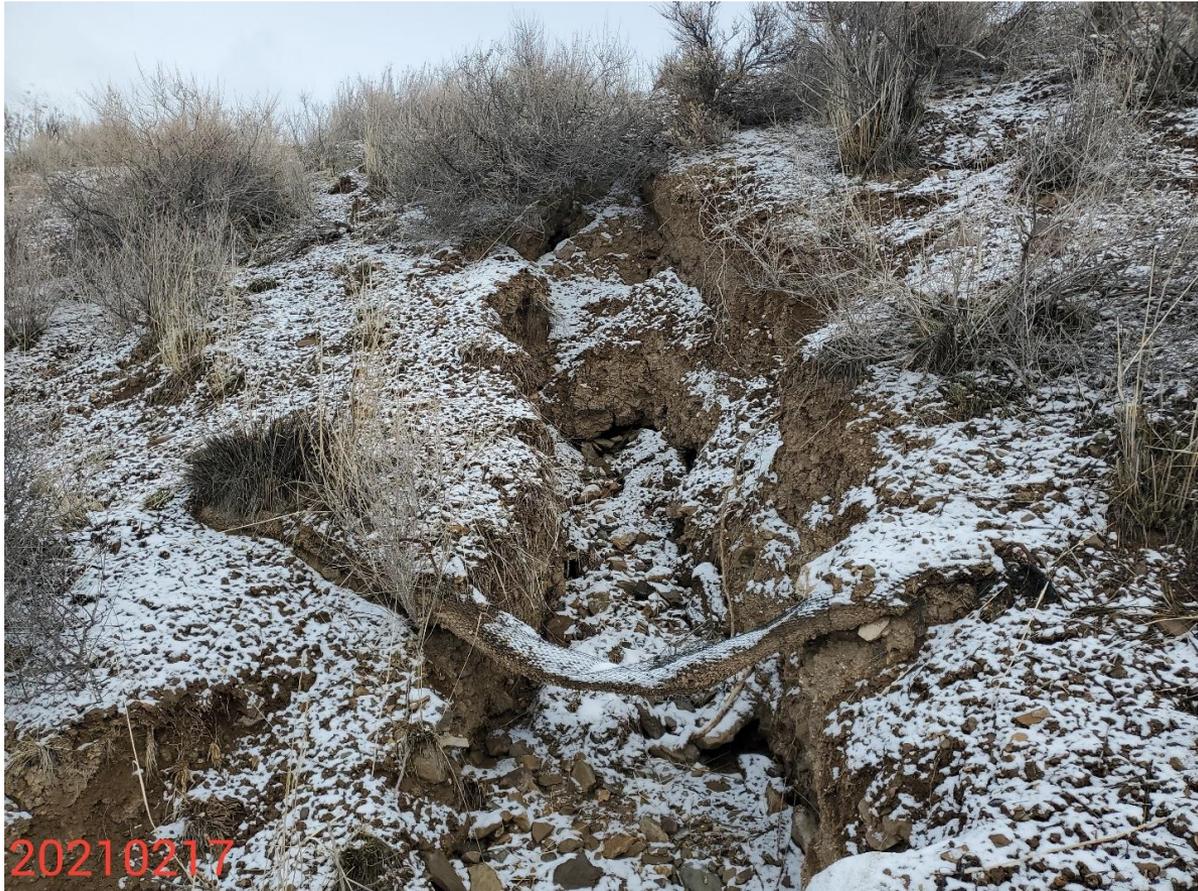
**Photo 15:** Photo shows gully erosion on the southern slopes of the Location.

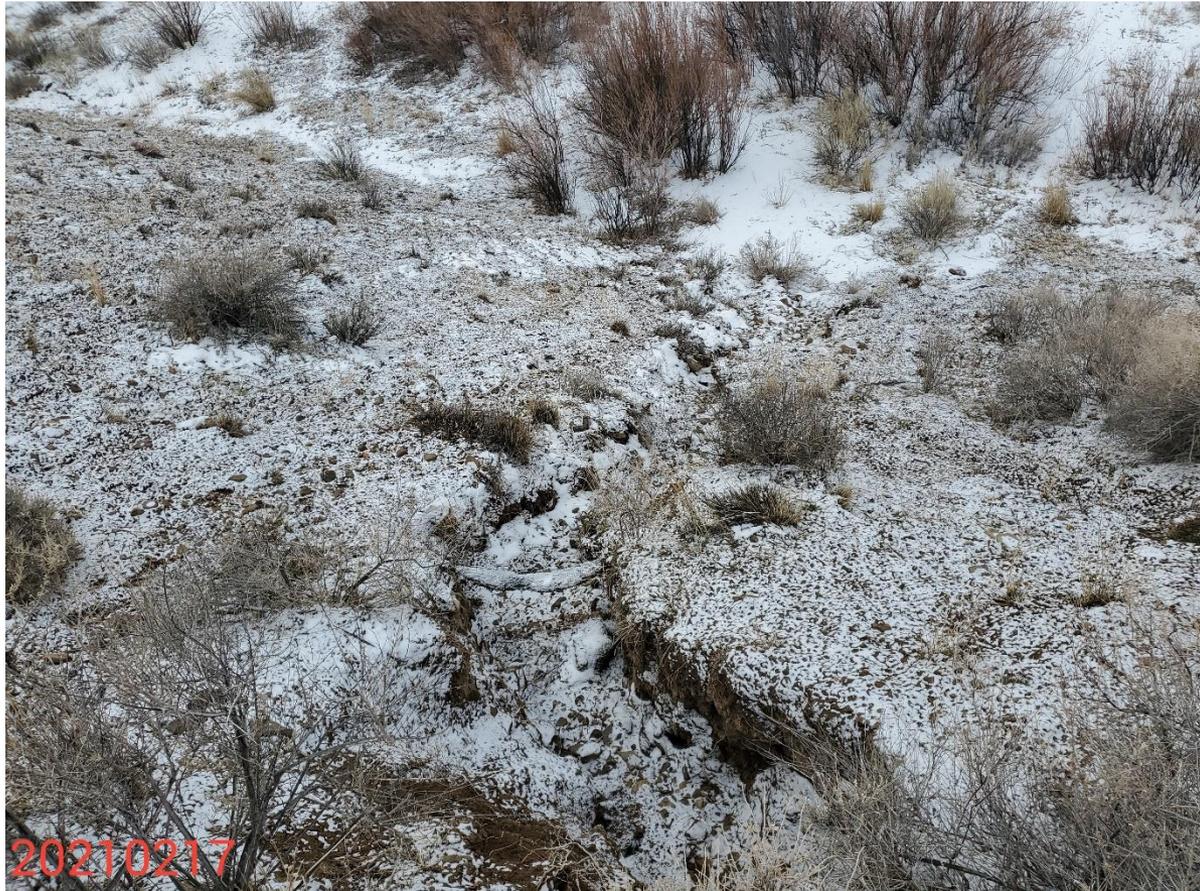
**Photo 16:** Photo taken from the south end of the Location, facing south. Photo shows gully erosion.

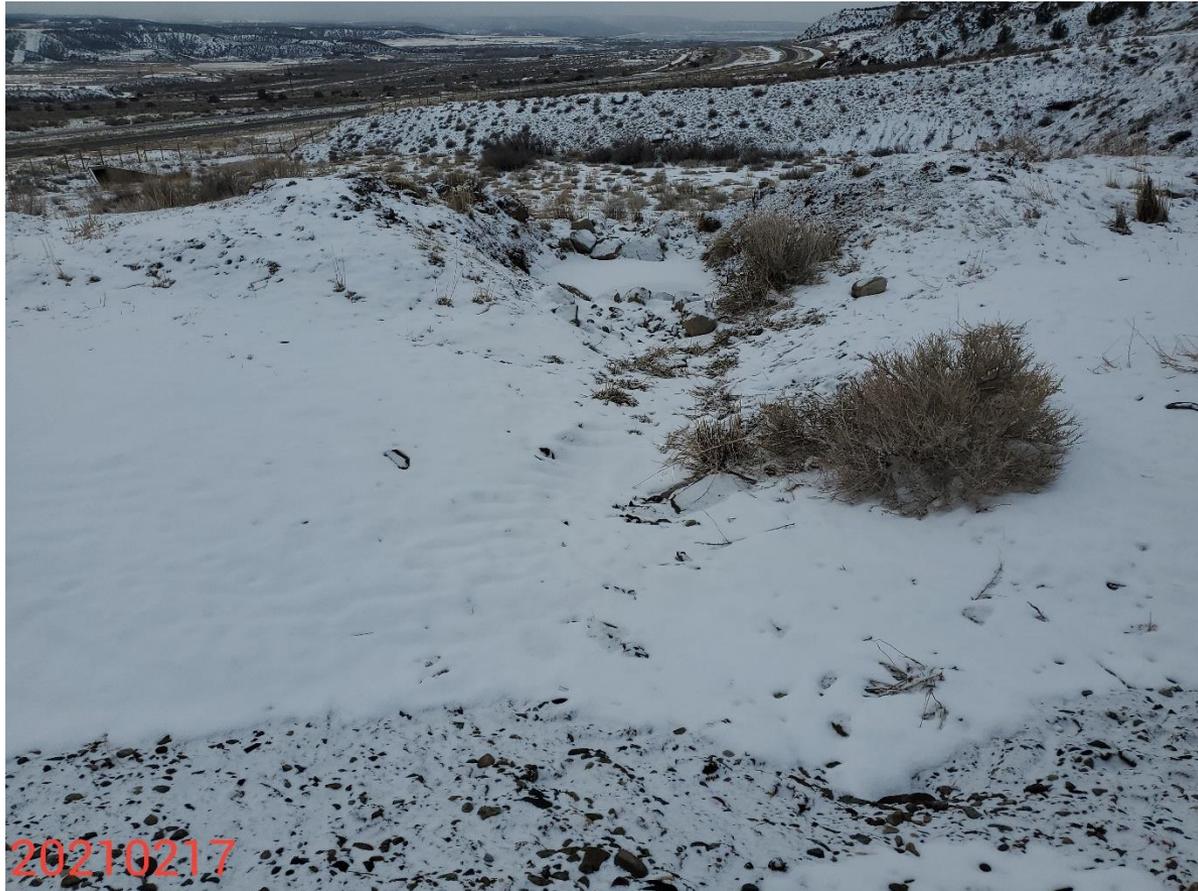
**Photo 17:** Photo shows the eastern sediment trap on the south end of the Location. Gully erosion observed in photos 13-16 observed below sediment trap.

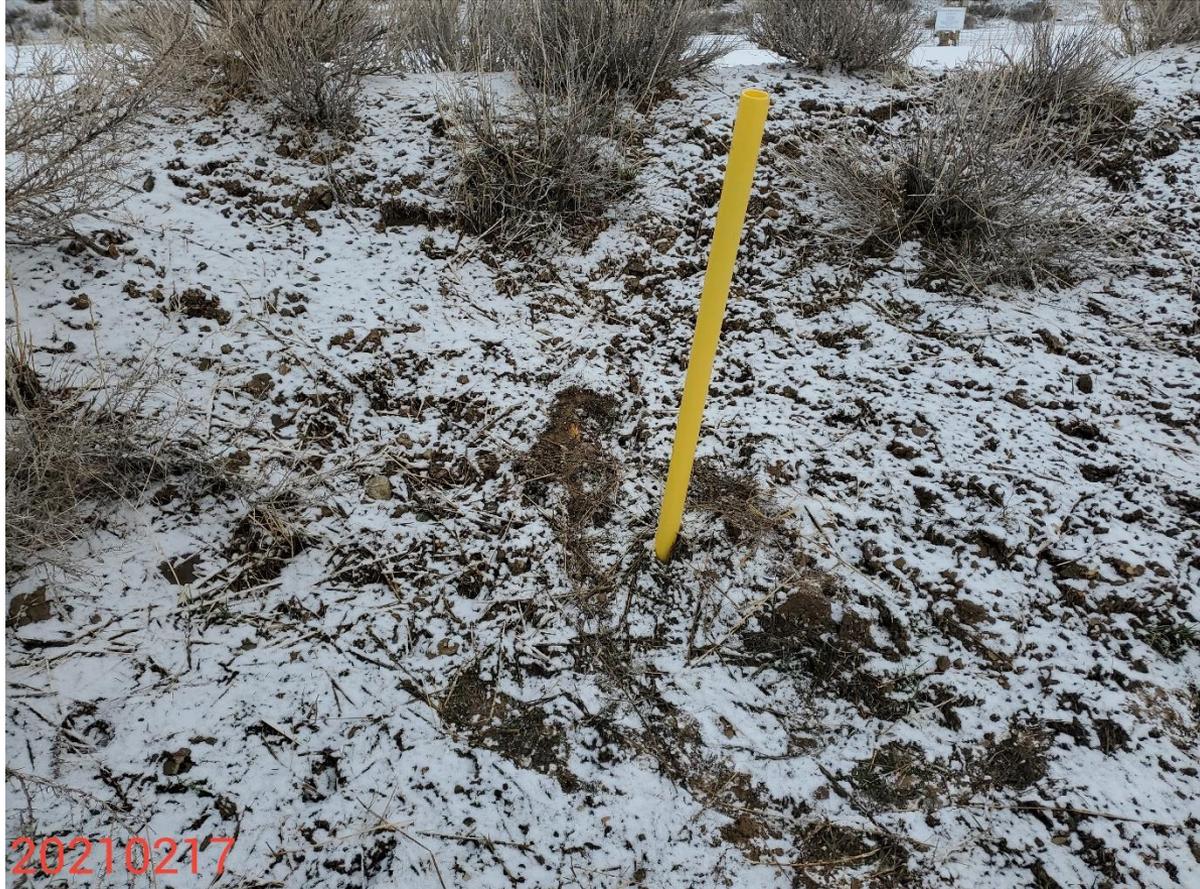
**Photo 18:** Photo shows example of marked anchors observed on the Location.
