Pit Status Evaluation Form

Pit Name: CINQUE 5	Facility ID: 118463
Current Status: Unknown	Status Date: 9/23/1999
Current Operator: MARTIN OIL SERVICE INC / 54200	
Updated Operator:	
Form 15 Pit Permit Doc #: 712492	Permit Date: 10/5/1978
Related Facilities: CINQUE #5 (API 123-07564; Facility ID 239776; Loc ID 317683)

County: WELD			
Township: 2N	Range: 68W	Section: 31	QQ: SENW
Original Latitude/ Longitude: 40.096607 / -105.048538			
Updated Latitude/ Longitude: 40.096395 / -105.048068			
Basis for Location Change:			
Pit location updated based on aerial imagery (circa 1993)

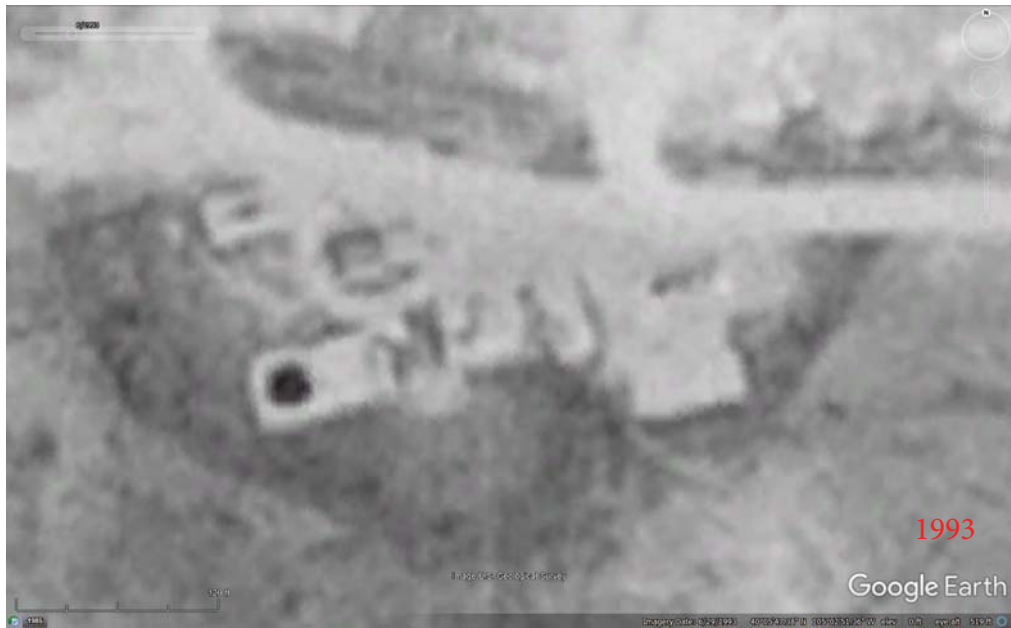
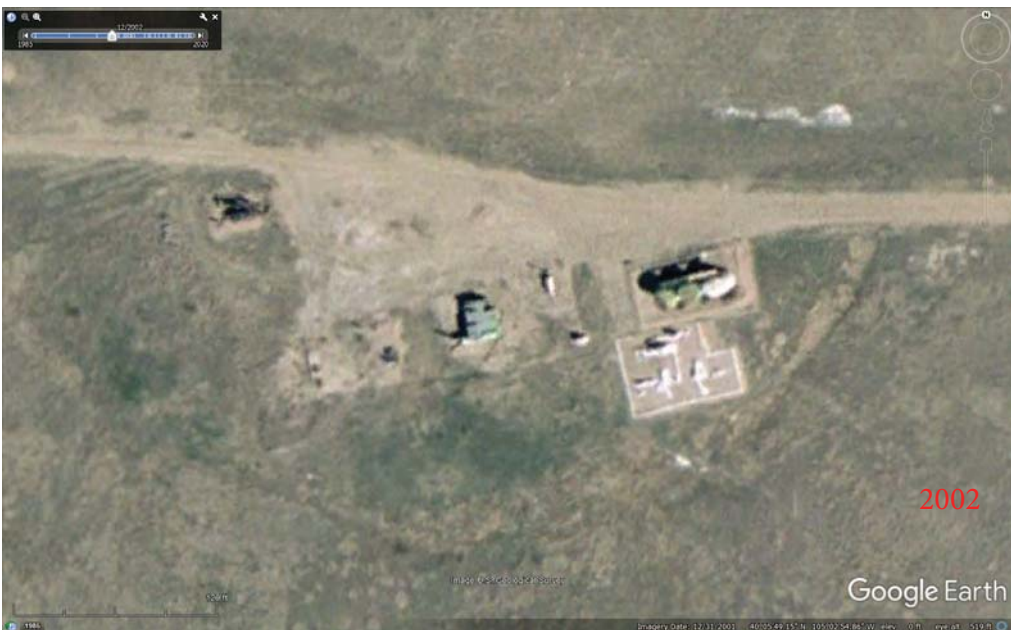
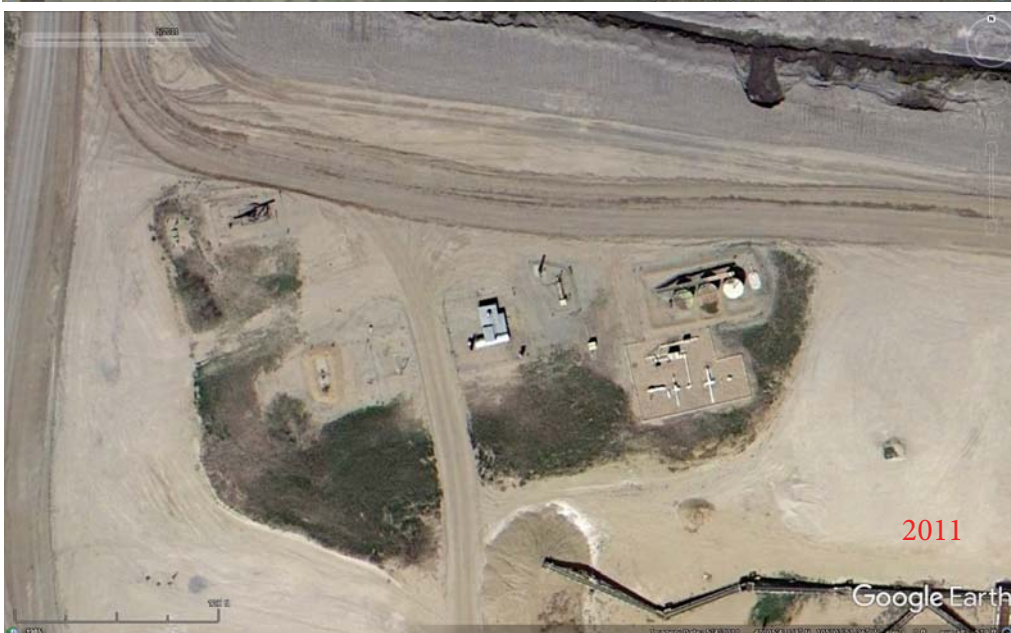
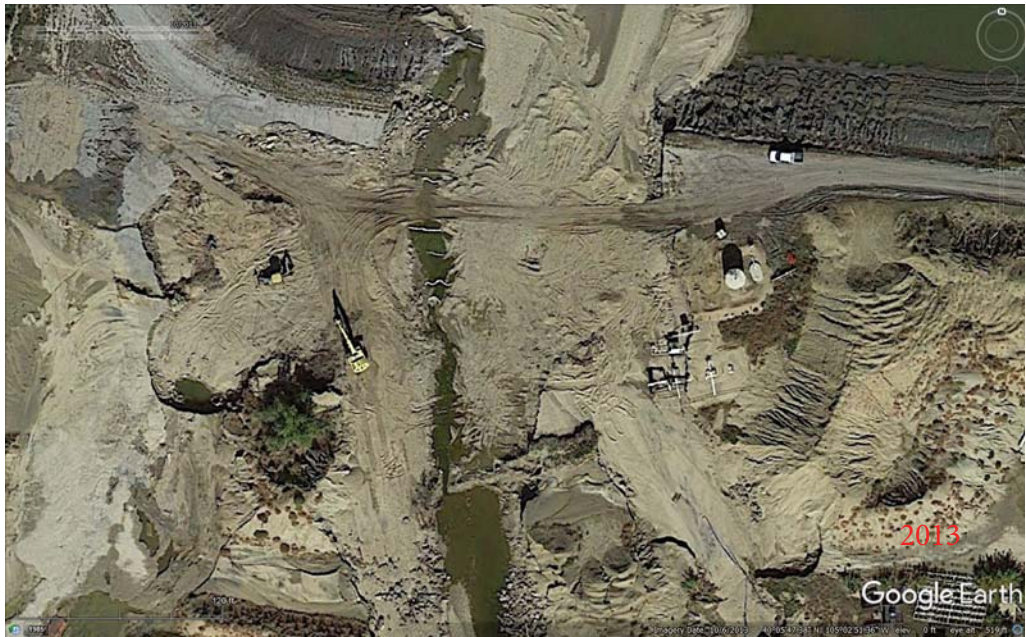
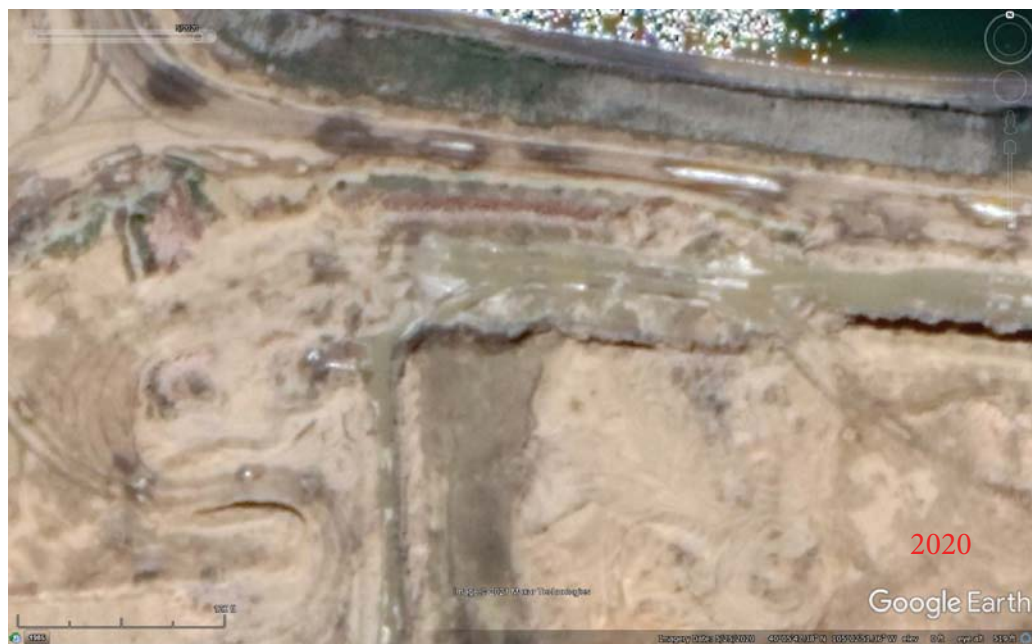
Closed after 1993 aerial imagery and prior to 1996 pit inventory report

Based on records review and aerial imagery the pit on location was replaced by a tank after 1993 aerial imagery and prior to 1996 pit inventory report. Pit inventories and inspections document a concrete vault on location (shared battery Cinque 1-6). Remediation from concrete vault performed under Remediation Project No 8084 (CL 3/23/2020). Pit Status has been changed to closed.
