Whiting Oil & Gas Corporation

WILDHORSE 06-0634H CORRECTIVE ACTION INSPECTION PHOTOS

Location ID: 427410
Section 6 T9N R59W

2/22/21

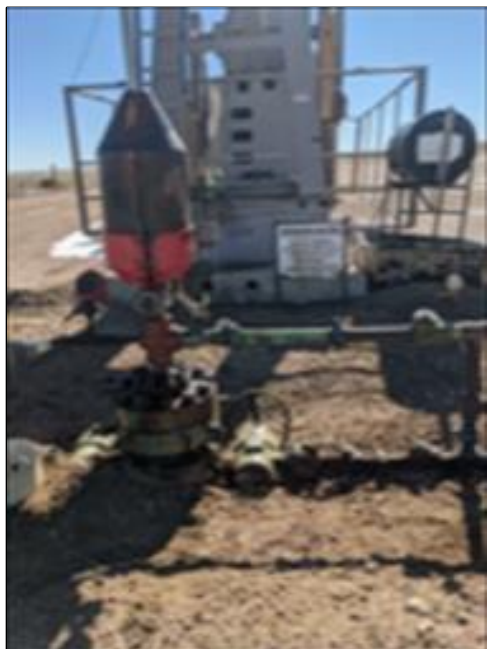
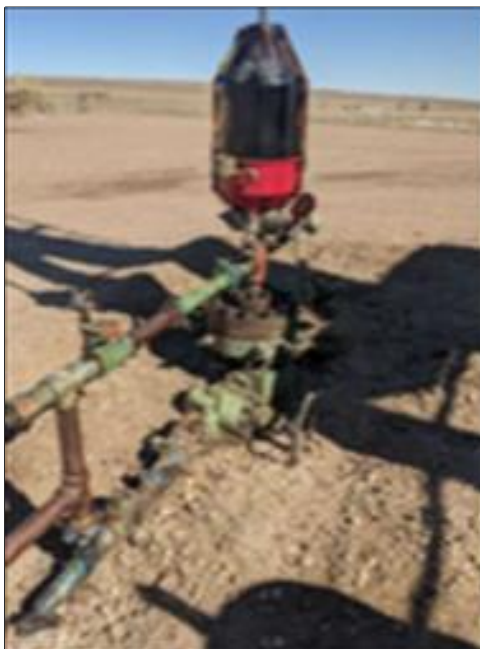
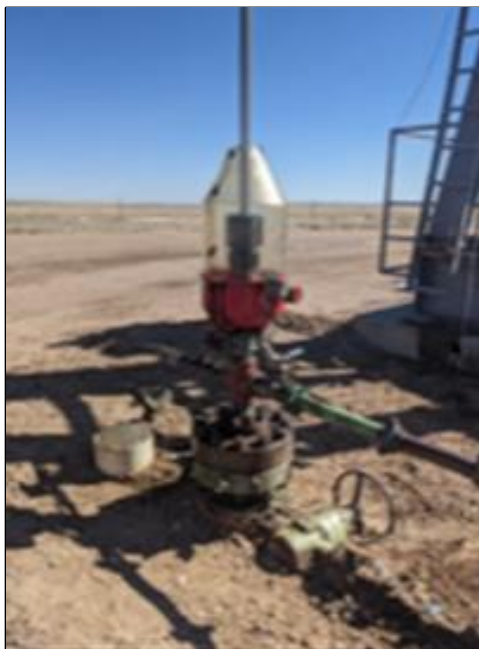
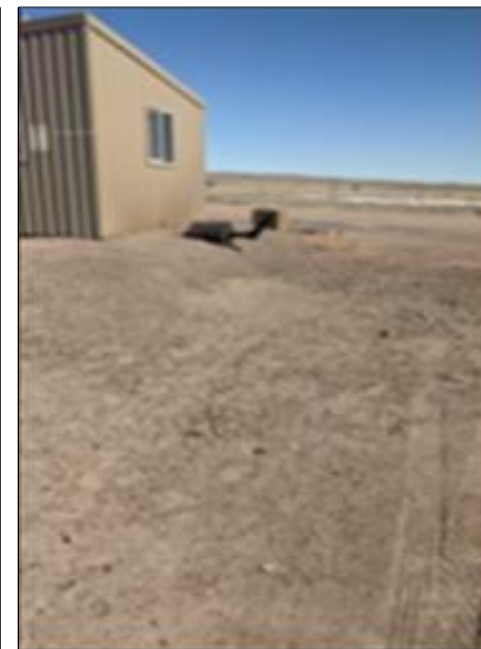
Impacted soils no longer at Wellhead
