# CAERUS PICEANCE LLC

## PUCKETT-66S96W 31SENW

### Location # 335297

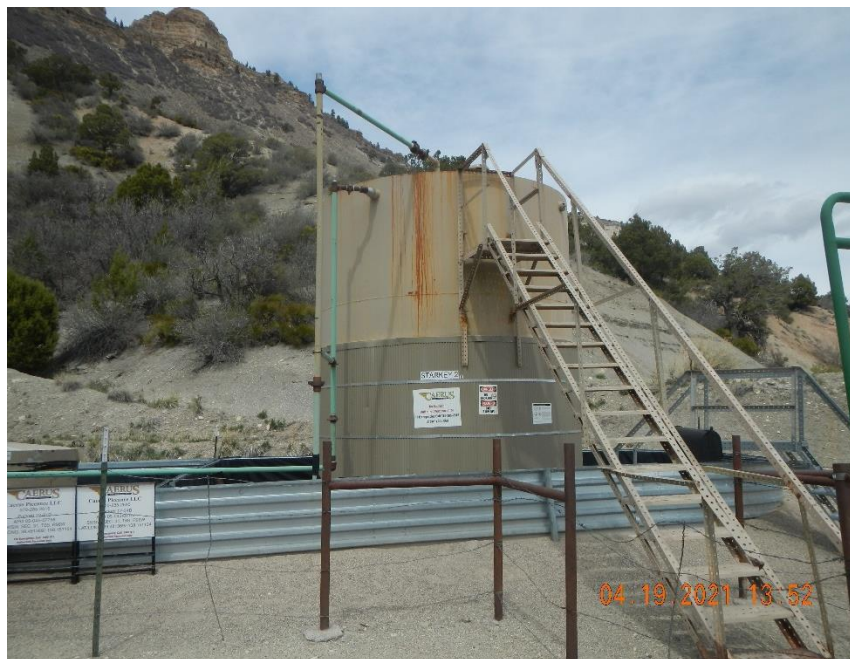
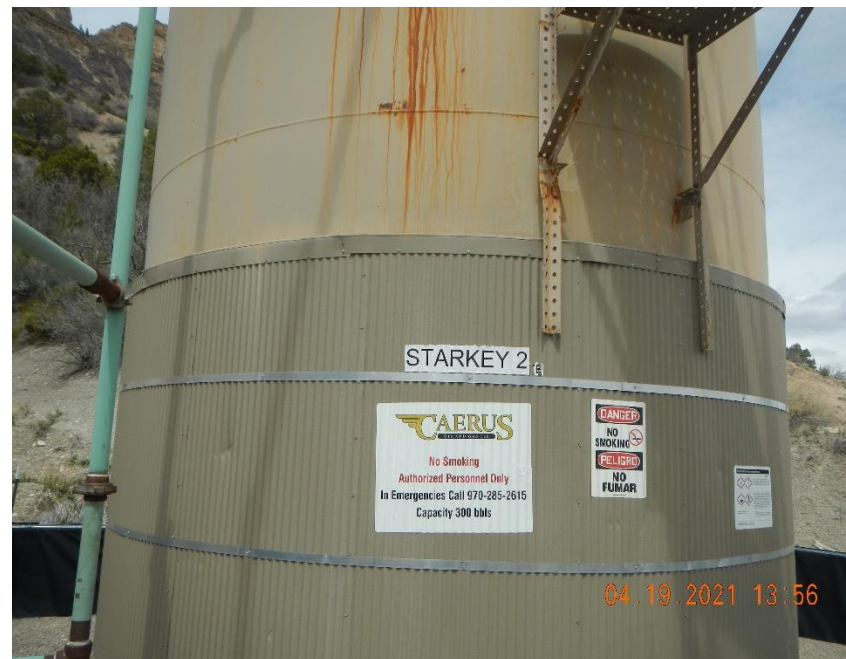
**No NFPA sticker on tank.**

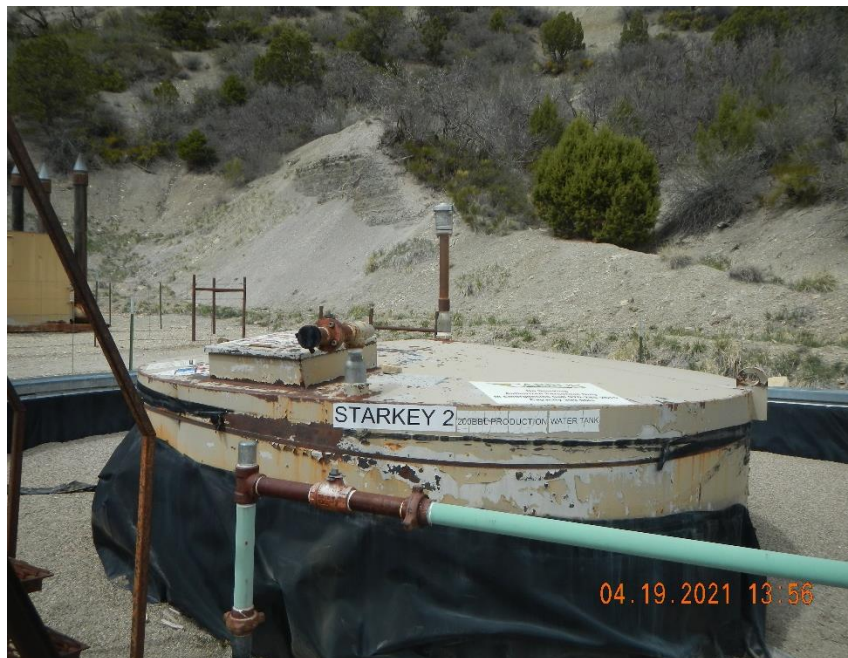
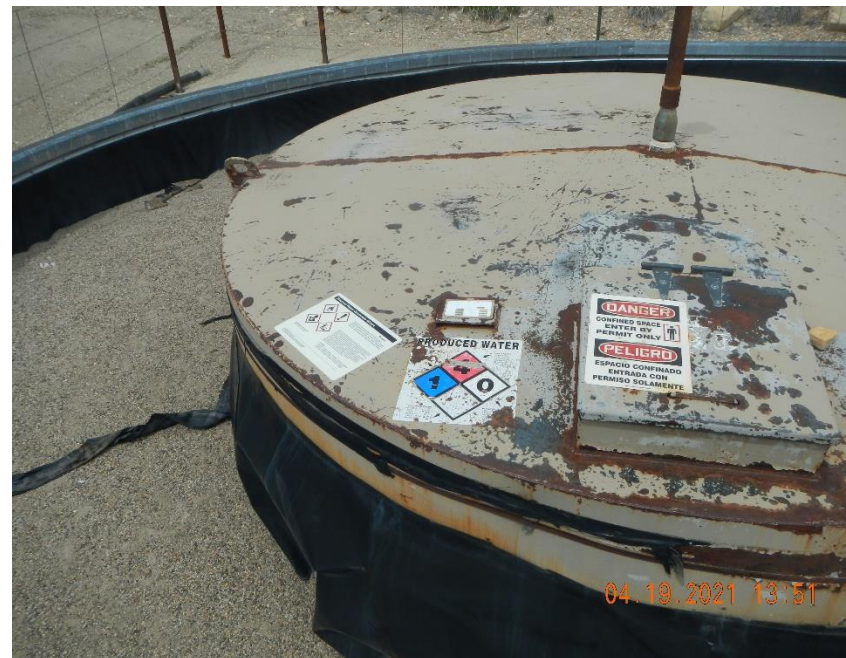
**NFPA sticker is damaged.**

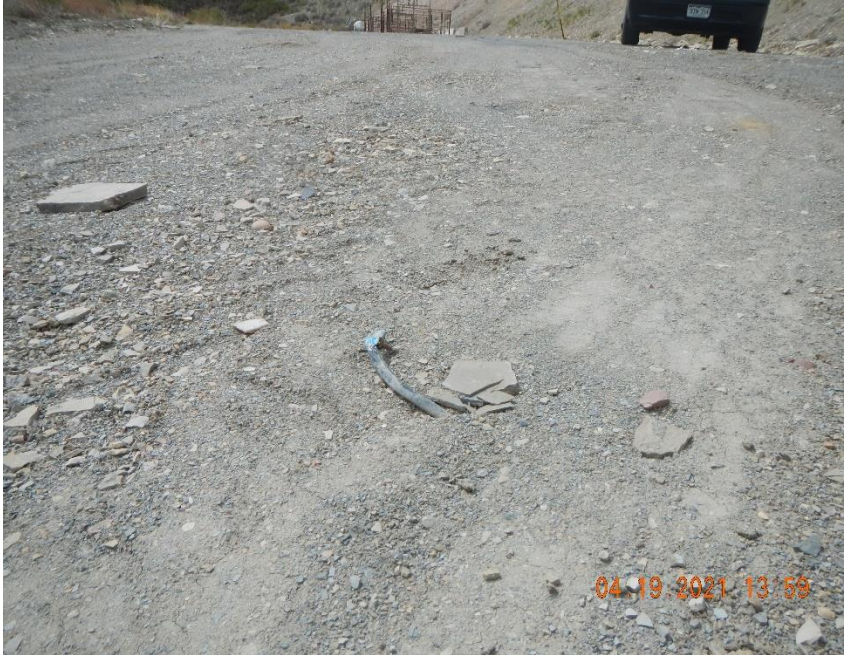
**Buried electric cables exposed.**

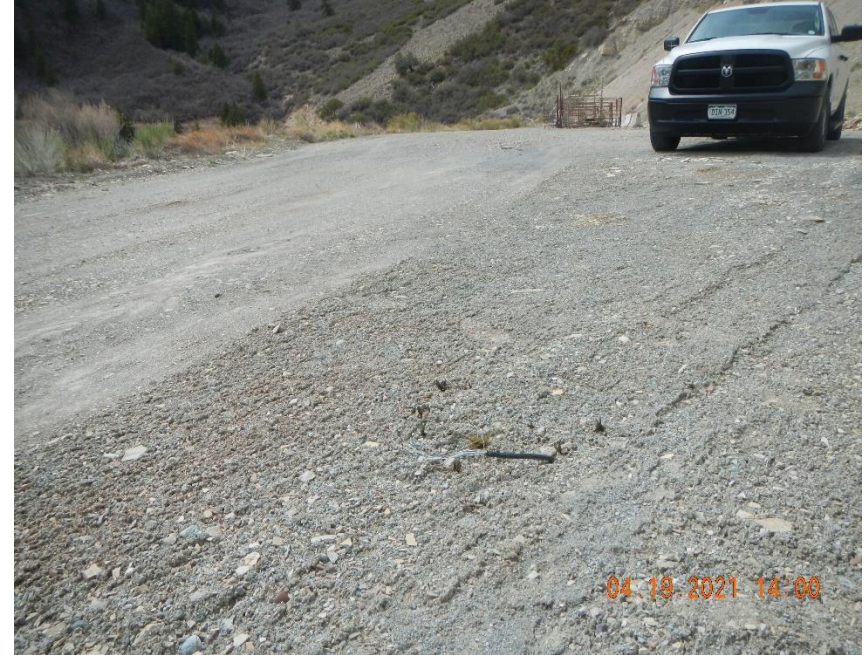
**Buried electric cables exposed.**

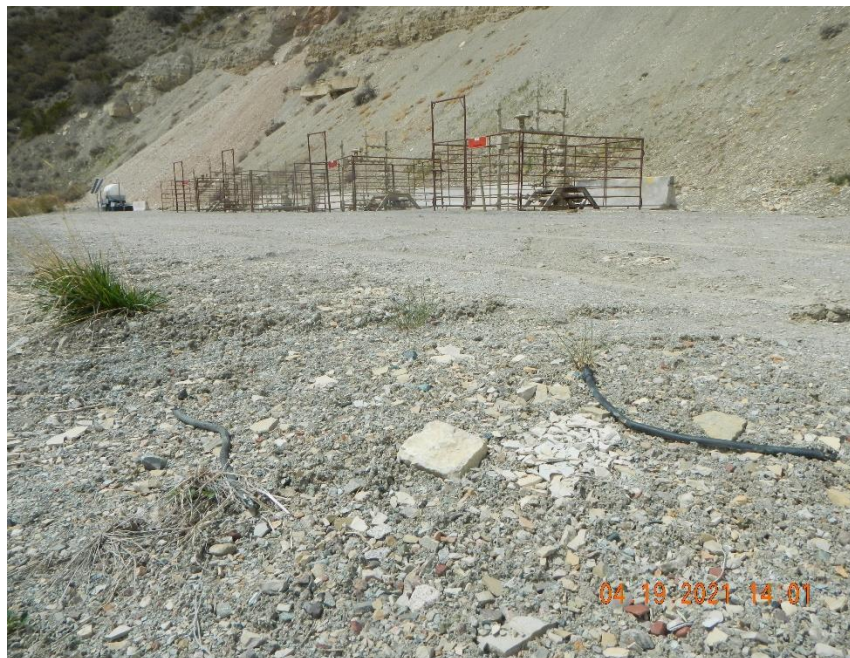
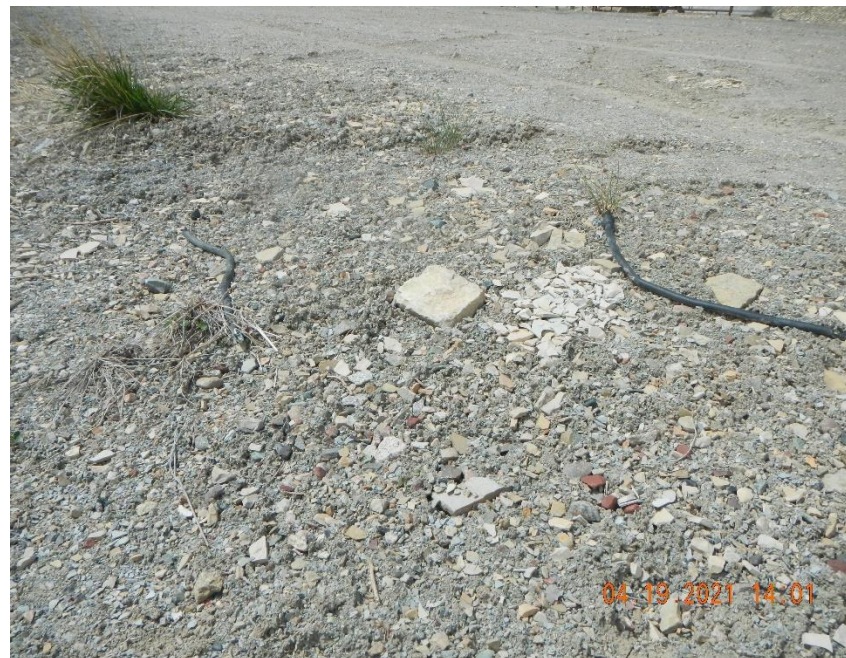
**Electric wire cable pieces on edge of location.**

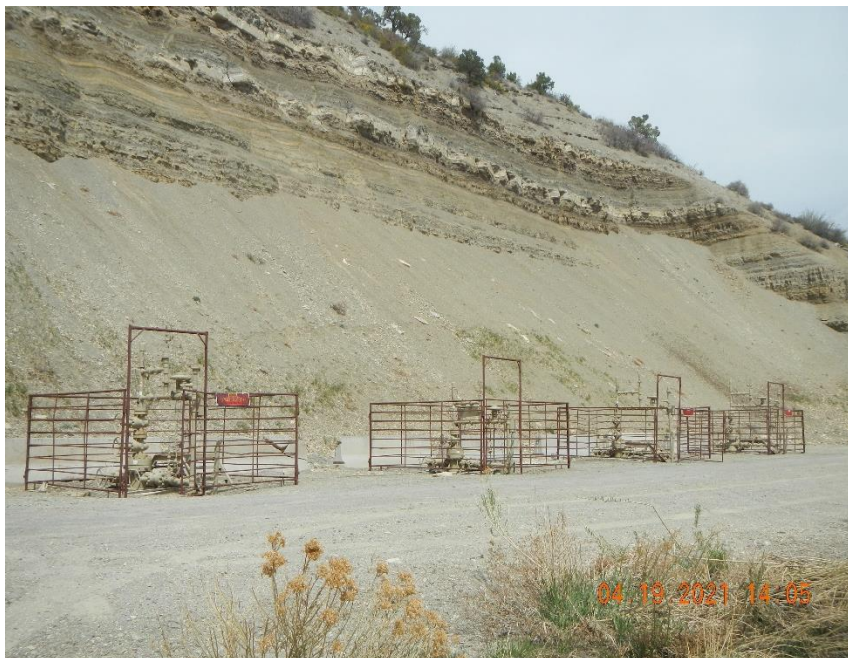
**Well signs are illegible and missing api#s.**

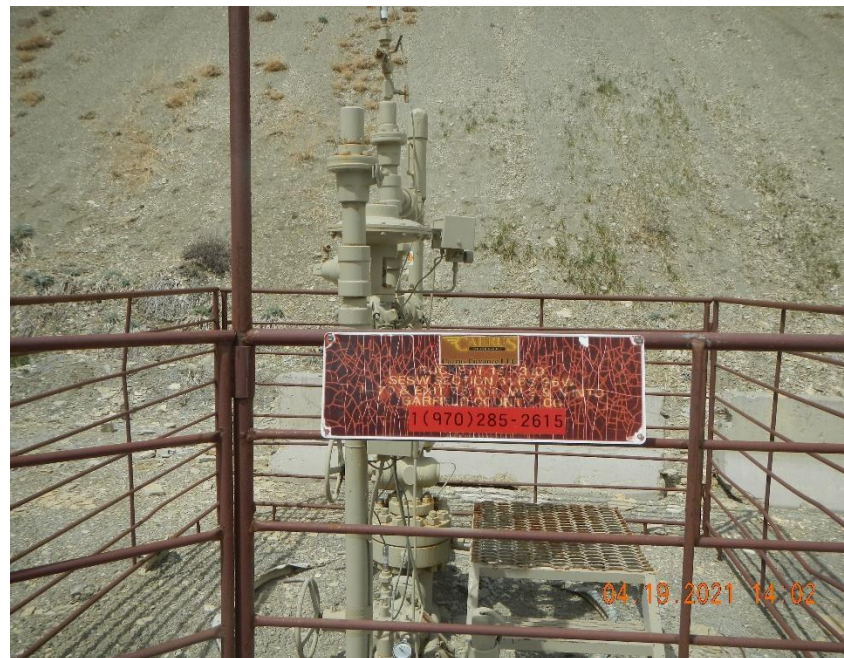
**Well signs are illegible and missing api#s.**

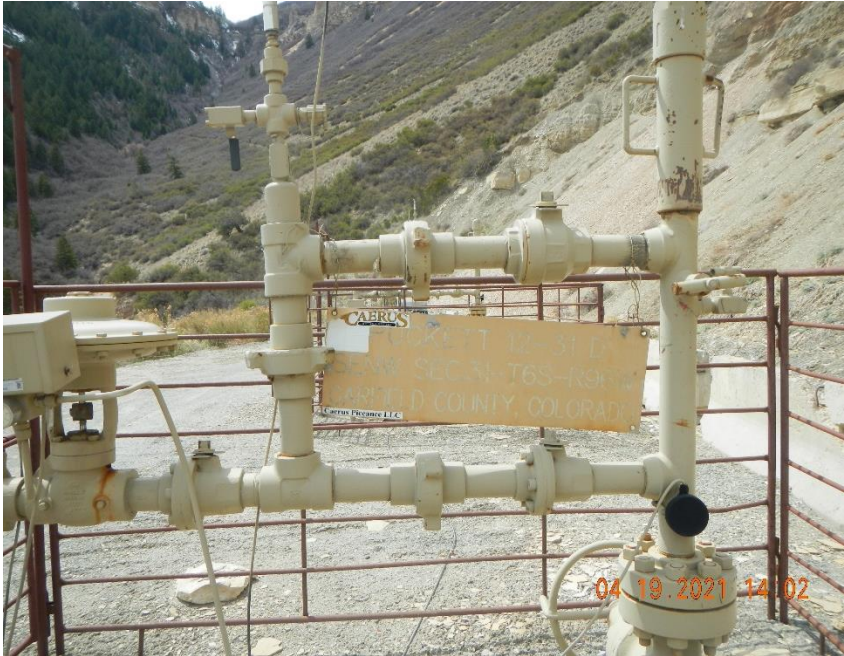
**Well signs are illegible and missing api#s.**

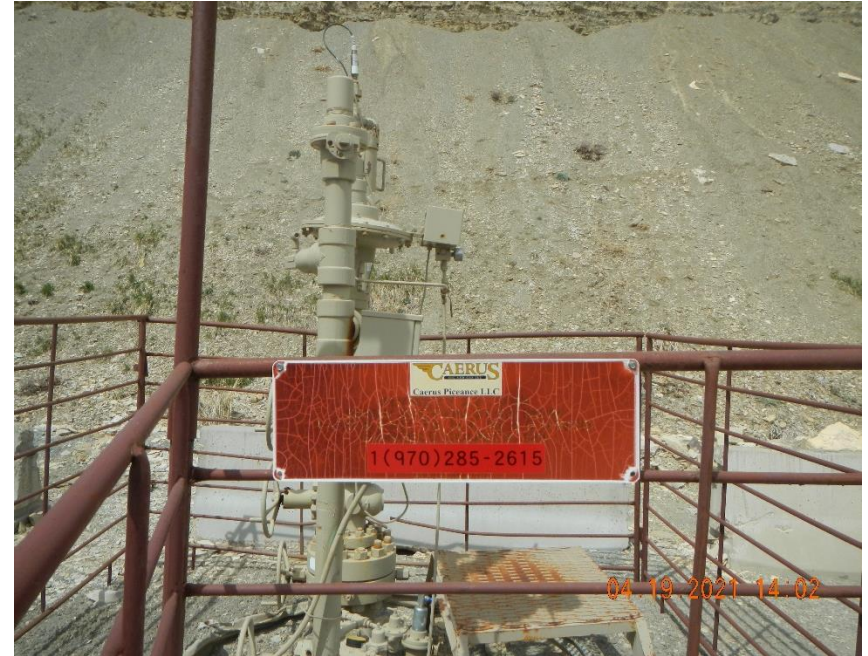
**Well signs are illegible and missing api#s.**

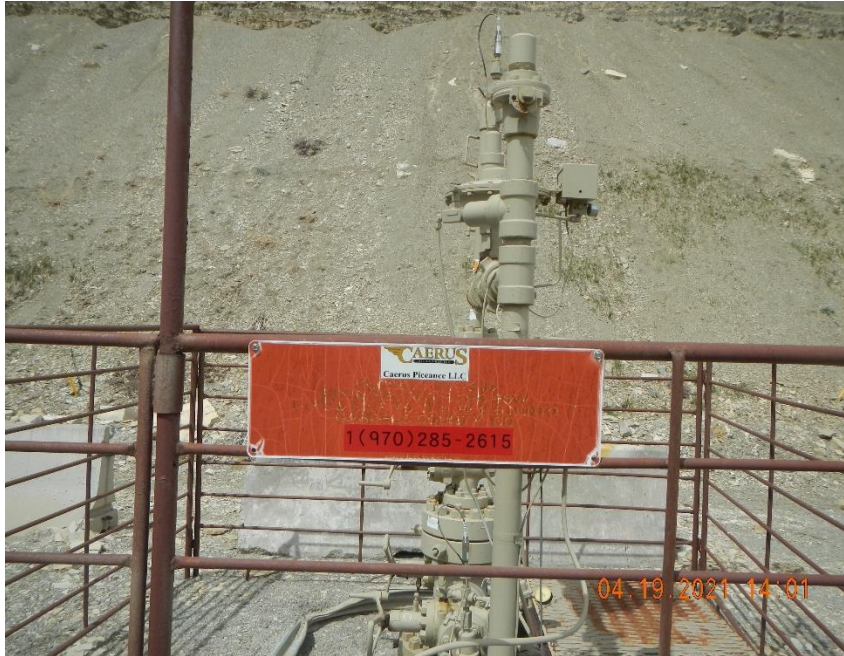
**Well signs are illegible and missing api#s.**

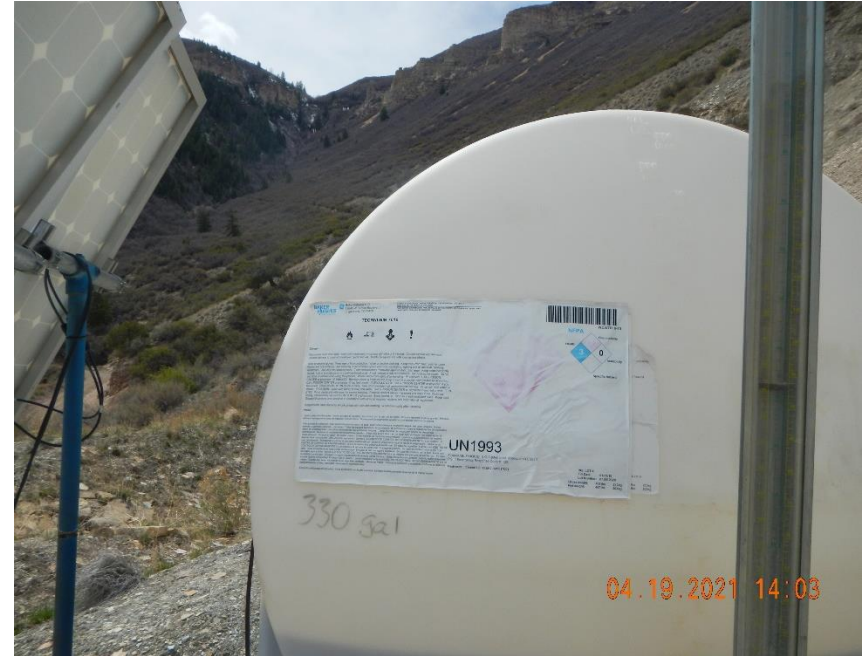
**DOT diamond is faded.**

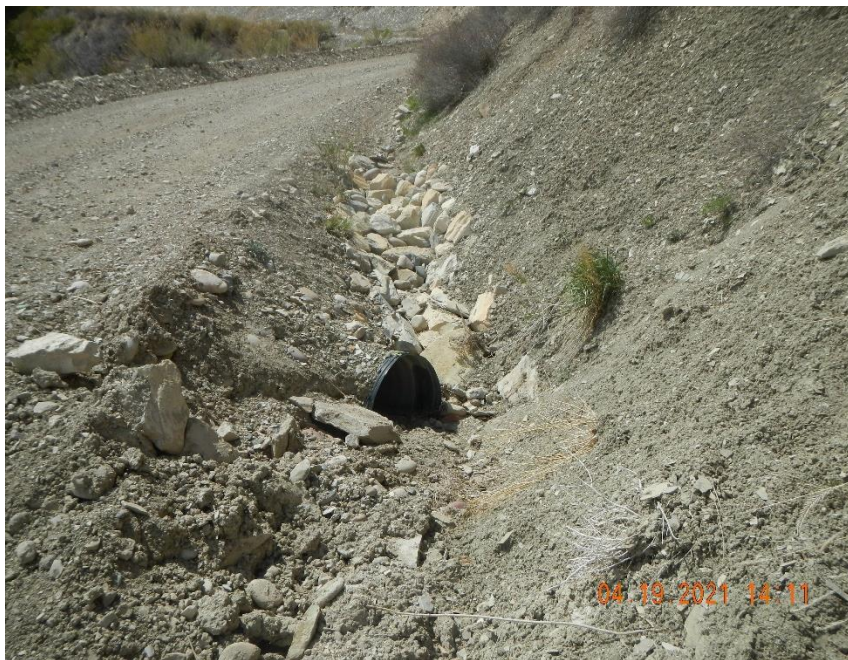
**Sediment in culvert.**

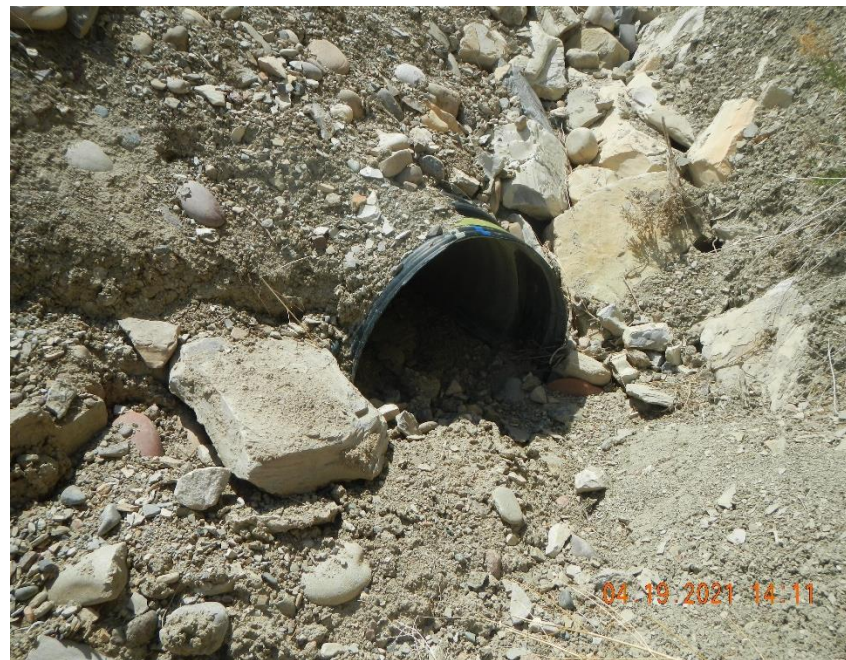
**Sediment in culvert.**

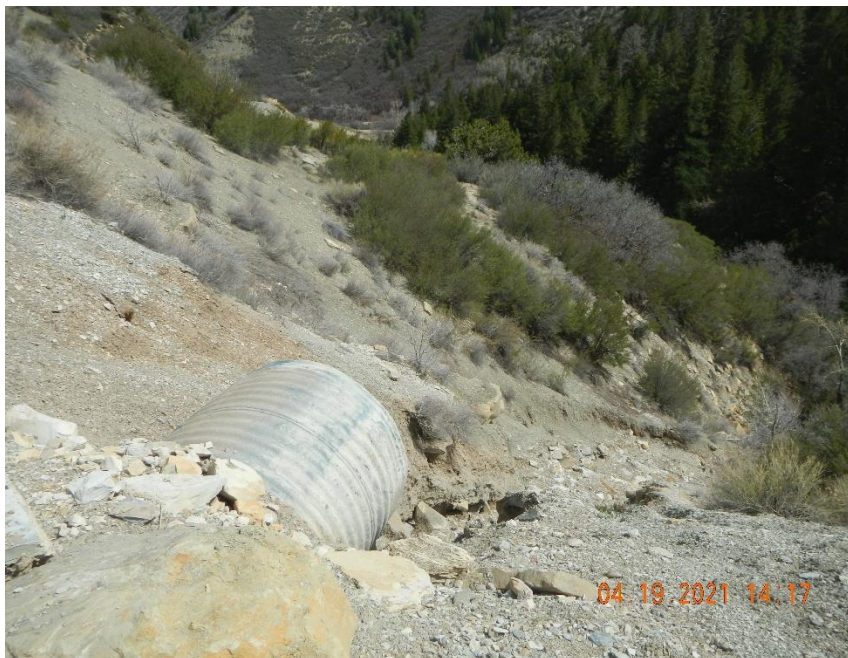
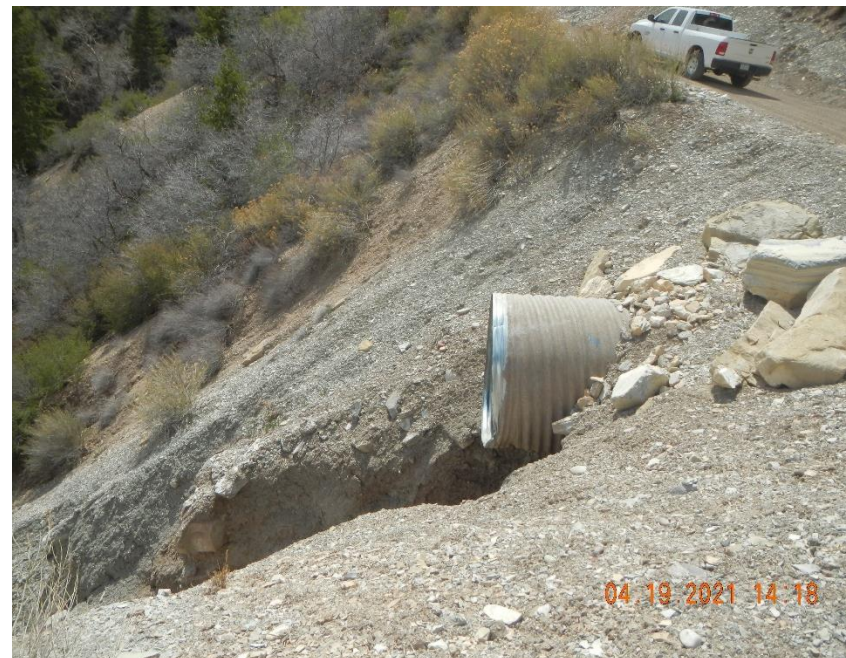
**Erosion created from flow of culvert.**

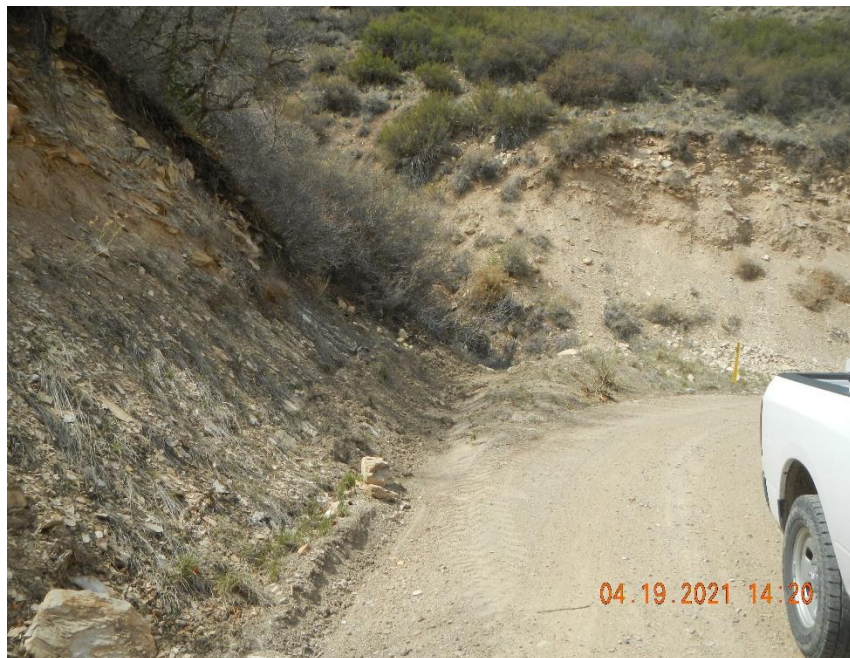
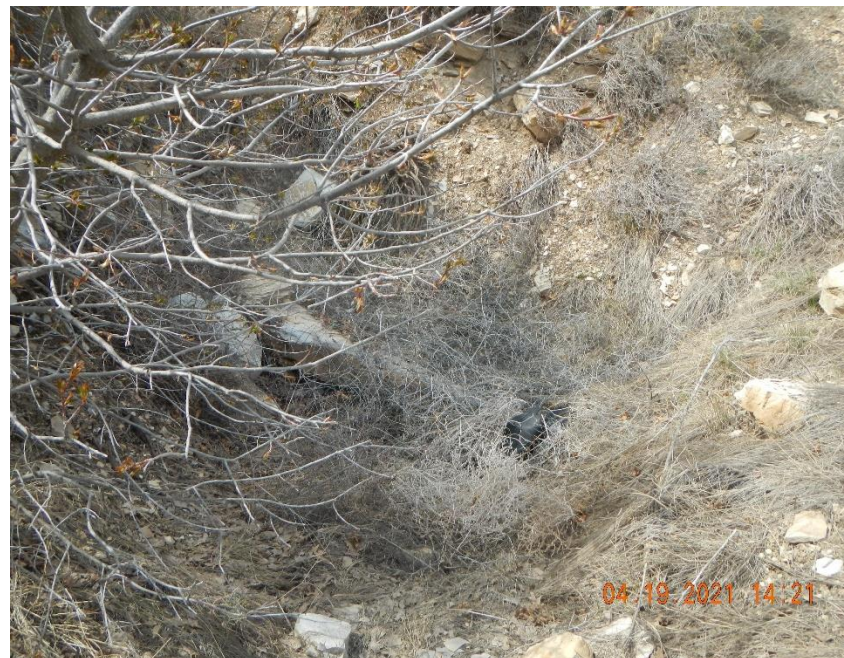
**Culvert basin needs cleaned out.**

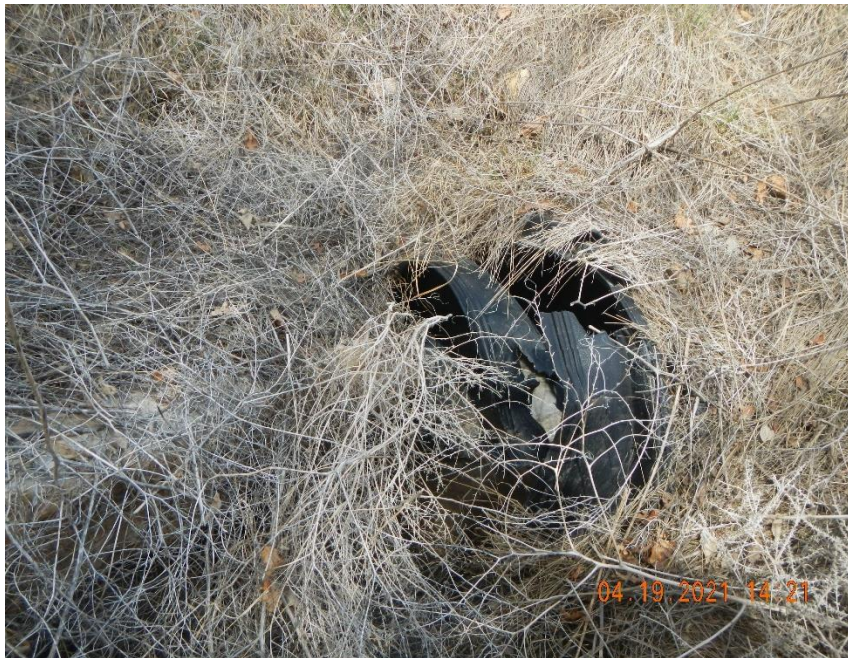
**Damaged culvert.**

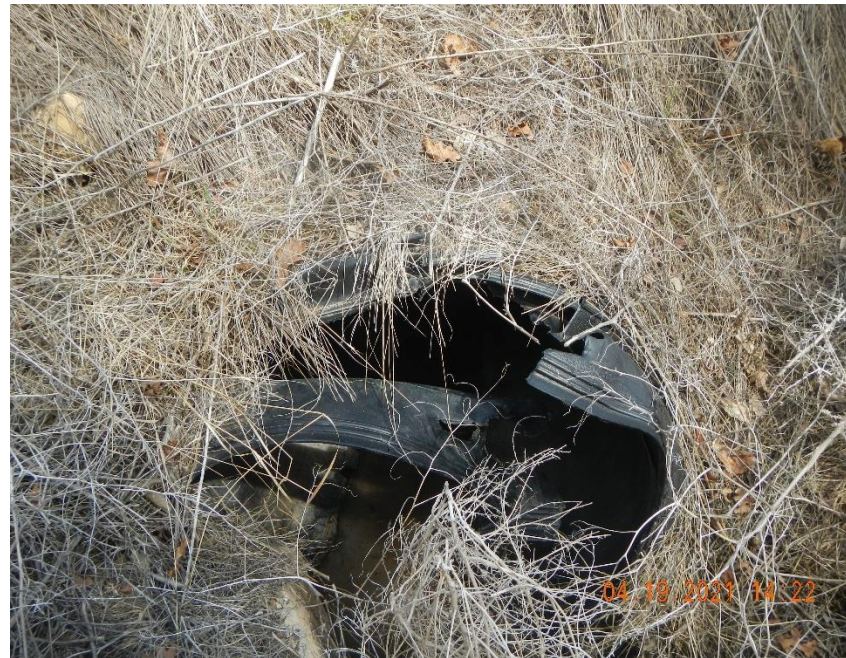
**Sediment and rock in culvert.**
