**Inspection Photos**  
**Location Name: Grant Tank BTRY**  
**Location ID: 446484**

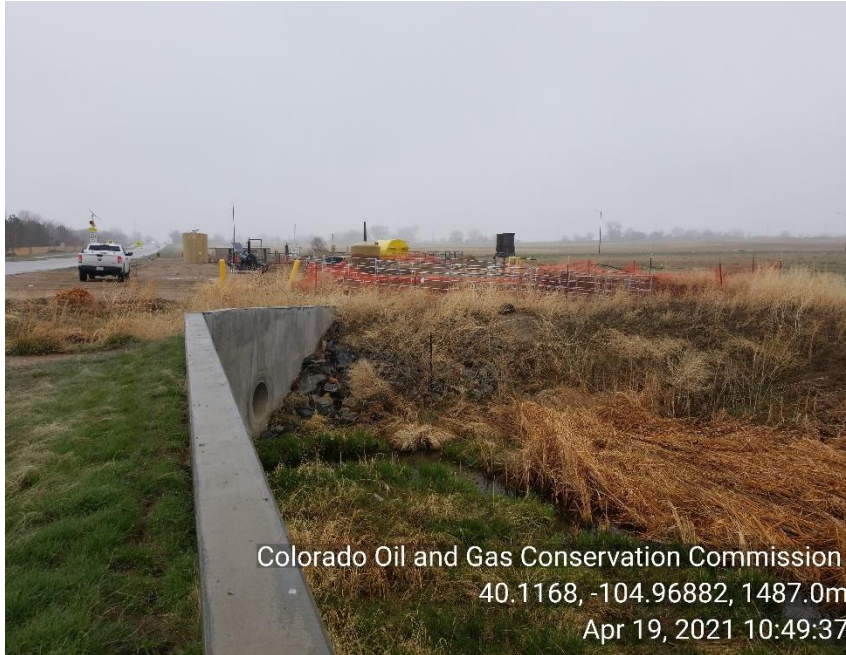
**Photo 1 no BMP's in place between active water way (riparian habitat) and open excavation.**

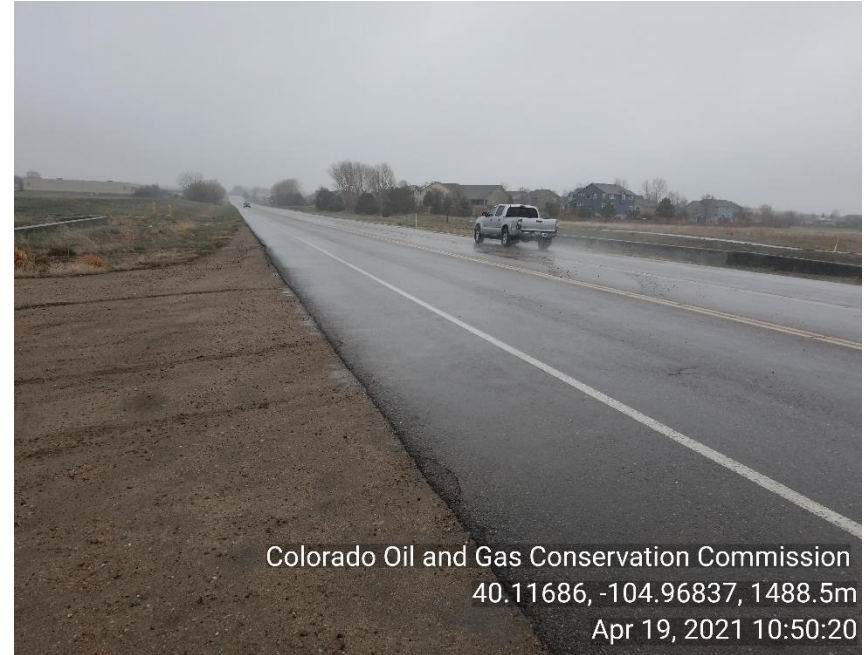
**Photo 2 No tracking pad BMP on entrance # 1**

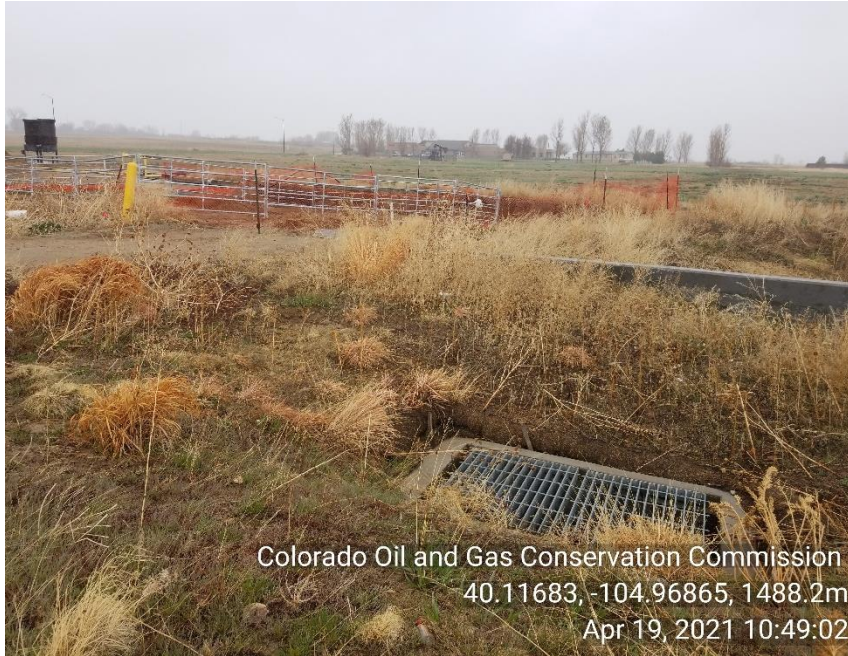
**Photo 3 No inlet protection around storm drain.**

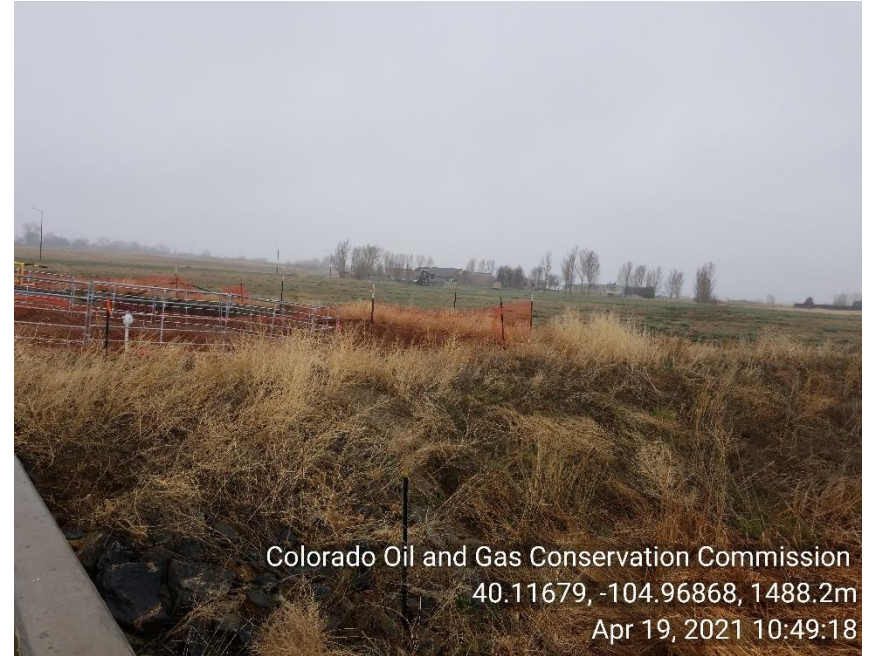
**Photo 4 no BMP's in place between active water way (riparian habitat) and open excavation.**

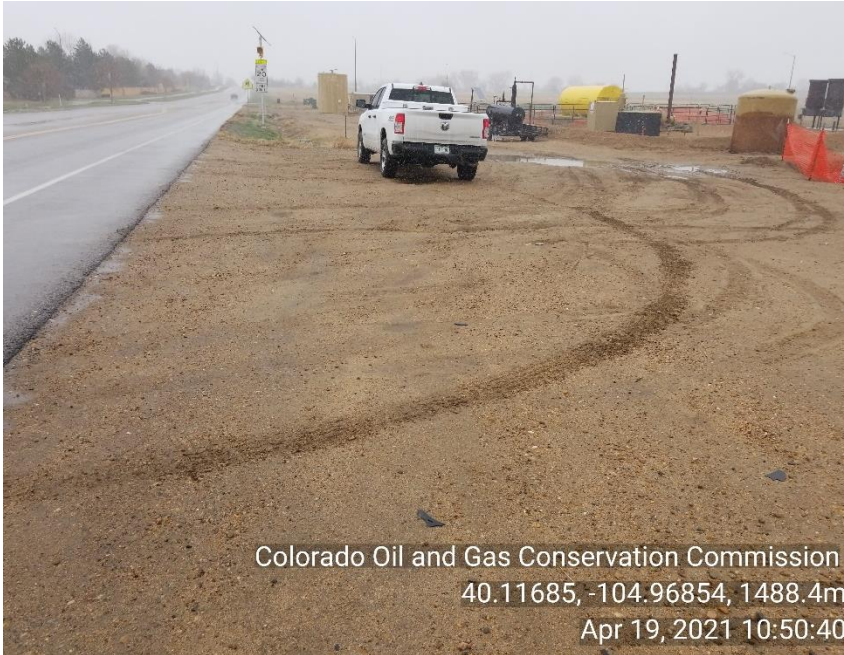
**Photo 5 No tracking pad BMP**

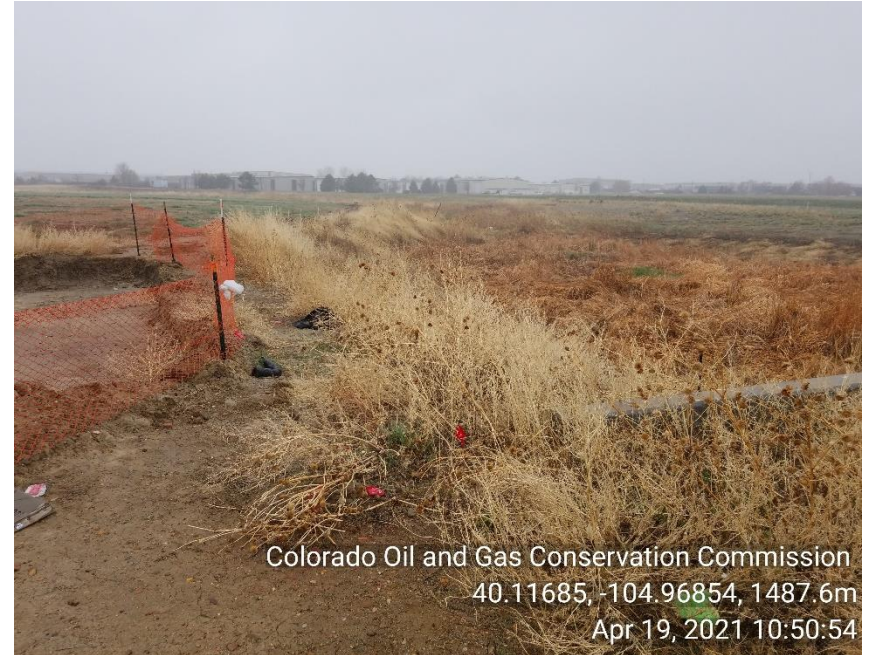
**Photo 6 Debris: dead weeds and not BMP between produced water tank excavation and water way.**

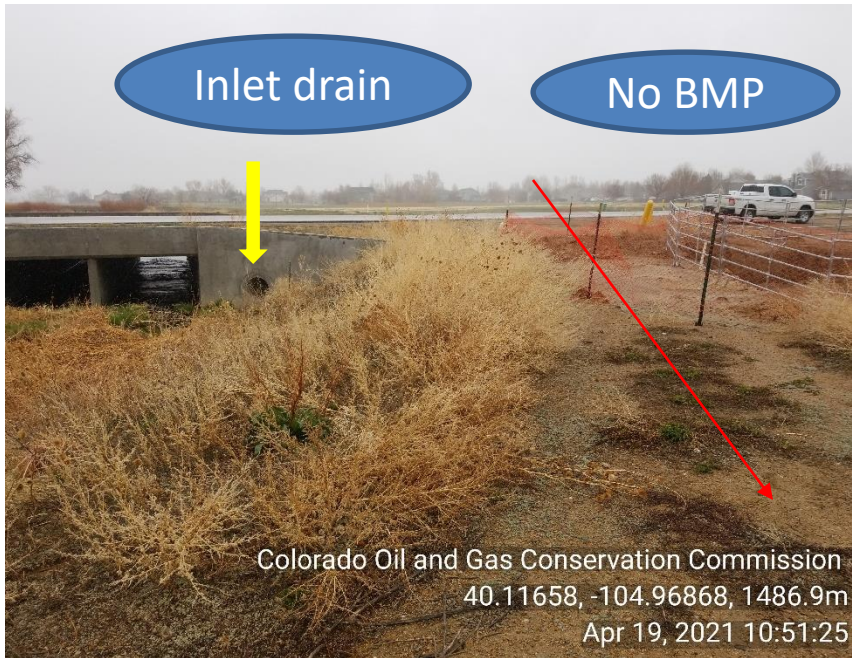
**Photo 7 Outlet of inlet drain not protected. No BMP between produced water tank and water way.**

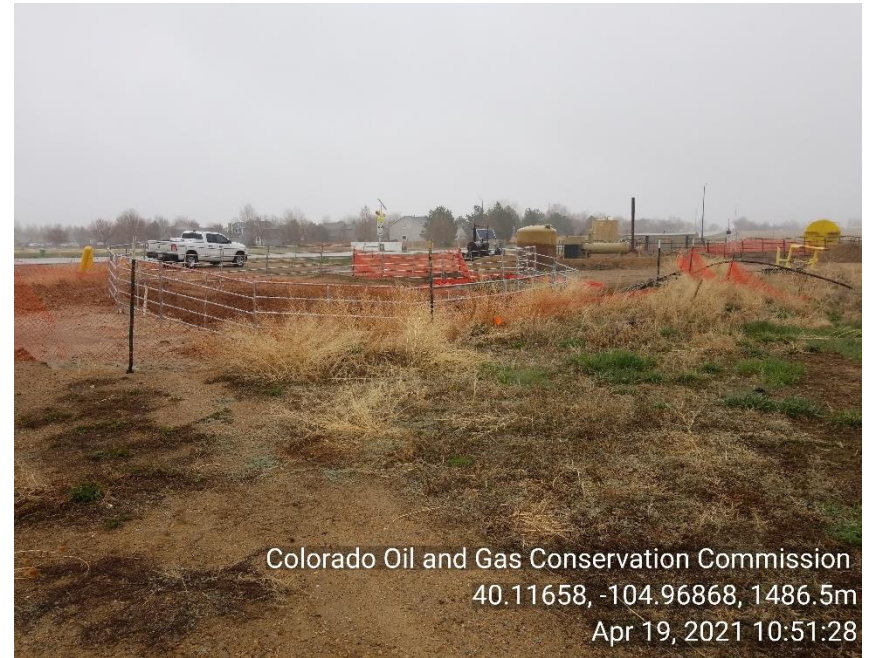
**Photo 8 Improper safety fence around work area.**

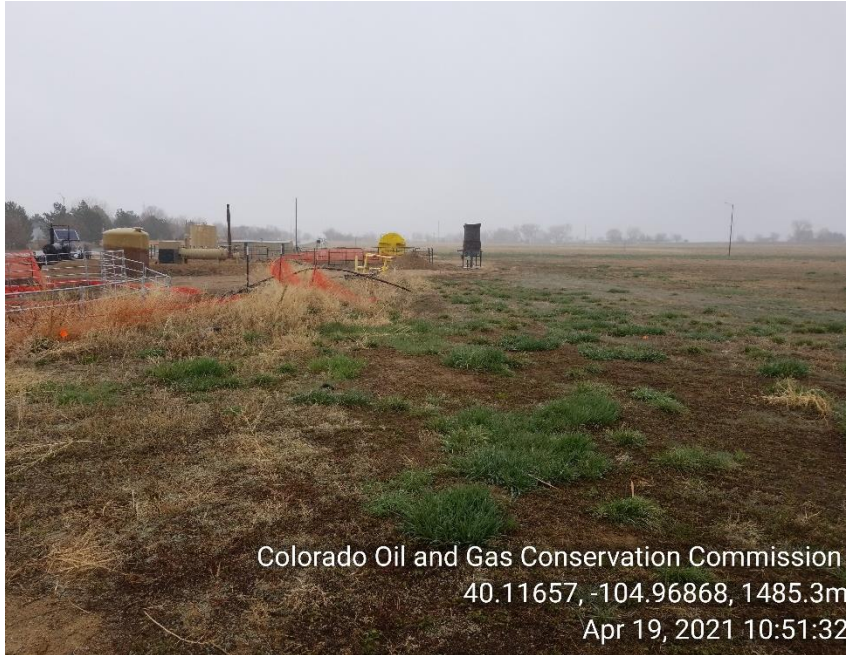
**Photo 9 No BMP's around work site to protect run on or run off.**

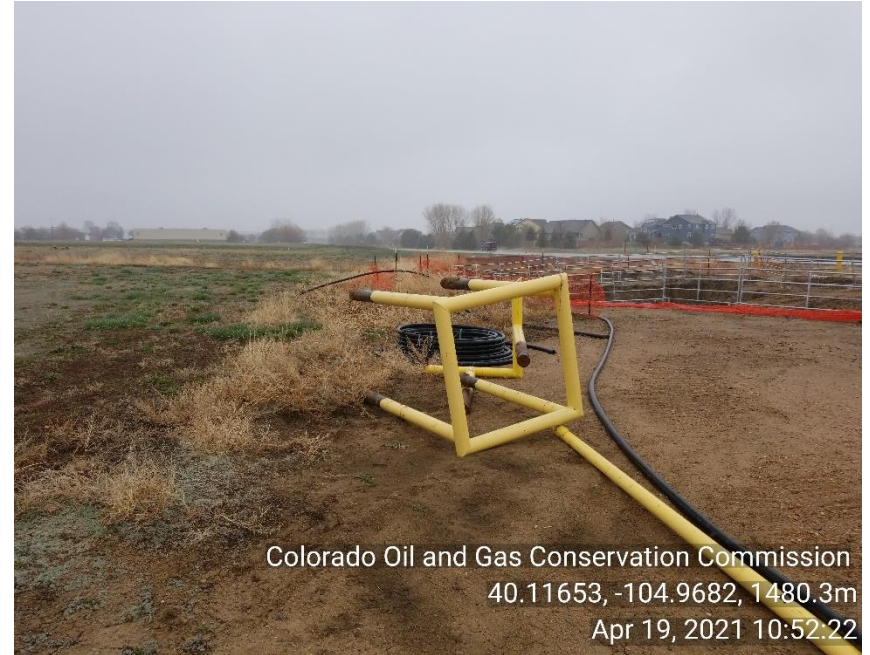
**Photo 10 unused equipment.**

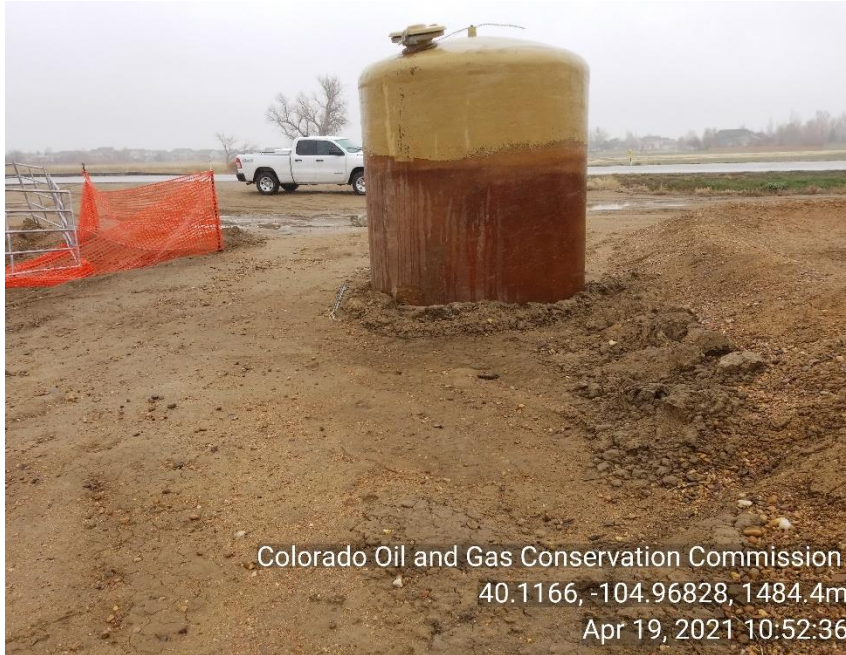
**Photo 11 Unused equipment**

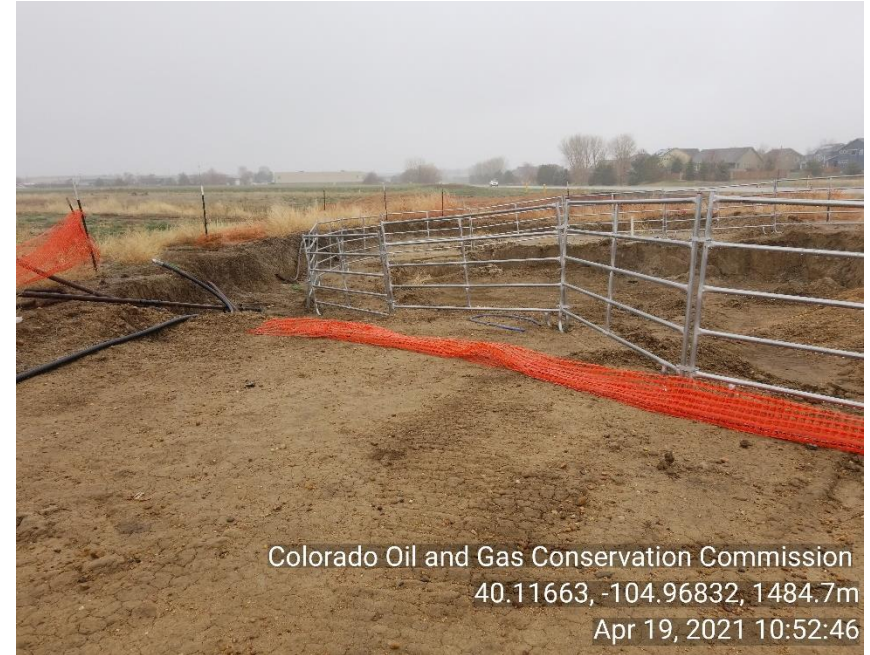
**Photo 12 improper safety fence around work zone and open excavation.**

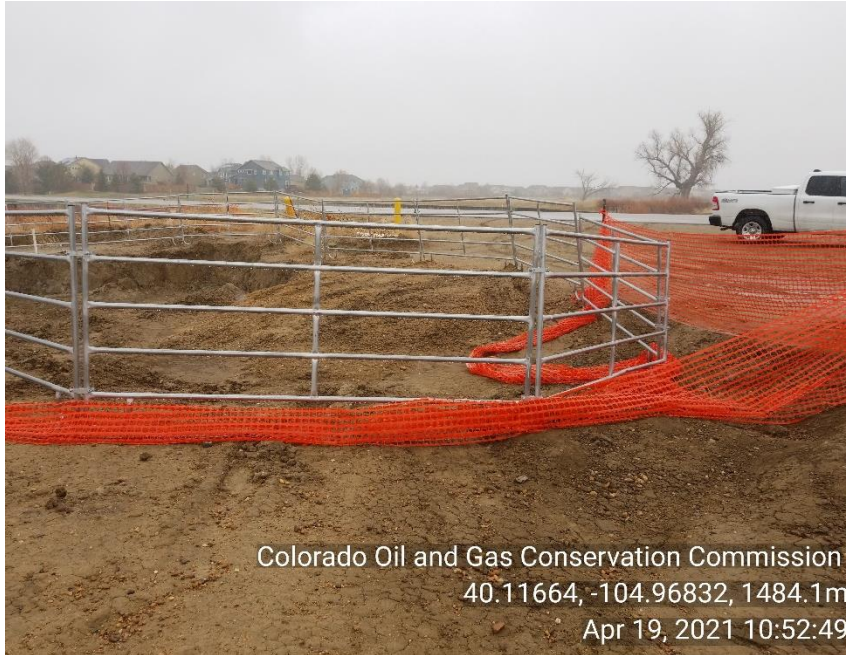
**Photo 13 Improper safety fence around work site.**

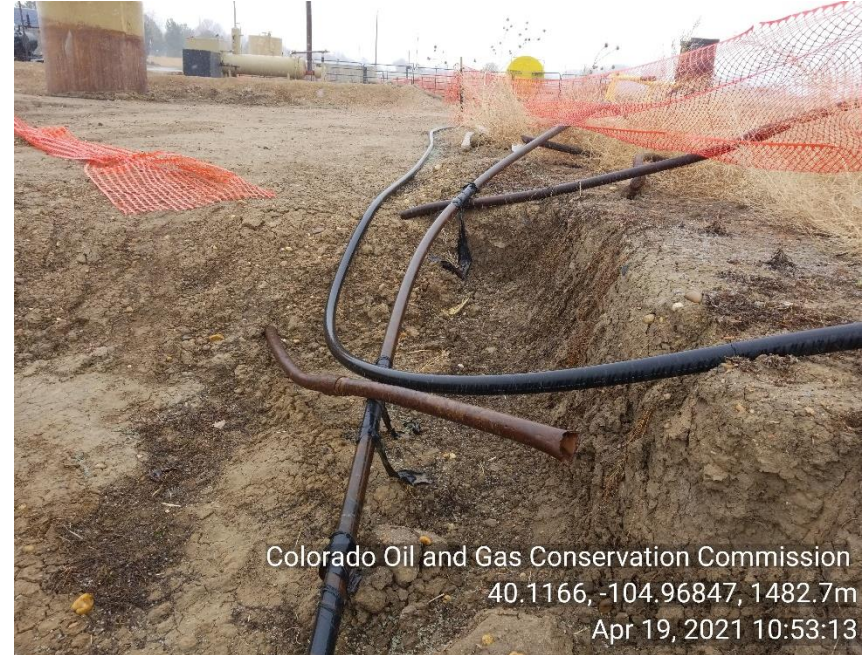
**Photo 14 exposed lines not plugged or capped.**

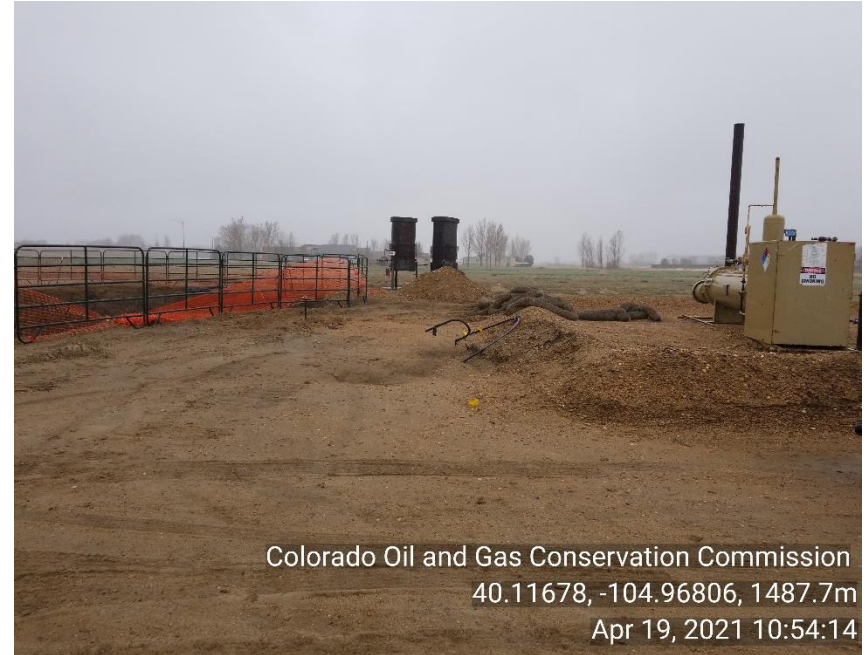
**Photo 18 unused equipment and improper safety fencing  
around work site.**

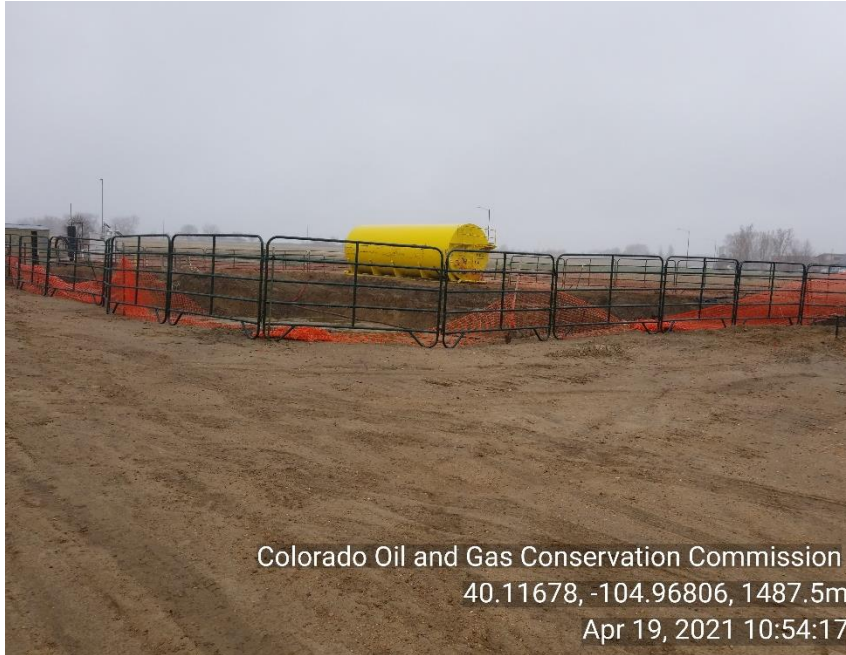
**Photo 19 improper fencing around open excavation and work site.**

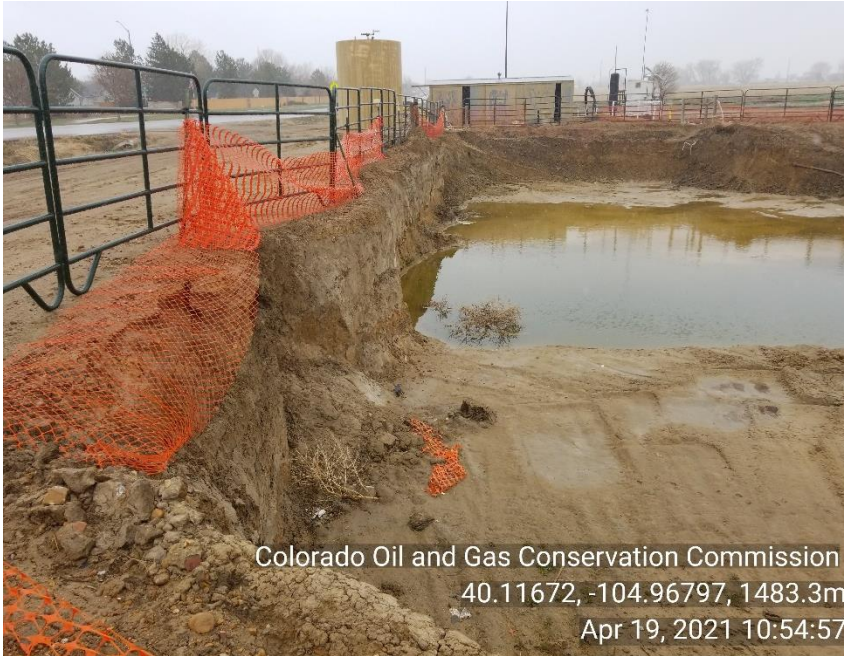
**Photo 21 unsafe and improper fencing around open excavation.  
What appears to be visible ground water.**

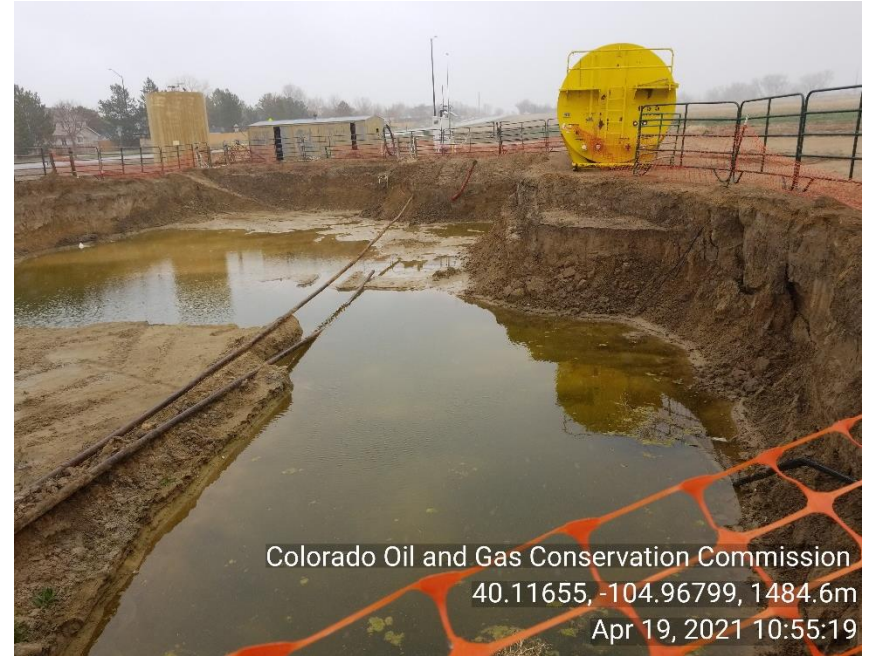
**Photo 22 What appears to be visible ground water, unsupported  
flow lines. Fencing and equipment on edge of vertical bank.**

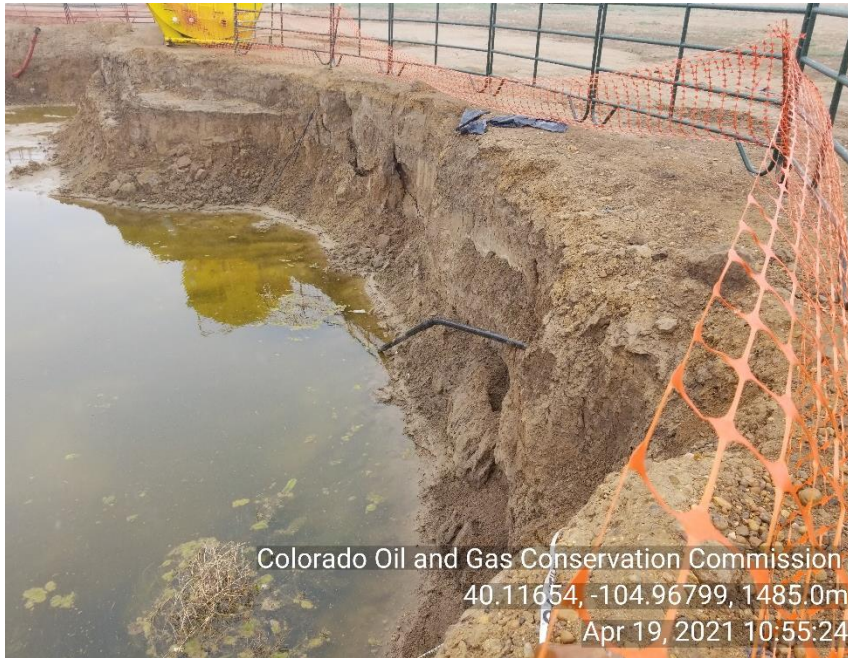
**Photo 23 Piping cut and in water**

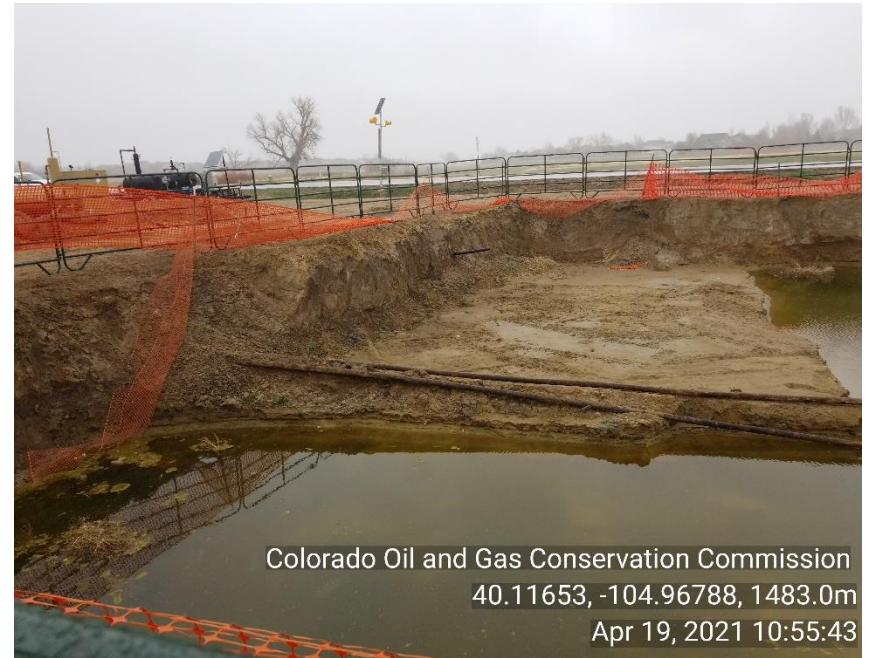
**Photo 24 open excavation pic. No BMP's in place to prevent storm water from entering excavation.**

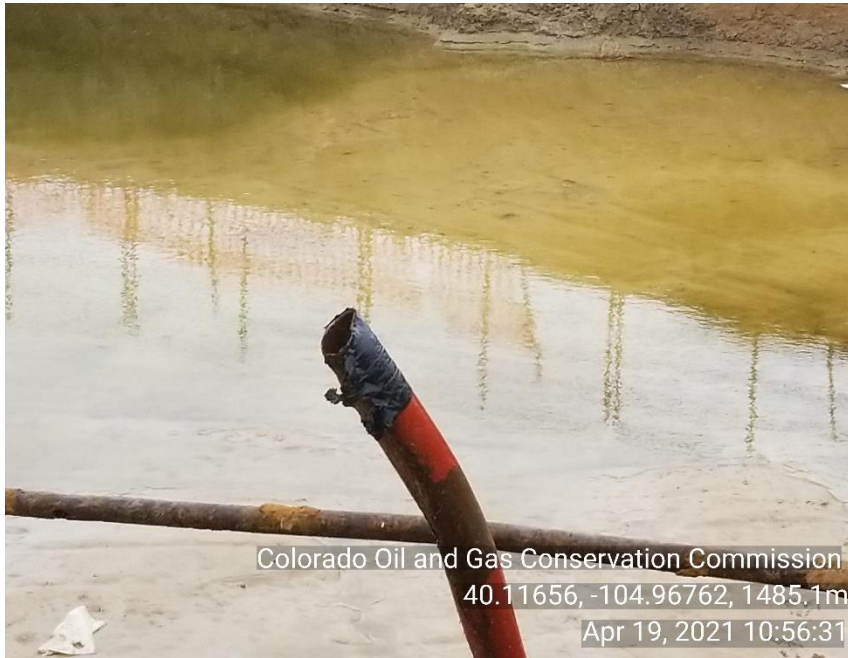
**Photo 27 open ended pipe in open excavation.**

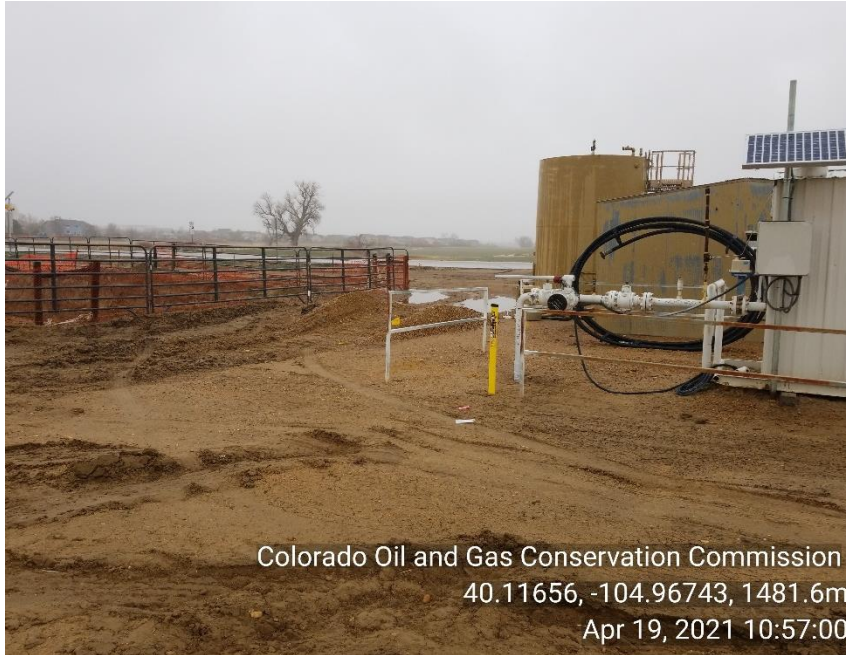
**Photo 30 Meter house. Sales line is in the open position.**

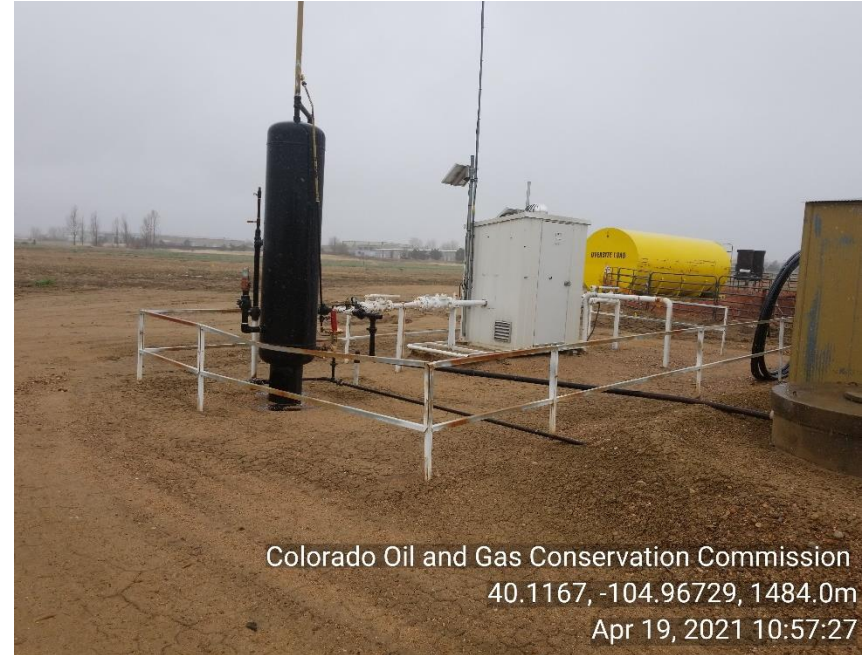
**Photo 31 Separator and Meter house. Meter does not have annual calibration performed.**

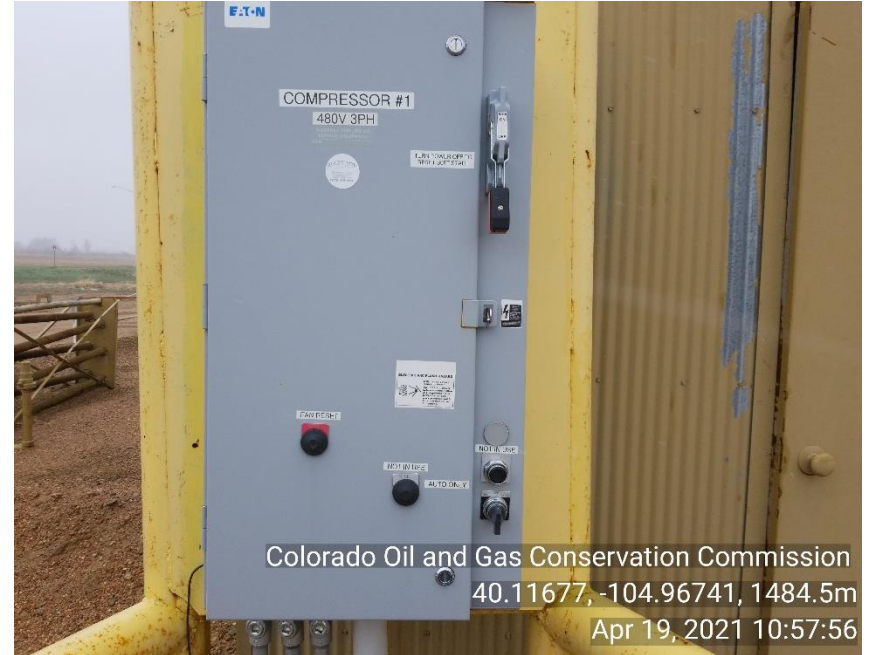
**Photo 33 Compressor breaker box not LOTO accessible to the public.**

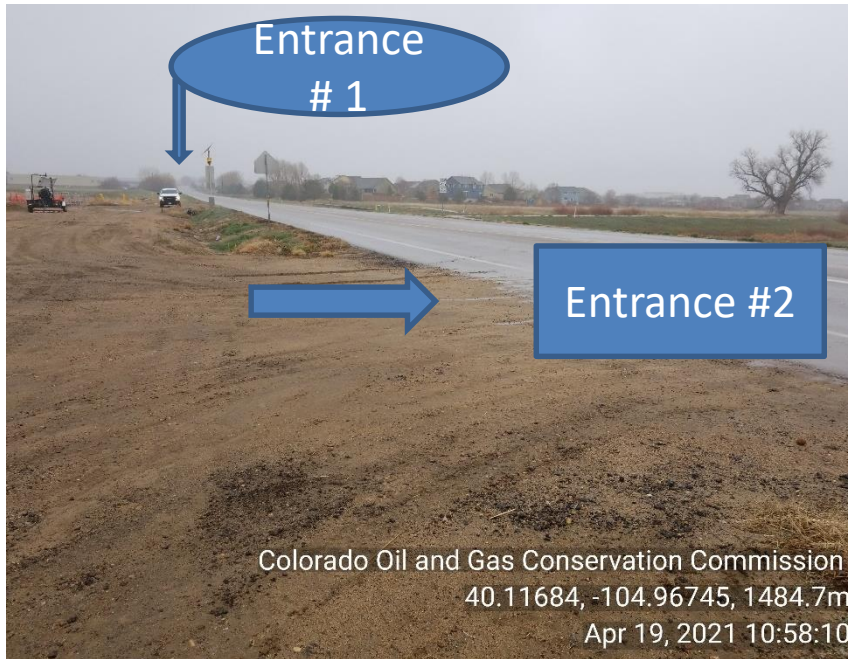
**Photo 34 not tracking pad BMP**

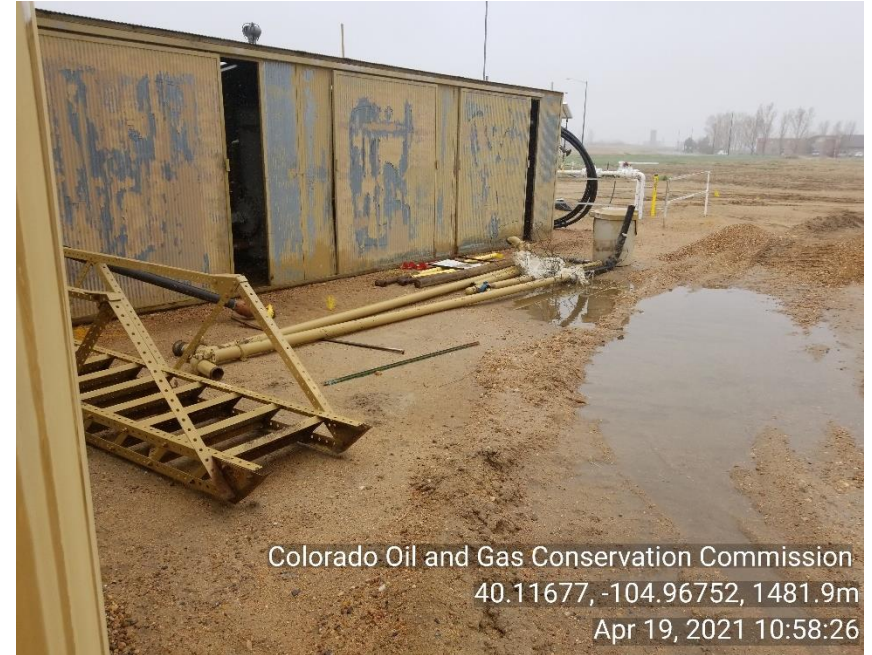
**Photo 35 Unused equipment**

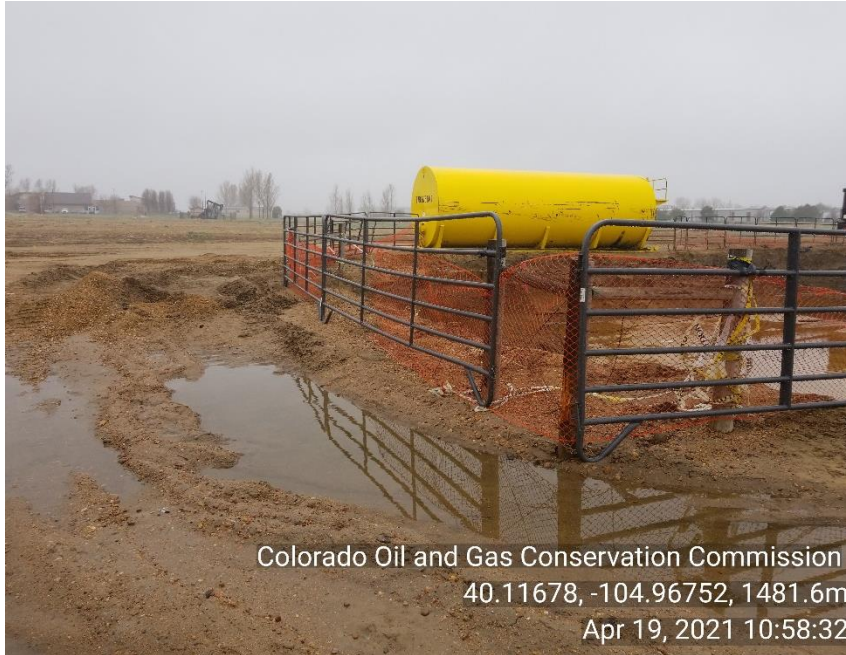
**Photo 36 Improper fencing around open excavation and work site**

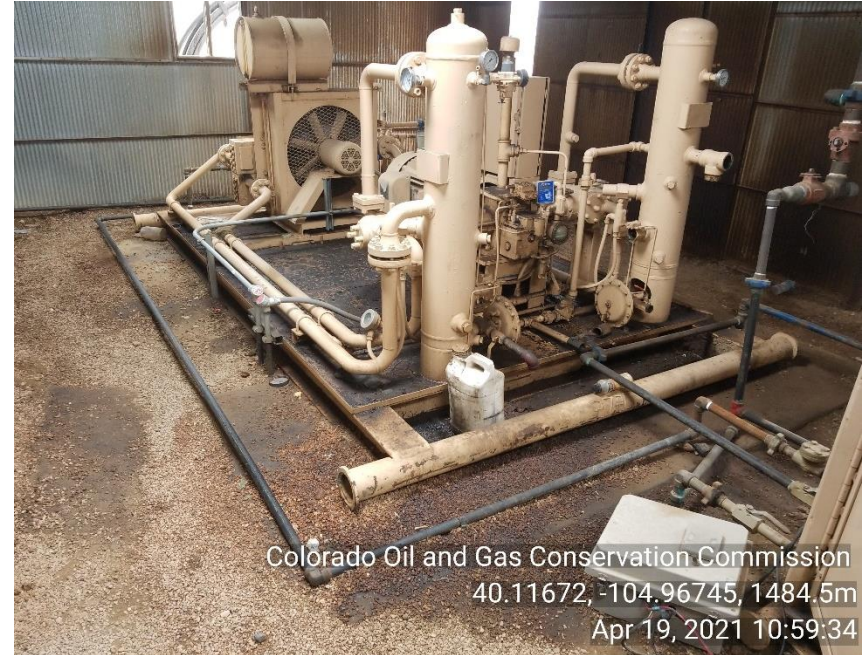
**Photo 37 Stained soil and mechanical issues inside compressor building.**

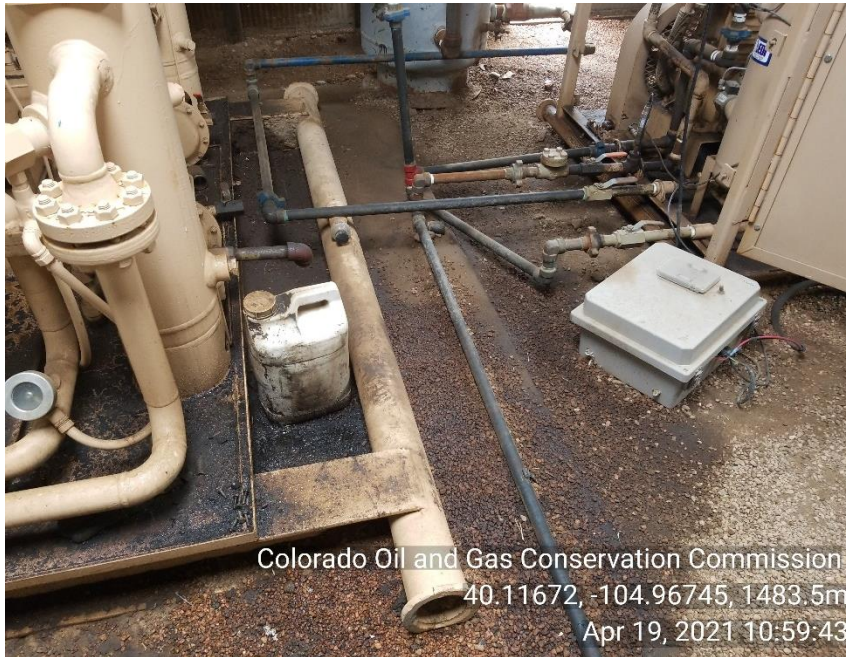
**Photo 38 Stained soil and mechanical issues inside compressor building**

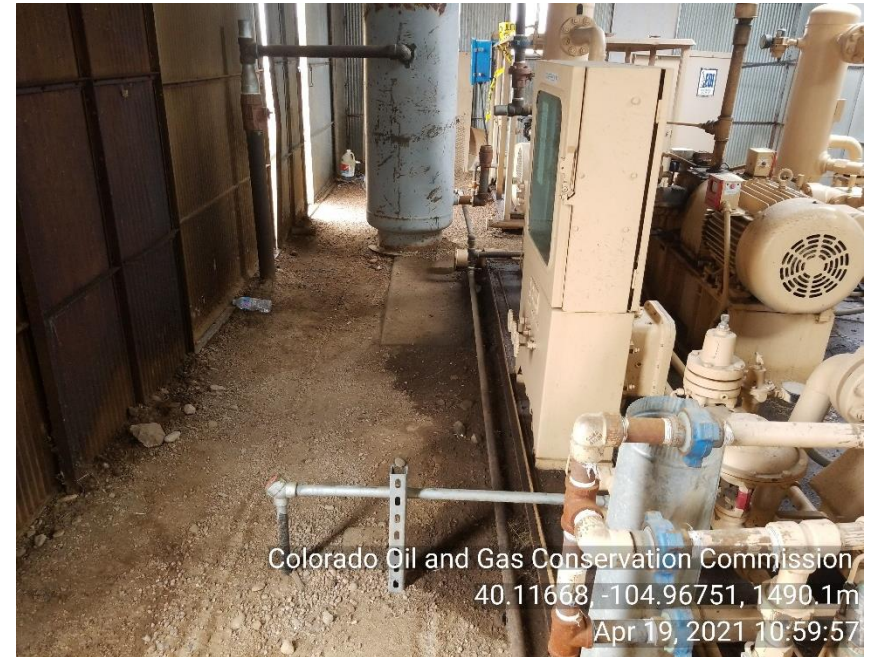
**Photo 39 Stained soil and mechanical issues inside compressor building**

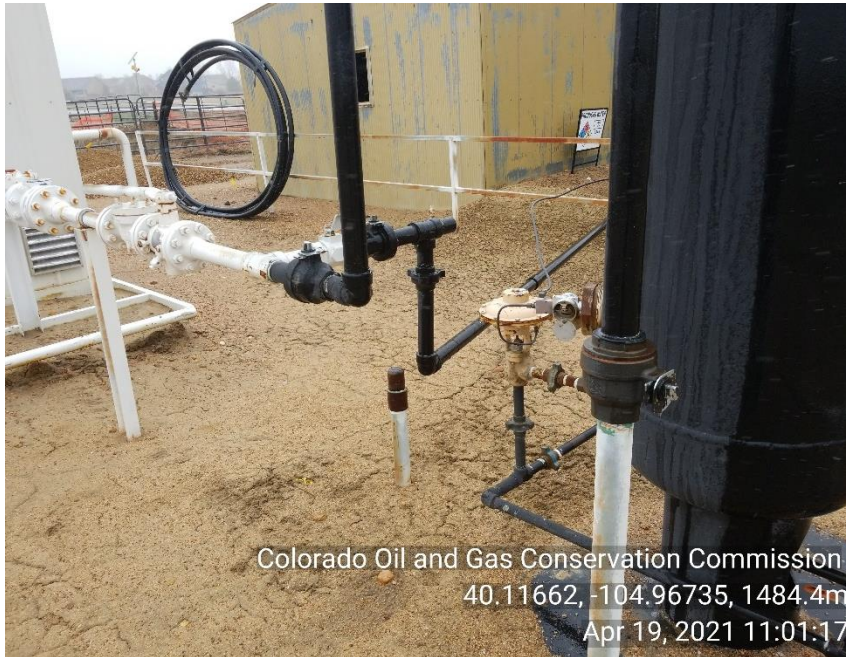
**Photo 40 Valves to sales meter in the open position**

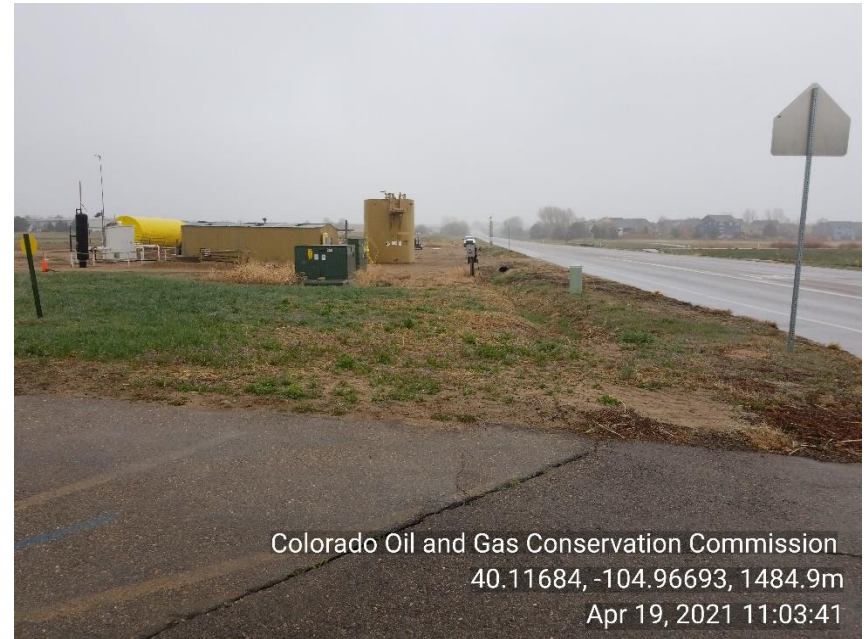
**Photo 41 side walk from school is approx. 100 feet form remediation work site.**

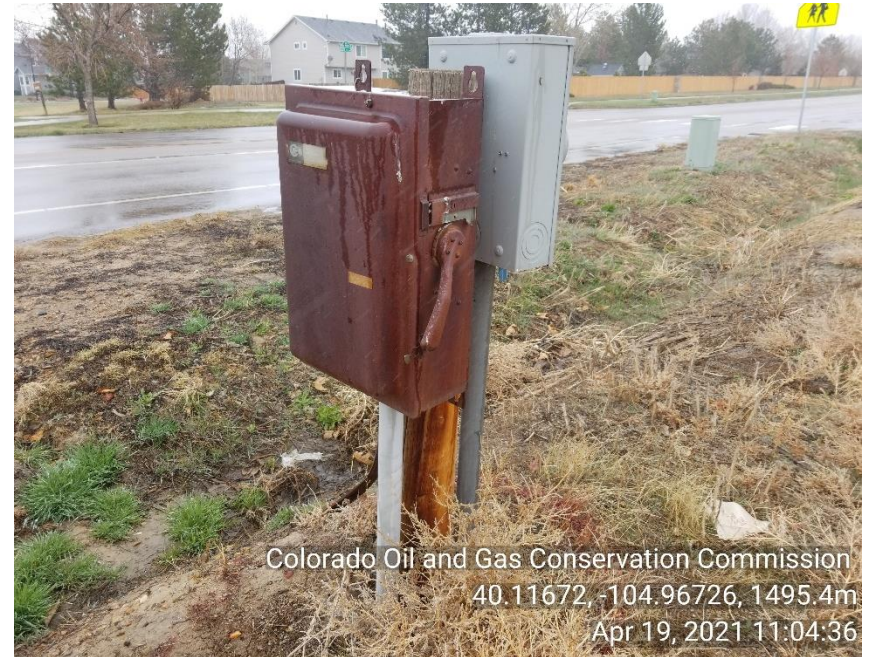
**Photo 44 electric box not LOTO.**

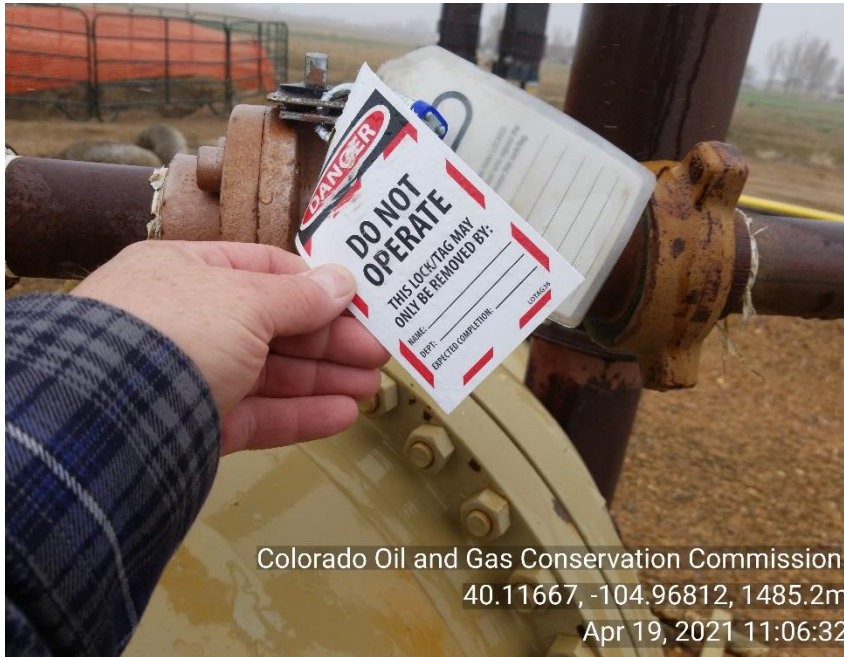
Photo 45 Separator not properly LOTO

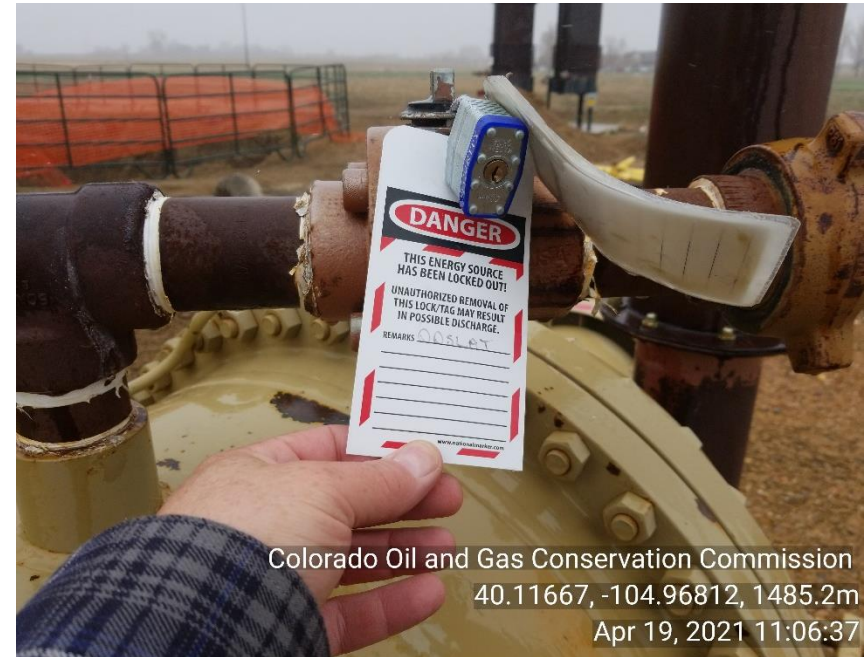
Photo 46 Separator not properly LOTO.
