# Inspection Photos

API: 071-06340

Operator: OGRIS OPERATING LLC

Inspection Date: 5/17/2021

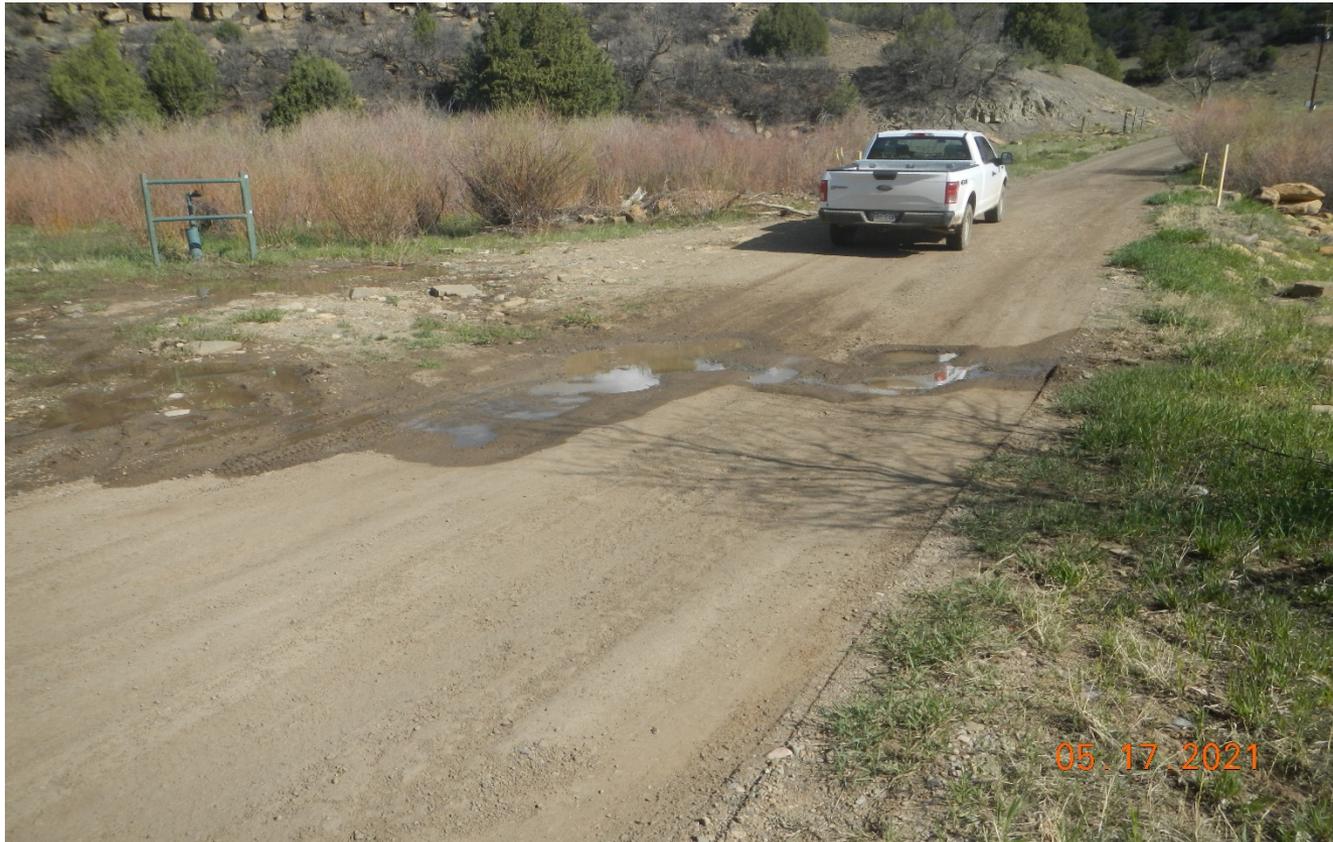
**Photo 1.** There is water from the river pooling onto the road in this area. BMP's need to be installed to prevent erosion of this area. E.G. Berm. Diversion ditch, culvert ect.

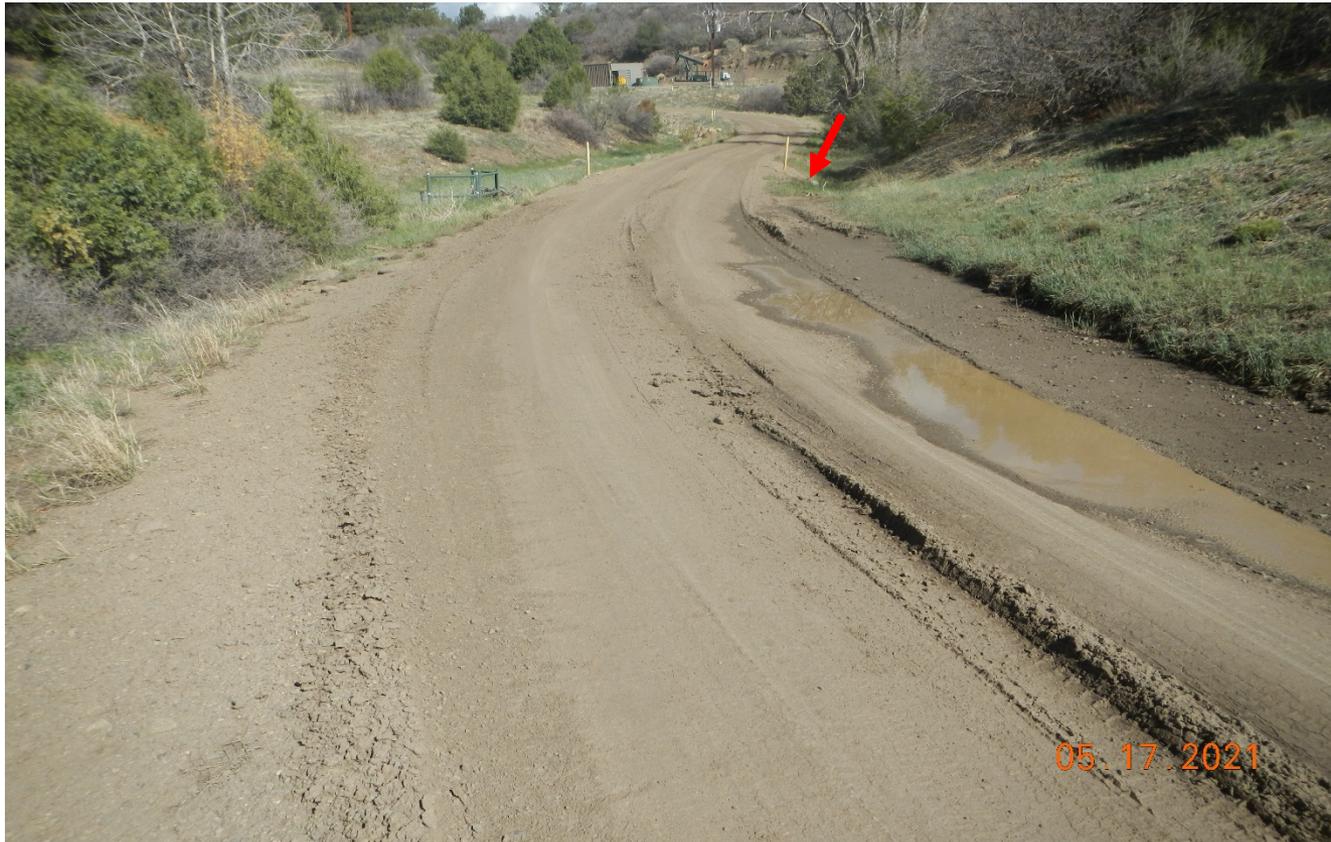
**Photo 2.** Stormwater is not directed toward the culvert (at red arrow) causing stormwater to accumulate on the road. Areas of rutting need to be stabilized.

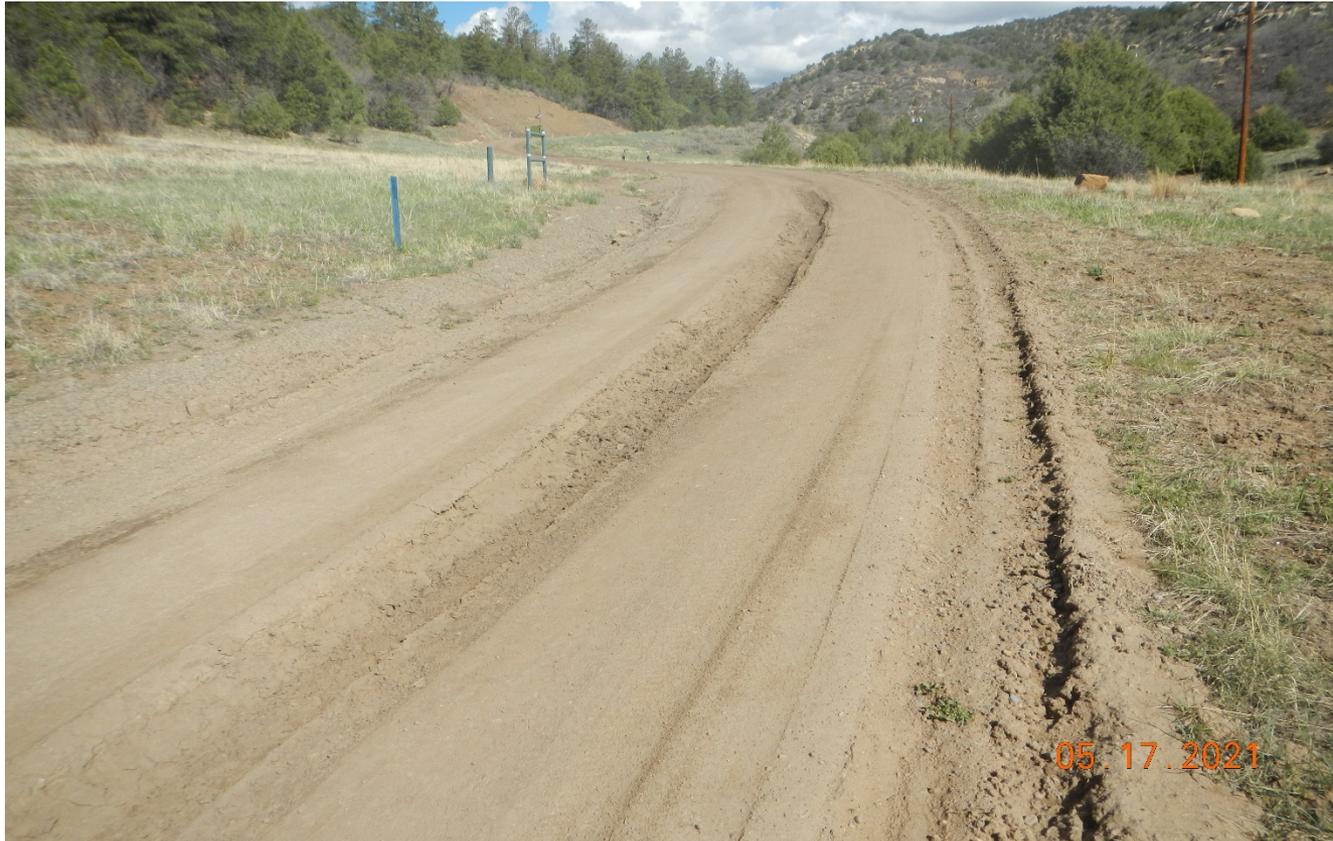
**Photo 3.** There is vehicle rutting along the main road. Areas of rutting need to be stabilized.
