Inspection Photos
Operator: Hilcorp
API: 067-08295
Date: 5/17/2021

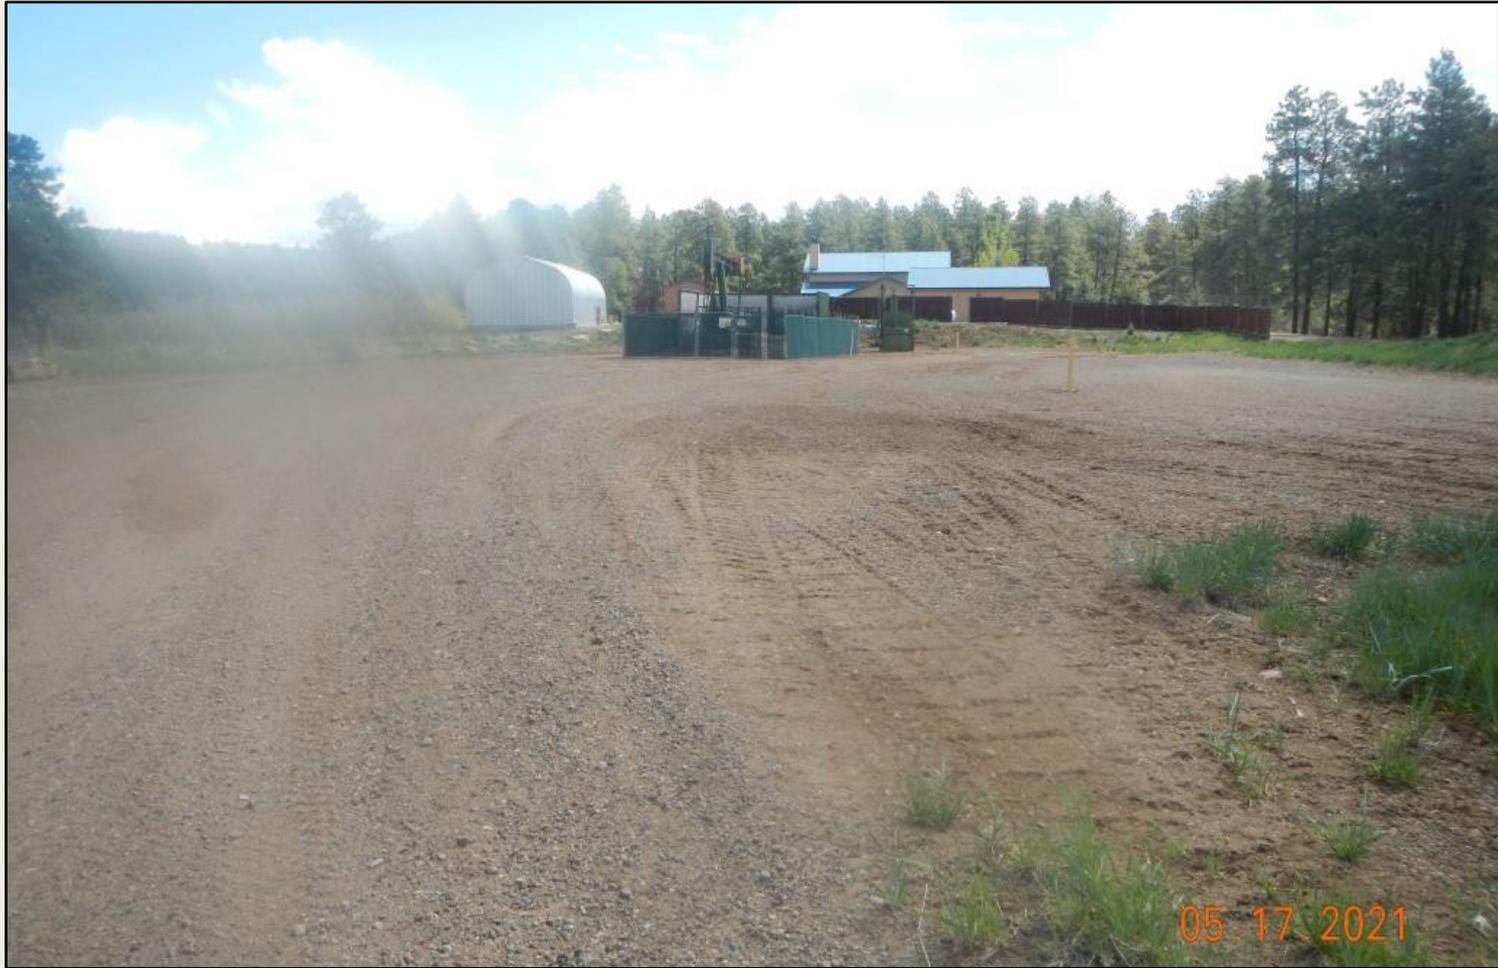
Photo 1. View of project area from the well pad entrance facing center.

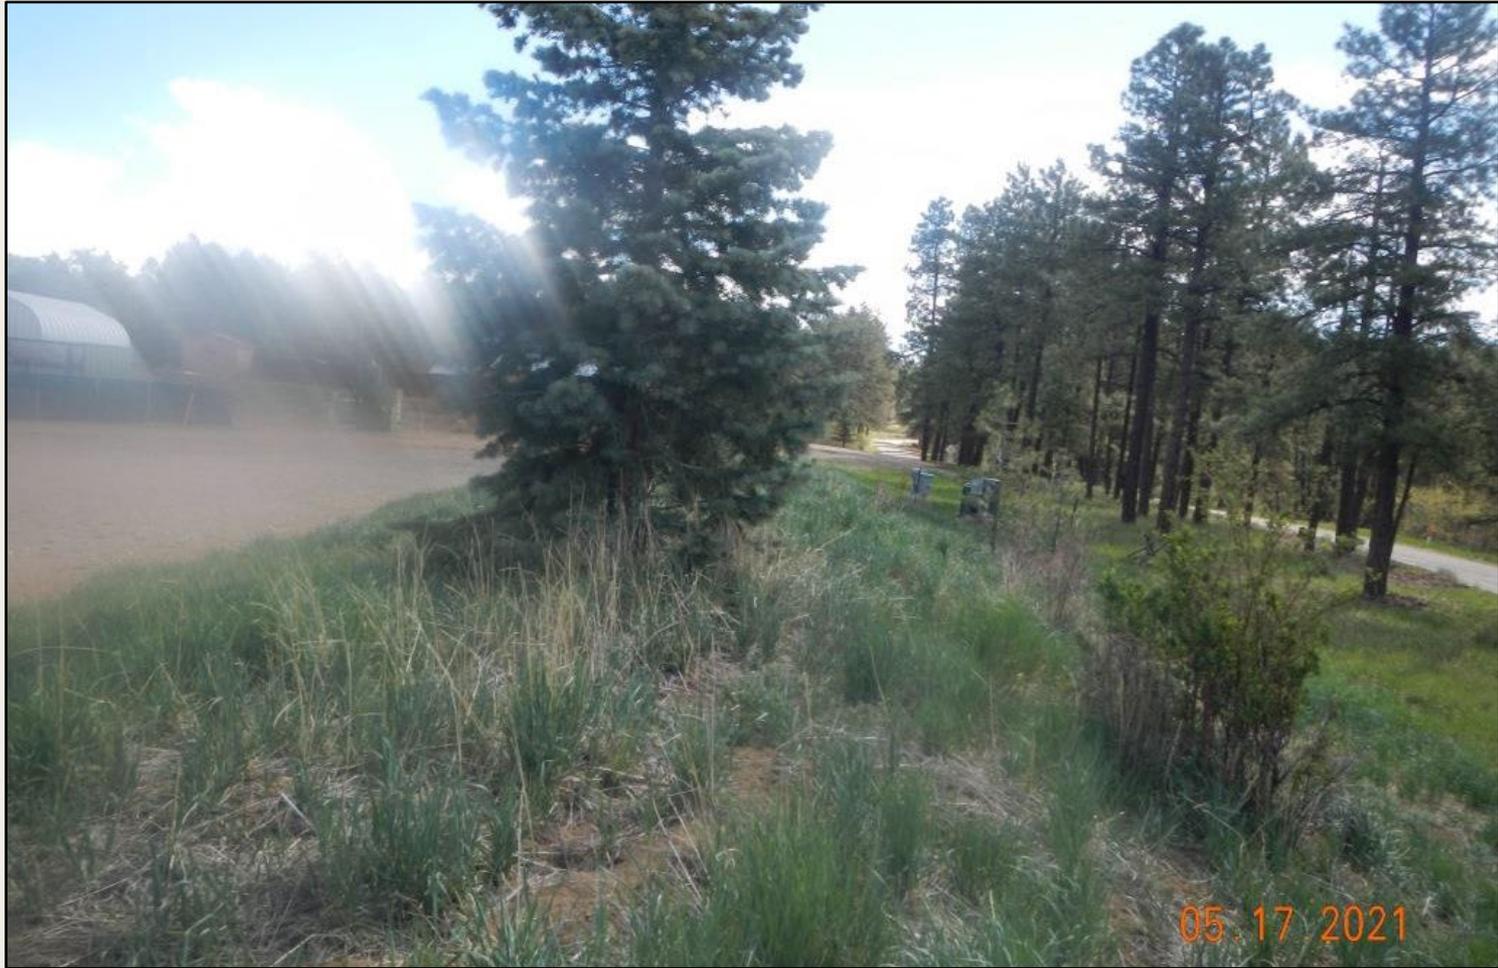
Photo 2. View of the southern project area from the northwestern corner facing eastward. Revegetation is progressing with a mixture of grasses such as western wheatgrass and smooth brome.

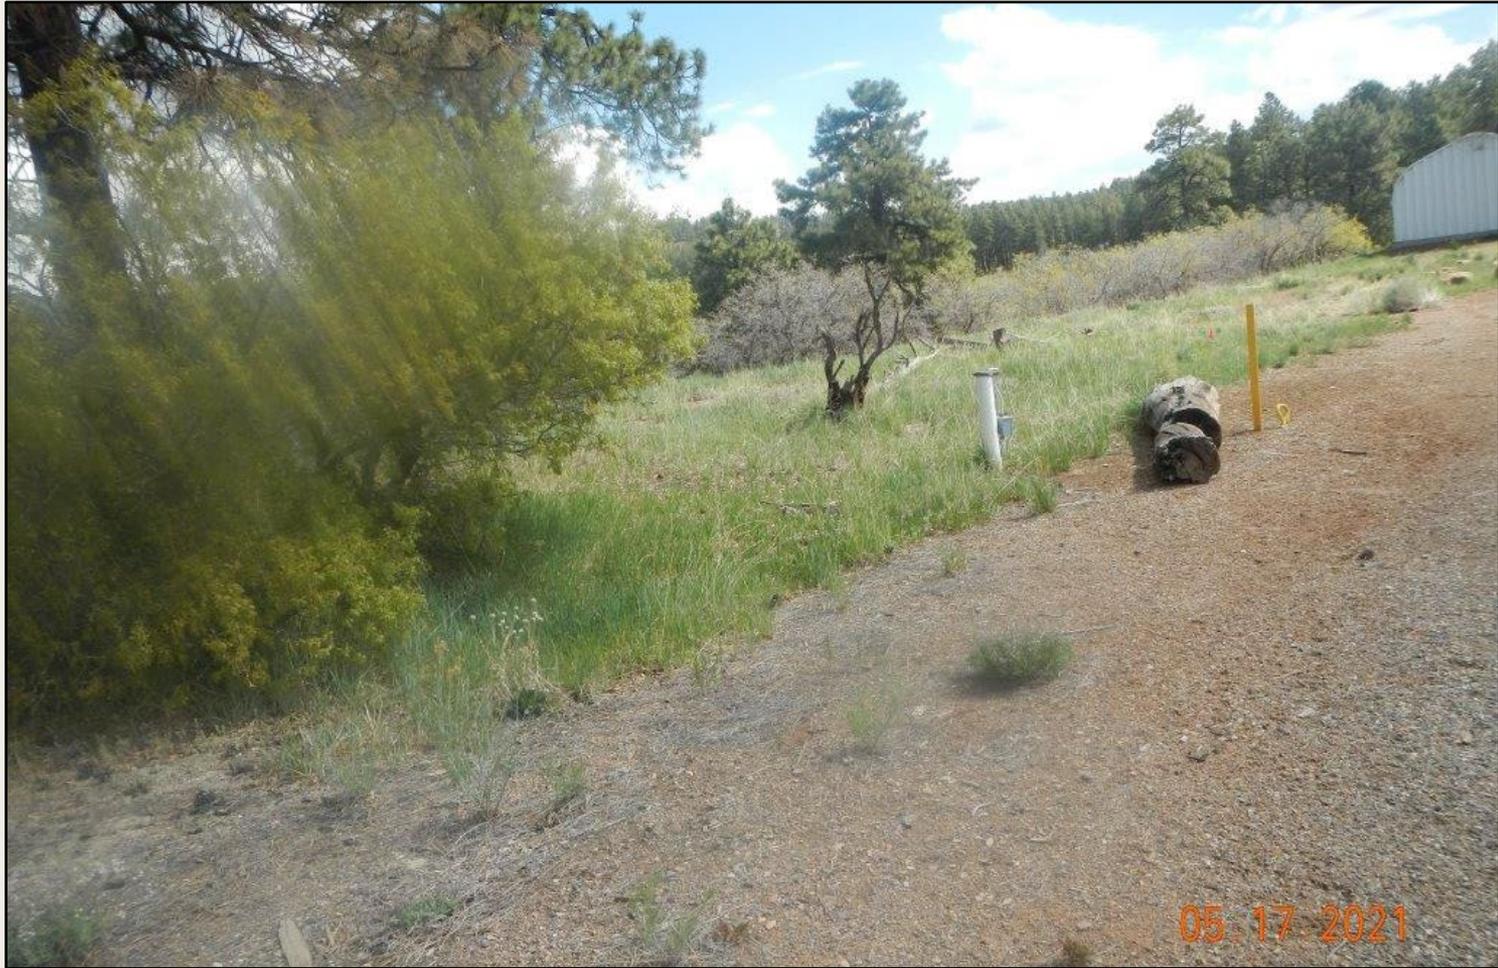
Photo 3. View of northern project area from the northwestern corner facing eastward.

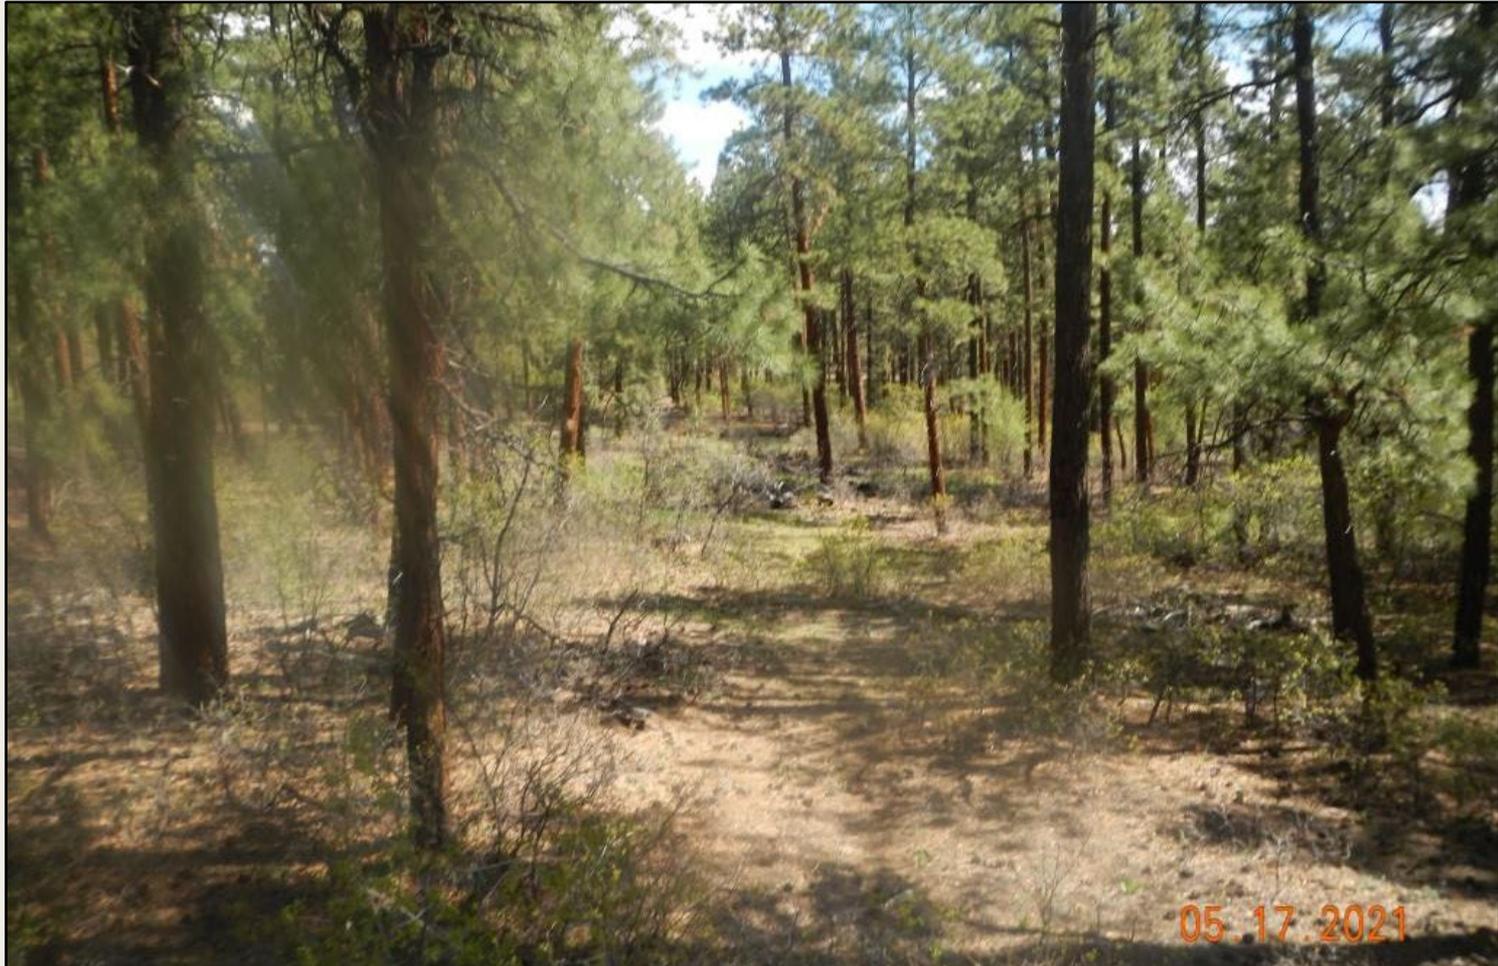
Photo 5. View of the reference area comprised of ponderosa pine forest with understory of gambel oak, Oregon grape, *Poa secunda*, and serviceberry.
