**Inspection Photos**  
**Location Name: UPRR 43 PAN AM B#7**  
**Location ID: 318400**

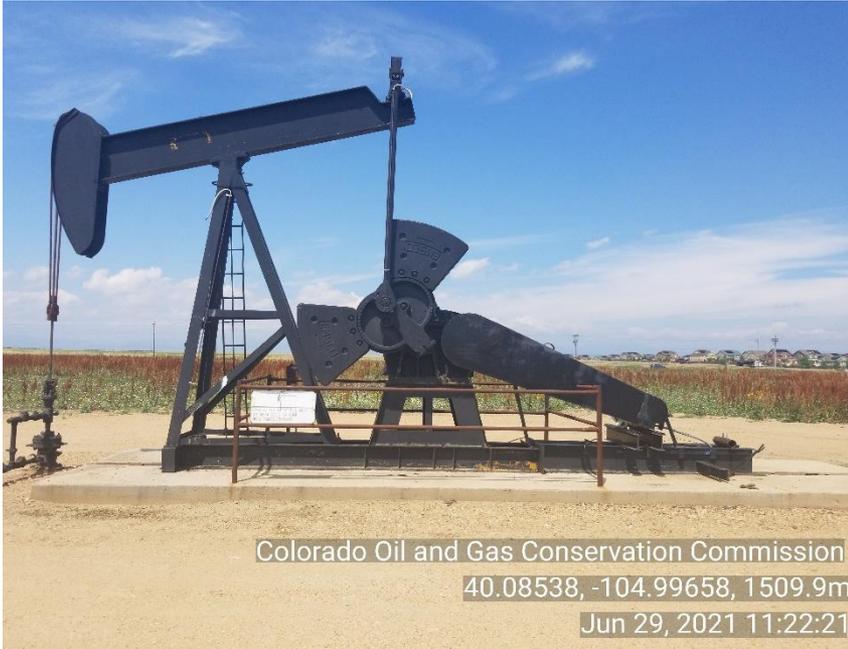
**Photo 1 WH sign faded**

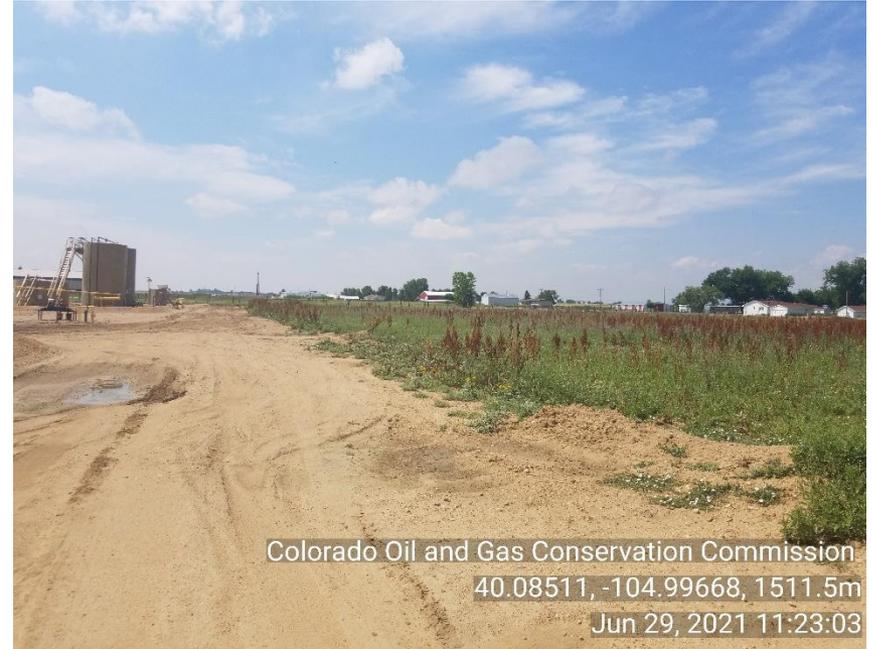
**Photo 2 Material being pushed off road no BMP.**

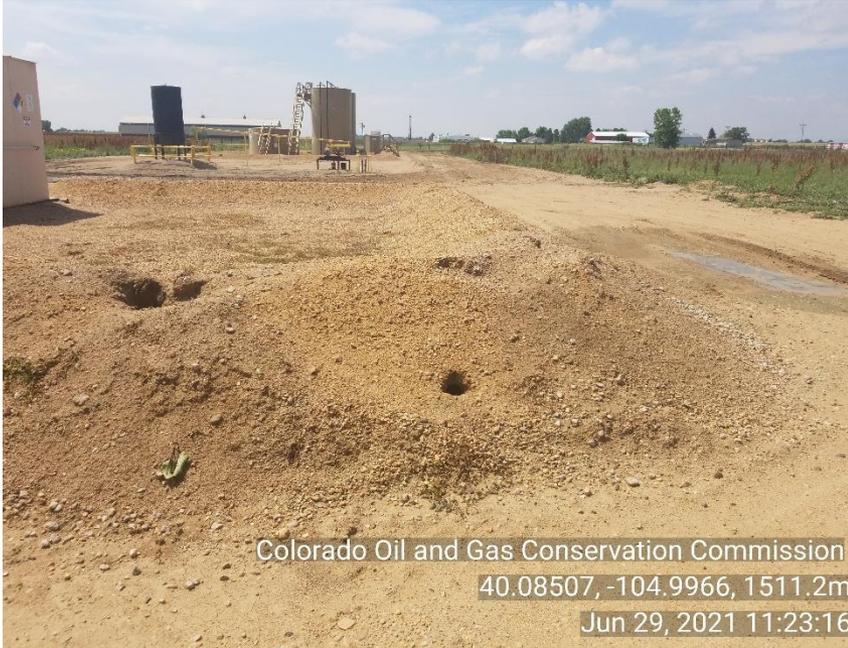
**Photo 3 Berms have holes and are in disrepair.**

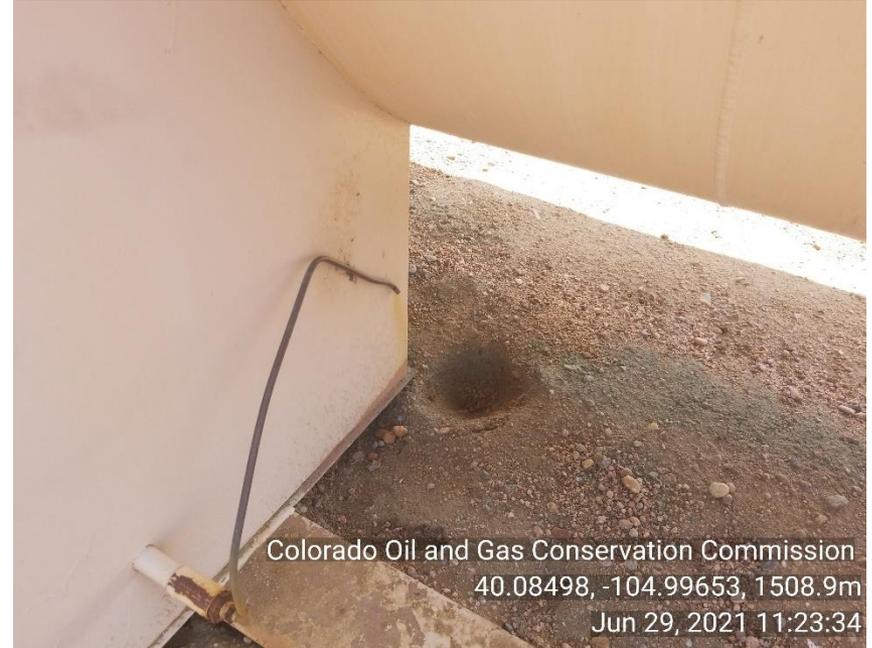
**Photo 4 draining separator on ground.**

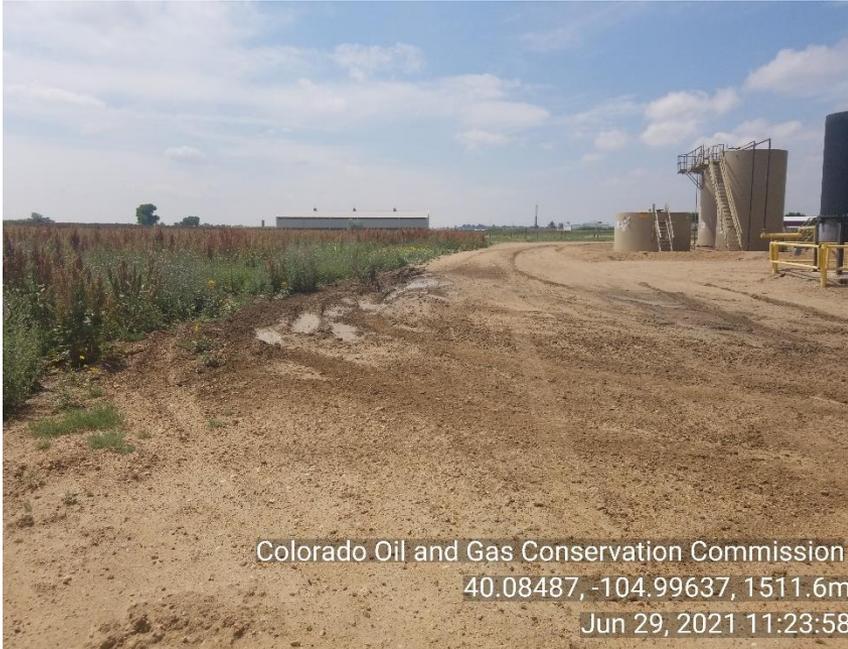
**Photo 5 road in disrepair no BMPs**

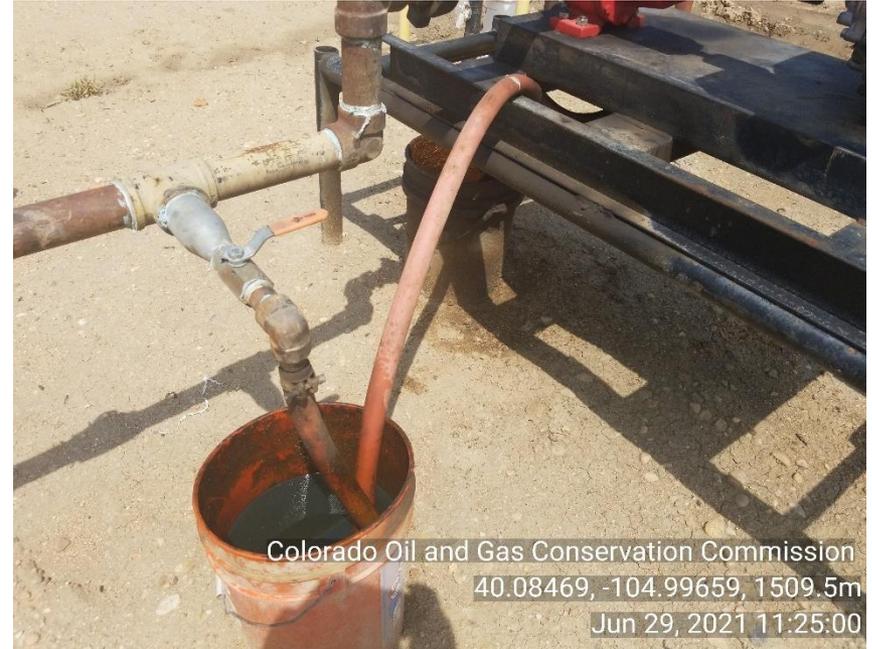
**Photo 6 Stained soil and Mechanical issues with recirc pump.**

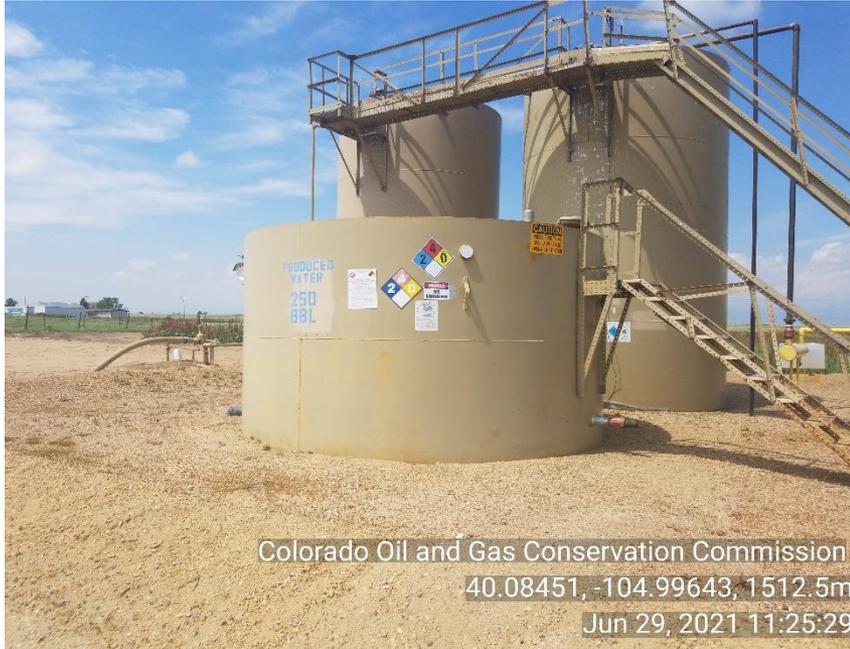
**Photo 7 produced water tank**

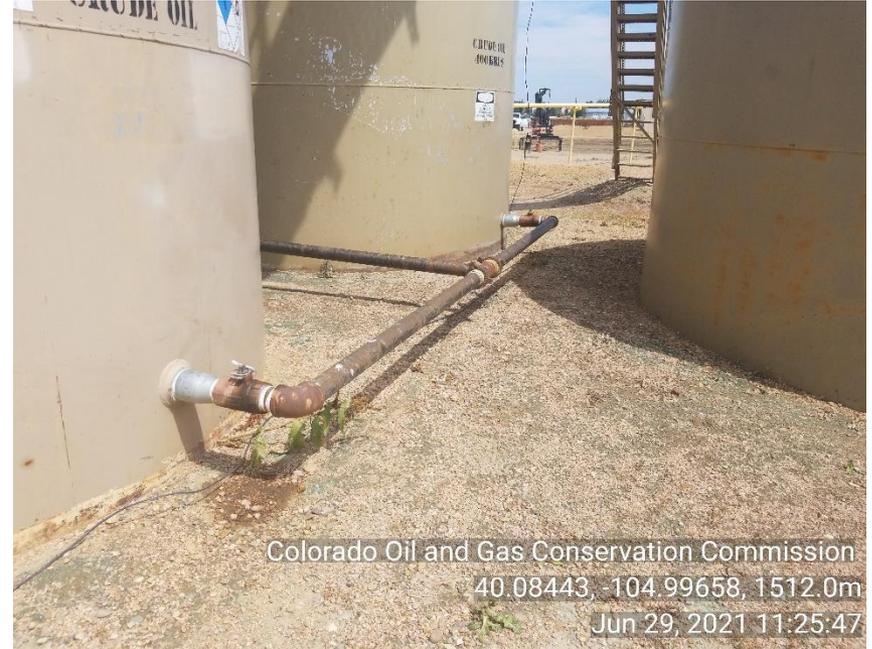
**Photo 8 Stained soil under crude oil load lines.**

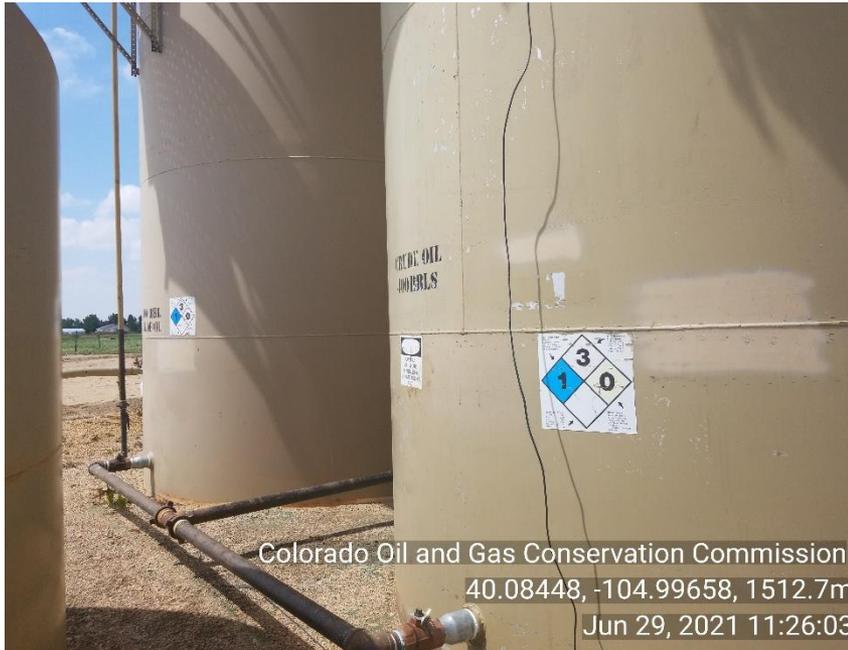
**Photo 9 NFPA placards faded**

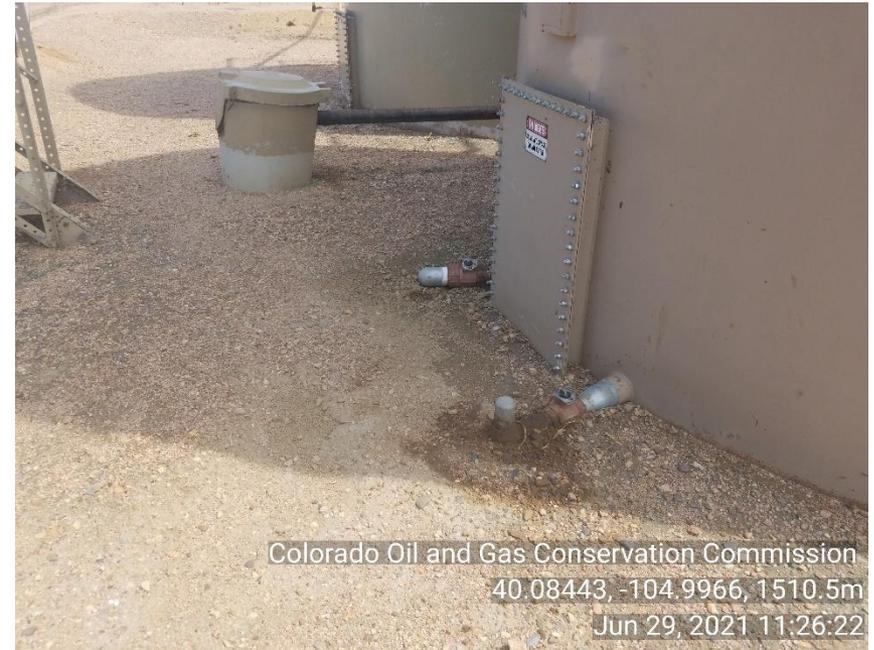
**Photo 10 Stained soil and Mechanical issues Crude oil load lines.**

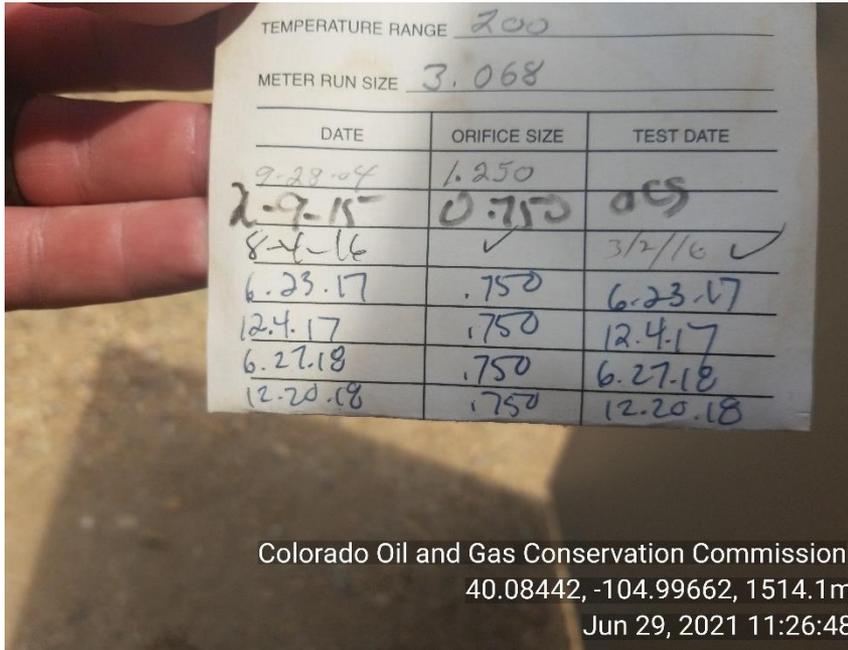
Photo 11 Meter calibration card out of date
