Inspection Photos

6/30/2021

Operator: WINDSOR ENERGY GROUP LLC -
10081

Location ID: 315696
Rio Blanco County, CO

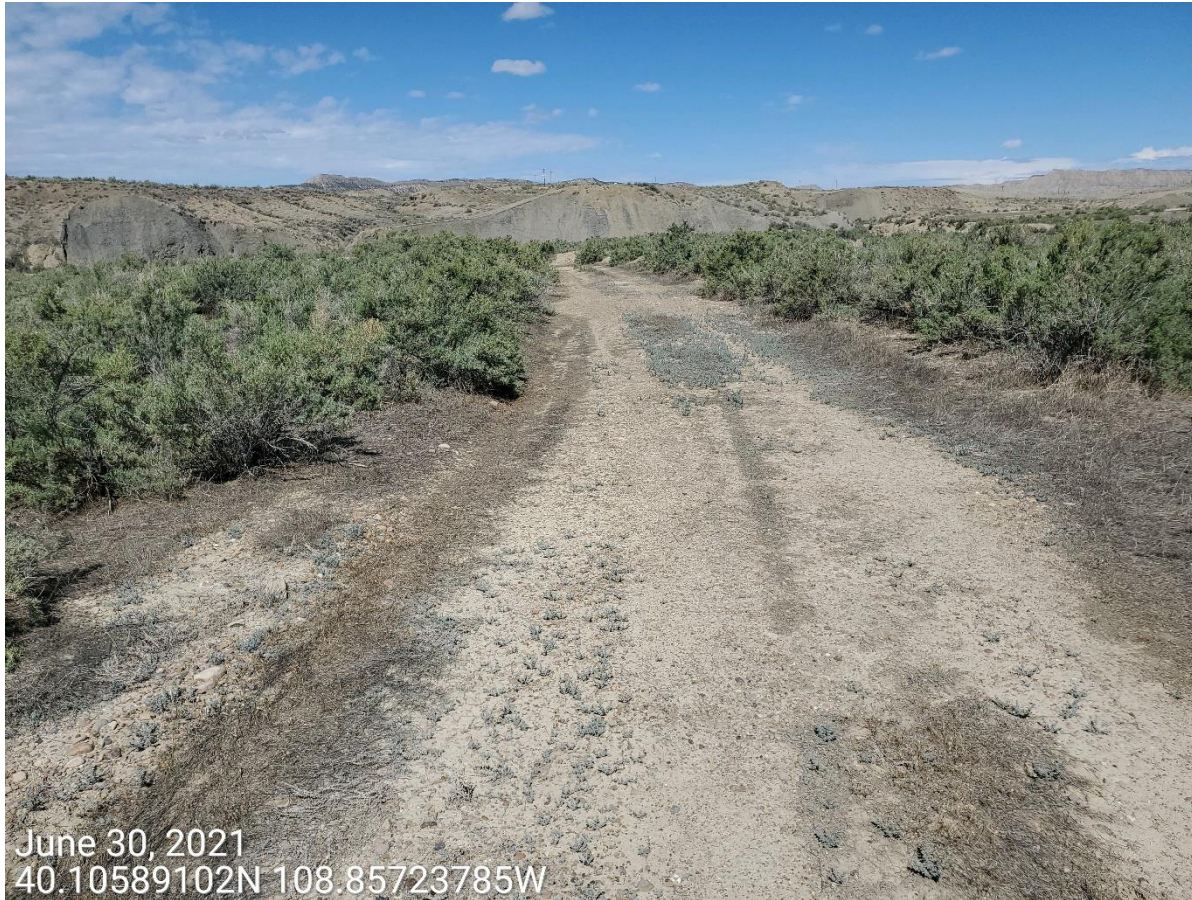
Photo 1: Photo taken from the northern access road, facing west; gravel/road base remains evident; compaction alleviation, recontouring and revegetation activities not performed.

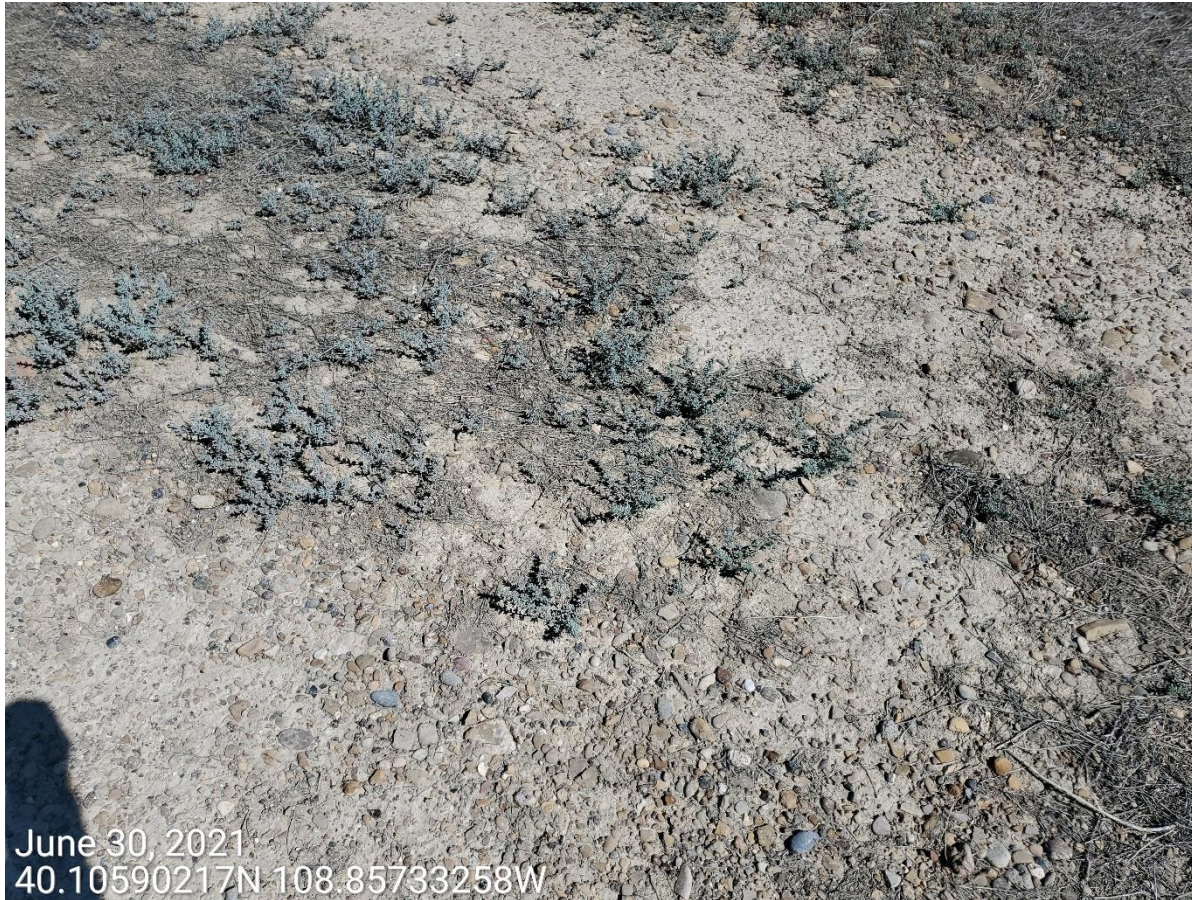
Photo 2: Photo taken from access road. Photo shows noxious weed (Halogeton) establishment.

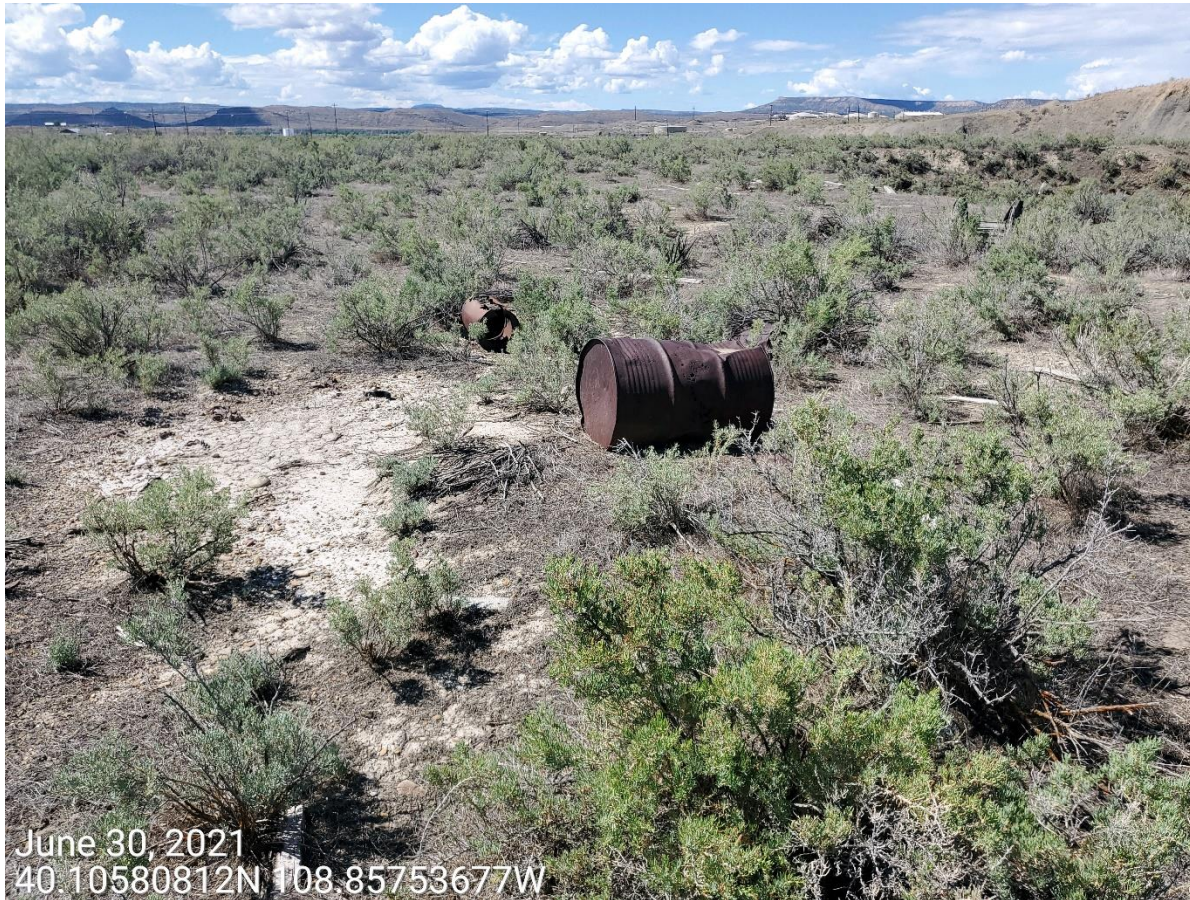
Photo 3: Photo shows trash debris along access road; trash debris not removed and properly disposed per corrective actions.

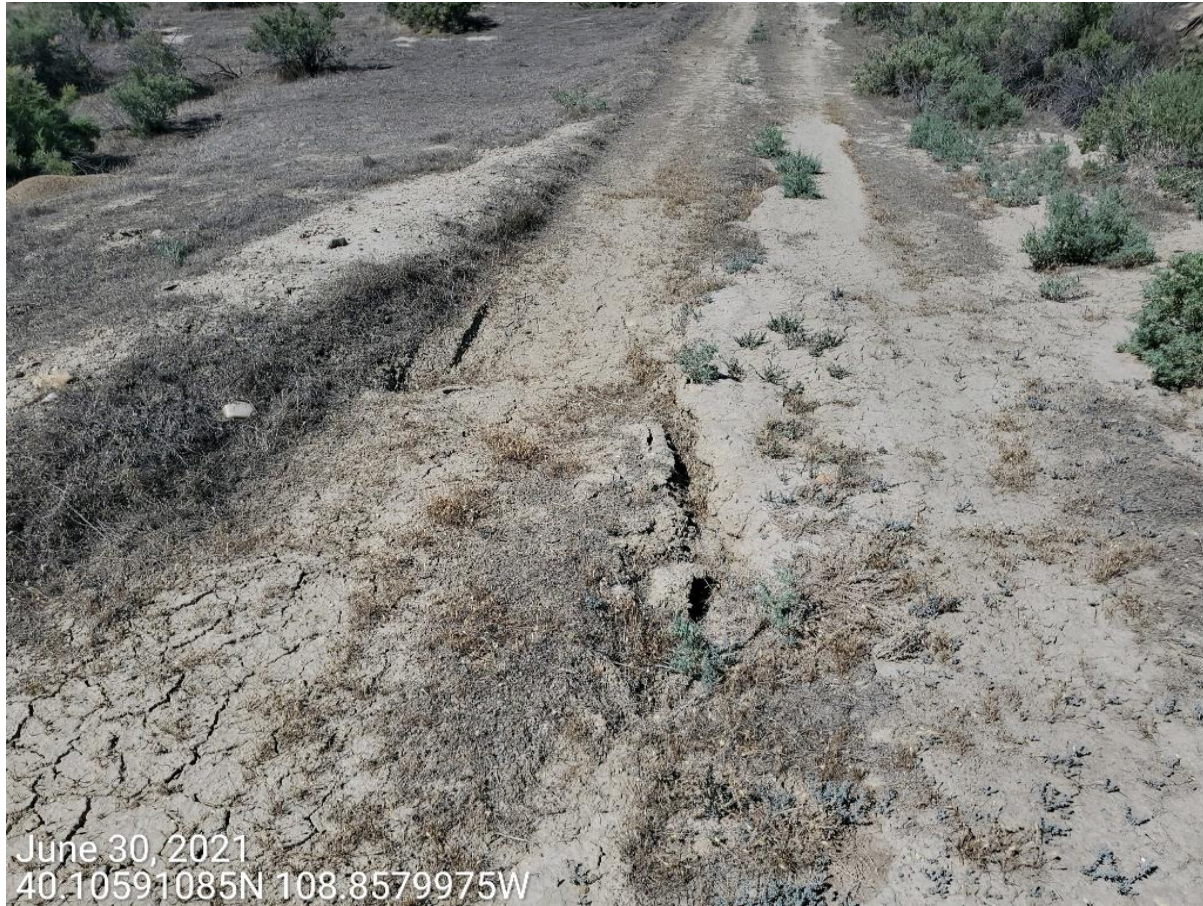
Photo 4: Photo taken along the access road. Photo shows erosion degradation.

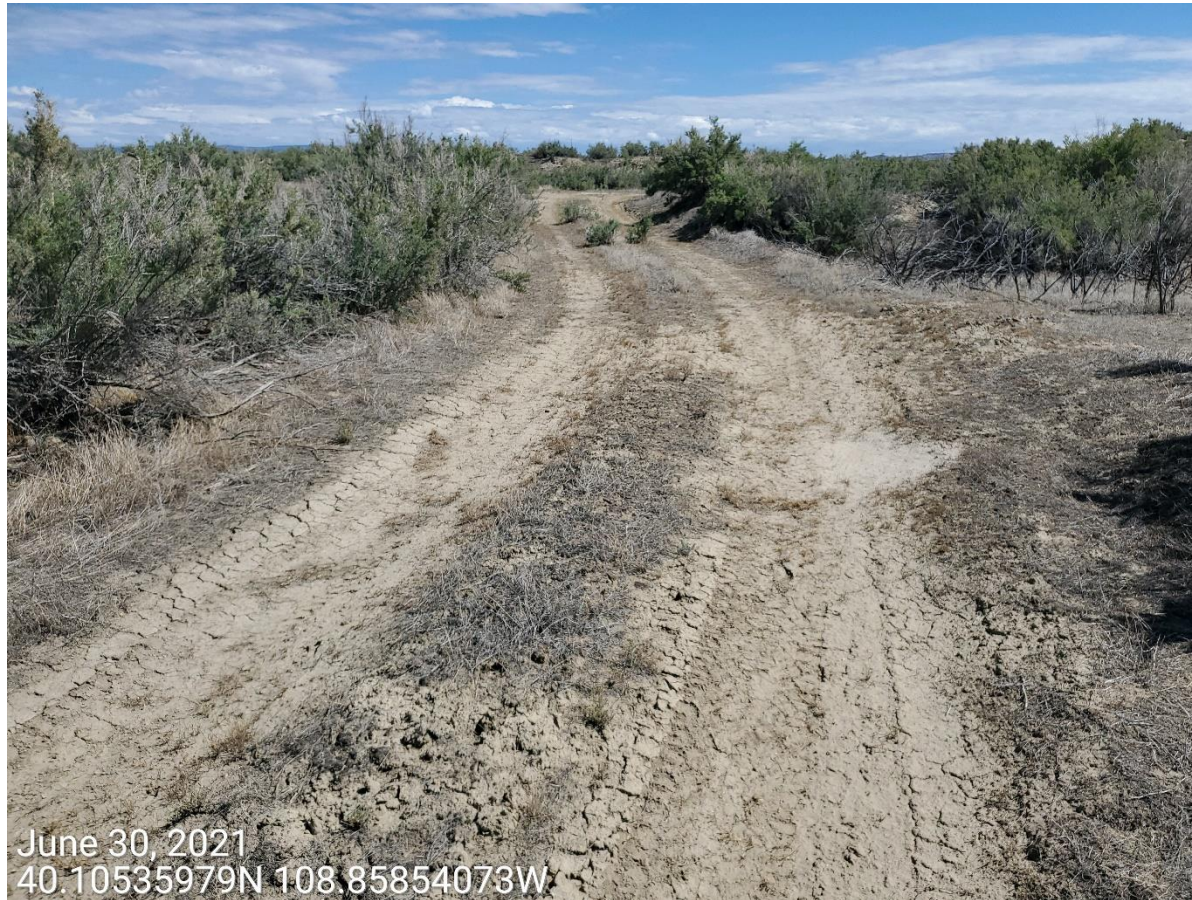
Photo 5: Photo taken from the access road, facing north. Compaction alleviation, recontouring and revegetation activities not performed.

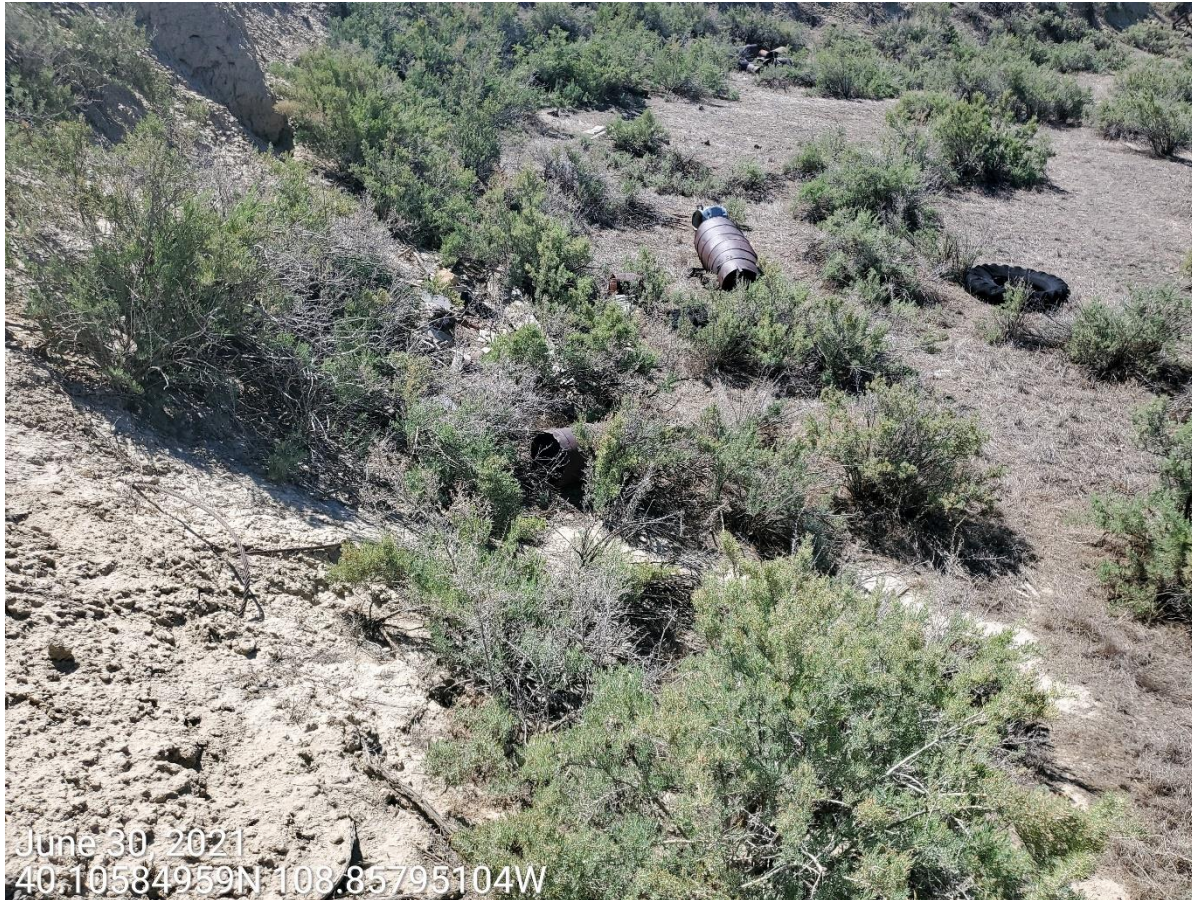
Photo 6: Photo taken from the access road, facing south. Photo shows trash debris along access road; trash debris not removed and properly disposed per corrective actions.

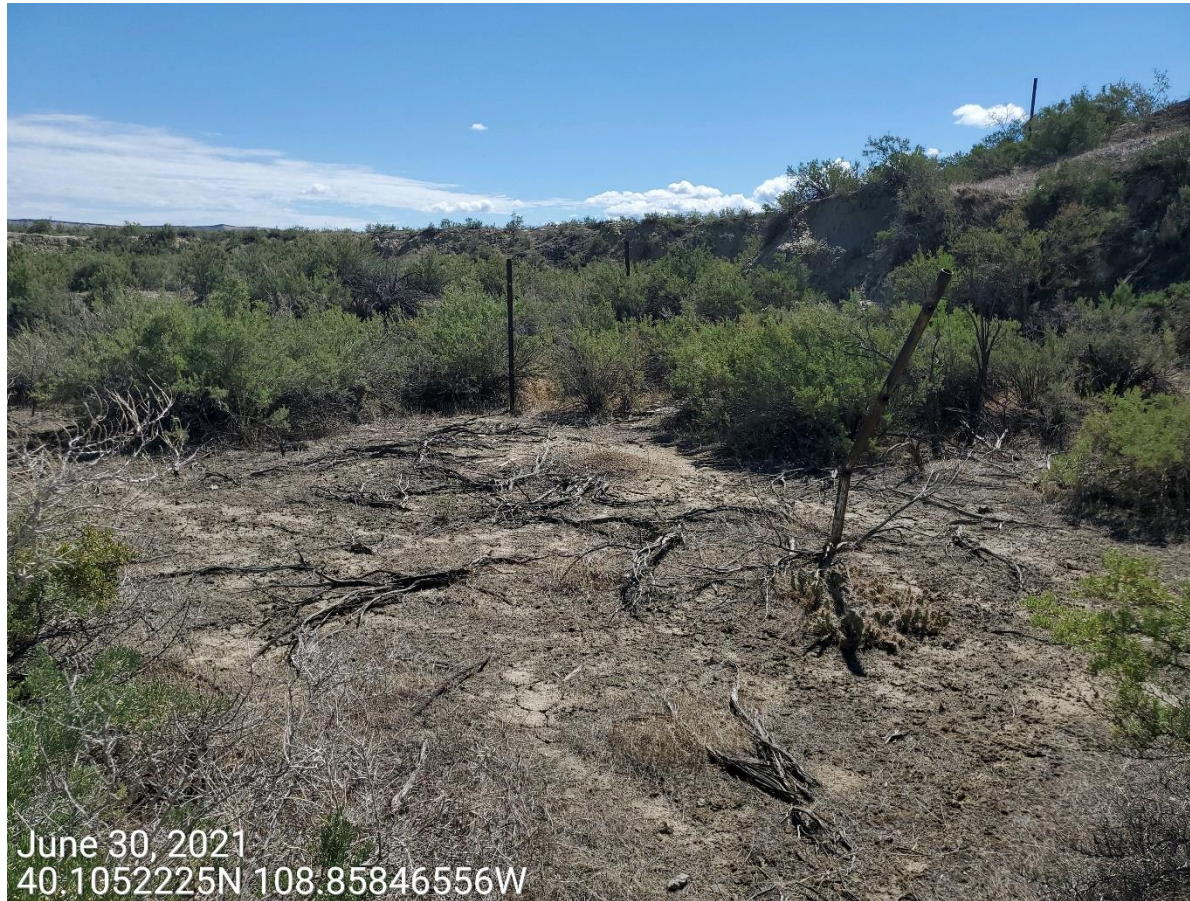
Photo 7: Photo taken from the east end of the Location, facing east. Photo shows pipe equipment remaining on the Location.

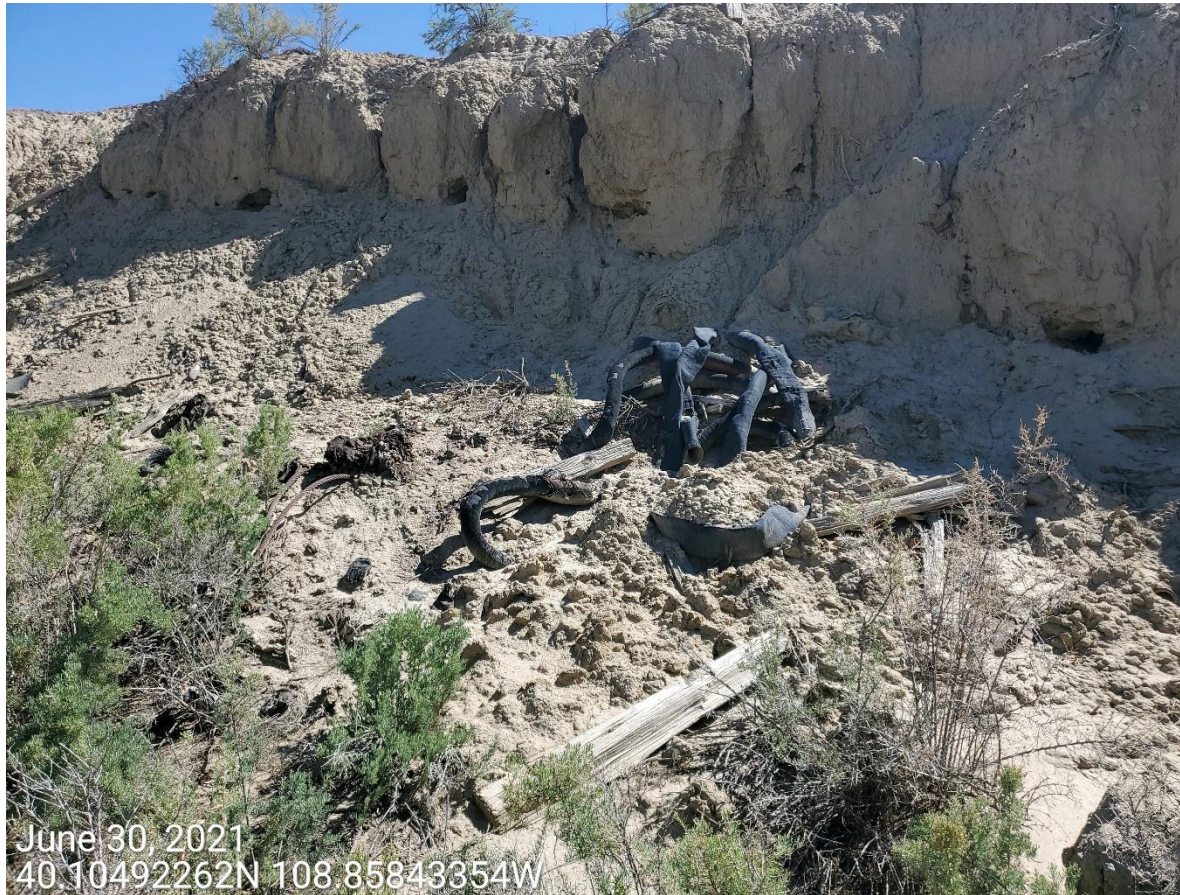
Photo 8: Photo taken from the access road, facing east. Photo shows trash debris along access road; trash debris not removed and properly disposed per corrective actions.

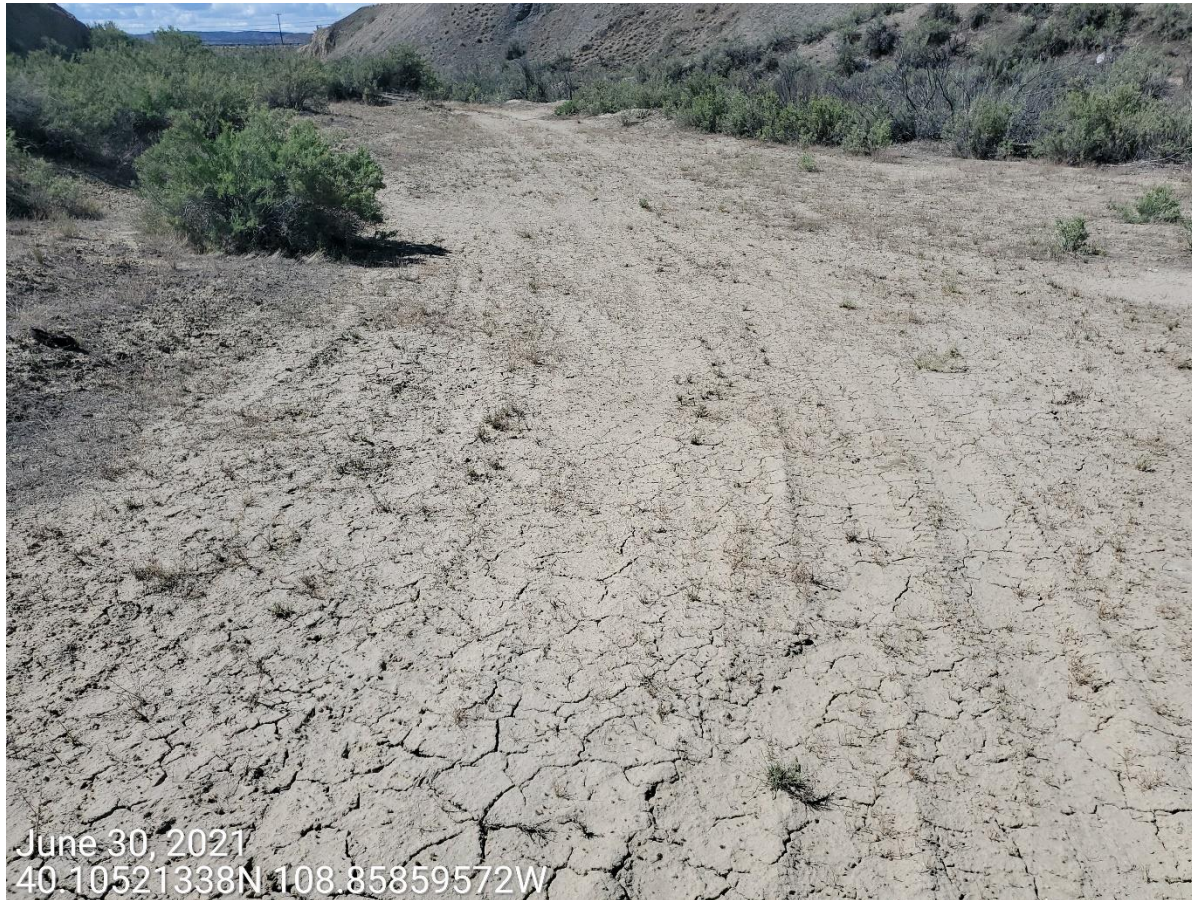
Photo 10: Photo taken from the north end of the Location, facing South. Location has not been reclaimed in accordance with 1004 Rules.

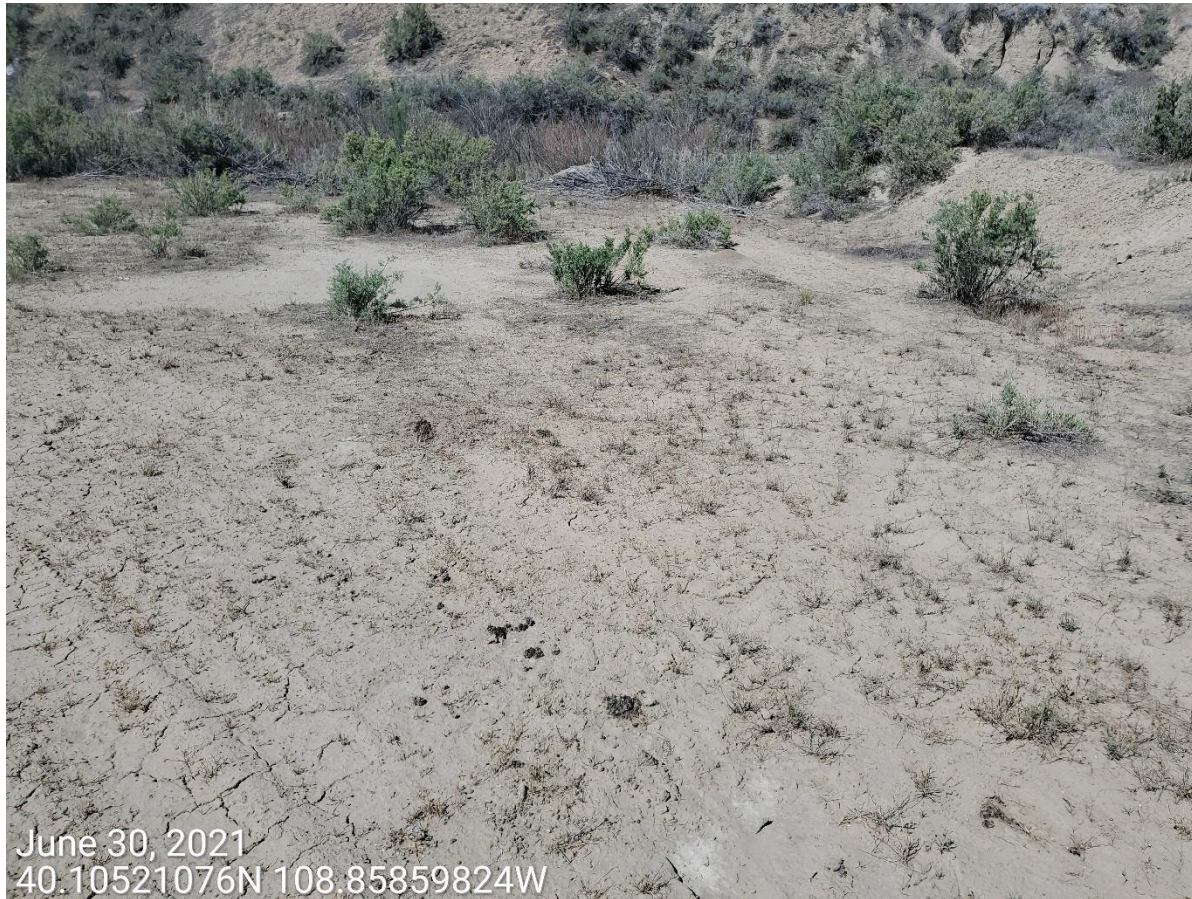
Photo 11: Photo taken from the north end of the Location, facing east. Location has not been reclaimed in accordance with 1004 Rules.

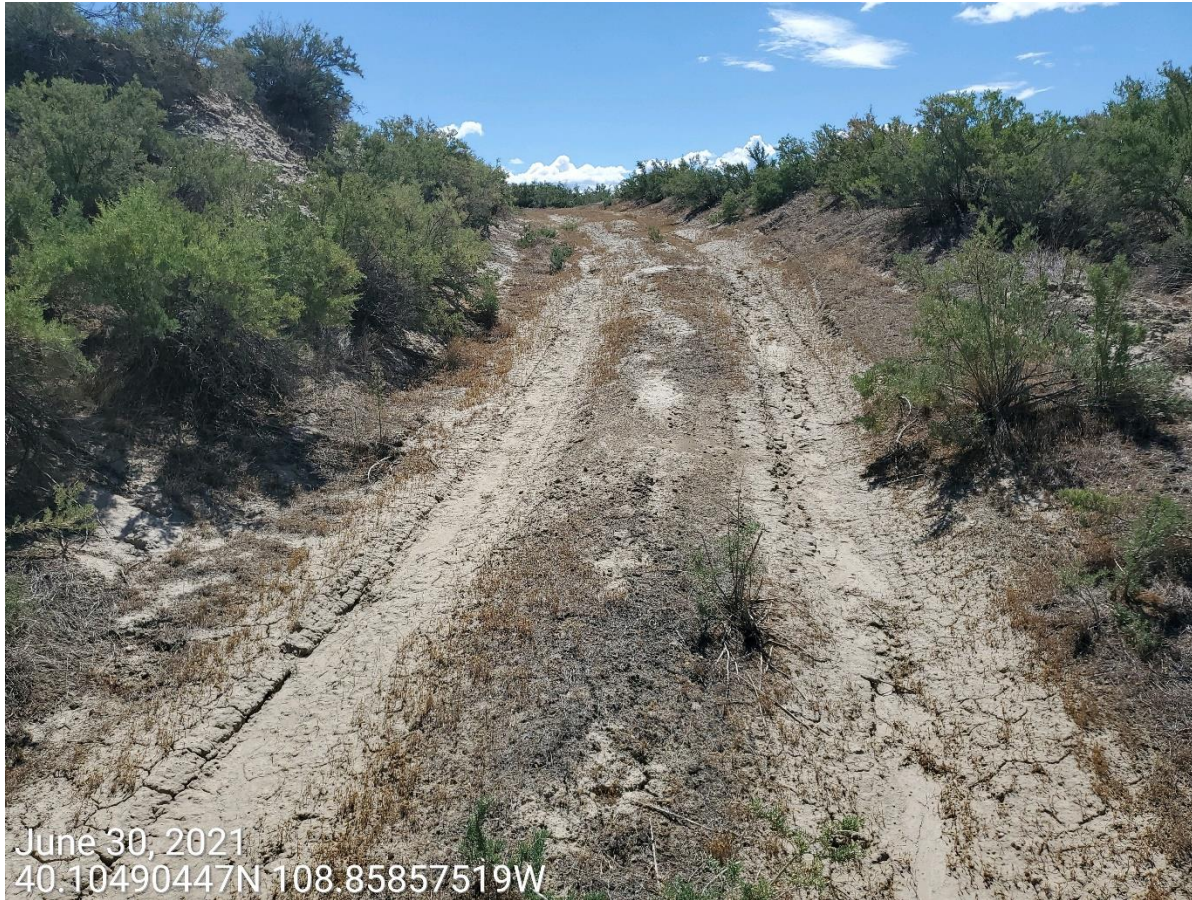
Photo 12: Photo taken from the southern access road, facing southeast. Compaction alleviation, recontouring and revegetation activities not performed.
