**Inspection Photos**  
**UPRR 43 PAN AM G Consolidation #2**  
**Remediation Project #16131/Spill ID 478086 (CL)**

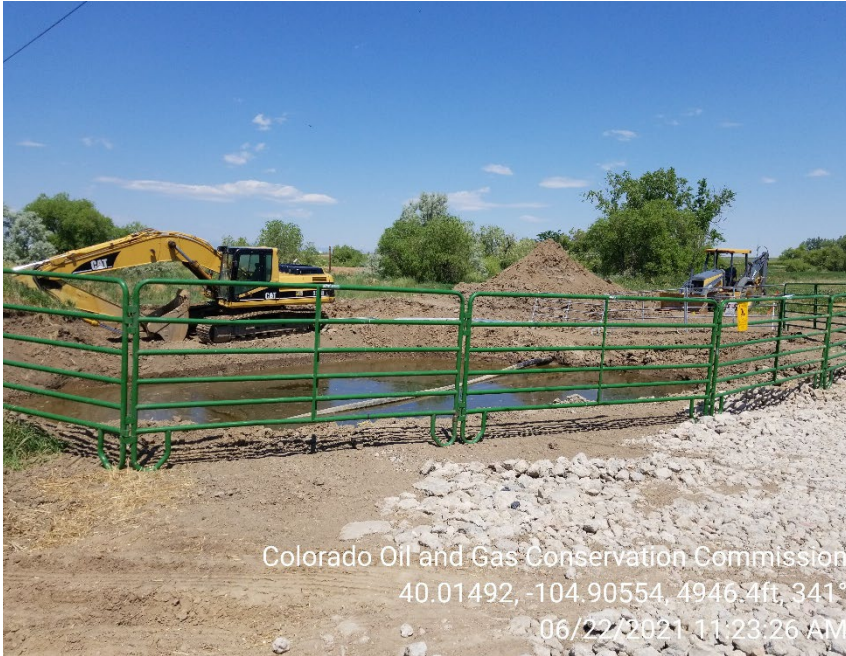
**Photo 1 – Spill area with open excavation.**

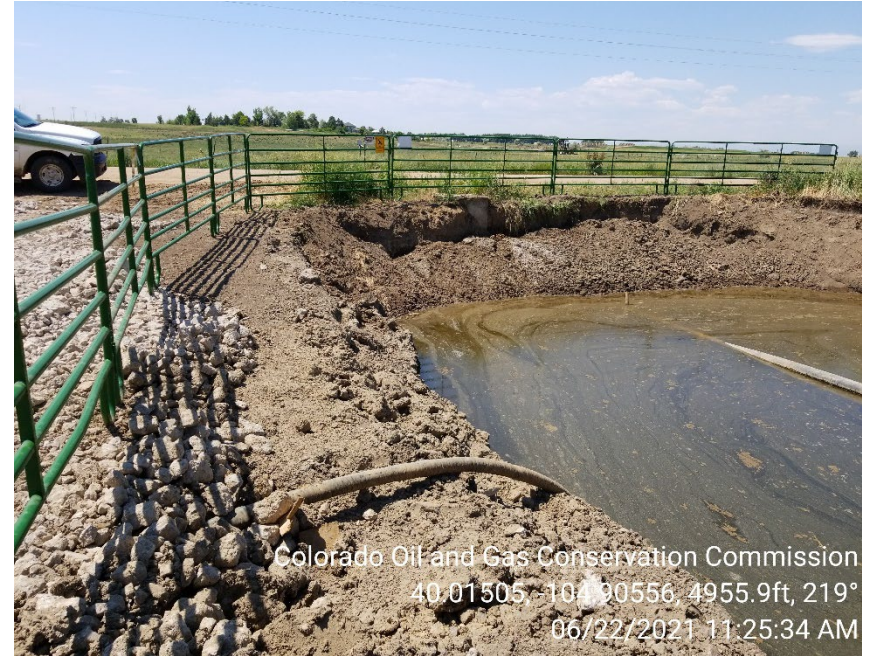
**Photo 2 – Open excavation with groundwater.  
Impacts appear to remain in situ in southern wall.**

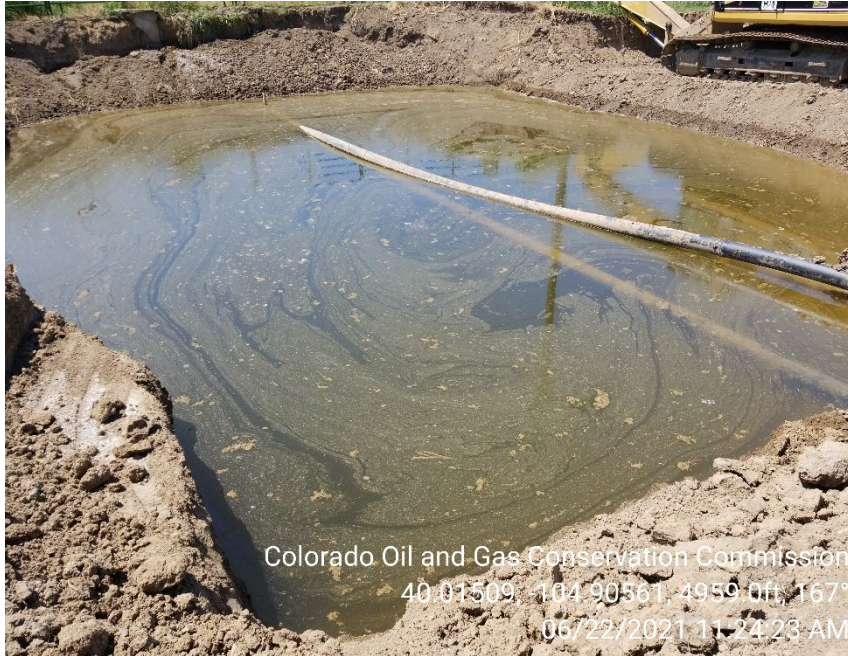
**Photo 3 – Open excavation. Hydrocarbon sheen observed on groundwater.**

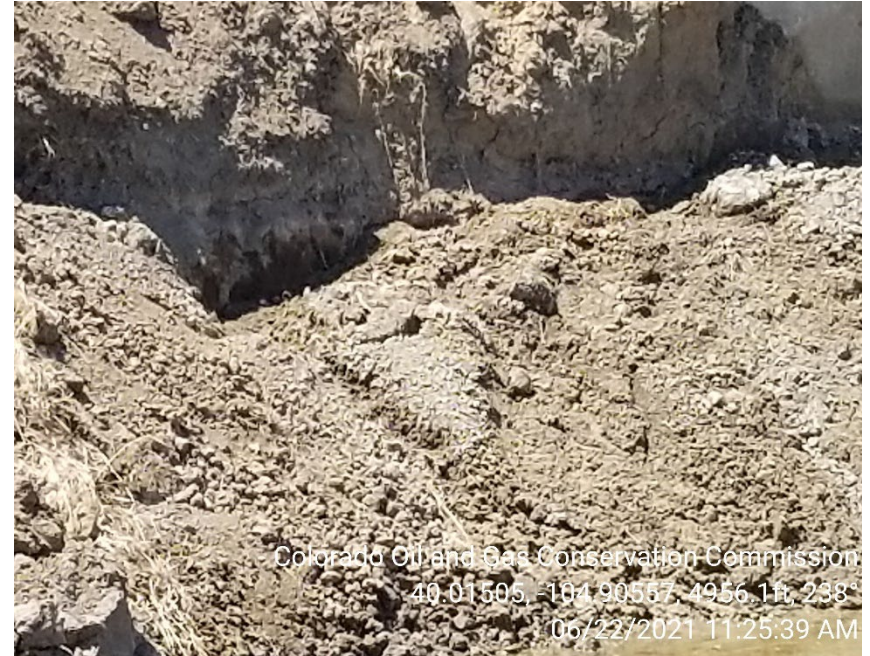
**Photo 4 – Impacts remain in-situ in southern wall.**

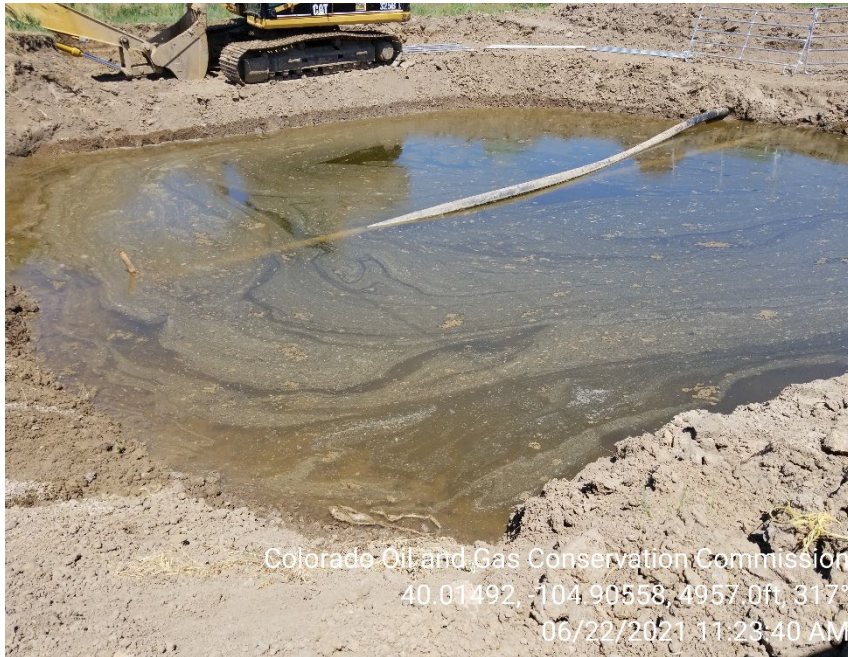
**Photo 5 – Open excavation. Hydrocarbon sheen observed on groundwater.**

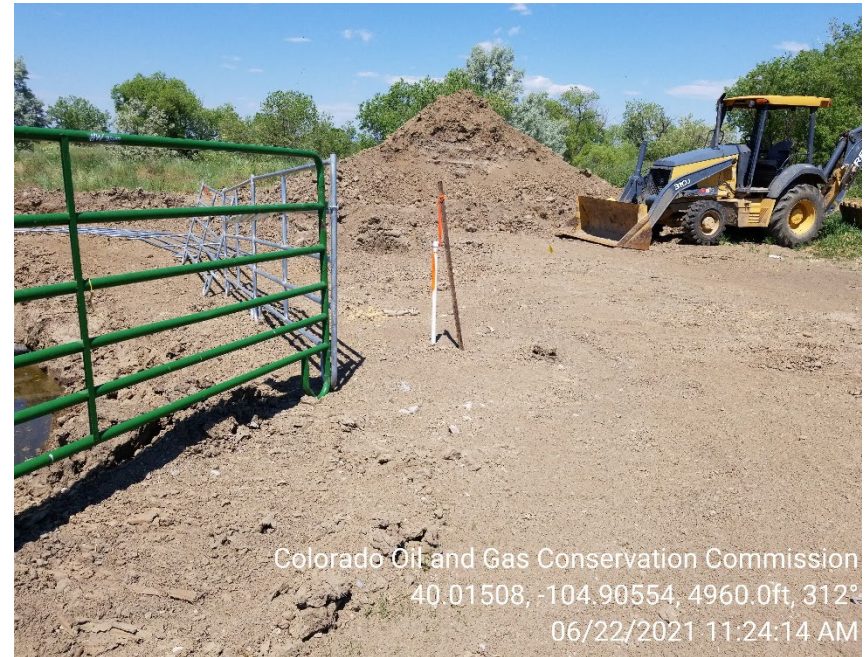
**Photo 6 – One monitoring well installed outside of open excavation.**

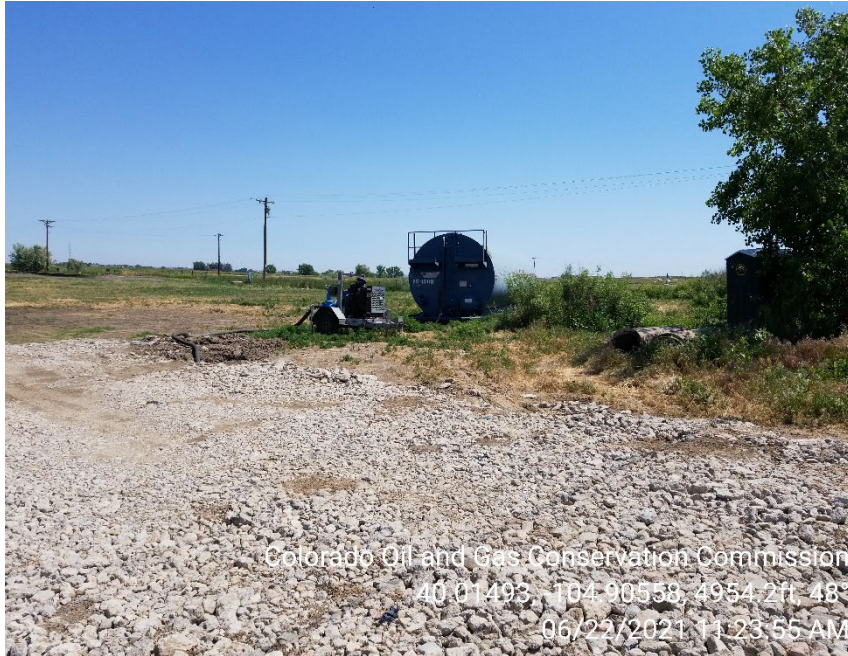
**Photo 7 – Groundwater removed from open excavation being stored on site.**

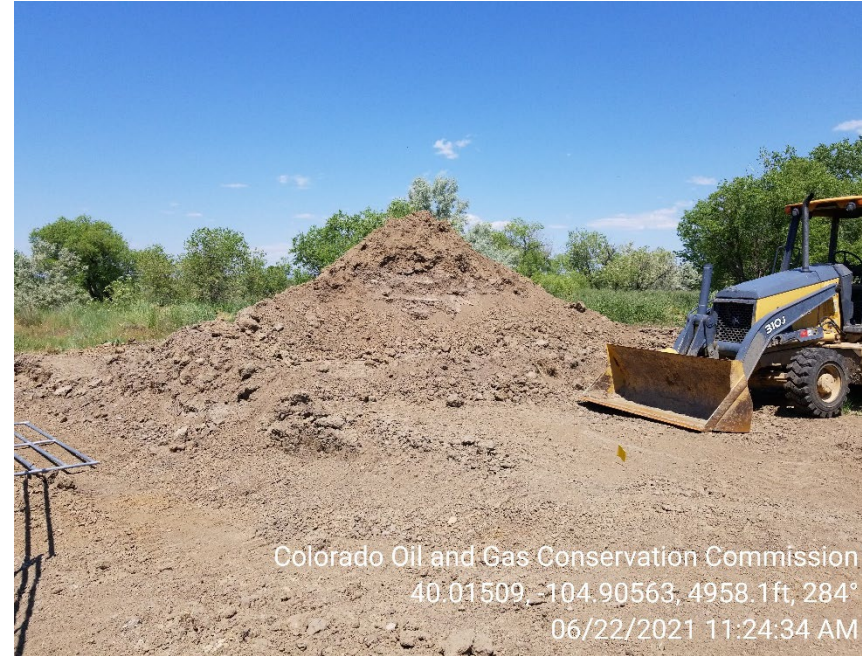
**Photo 8 – Soils stockpiled on location with inadequate BMPs.**
