Inspection Photos
Location Name: jacobucci Jean #1
Location ID: 317872

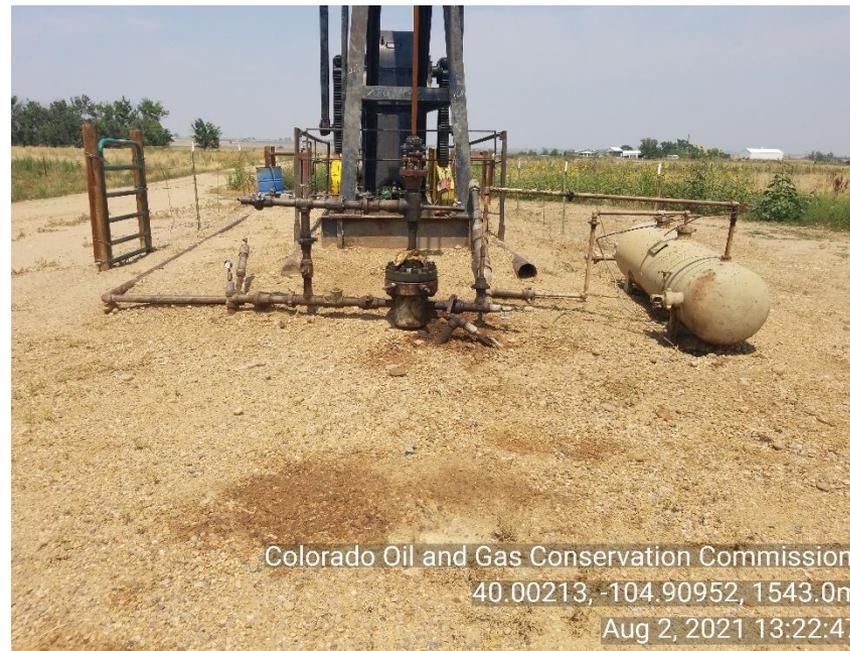
Photo 2 Stained soil in front of and around well head. Well head mechanical issues.

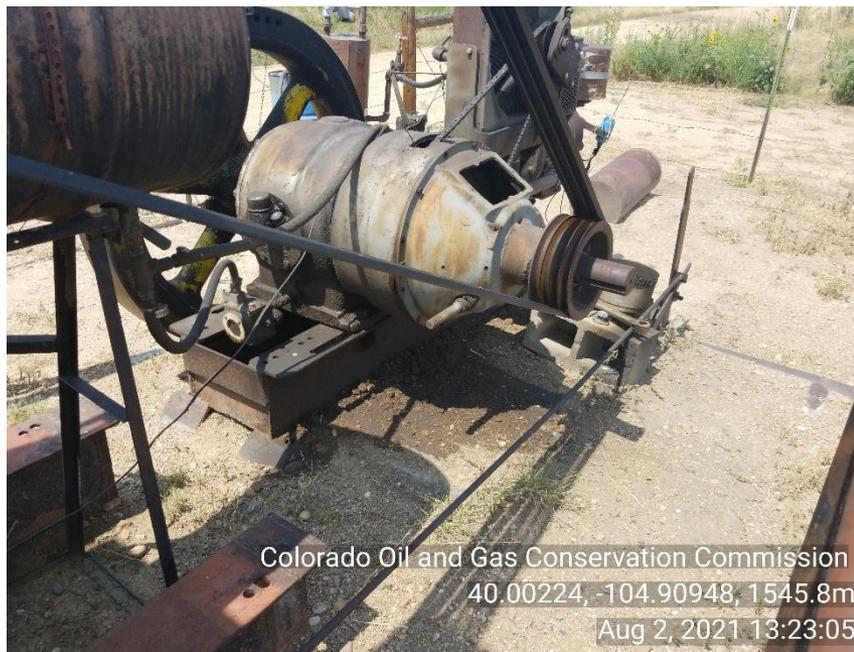
Photo 3 Stained soil and mechanical issues PU motor skid

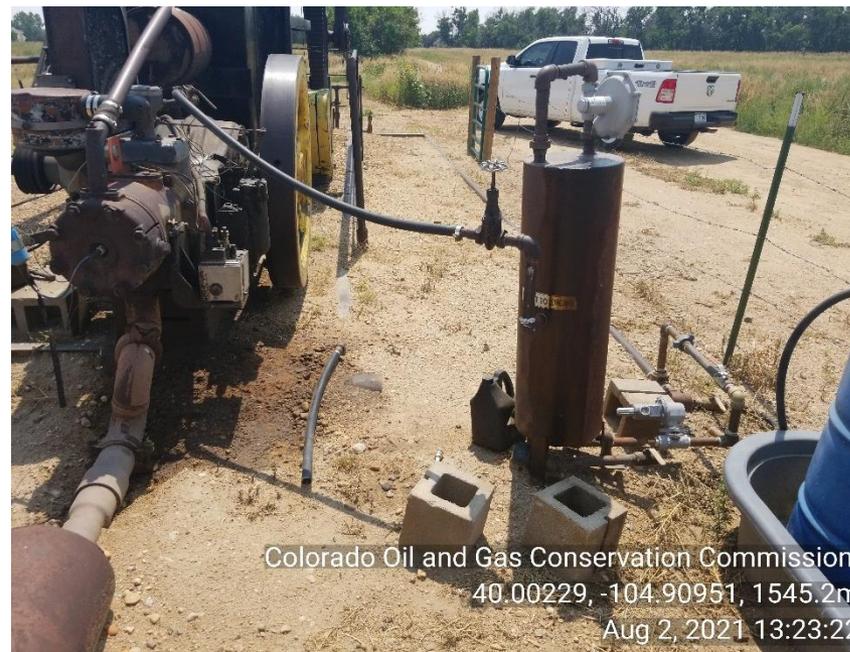
Photo 4 Stained soil and mechanical issues PU motor skid
