Inspection Photos

API: 071-08105

Operator: EVERGREEN NATURAL RESOURCES

Inspection Date: 8/16/2021

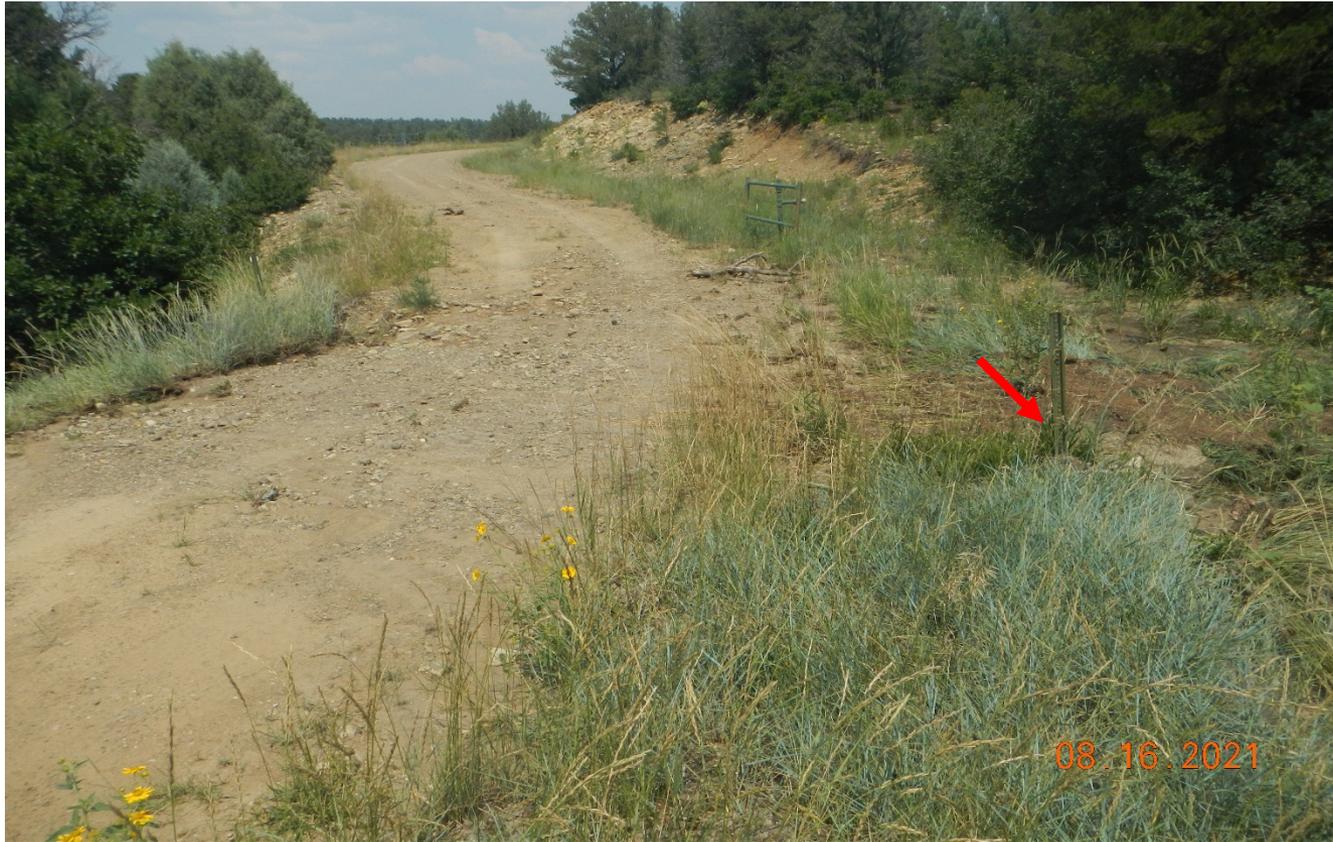
Photo 1. Facing northeast toward the access road. The culvert shown at red arrow is filled in with sediment. Stormwater flowed across the road in this area. The culvert will need to be repaired.

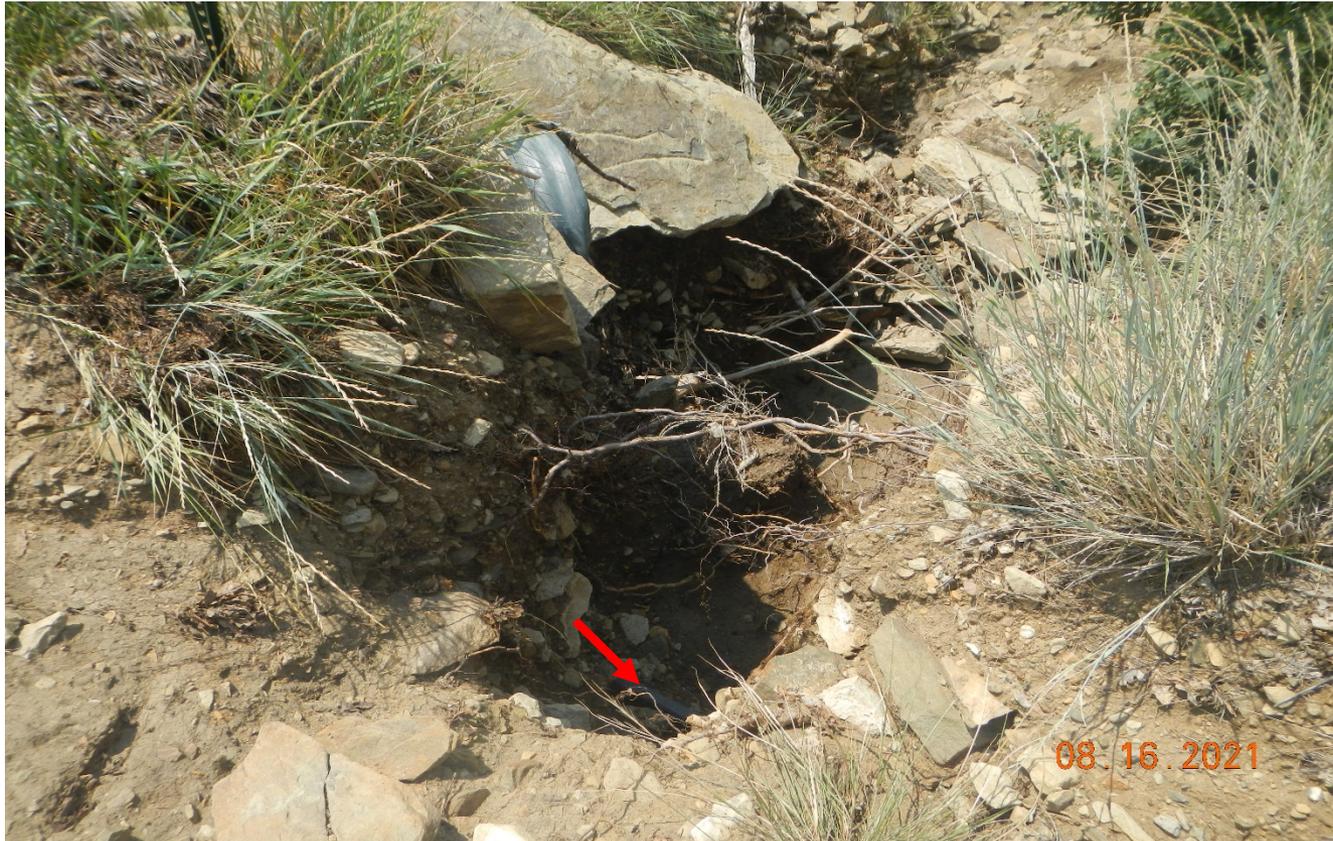
Photo 2. Erosion at the culvert outlet has exposed the pipe line shown at red arrow. This area will need to be repaired.

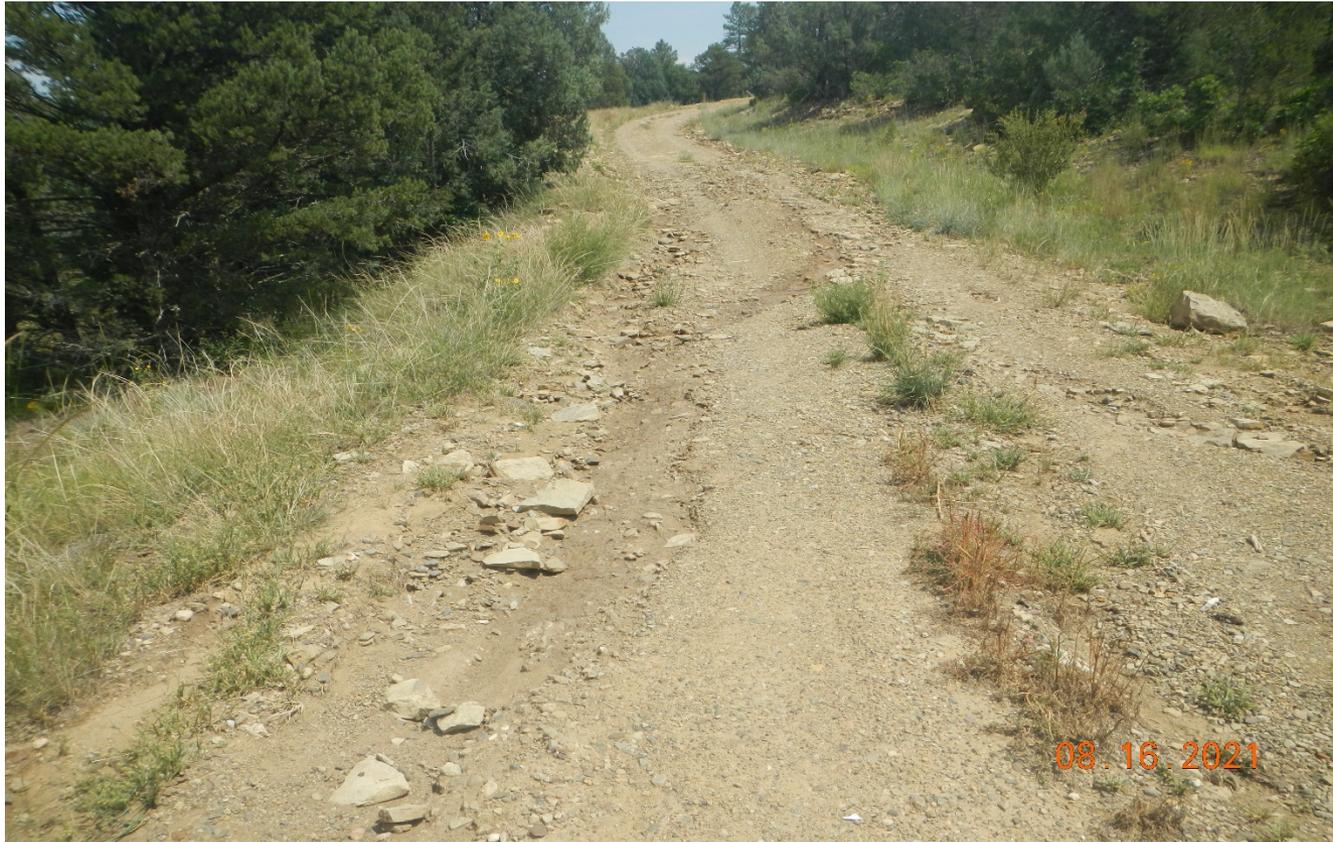
Photo 3. Stormwater erosion is occurring down the road. The road will need to be graded and repaired.
