Inspection Photos

10/08/2021

Operator: TEP ROCKY MOUNTAIN LLC - 96850

Location ID: 480732

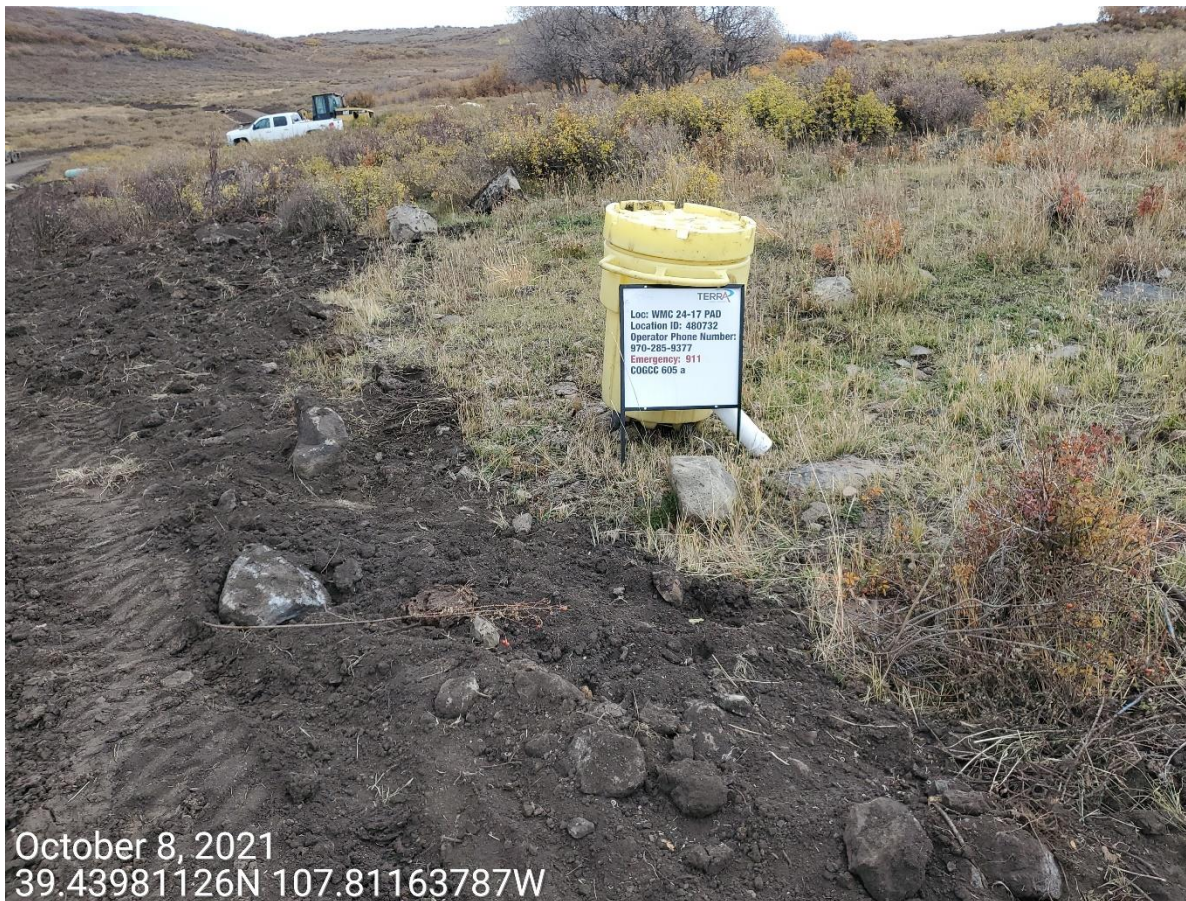
Photo 1: Photo taken from the access road west of the Location. Construction of the Location has been completed; signage will need to be placed at the Location's entrance to comply with Rule 605.a. Permit information Per Rule 406.c observed attached to Location sign.

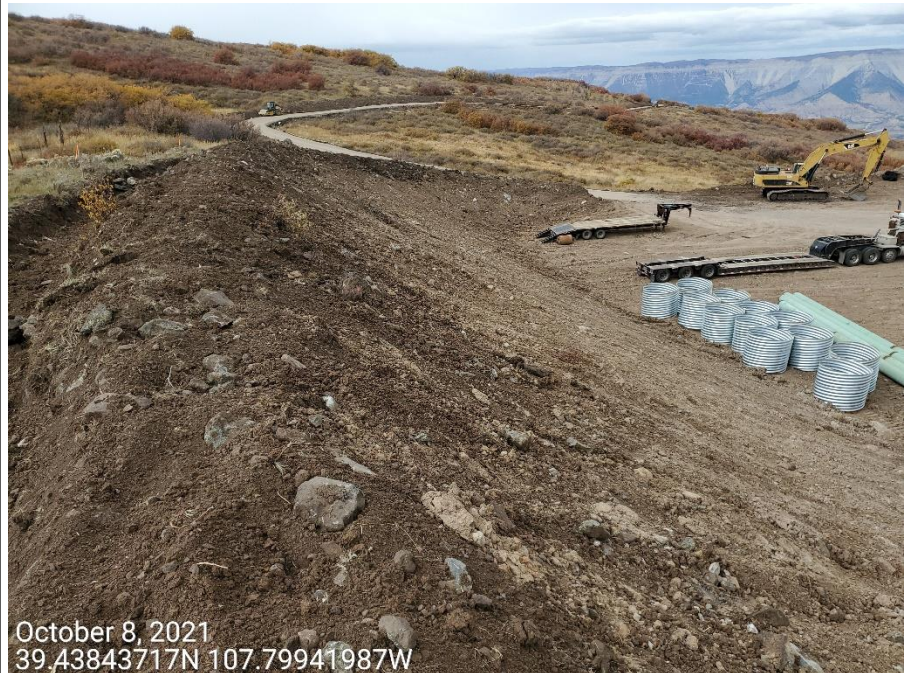
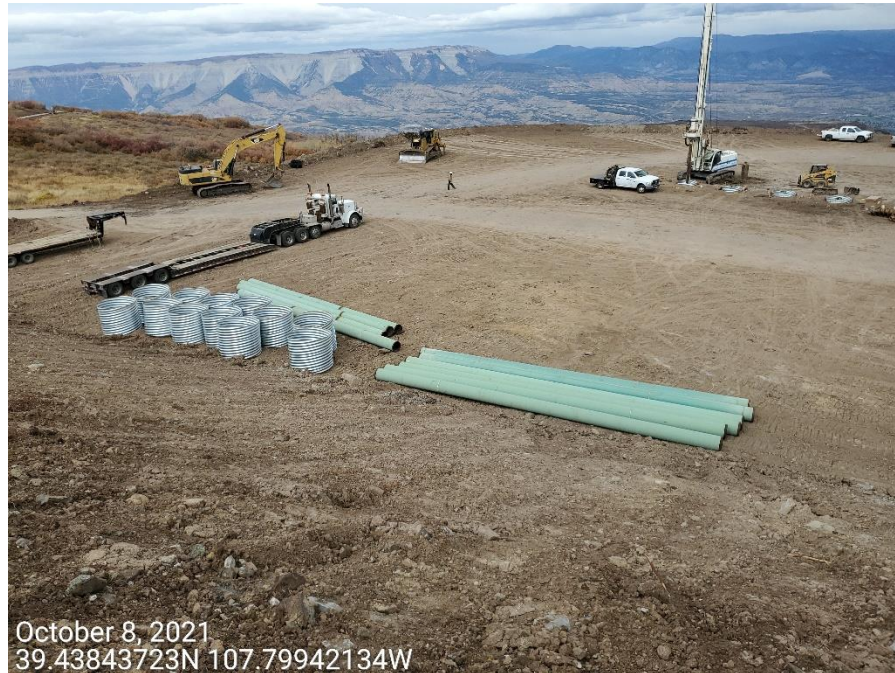
Photo 2: Photos 2-3 taken from the north end of the Location. Photos provide an overview of the site from west, northwest, northeast to east. Pad construction has been completed; Operator installing conductor settings at time of inspection.

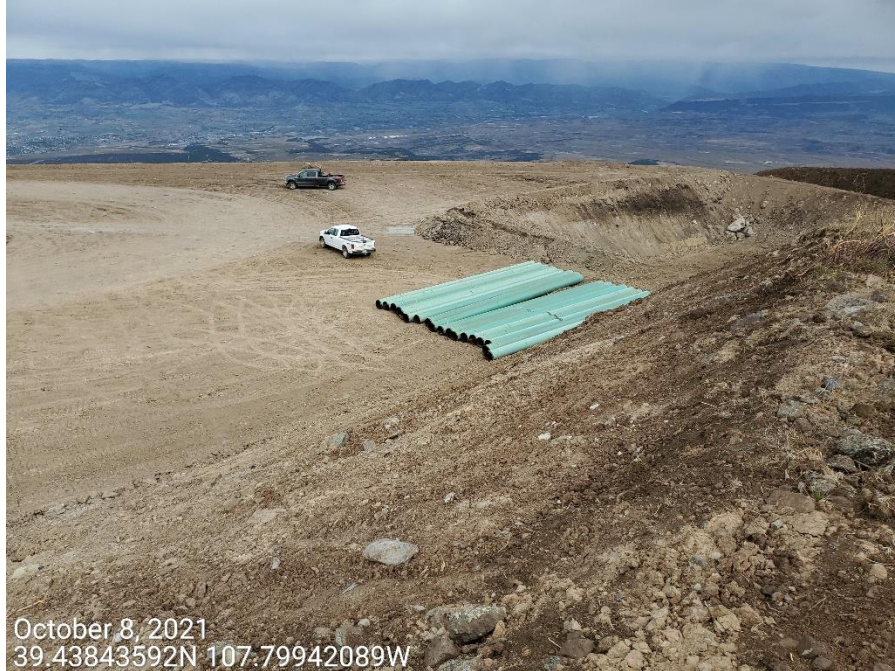
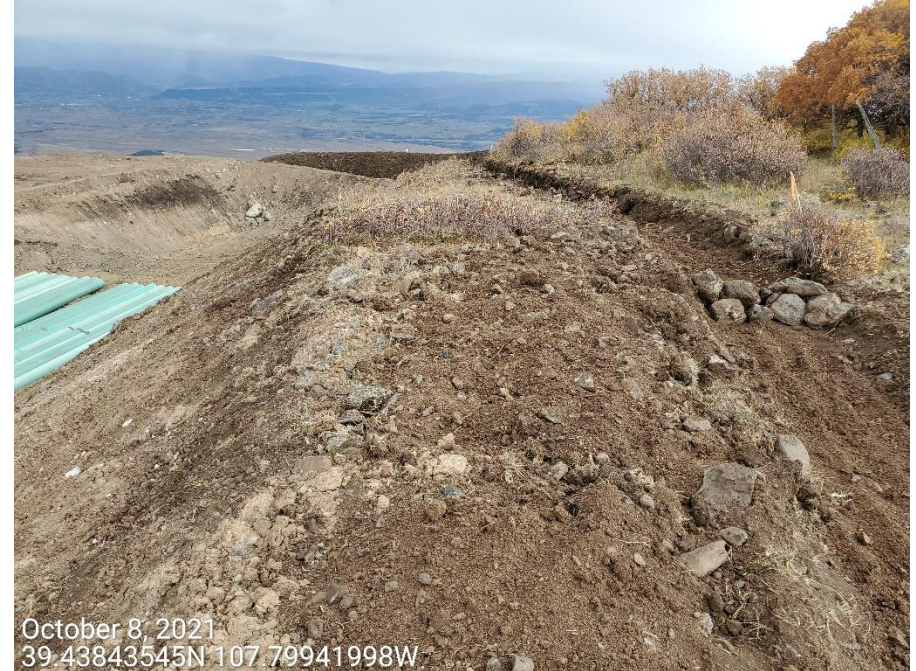
Photo 3: See comments under photo 2.

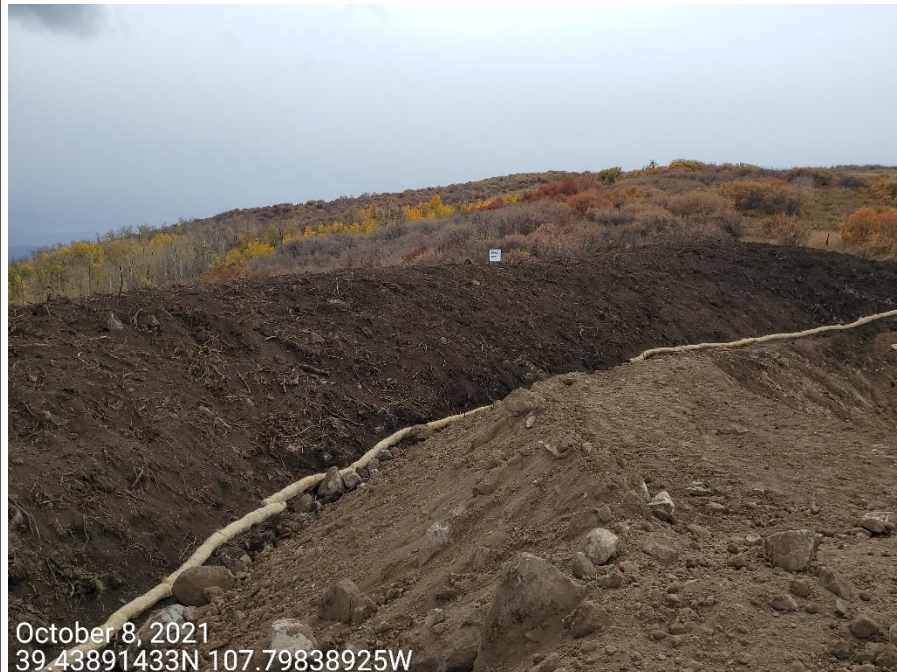
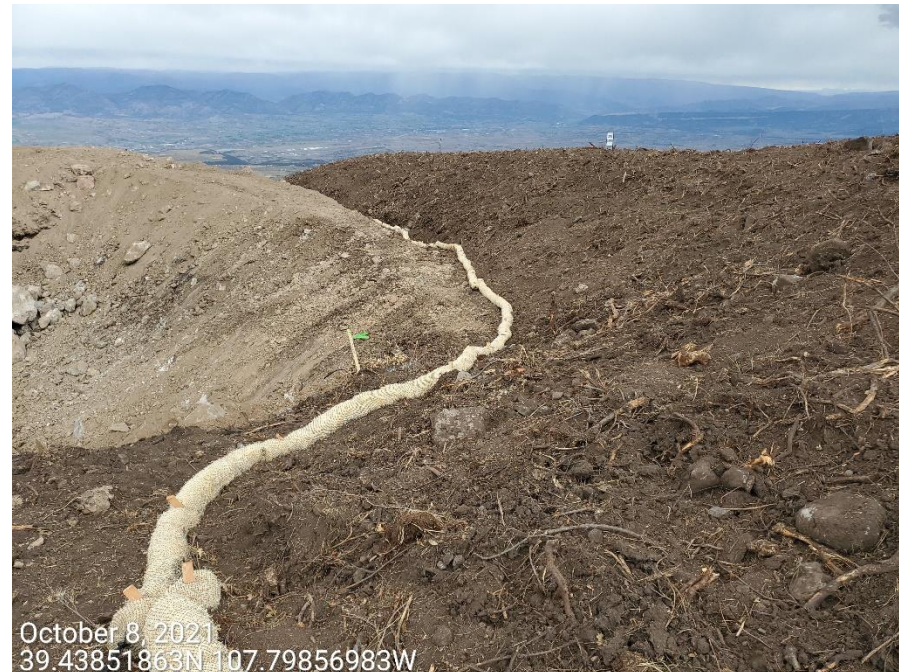
Photo 4: Photos taken from the topsoil stockpile on the west end of the Location. Erosion logs placed along perimeter of stockpile. Photos also show control measures to protect/stabilize the topsoil stockpile are missing or insufficient

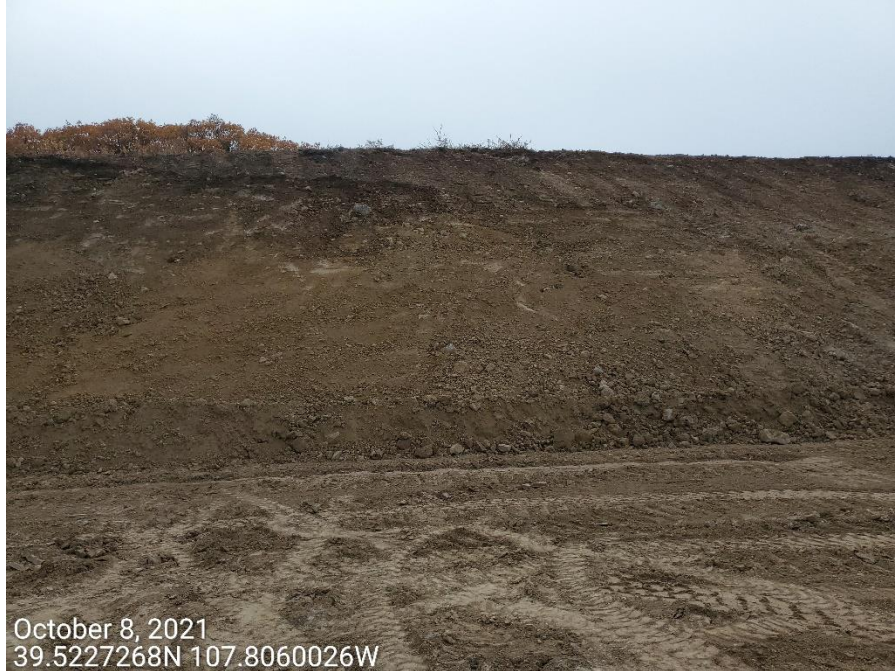
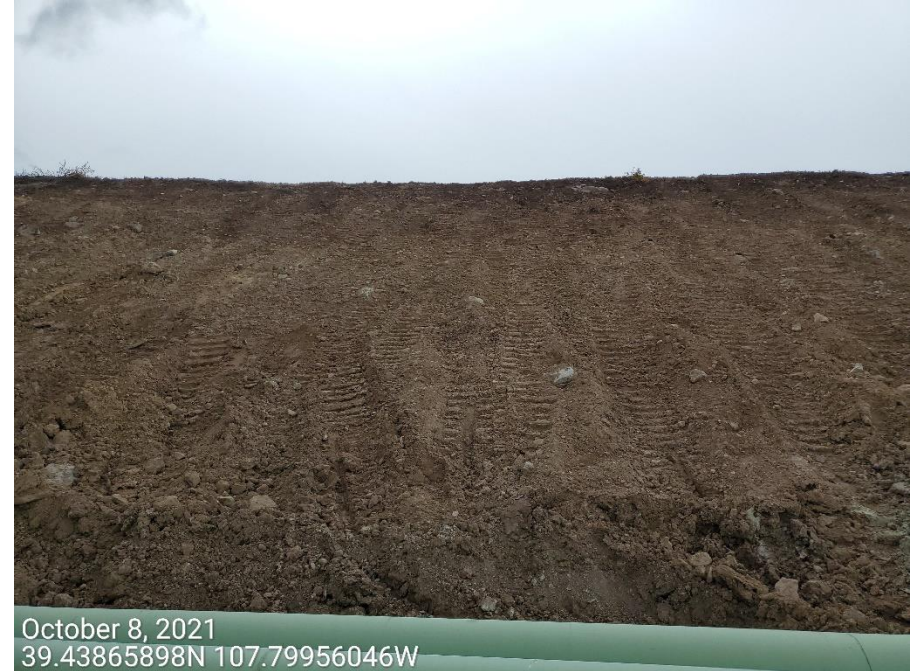
Photo 5: Photos taken from the cut slope of the Location, facing north. Photos show control measures to protect and stabilize the cut and fill slopes are missing or insufficient. Photo on right shows Operator implemented surface roughening (tracking) on portions of the cutslope; tracking insufficient along entire cut and has not been implemented in accordance with good engineering practices. Slopes currently loose/unconsolidated material.

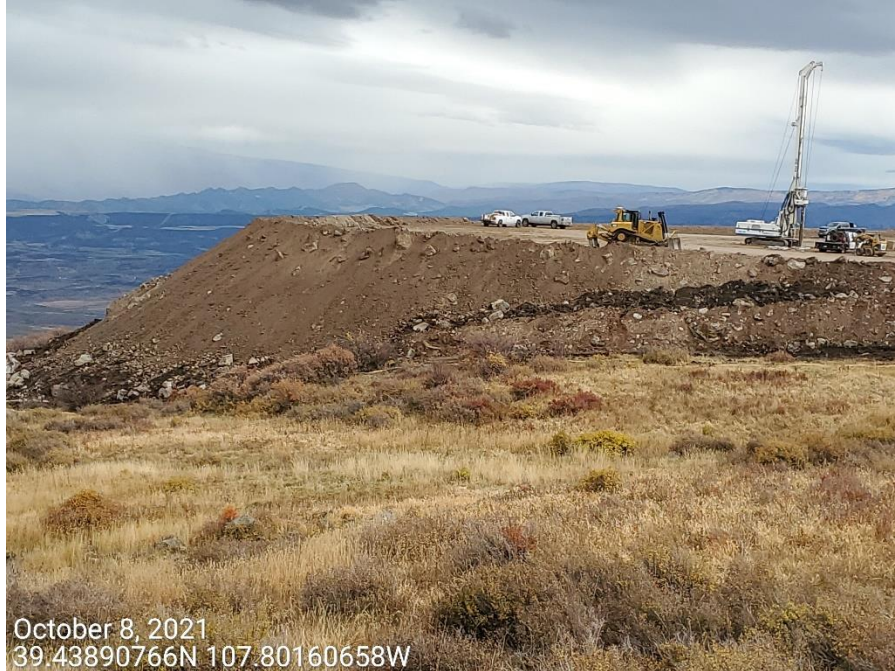
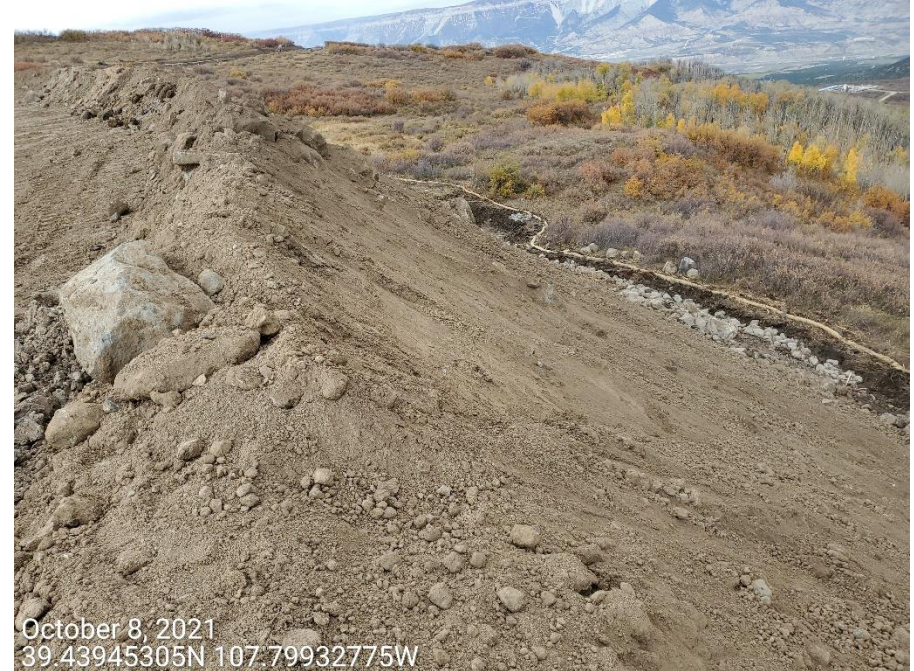
Photo 6: Photos provide examples of the fill slopes on the Location; stormwater and erosion control measures to protect/stabilize the fill slopes are missing or insufficient; slopes are loose/unconsolidated material

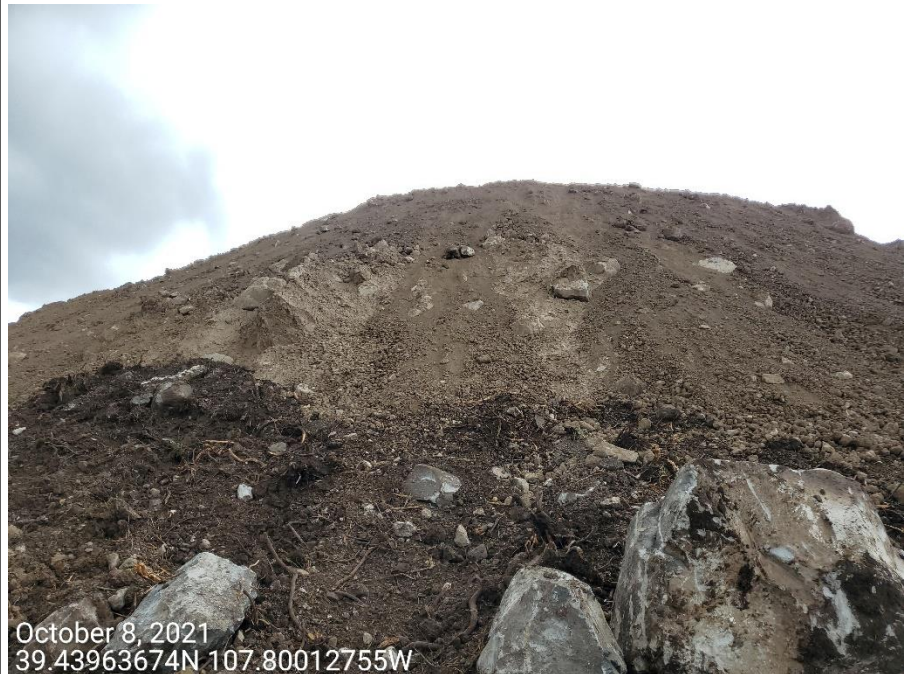
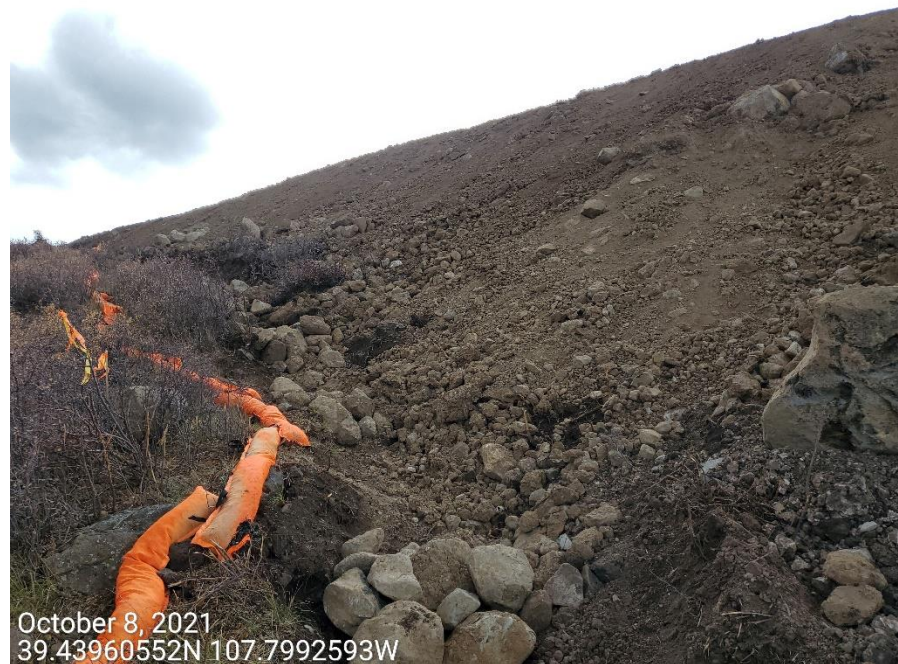
Photo 7: Photos provide examples of the fill slopes on the Location; stormwater and erosion control measures to protect/stabilize the fill slopes are missing or insufficient; slopes are loose/unconsolidated material

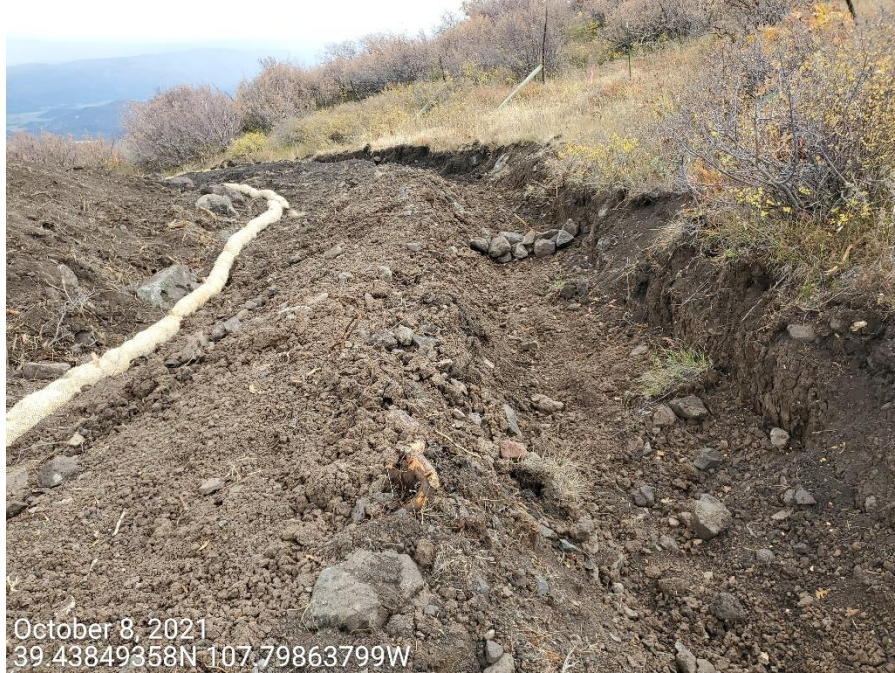
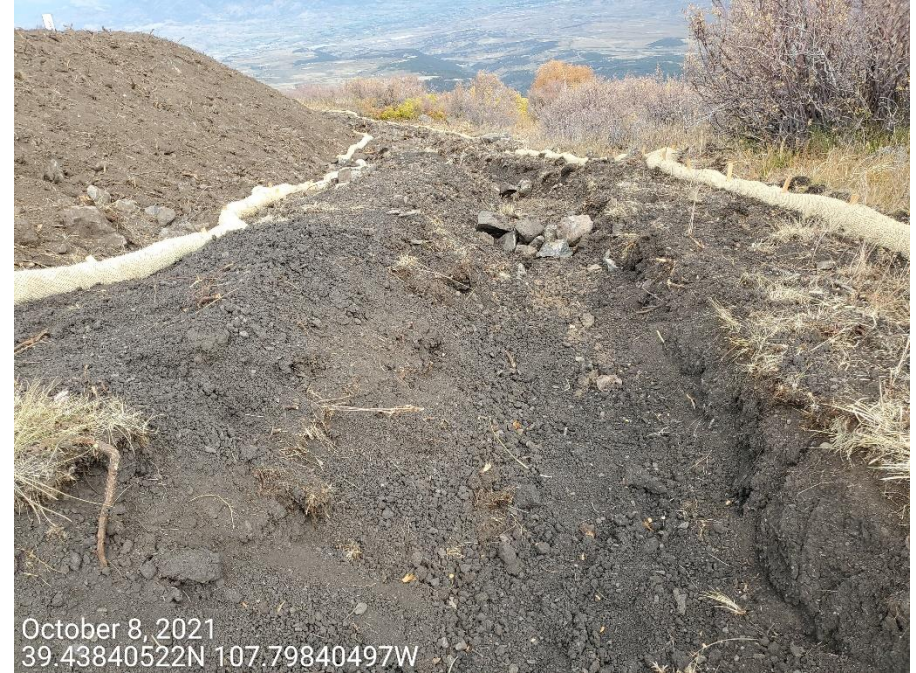
Photo 8: Photos taken from the perimeter stormwater diversion ditch. Photos provide examples showing that the stormwater diversion ditch has not been constructed in accordance with good engineering practices; BMP improperly constructed with vertical slopes; soils within the control measure are unconsolidated and is a pollutant source.

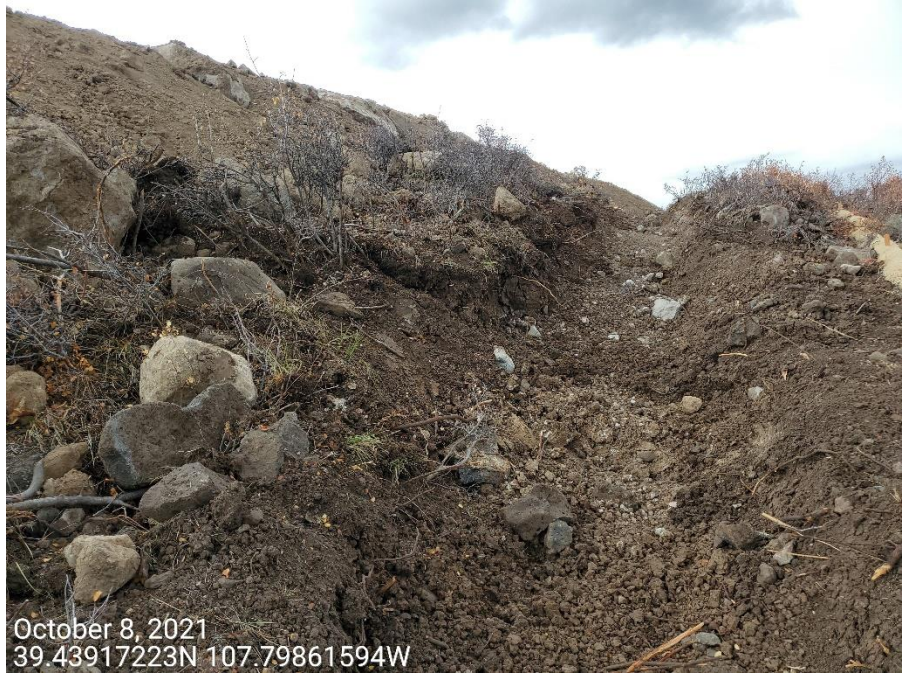
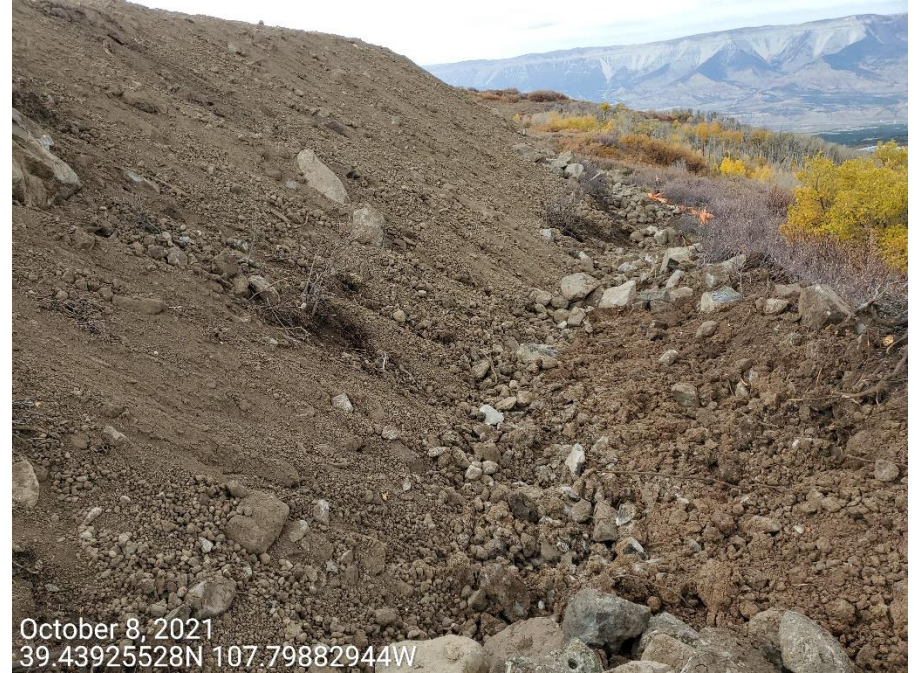
Photo 9: Photos taken from the perimeter stormwater diversion ditch. Photos provide examples showing that the stormwater diversion ditch has not been constructed in accordance with good engineering practices; BMP improperly constructed with vertical slopes; soils within the control measure are unconsolidated and is a pollutant source.

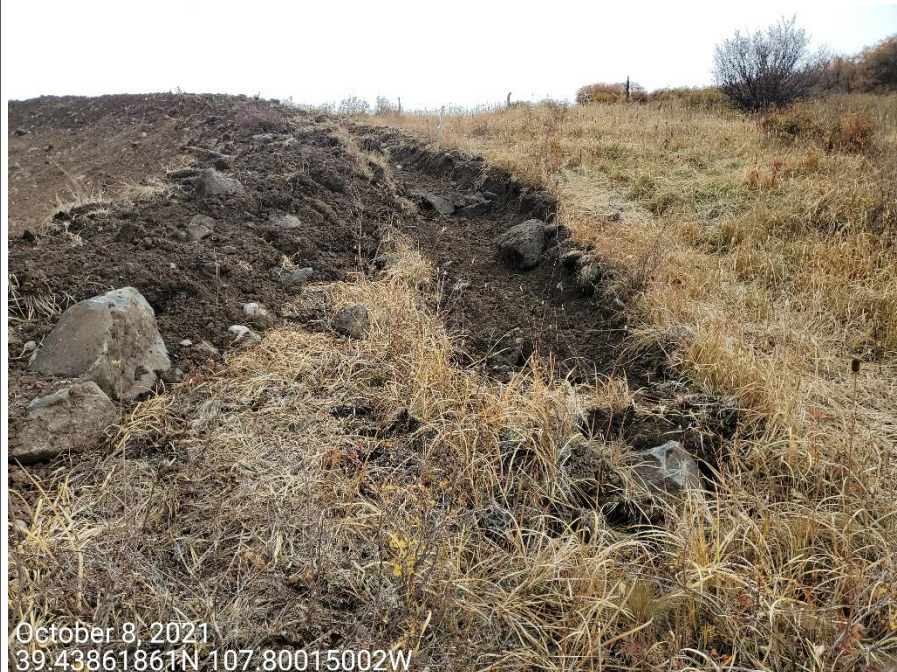
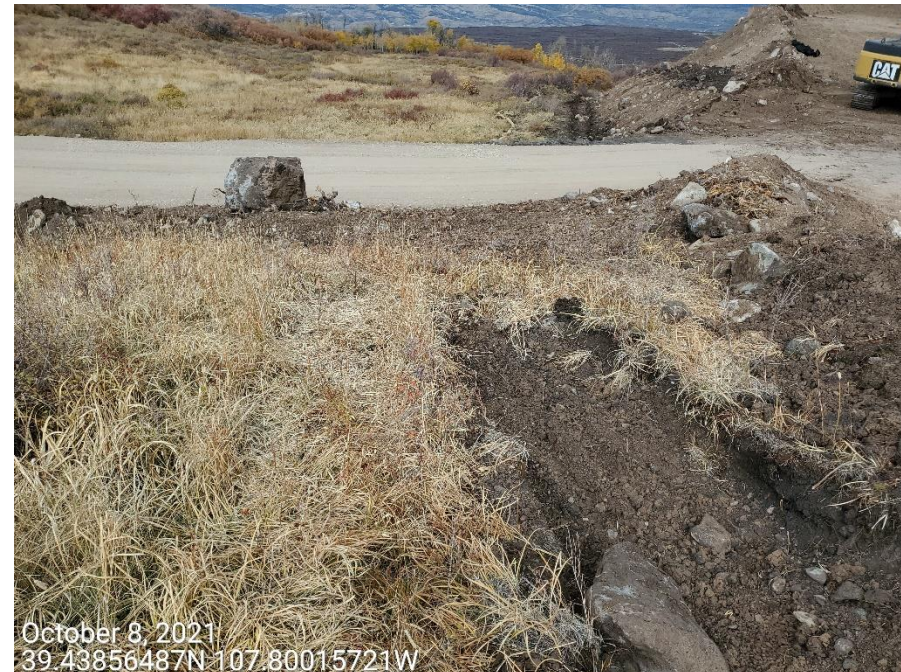
Photo 10: Photo taken from the stormwater diversion ditch on the southwest corner of the Location. Photo shows ditch has not been constructed with an appropriate outlet to allow for proper sediment laden-free stormwater discharge.

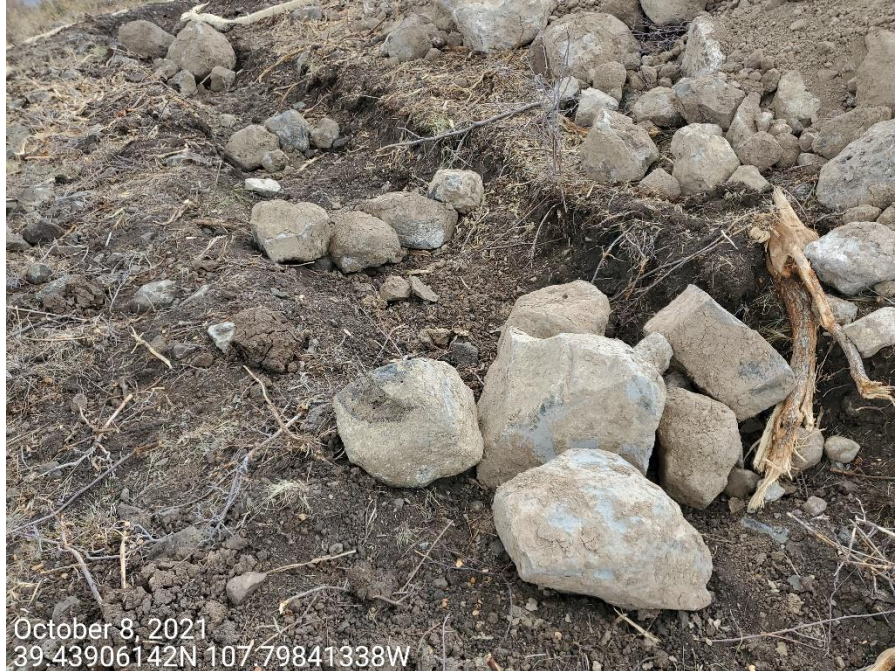
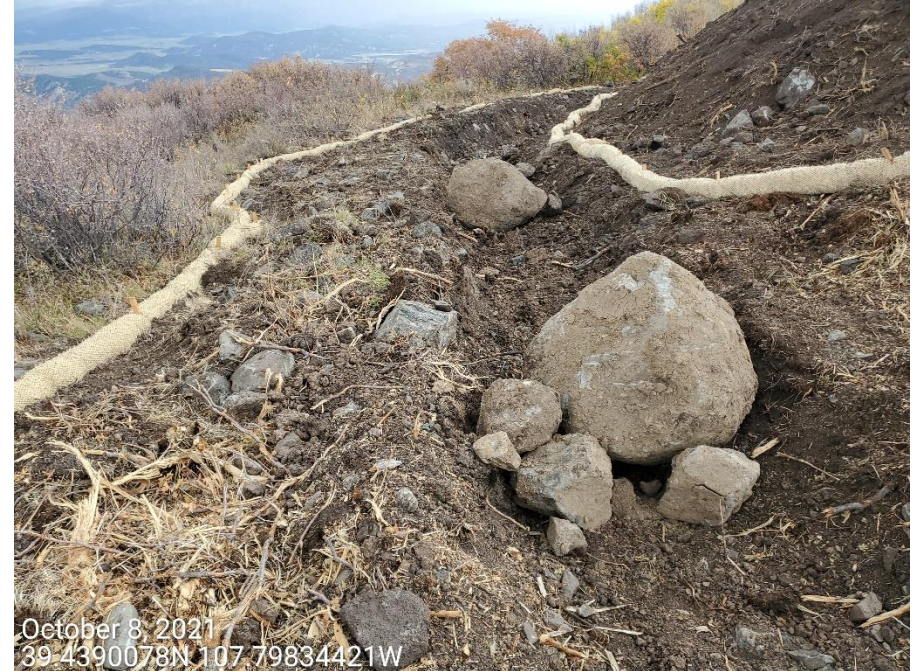
Photo 11: Photos taken from the stormwater ditch provide example showing velocity checks (rock checks) within the ditch have not been constructed in accordance with good engineering practices; rock material utilized in several checks observed to not be an appropriate size, and will facilitate erosion degradation within the ditch.

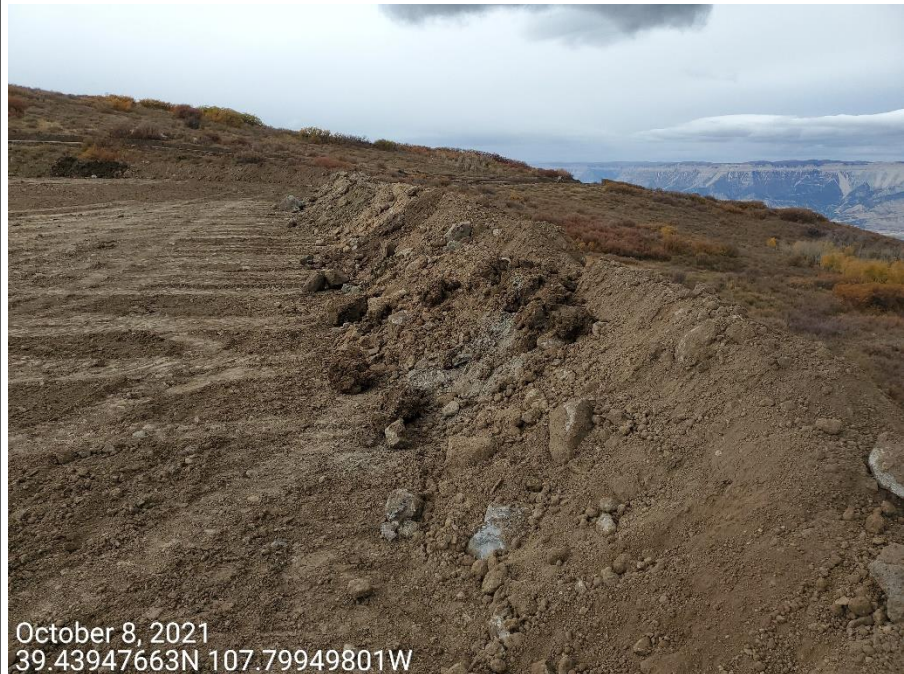
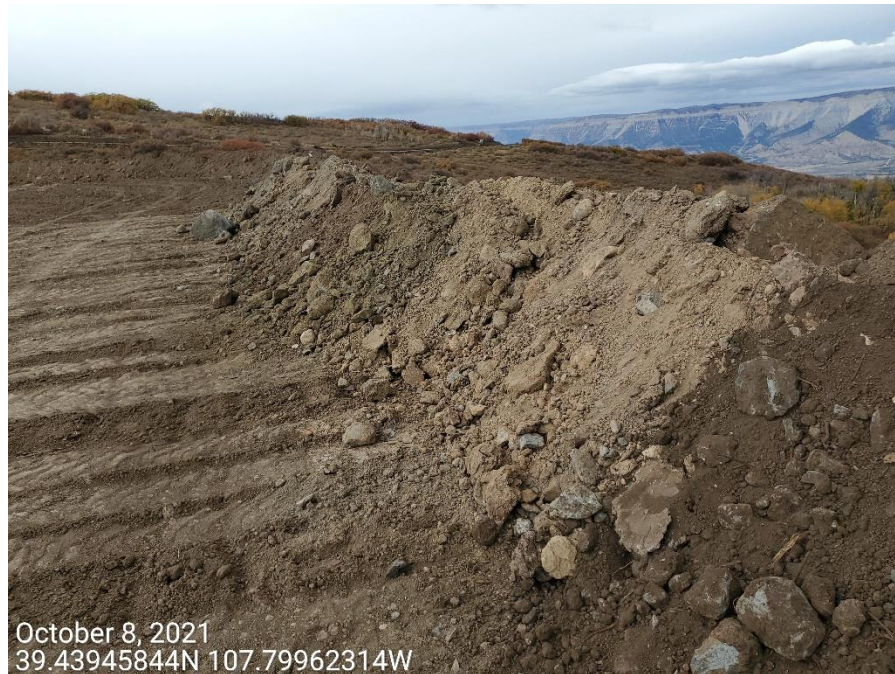
Photo 12: Photos provide example showing the berm along the perimeter of the working pad area has not been installed in accordance with good engineering practices; berm is currently unconsolidated material and a pollutant source.

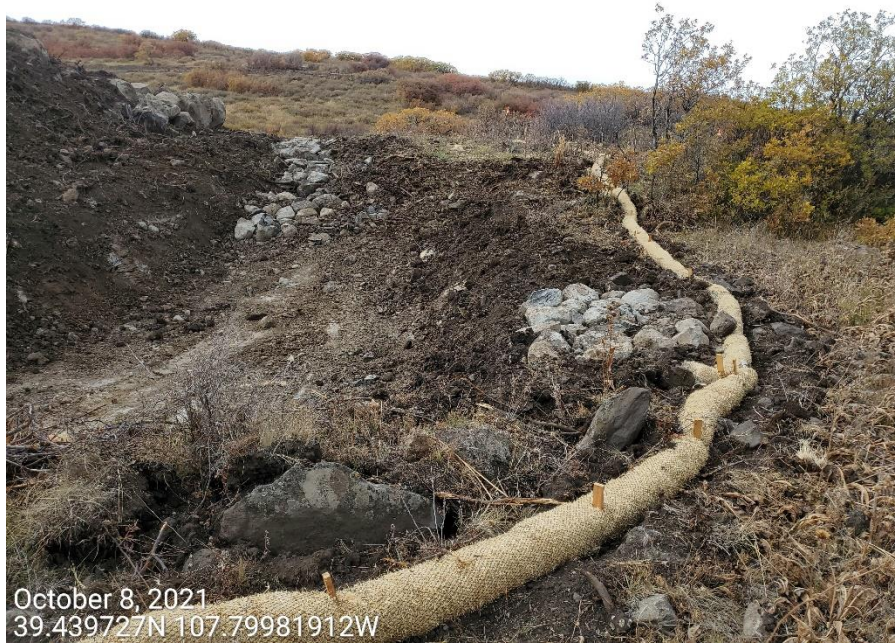
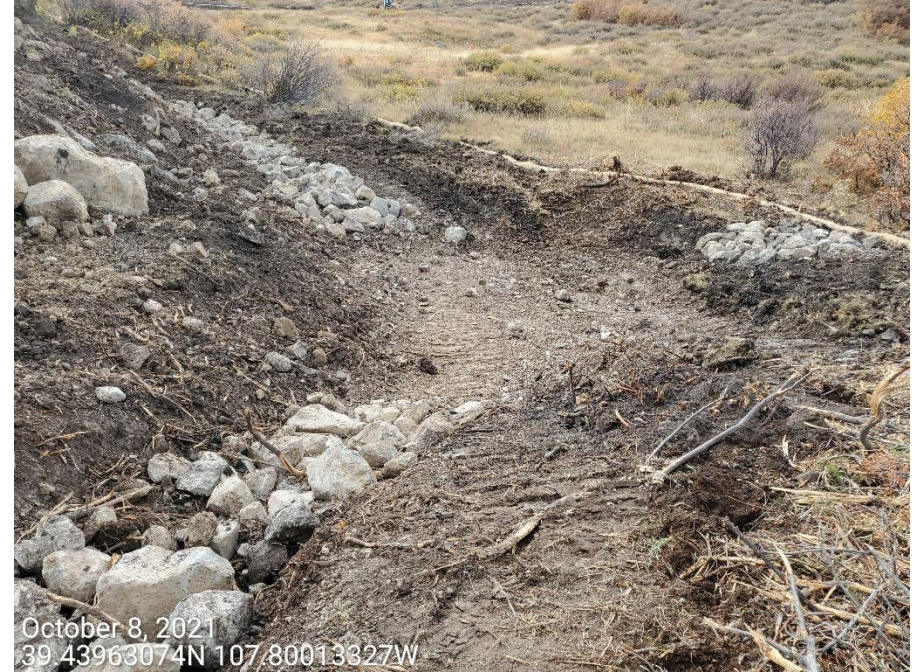
Photo 13: Photos taken from the northwestern corner of the Location. Operator's Location "Layout Drawing" attached to the Form 2A shows 3 sediment traps to be constructed on the northeast/northwest corner, and northern end of the Location. Photo shows only 2 traps have been constructed on the northwest corner of the Location. It is unclear if traps have been constructed per good engineering practices and are appropriate in size to manage runoff from the drainage area of the pad, and upslope undisturbed areas.

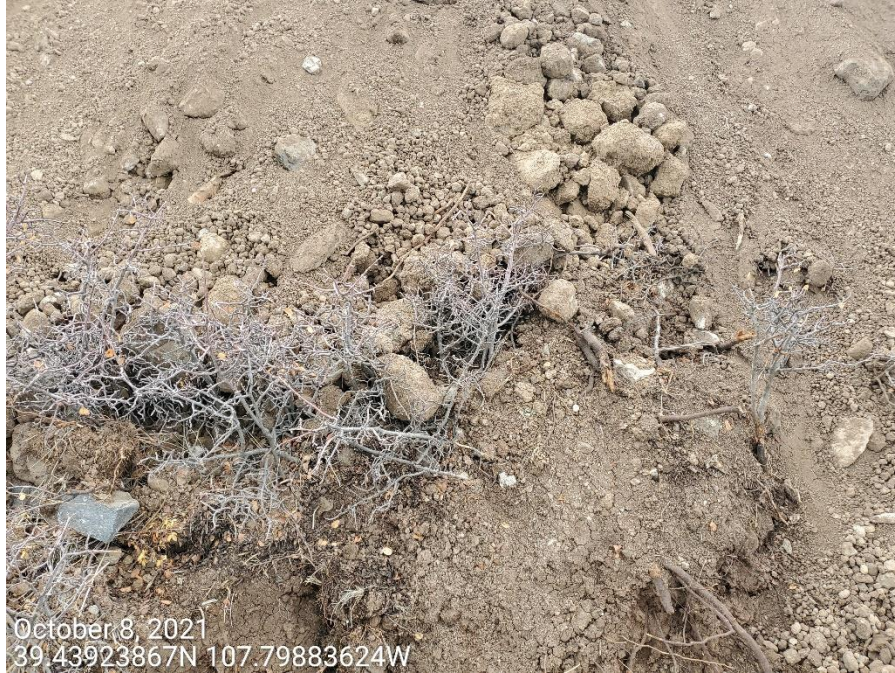
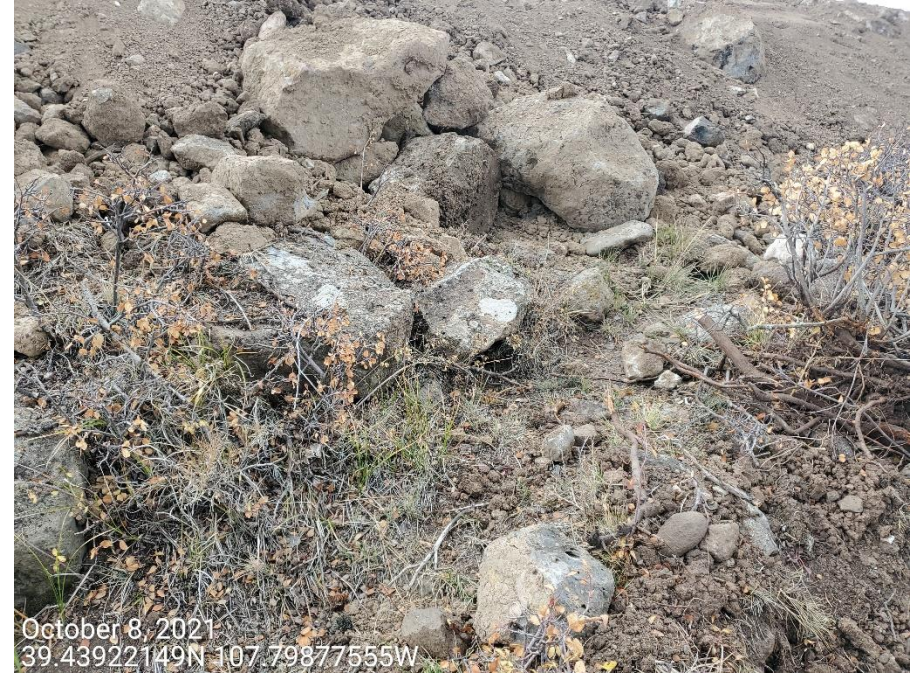
Photo 14: Photos taken from the fill slopes of the Location. Photos provide examples of areas observed where intact, rooted vegetation and topsoil can be observed beneath fill material; Operator failed to salvage, segregate and store all topsoil within the Location's disturbance area during construction.

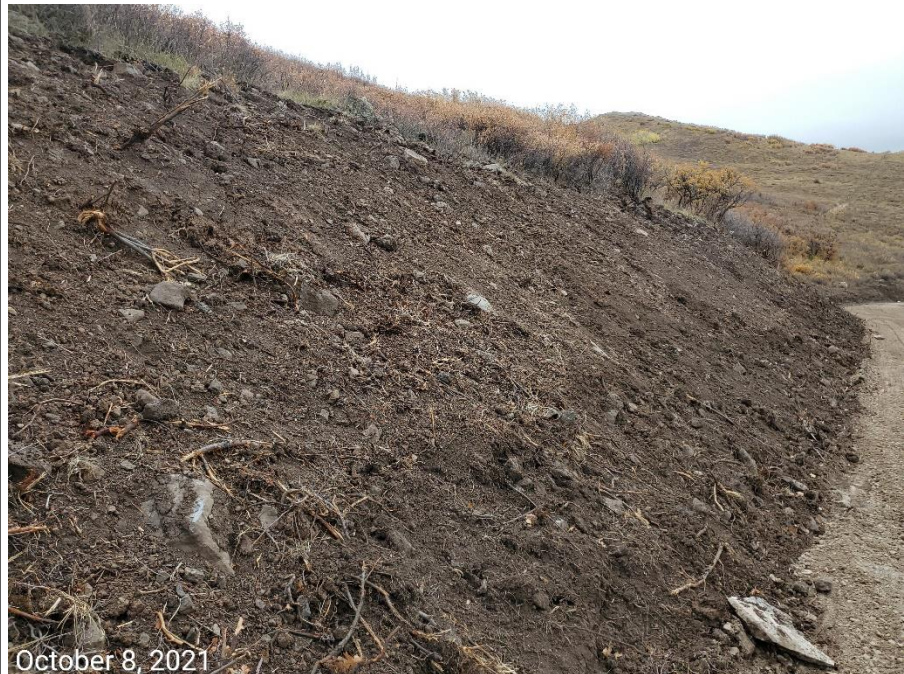
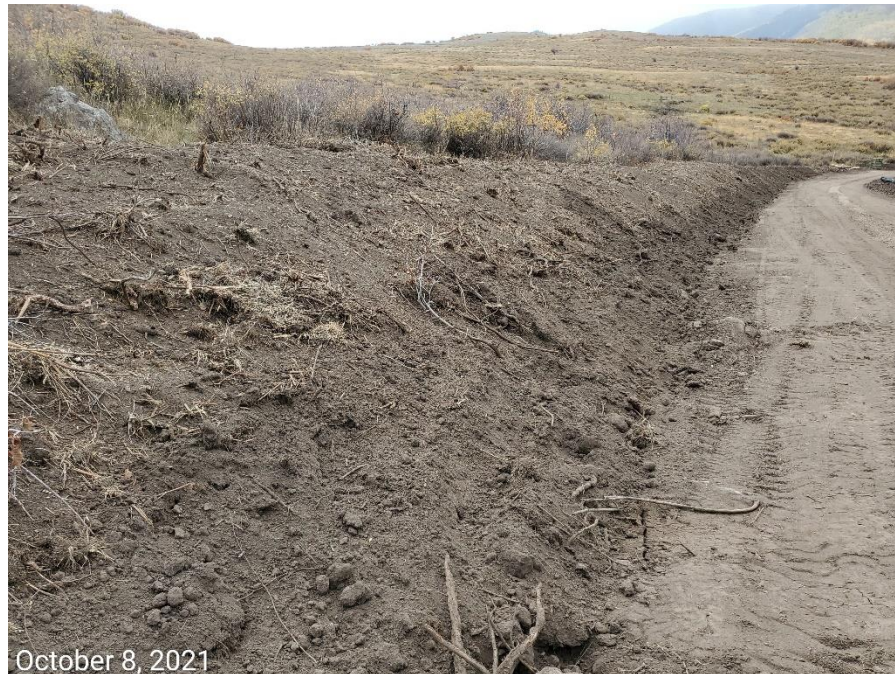
Photo 15: Photos taken from the access road west of the Location. Photo shows example of stockpiled soils and cut slopes along the road where control measures to protect/stabilize the soils are missing or insufficient.

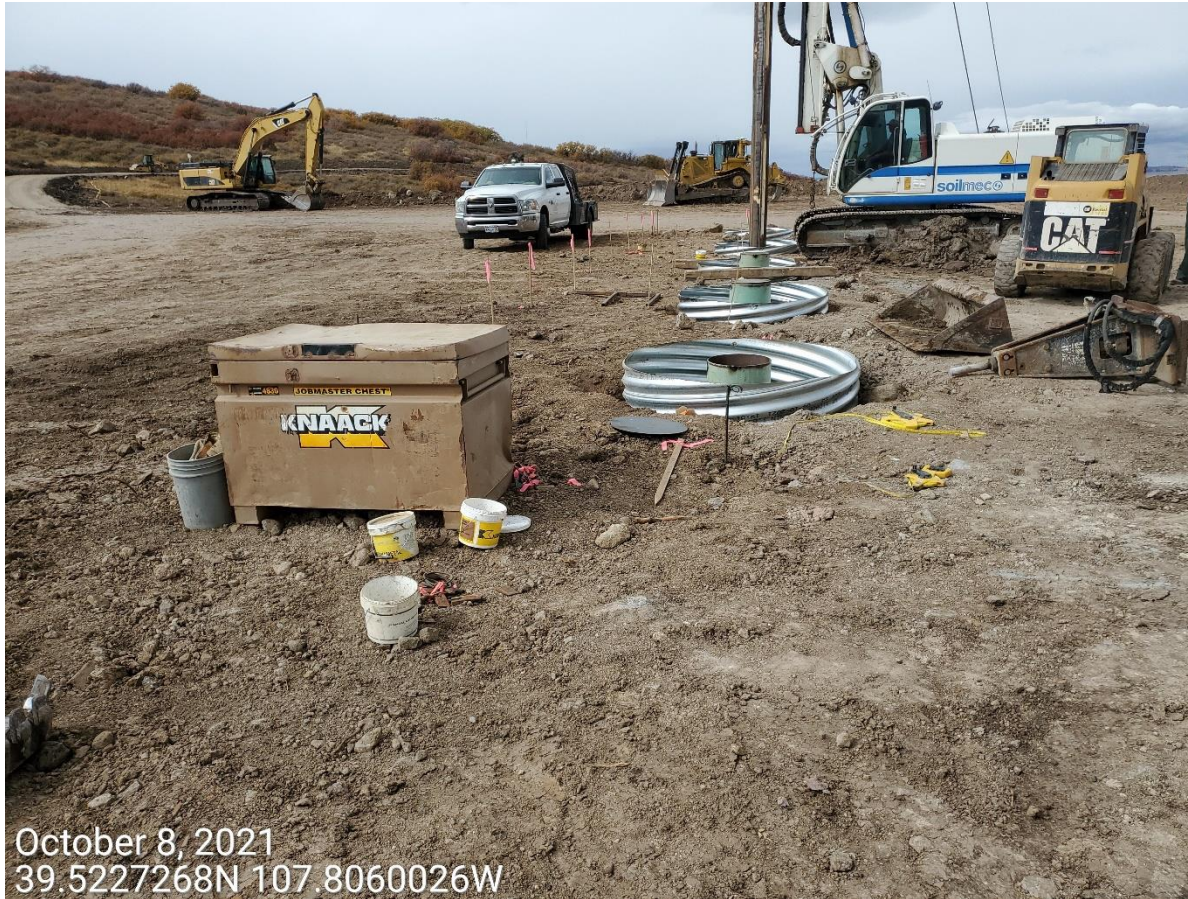
Photo 16: Photo taken from the Location. Photo shows Operator was in the process of drilling/installing conductor settings at time of inspection.
