Inspection Photos
Operator: Simcoe
Loc ID: 471426
Date: 10/13/2021

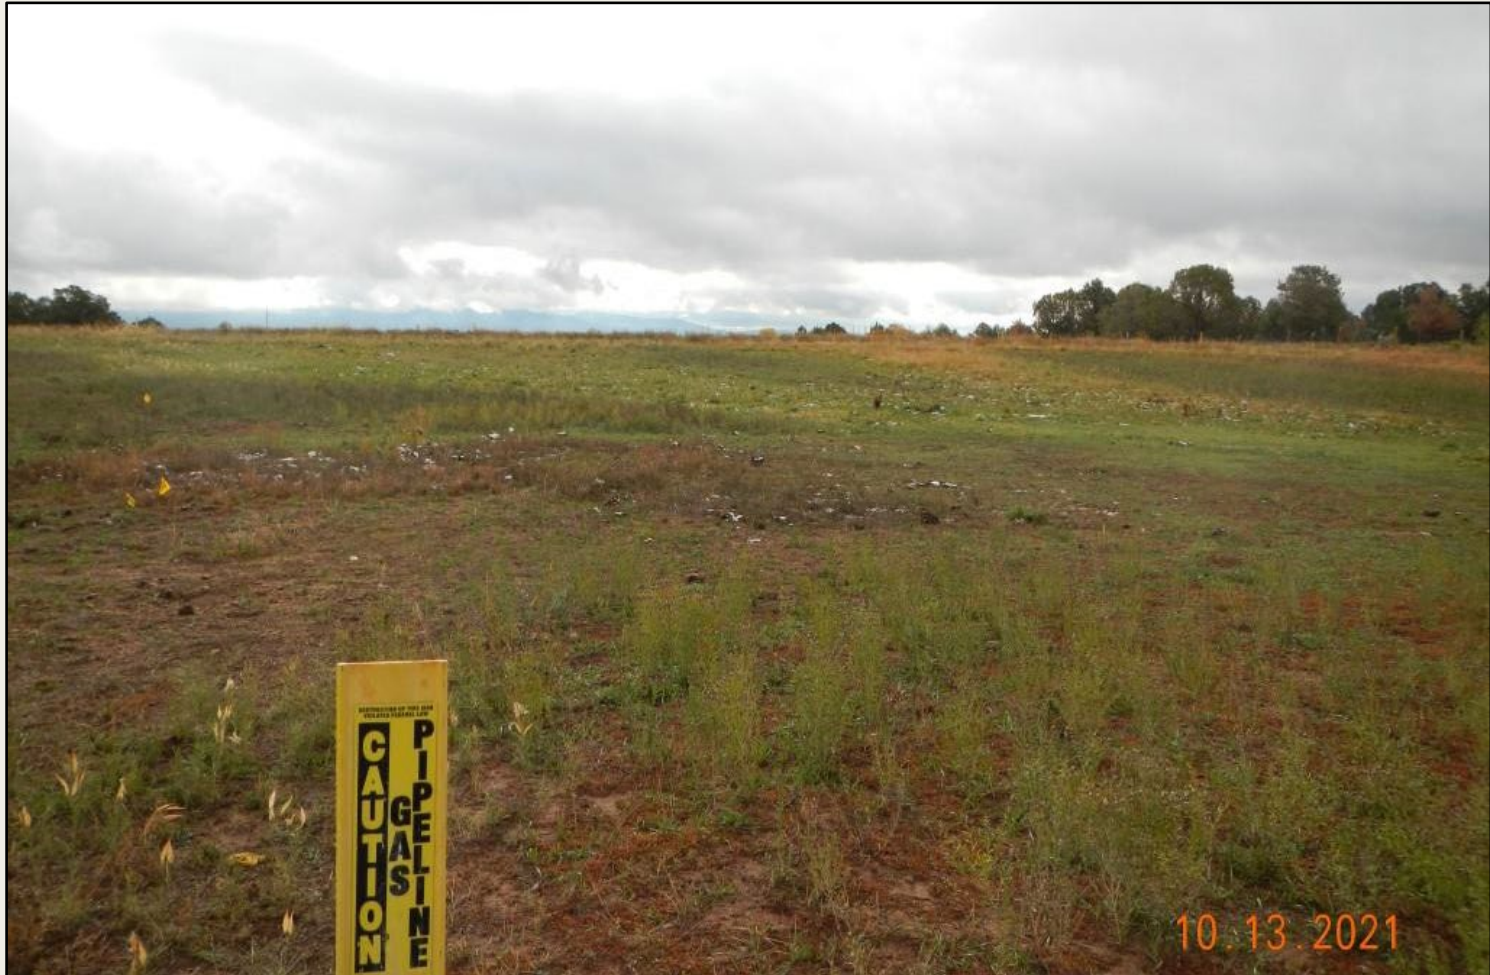
Photo 1. View of gas line right of way, facing eastward. Dense Russian knapweeds observed. Within and outside of the project area.

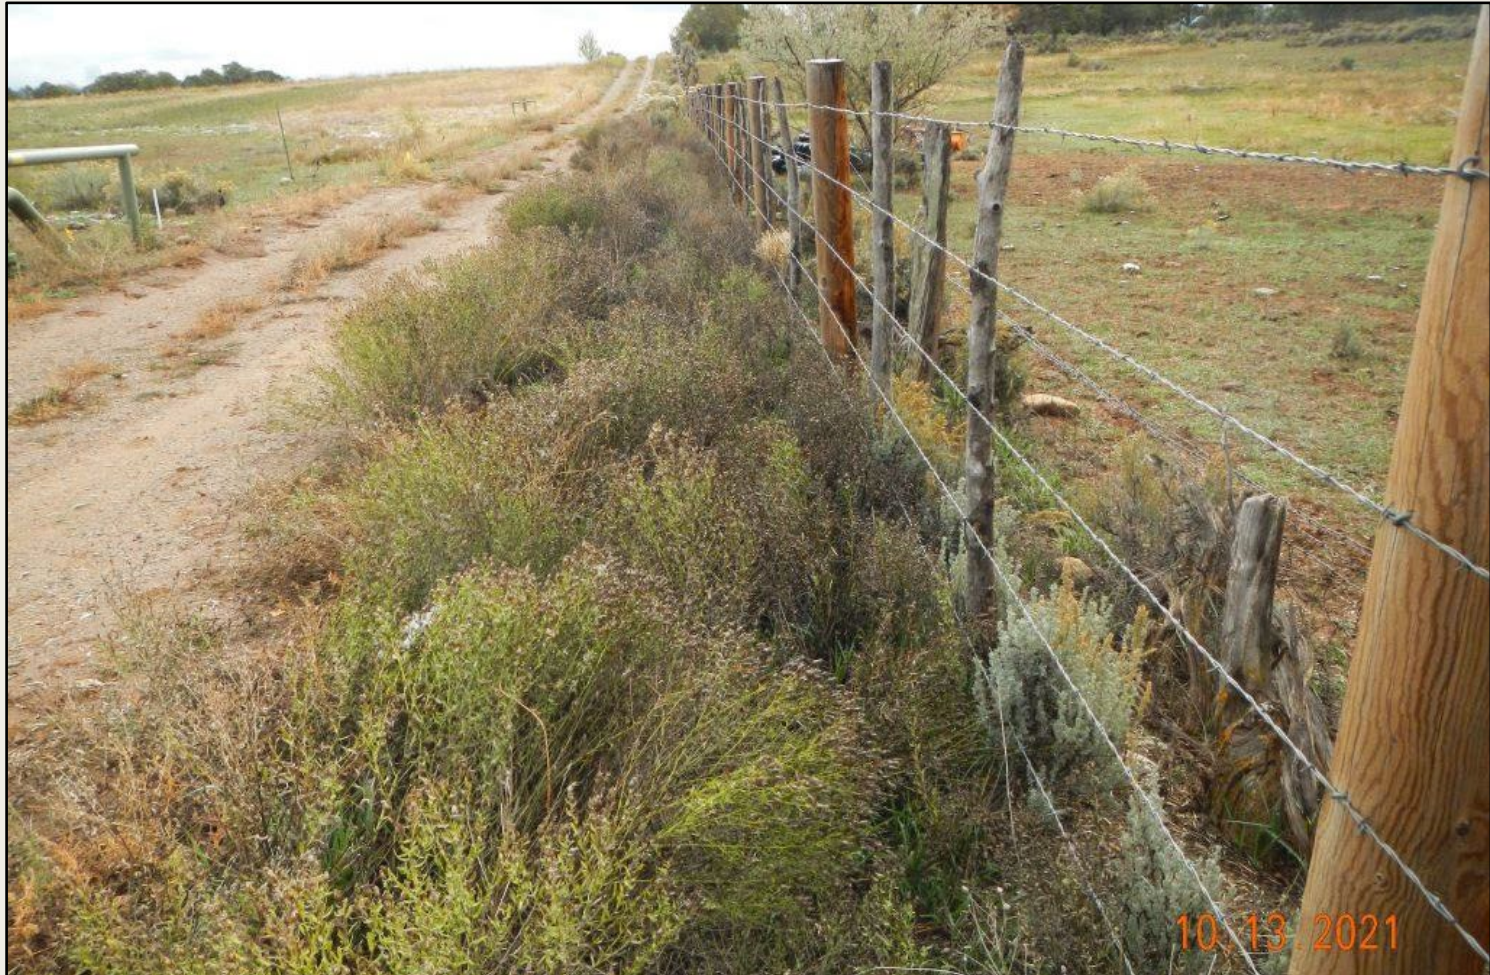
Photo 2. View of dense Russian knapweeds along the fenceline within the right of way, facing eastward. Weeds are not being controlled.

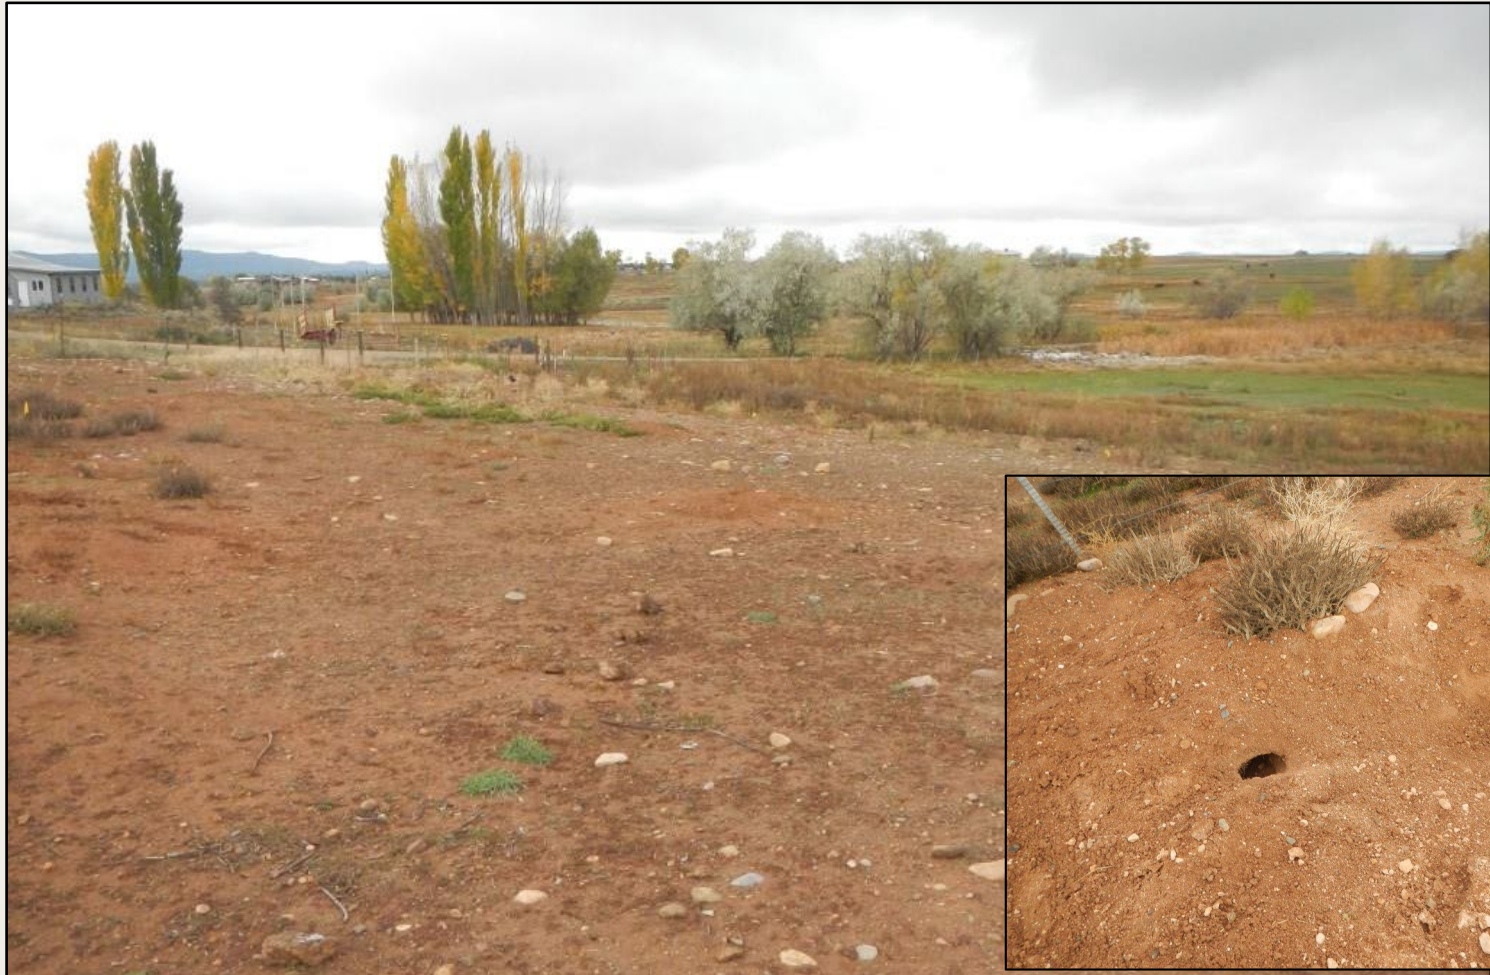
Photo 3. View of area along the right of way where little desirable vegetation is present. Inset shows rodent holes in bare soils.

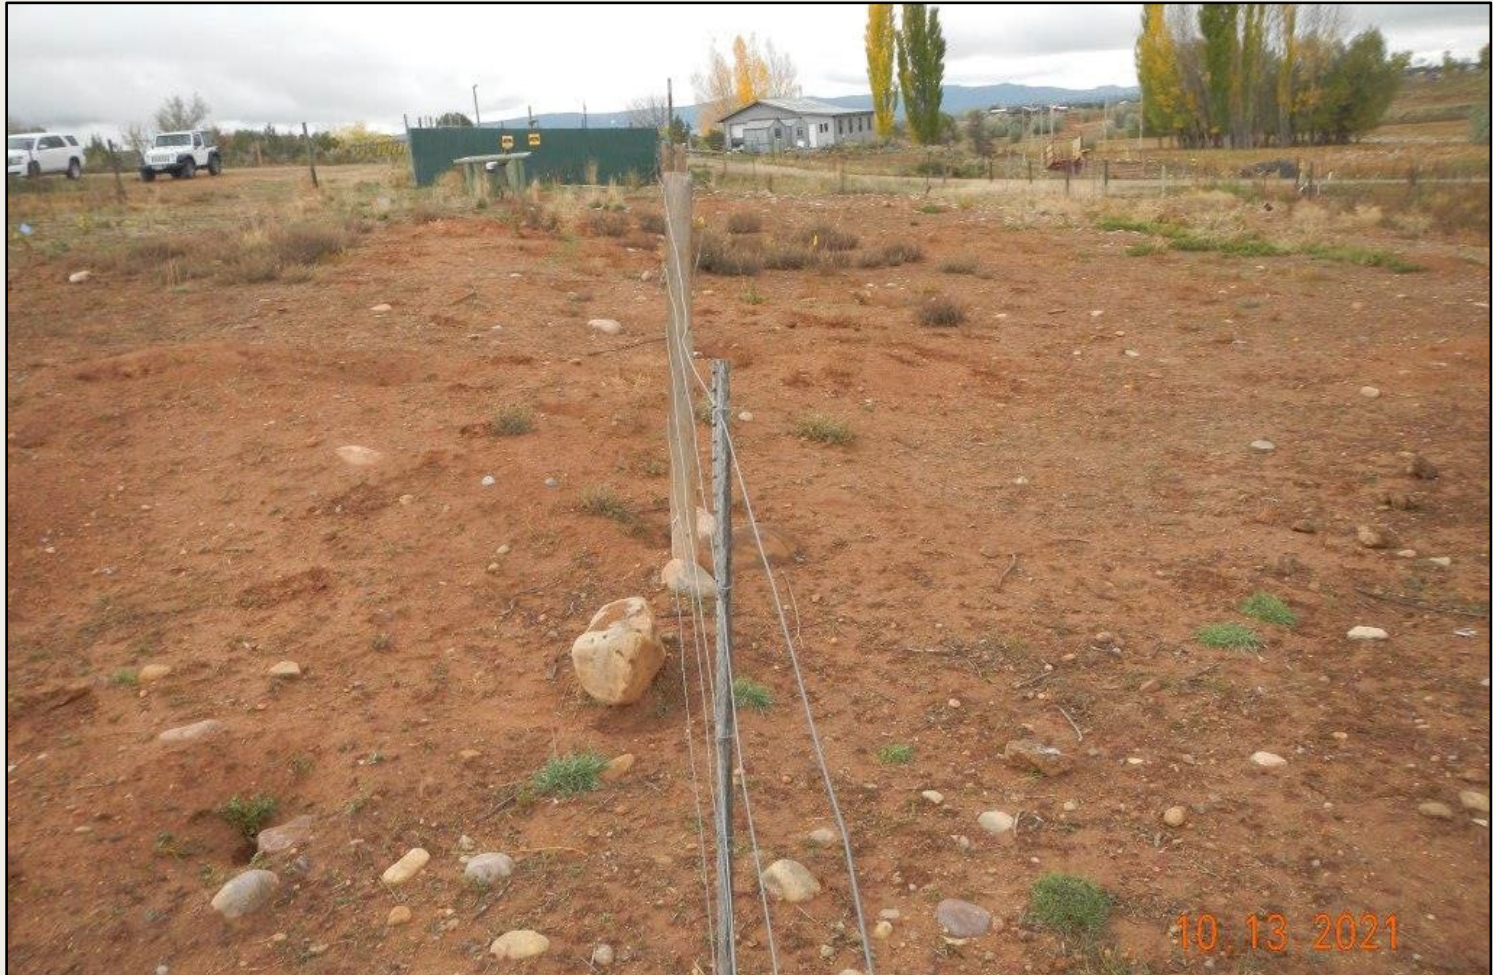
Photo 4. Another view of bare soils along the right of way, needing revegetation.

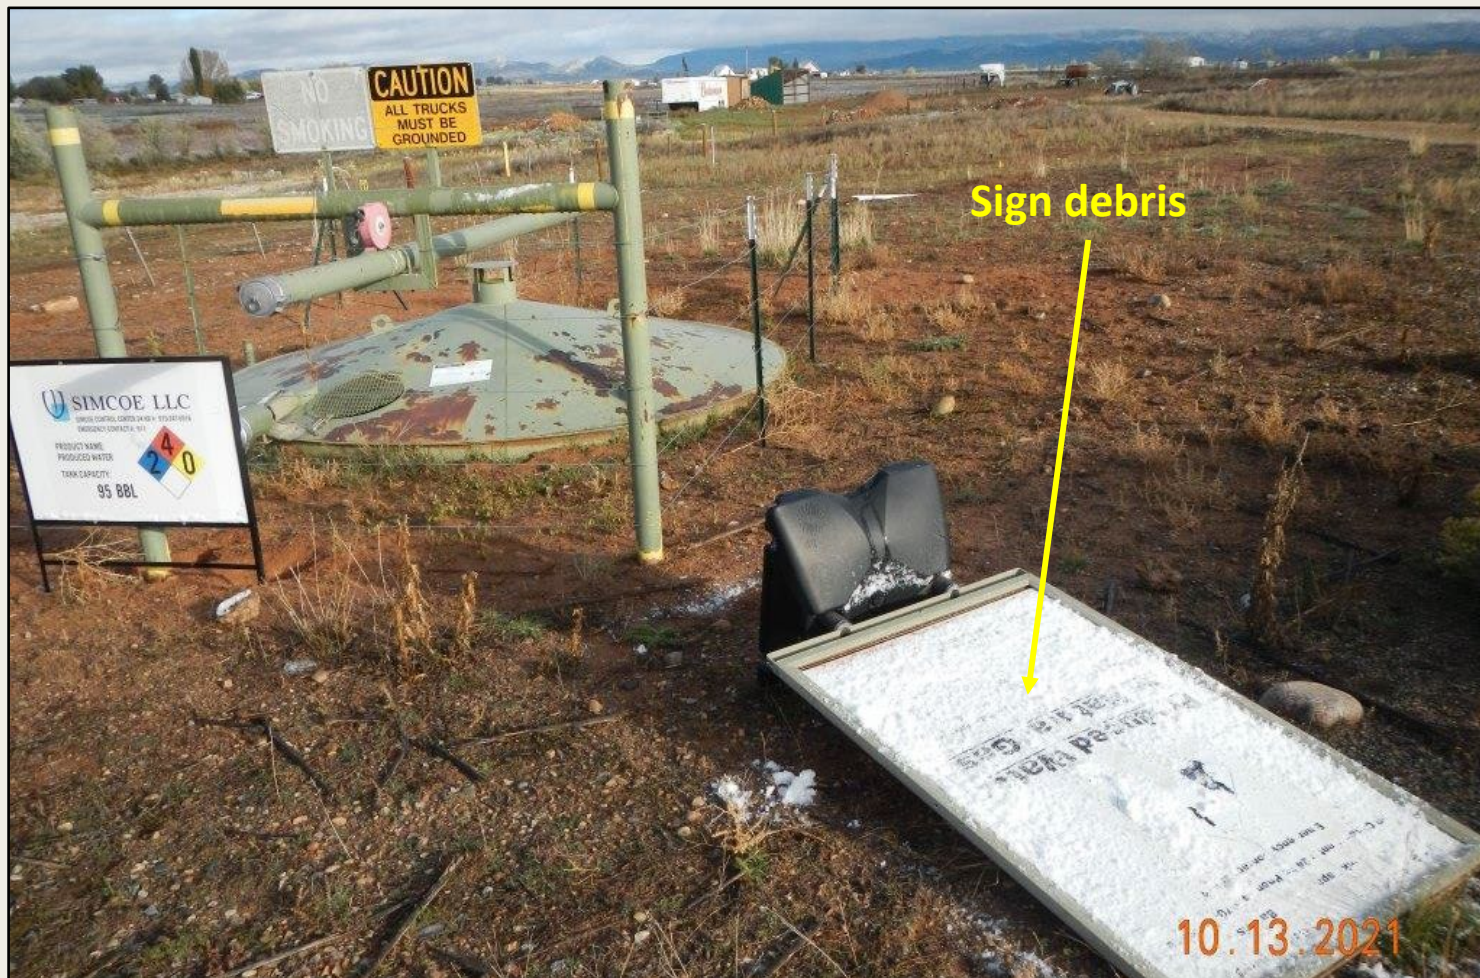
Photo 5. View of sign debris within the project area, needs to be removed.
