Inspection Photos
Operator: Simcoe
API: 067-08852
Date: 11/17/2021

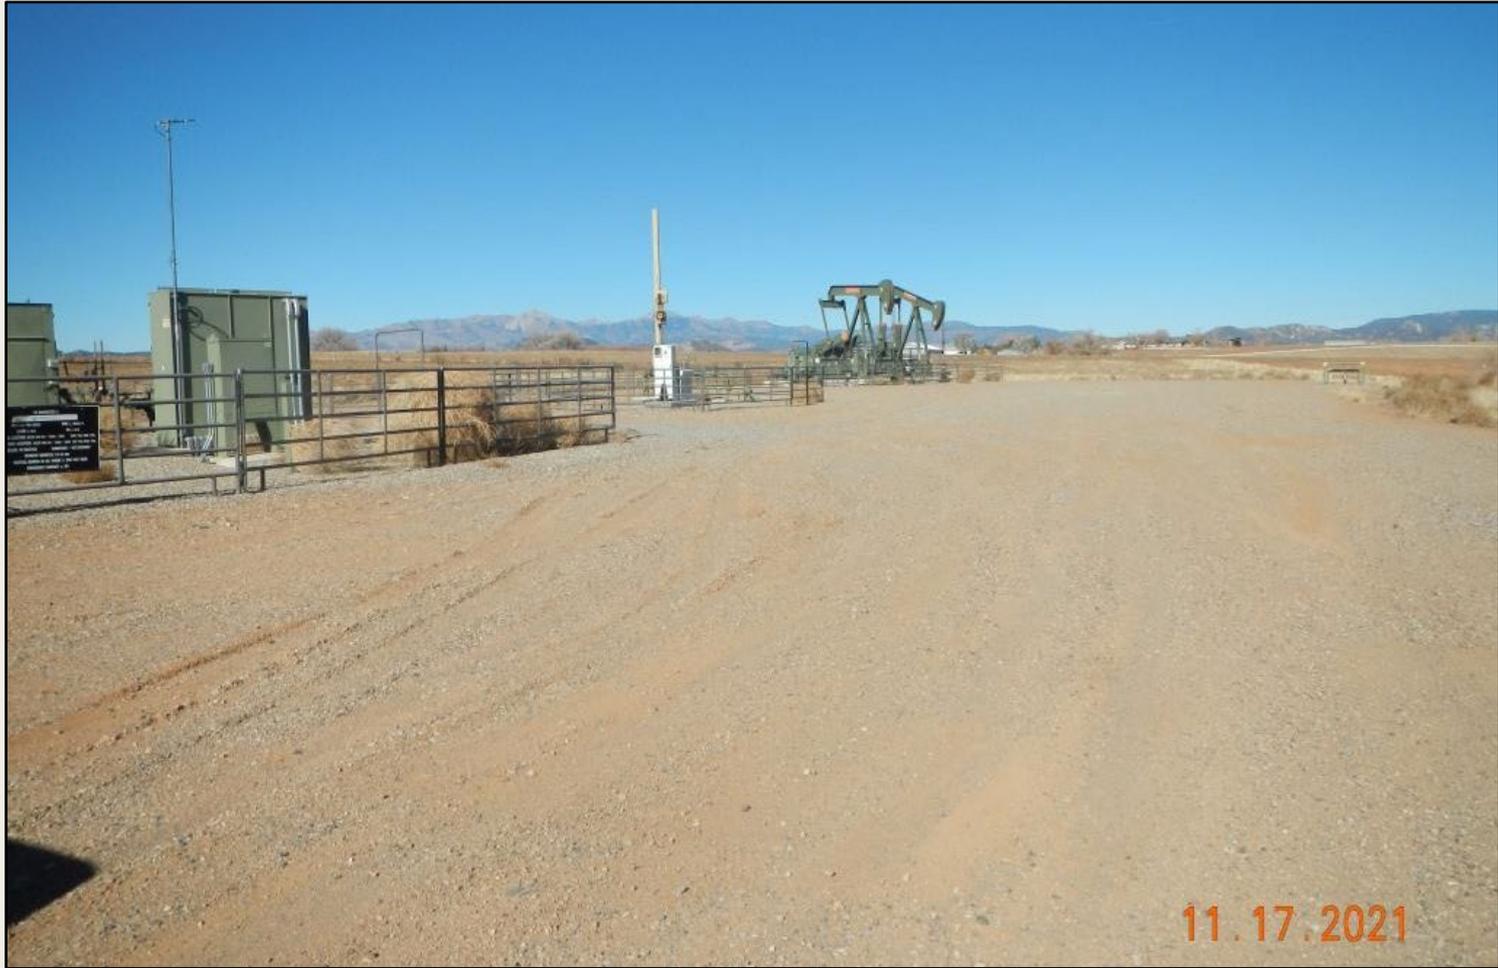
Photo 1. View of the project area from the well pad entrance facing center.

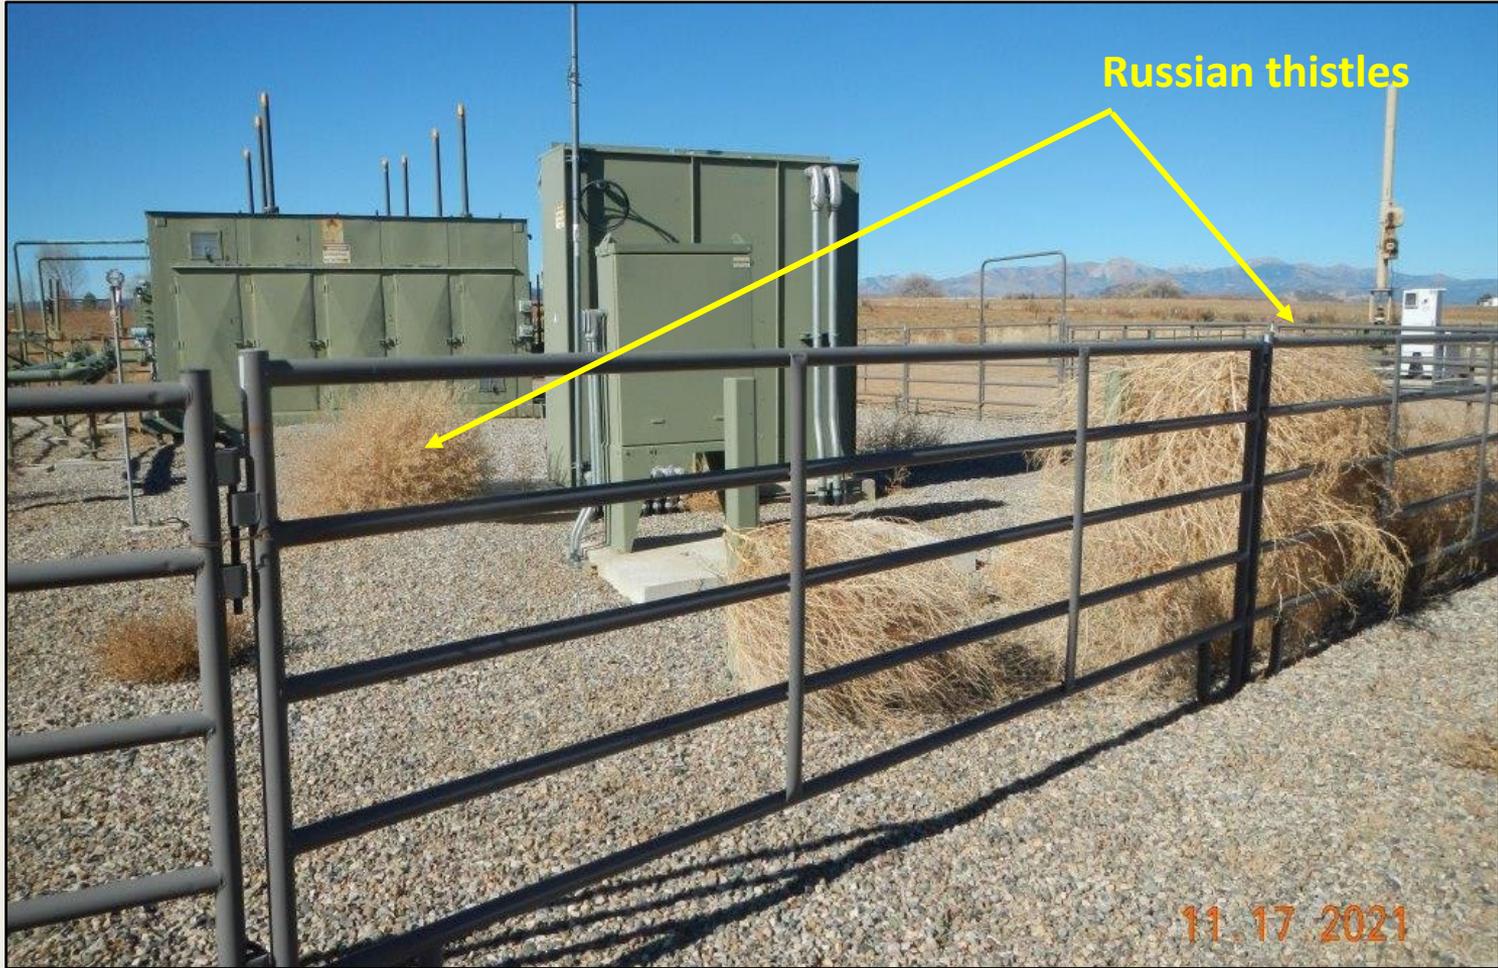
Photo 2. View of Russian thistle debris around facilities, needs to be removed.

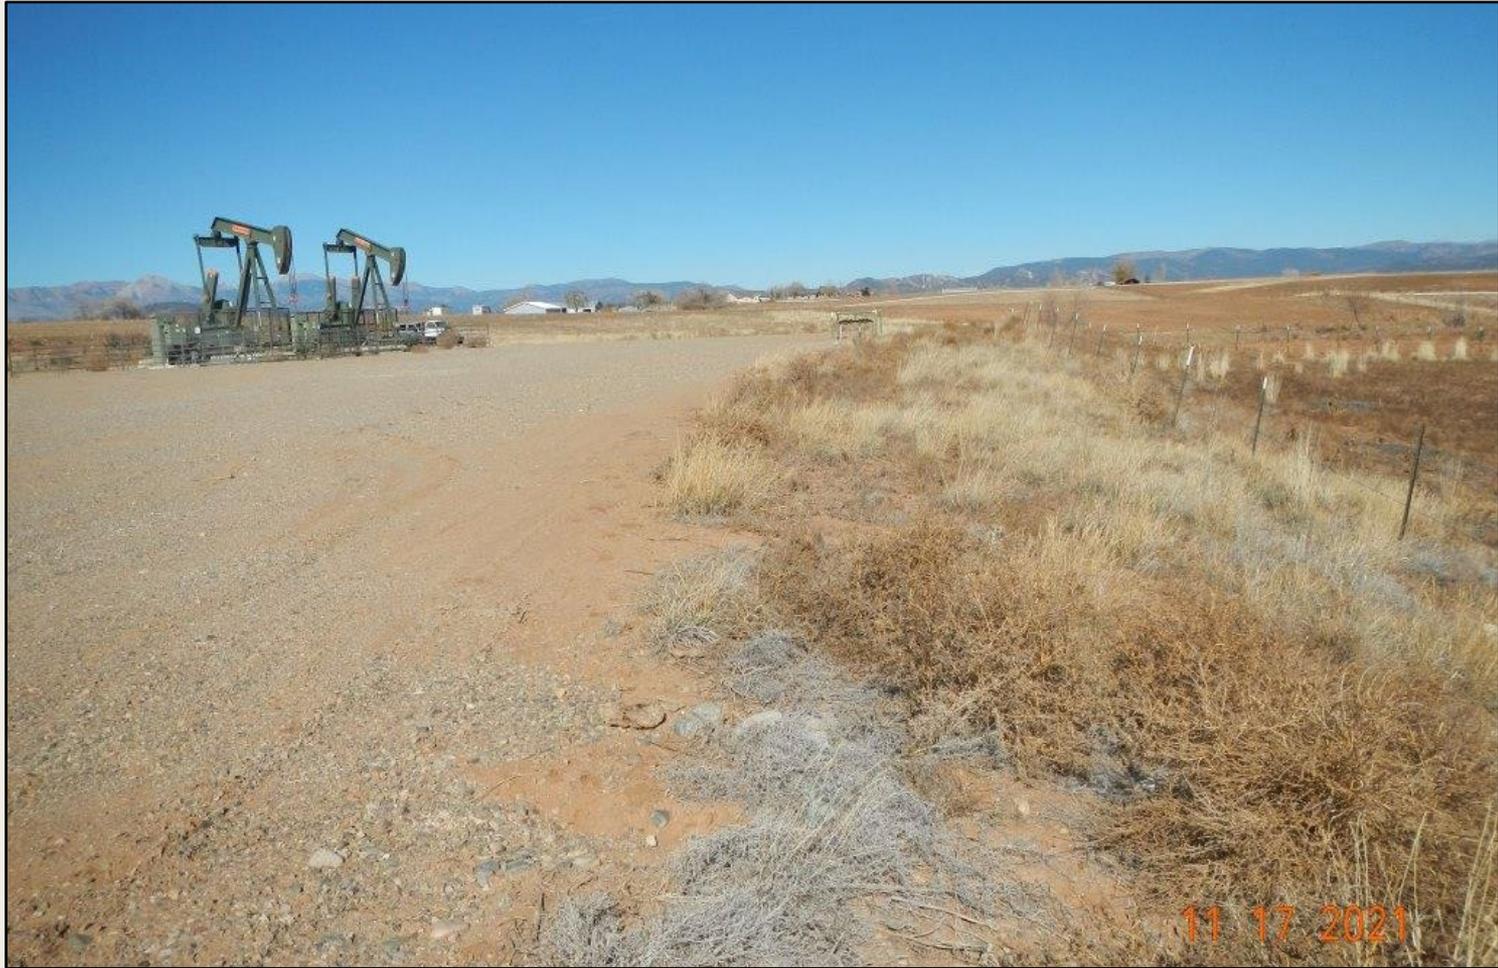
Photo 3. View of the eastern project area from the southeastern corner facing northward. Revegetation is progressing in portions with western wheatgrass, sand dropseed, and crested wheatgrass.

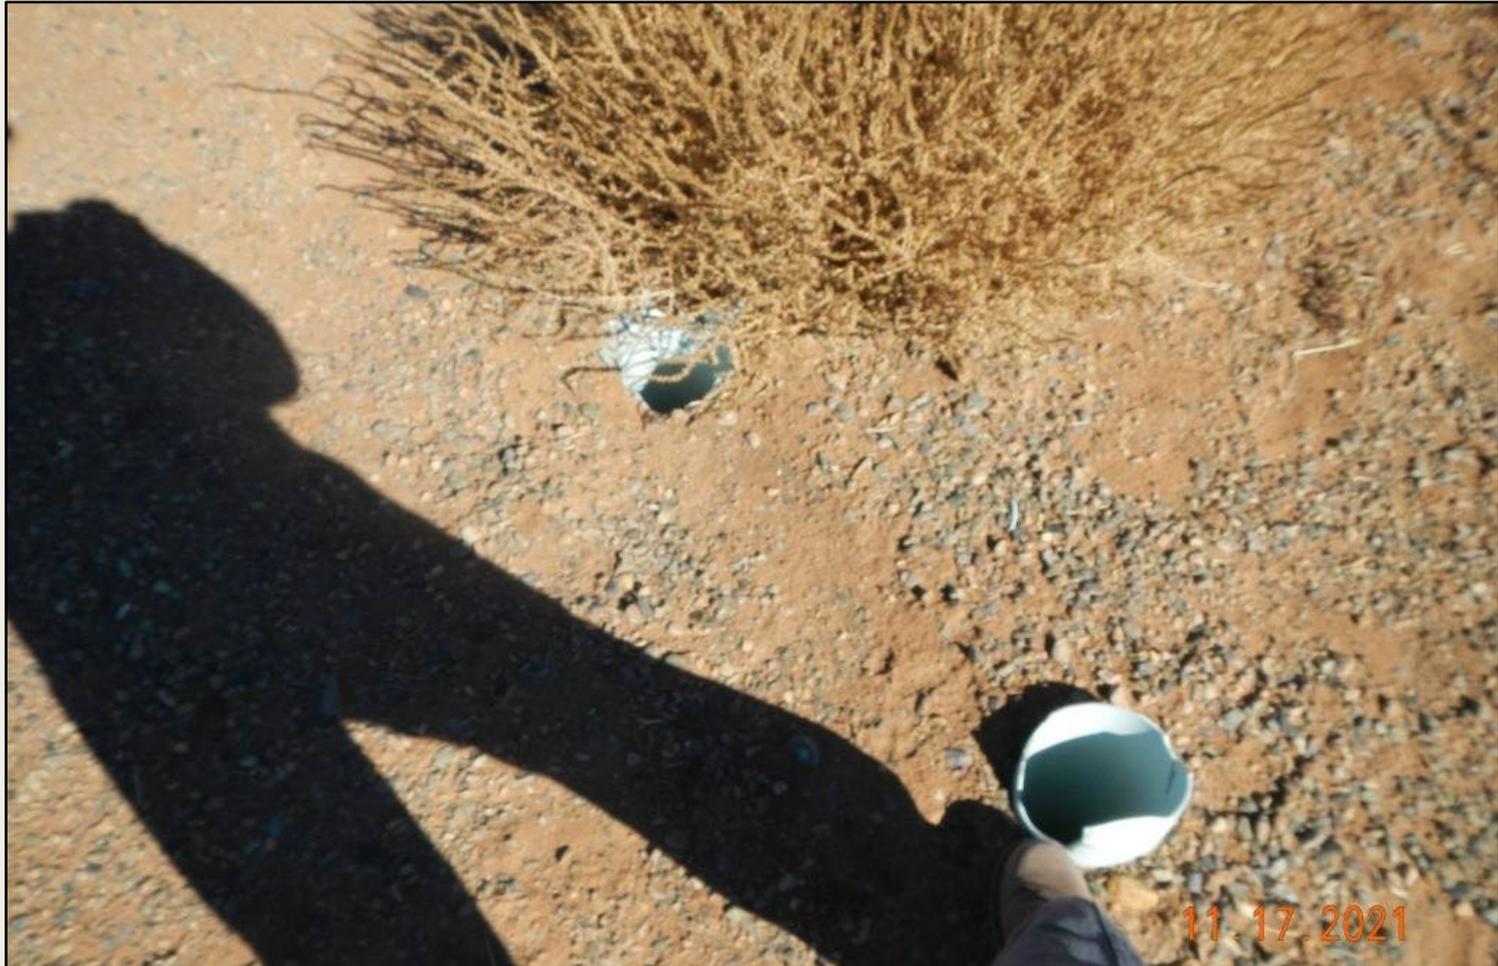
Photo 4. View of open pipes within the eastern project area, need to be filled/covered.

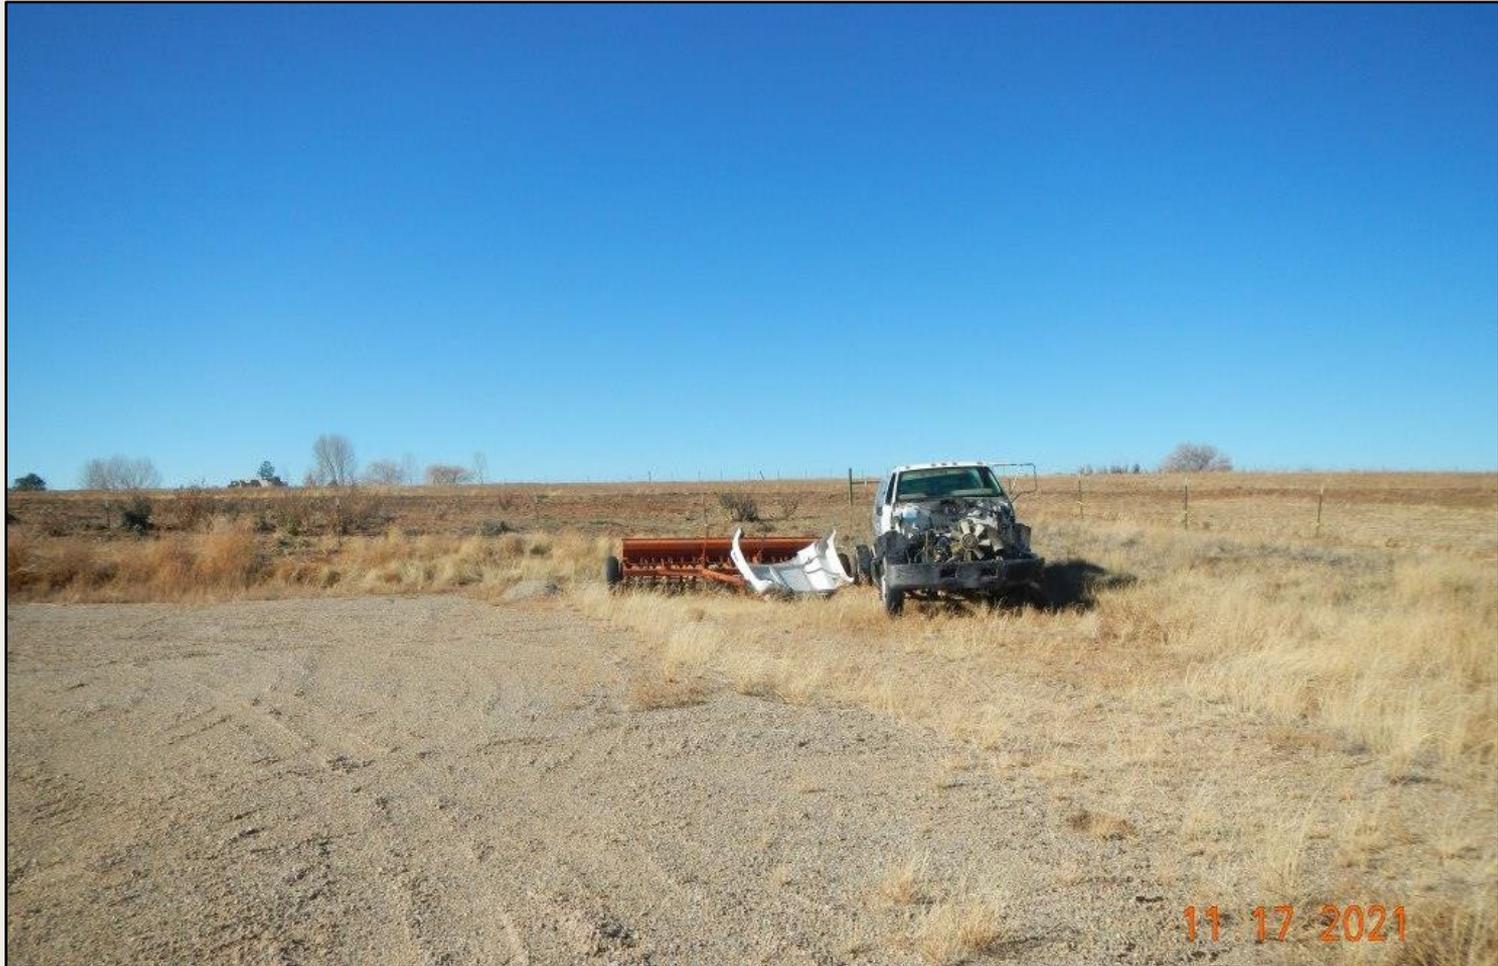
Photo 5. View of what appears to be landowner equipment and debris stored within the northwestern corner of the well pad.

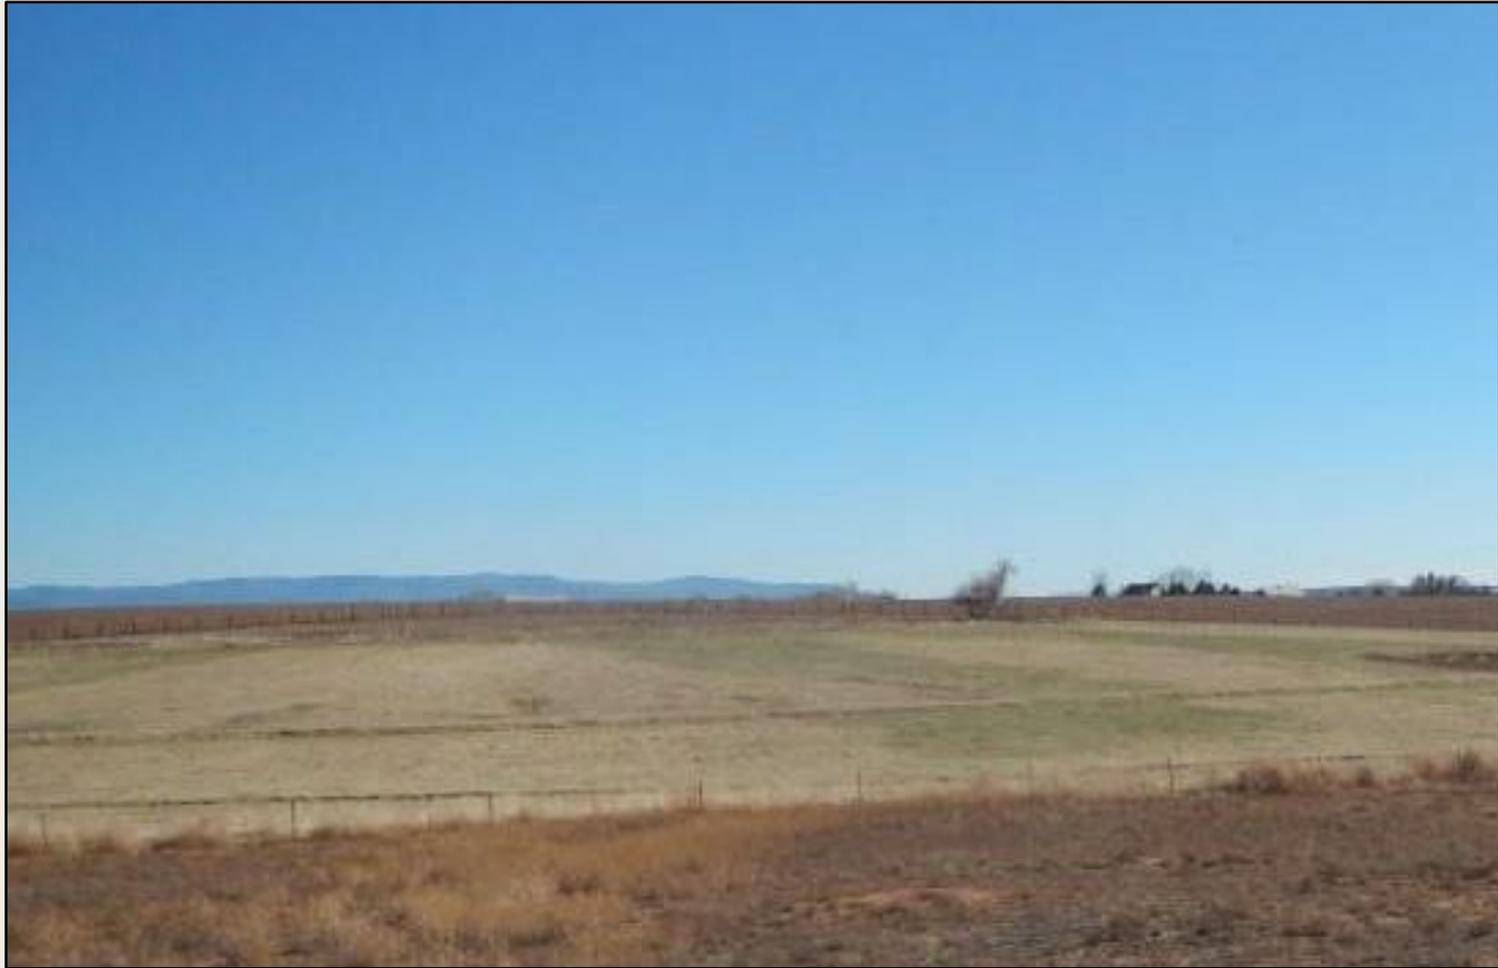
Photo 6. View of reference area comprised of irrigated grass and alfalfa field, as well as non-irrigated field, largely fallow at this time.
