FREMONT ENVIRONMENTAL INC.

Subject: **Flow Line Closure Submittal**
 Heinze 31-44 Flow Line
 API # 05-123-24929
 SESE Sec 31, T7N, R63W
 Weld County, Colorado
 Facility #465757, Remediation #16818
 Fremont Project No. C021-016

Flowline Closure Checklist

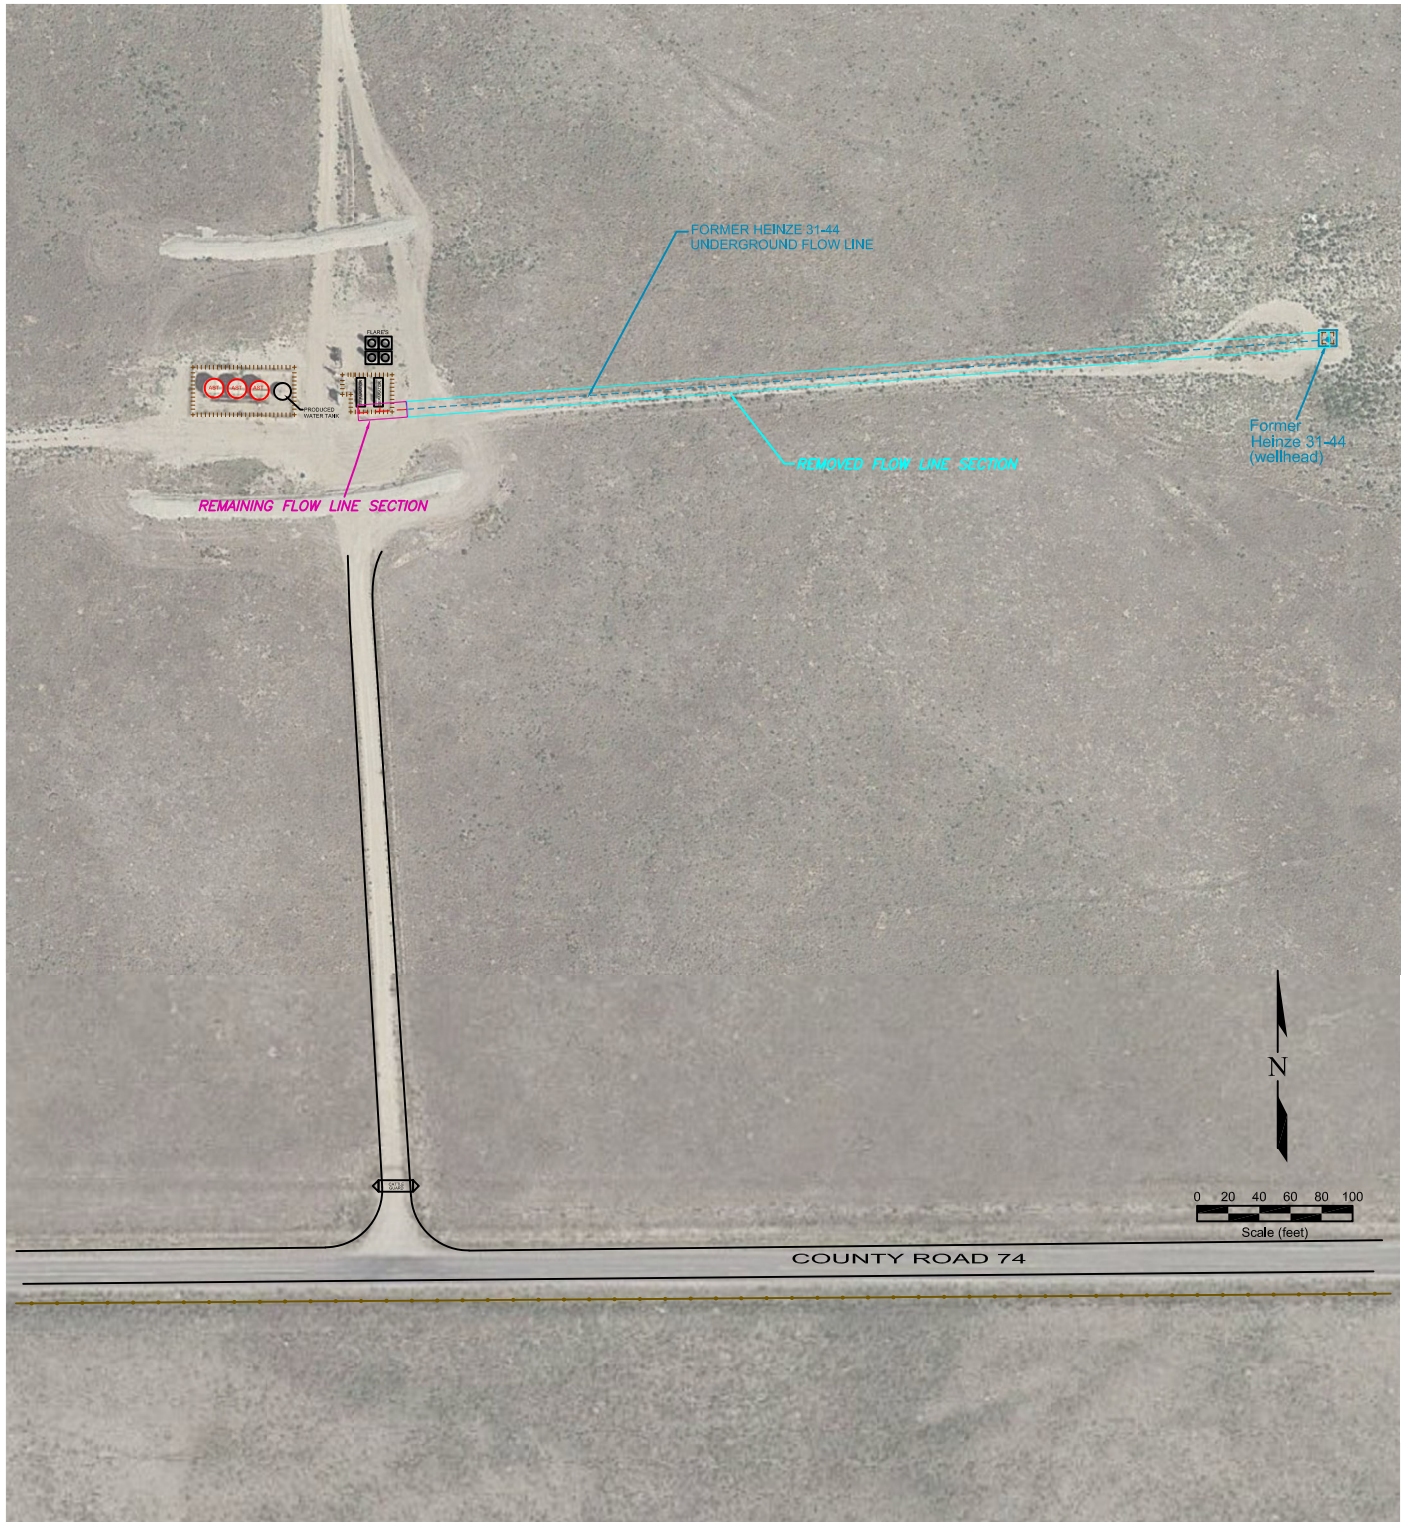
Figure 2
FLOW LINE REMOVAL

Due to the proximity to operating facilities at the production site. A short section of the flow line was left in place beneath the existing separator and associated facility lines. That section will be removed during facility closure activities at a later date. Approximately 65 feet of flow line remains in the subsurface beneath.

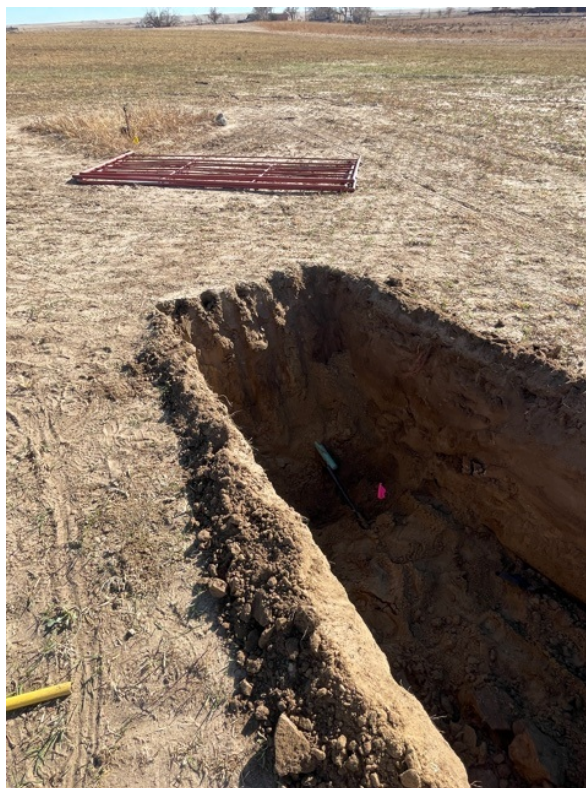
E1- Facing southeast PID-0.0

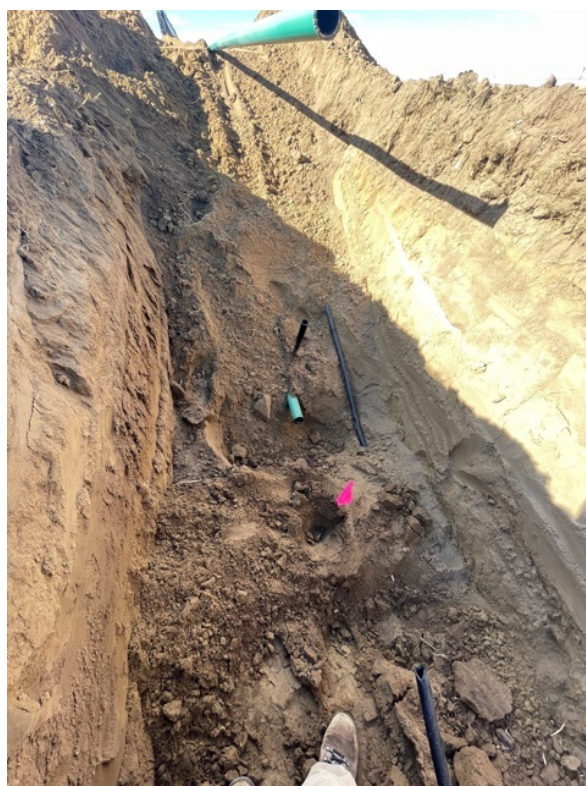
E2 – Facing west PID 0.0

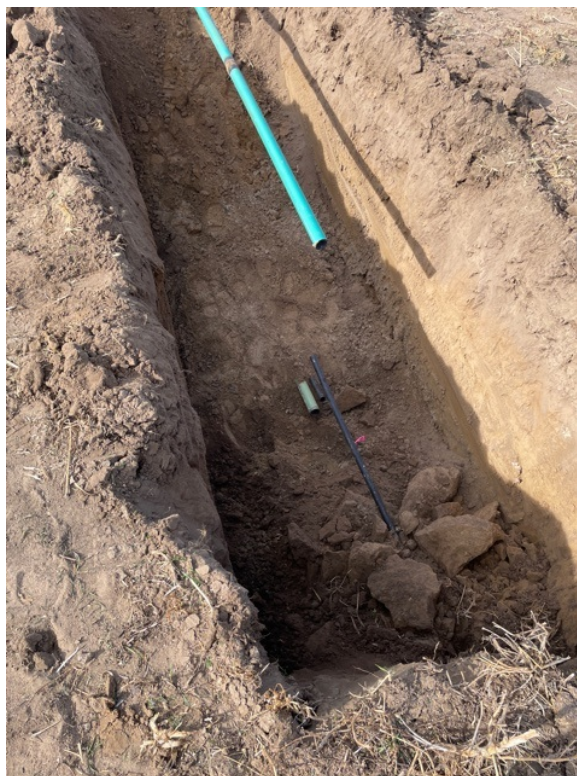
E-3 -Facing northwest- PID-0.0

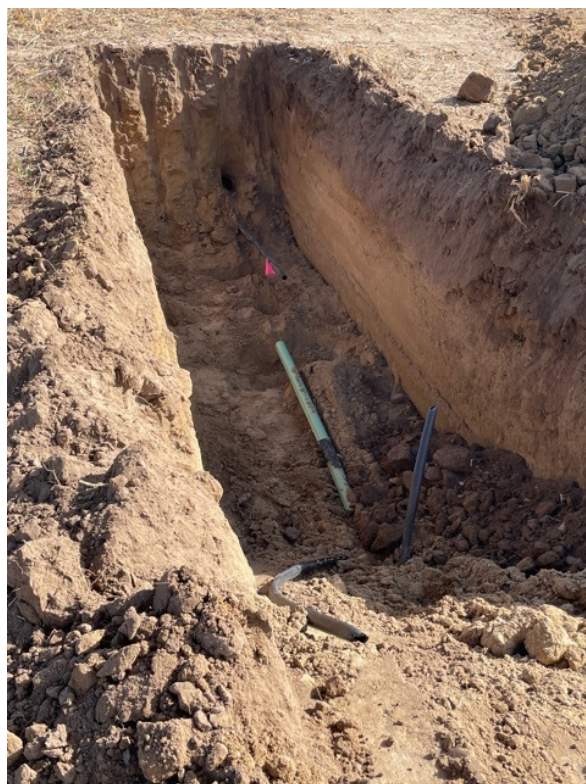
E-4 – Facing Southeast PID-0.0

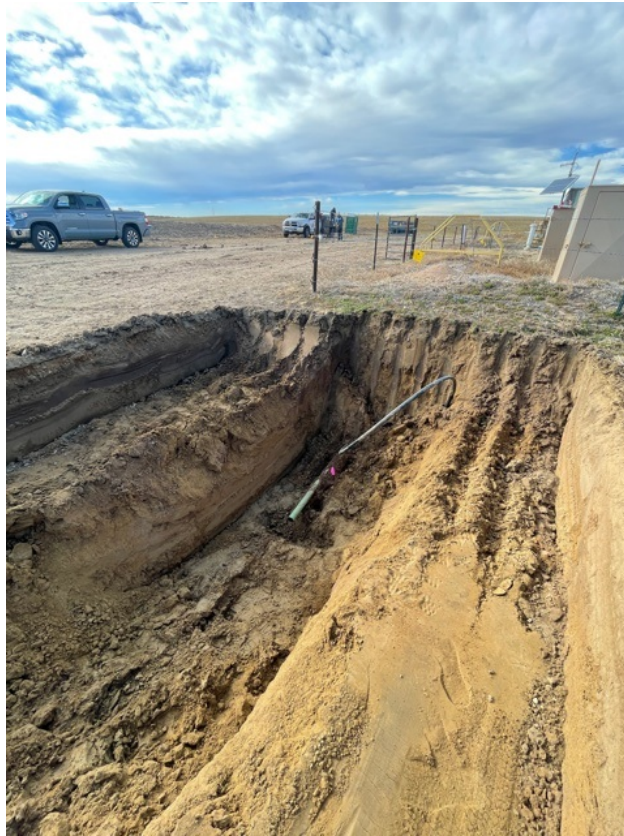
| Other observations regarding on location flowlines: Segment of the flow line left in place. Section could not be removed due to site constraints including: operating separator, dump and flow lines from adjacent facilities. GWOC to abandon remaining flow line at later date. Approximately 65' remain in subsurface. | | | | | | | | |

E-6 Facing southwest- PID 0.0 End of removed section. Portion remains in subsurface, capped at separator.
