Inspection Photos

API: 071-08046

Operator: EVERGREEN NATURAL RESOURCES

Inspection Date: 12/9/2021

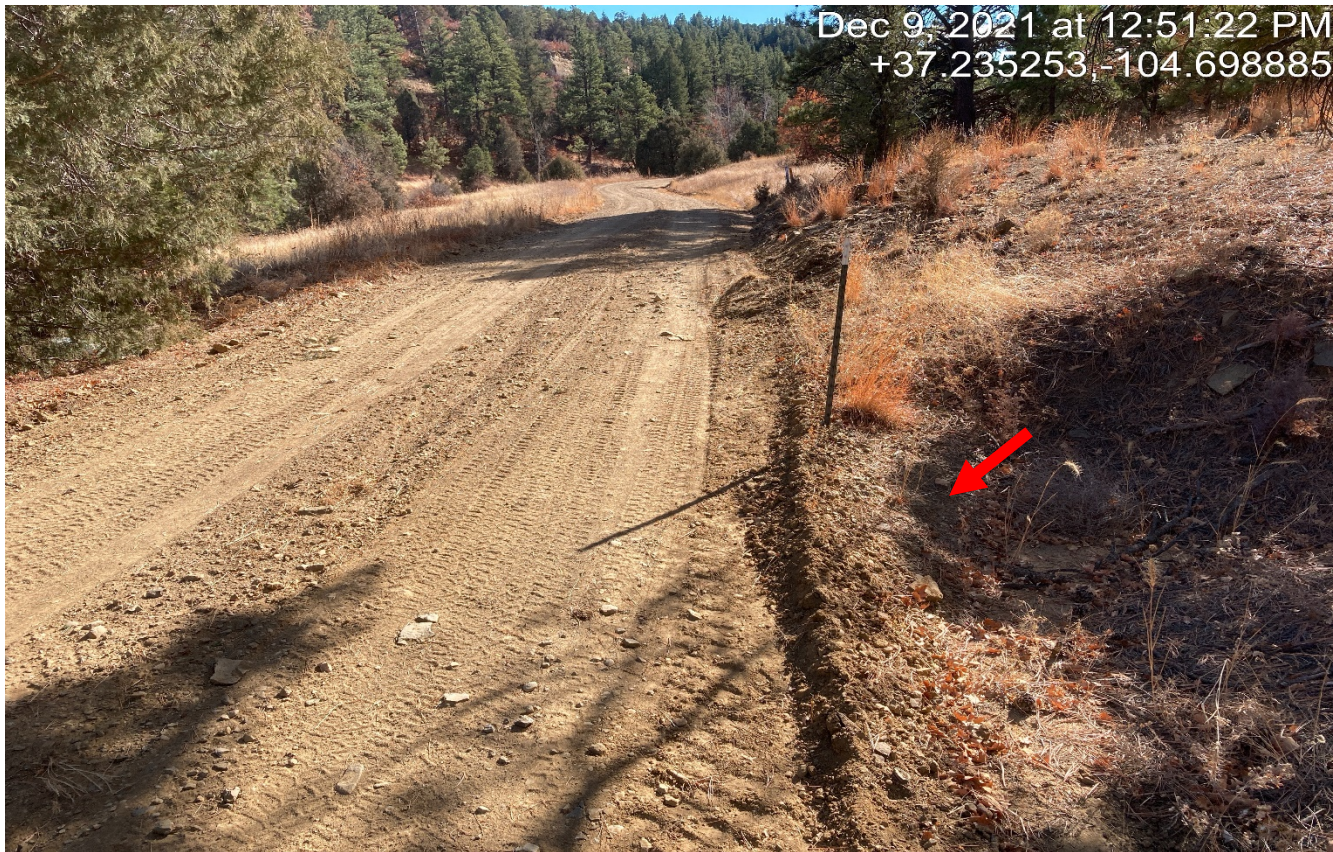
Photo 1. Facing southeast along the access road. The culvert along the road is filled in with sediment. Previous corrective action was not performed.

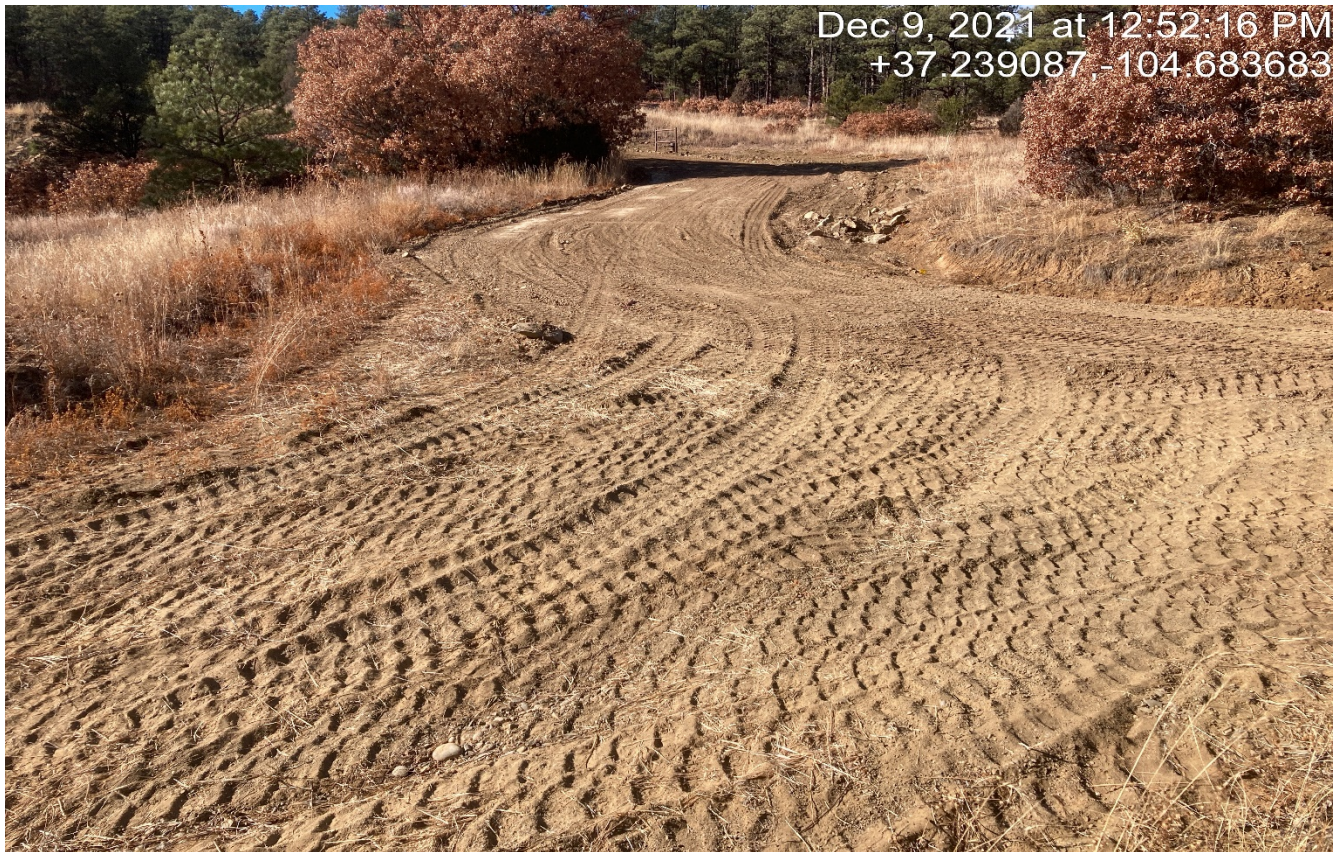
Photo 2. Facing west toward the access road near the location. The road was graded where vehicle rutting has occurred. There is disturbance shown in the bottom left of the photo that needs to be seeded and reclaimed.

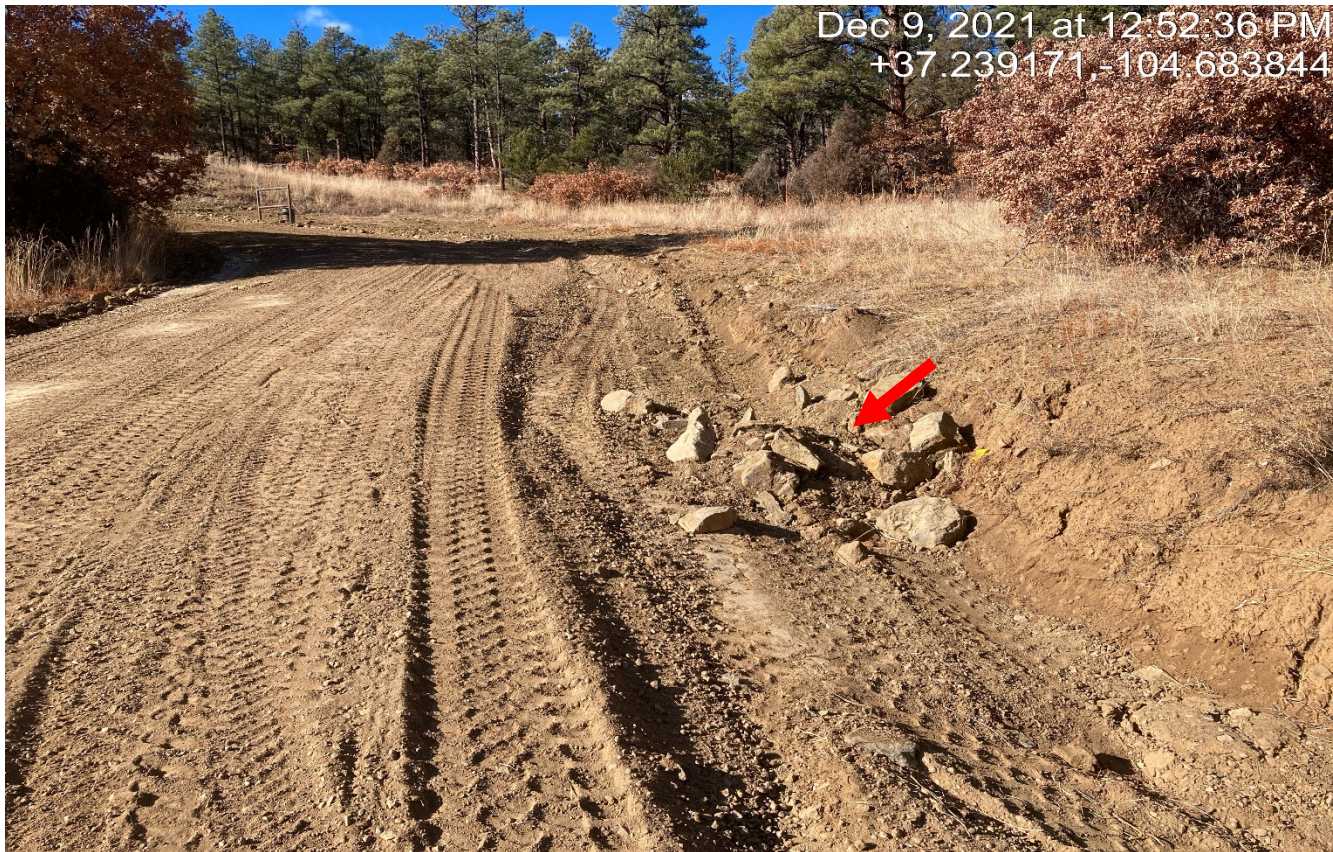
Photo 3. The rock check dam at red arrow is not properly installed. There is loose gravel that needs to be compacted.

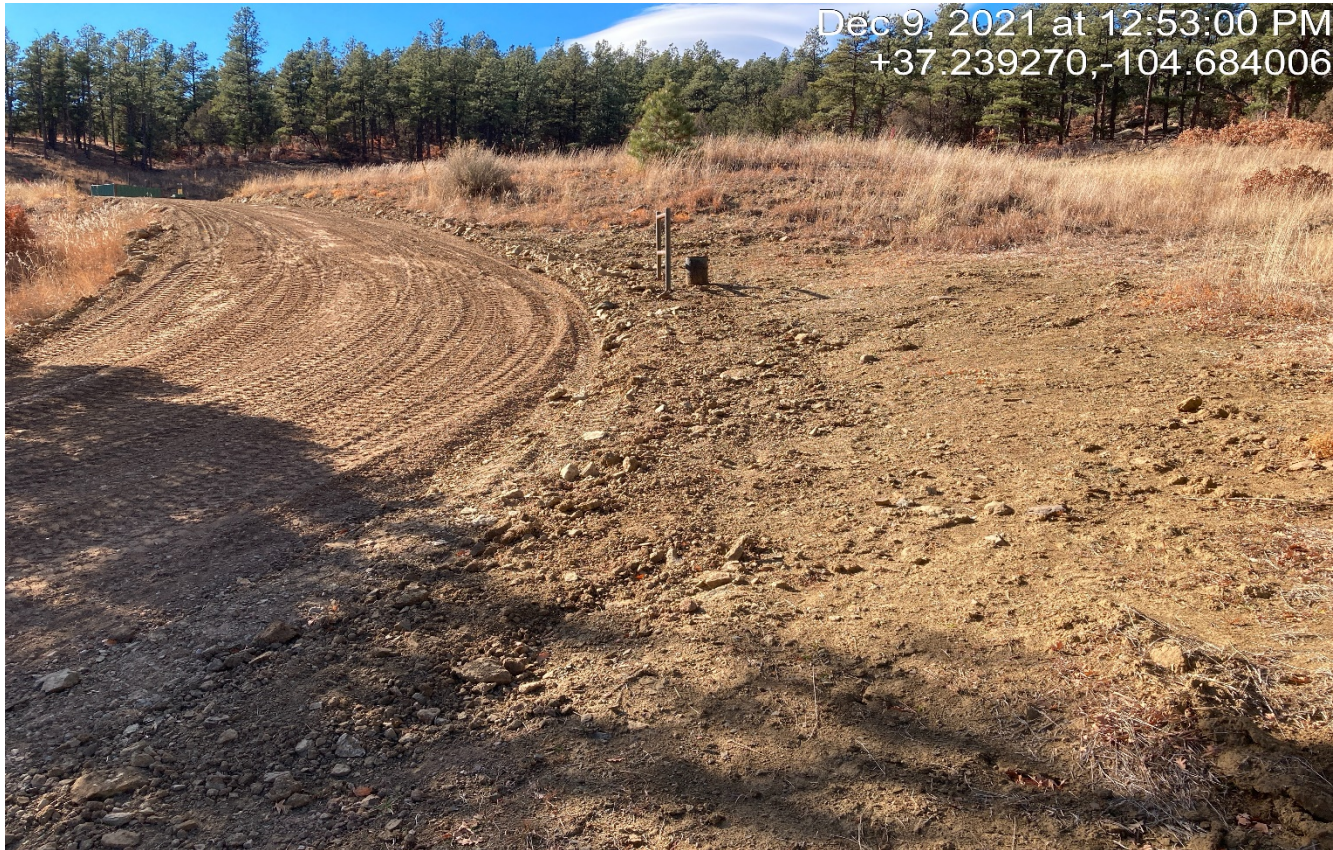
Photo 4. Facing west along the access road at the location. There was disturbance that has occurred in this area which needs to be reclaimed.

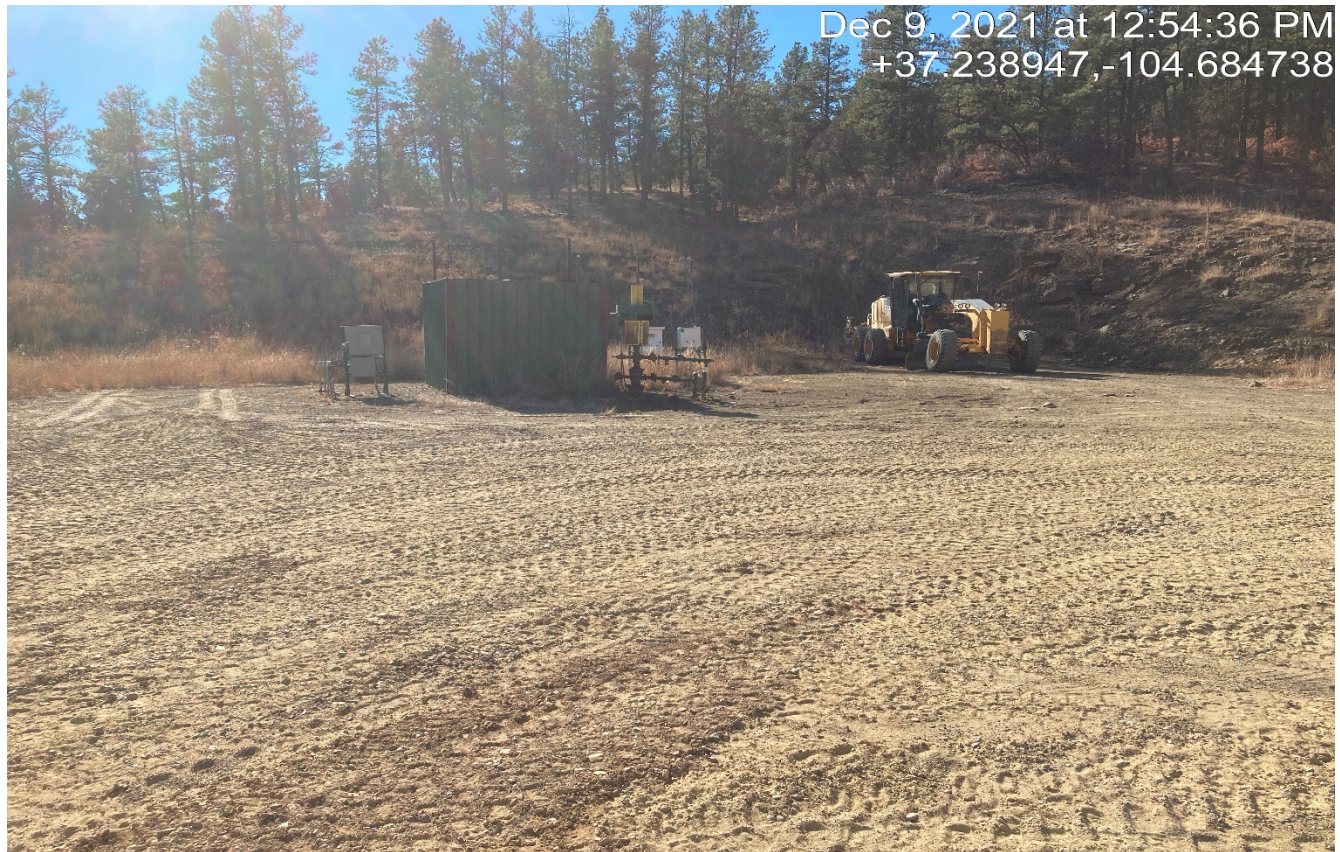
Photo 5. Facing southwest toward the well site.
