Inspection Photos

Loc ID: 334229

Operator: EVERGREEN NATURAL RESOURCES

Inspection Date: 12/9/2021

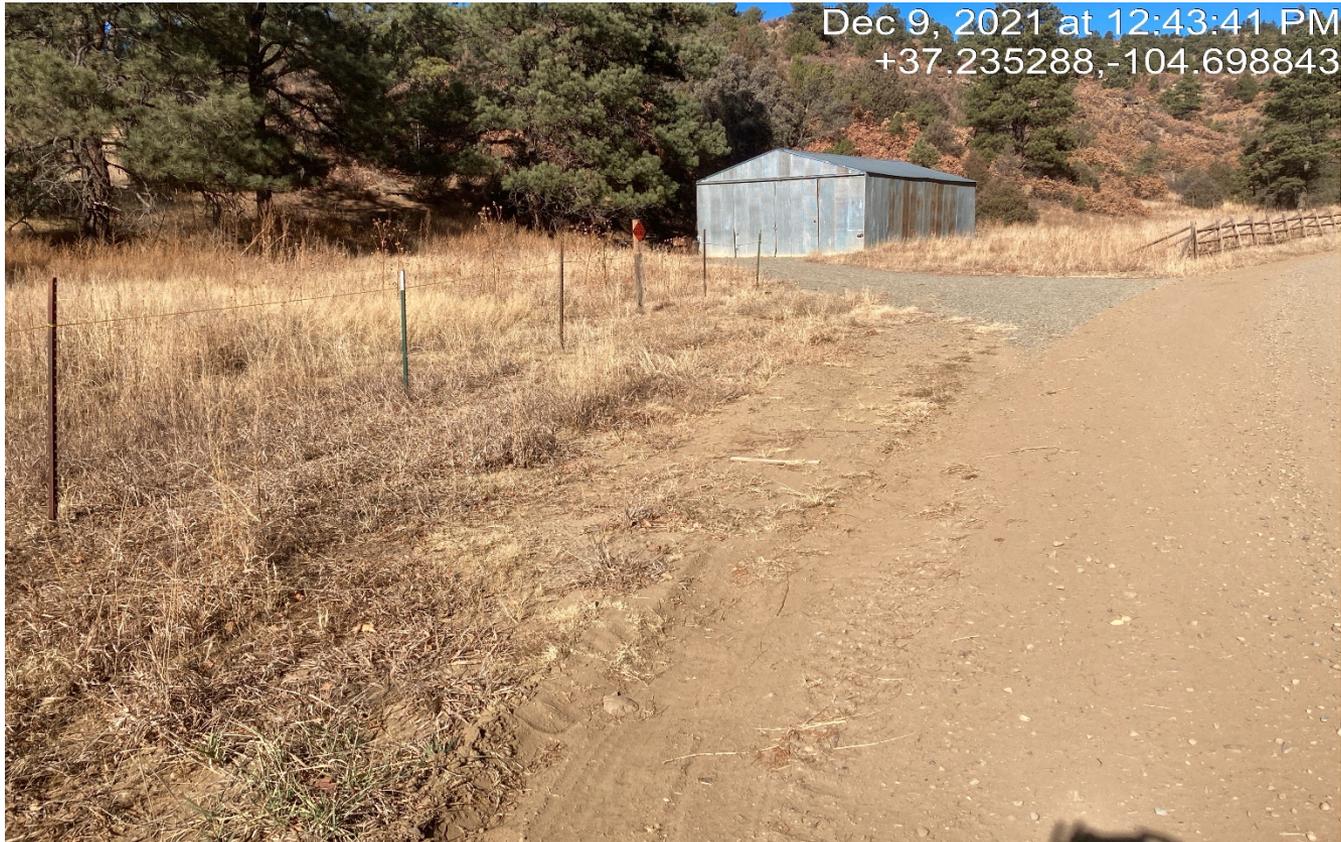
Photo 1. There is a metal building along the access road where oil and gas vehicles parked off the designated road way blocking this building. This area has not been restricted to prevent access.

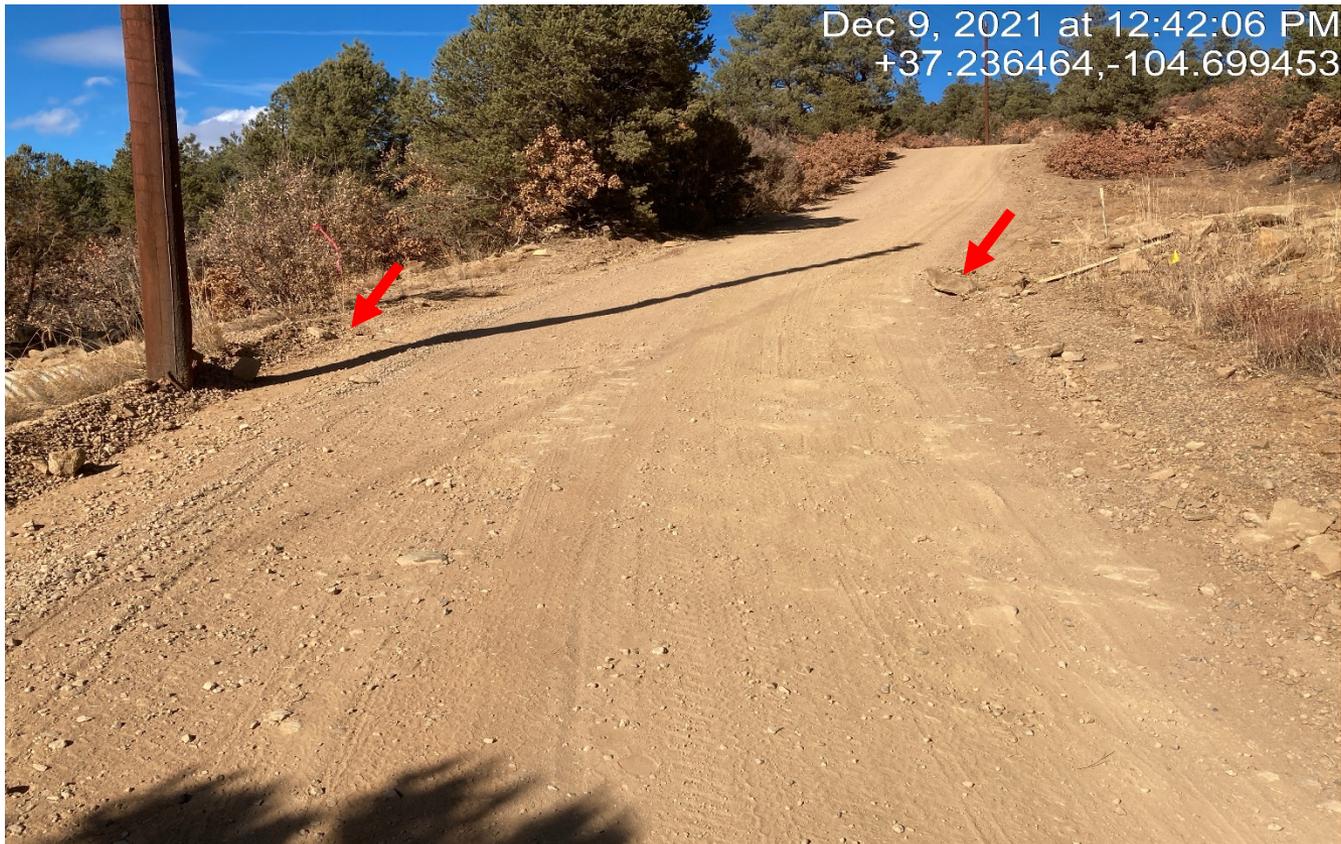
Photo 2. The access road has been regraded however there are steep areas with insufficient gravel and stabilization. The red arrow points to a culvert that was damaged from grading. Lat/Long:37.23640,-104.69944. There is also a rock piled up on the road.

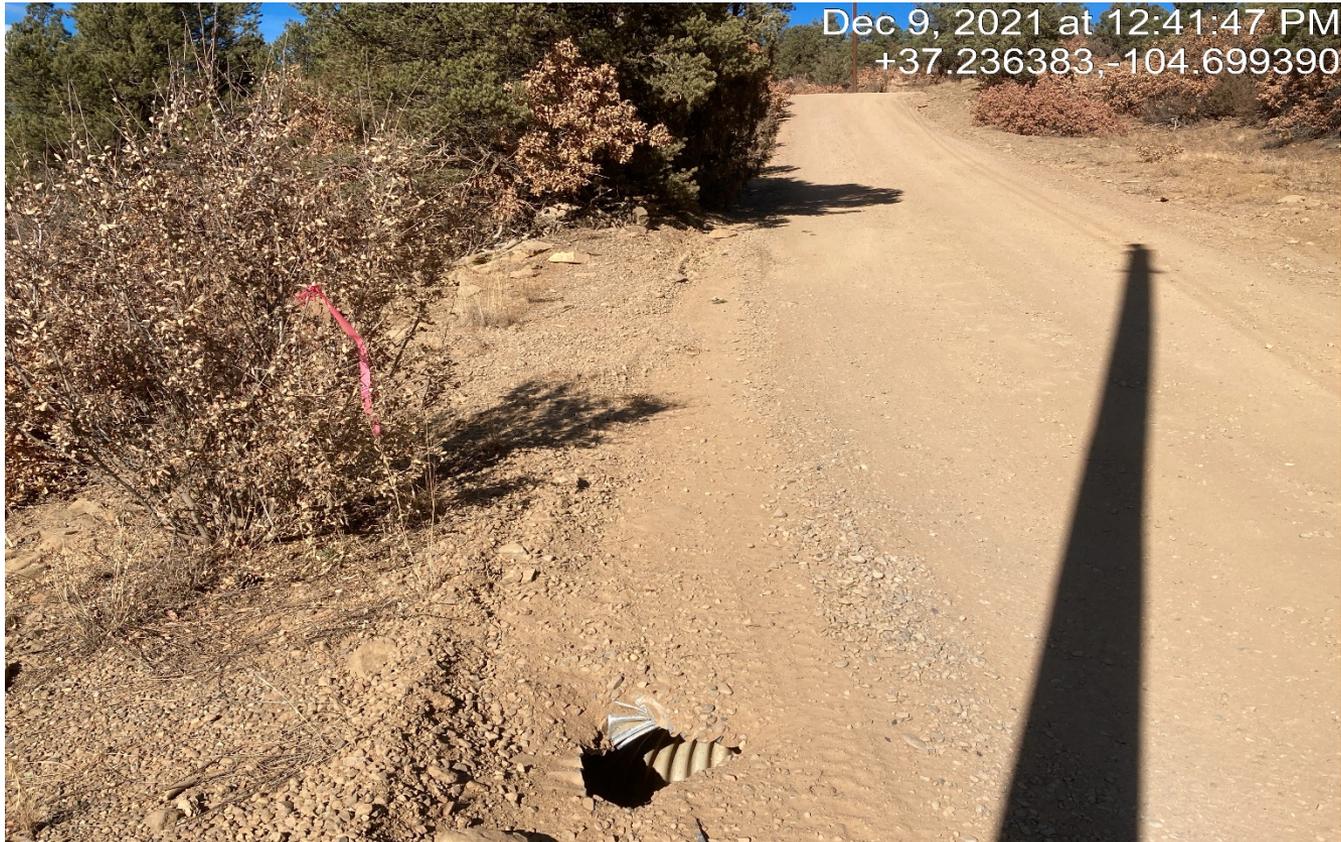
Photo 3. The culvert was damaged which can puncture a tire. This needs to be repaired. There is sand and gravel filling into the opening of the culvert.

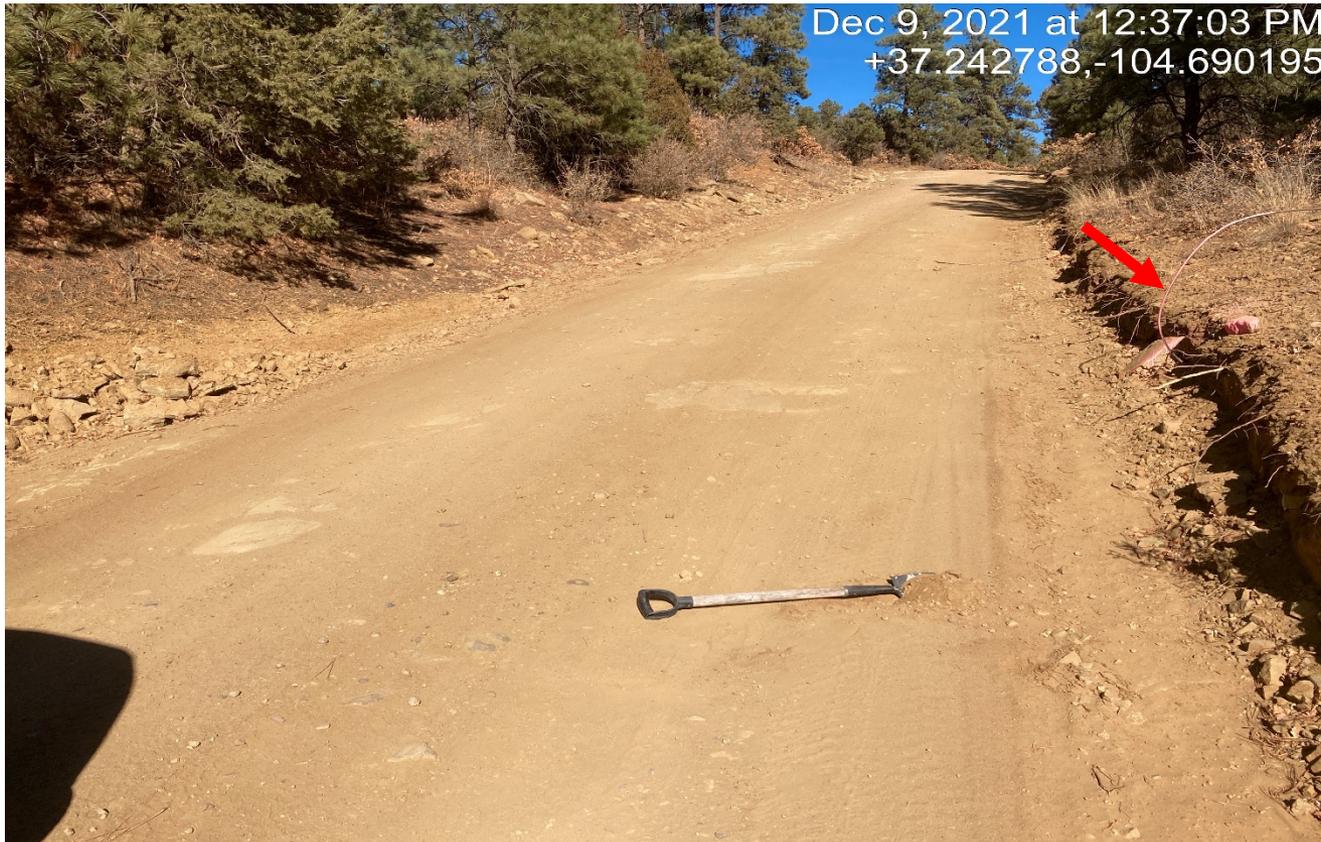
Photo 4. This steep area of the road was regraded however there is now loose soils shown by shovel. This area needs to be stabilized (e.g. gravel, road base). There is also an exposed wire at red arrow.
