Inspection Photos

Location Name: Terri 14-4

Location ID: 320096

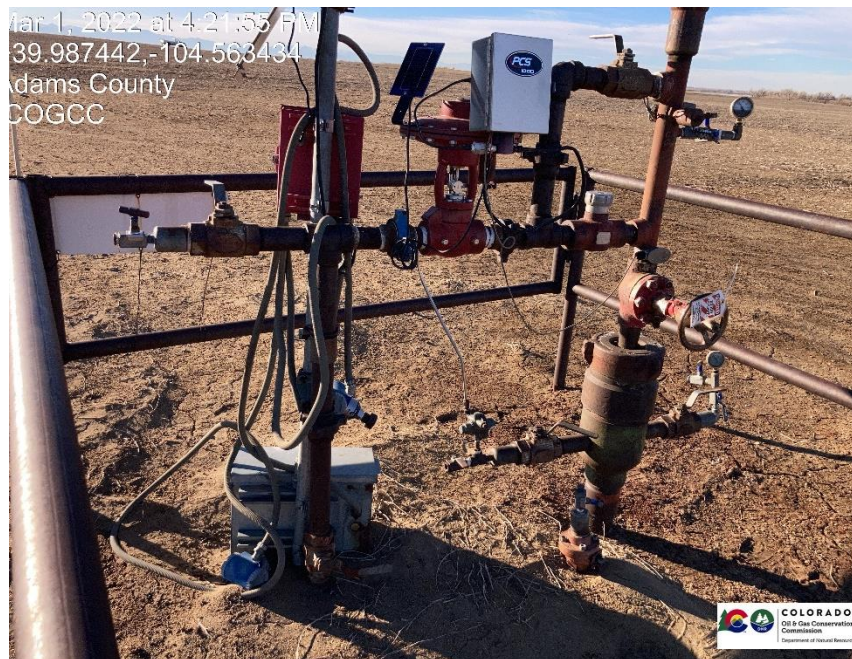
Pic 1 Flowline valves, and master valve were in the open position at time of inspection. Valves were put in close position, and LOTO installed on master valve. All P3 wells are in need of annual bradenhead test.

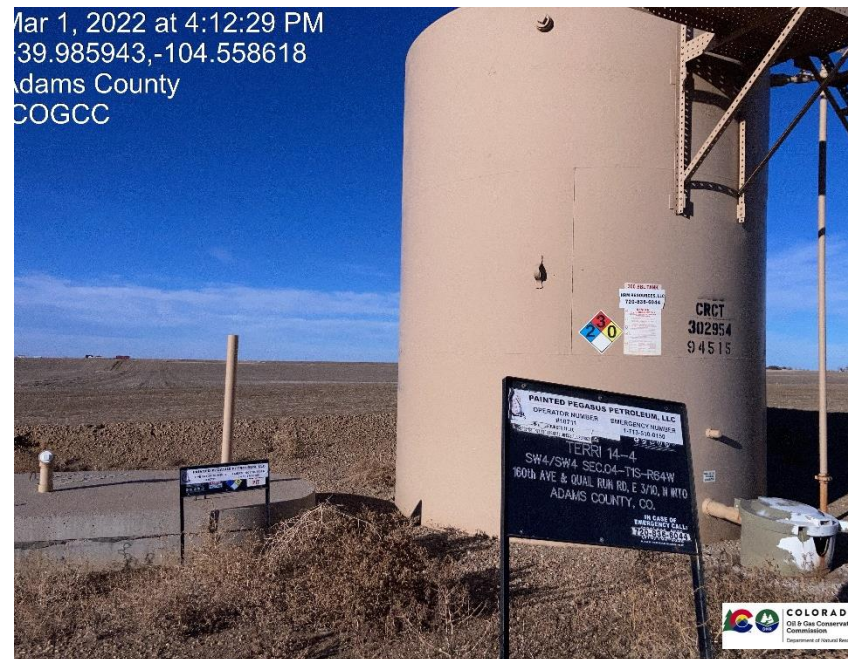
Pic 2 both tanks appear to have fluid inside.

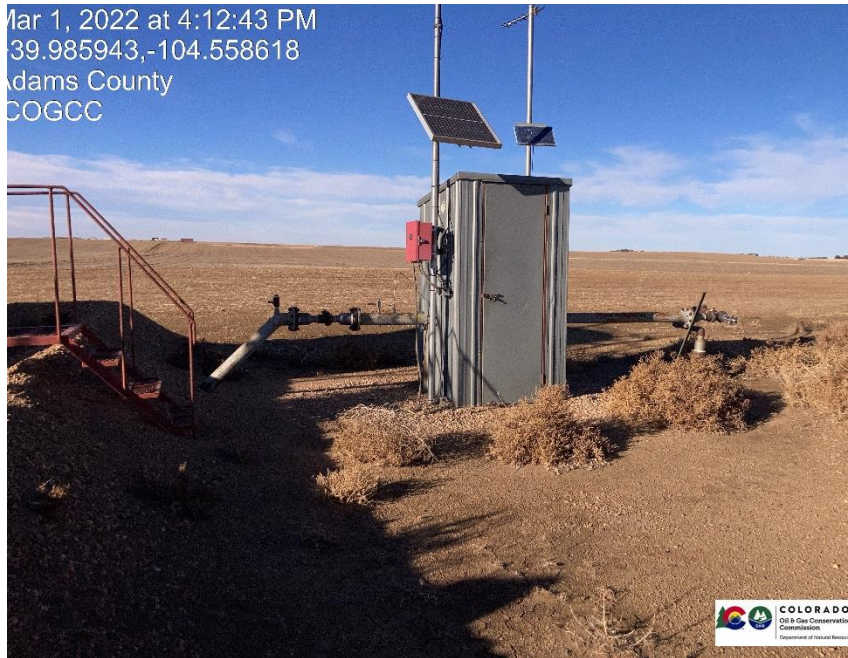
Pic 3 gas meter run

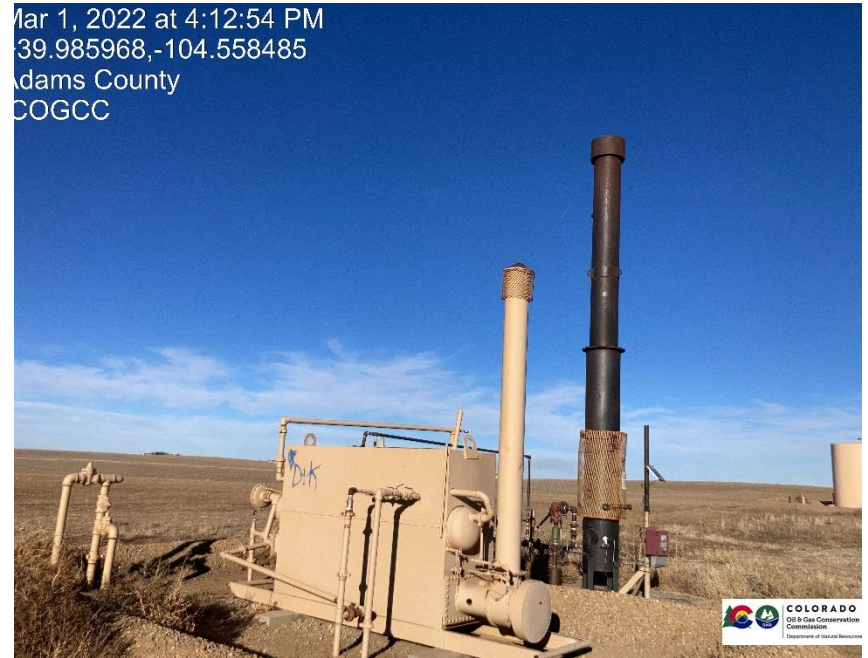
Pic 4 separator, ECD.
