Inspection Photos
Operator: Morningstar Operating
API: 007-06200
Date: 2/28/2022

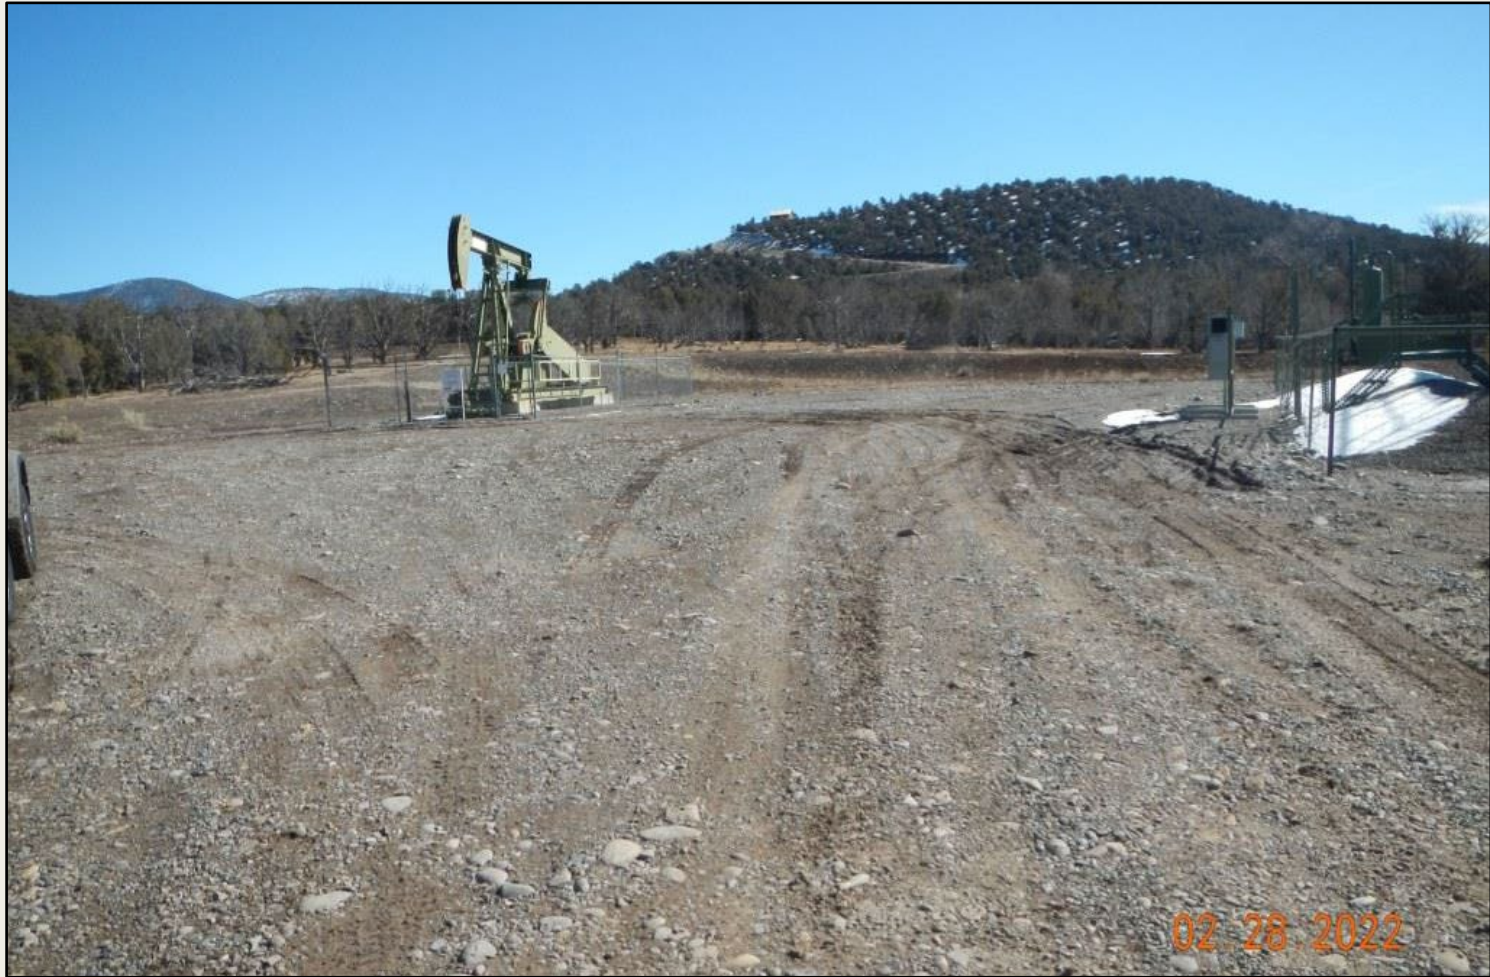
Photo 1. View of project area from the well pad entrance facing center.

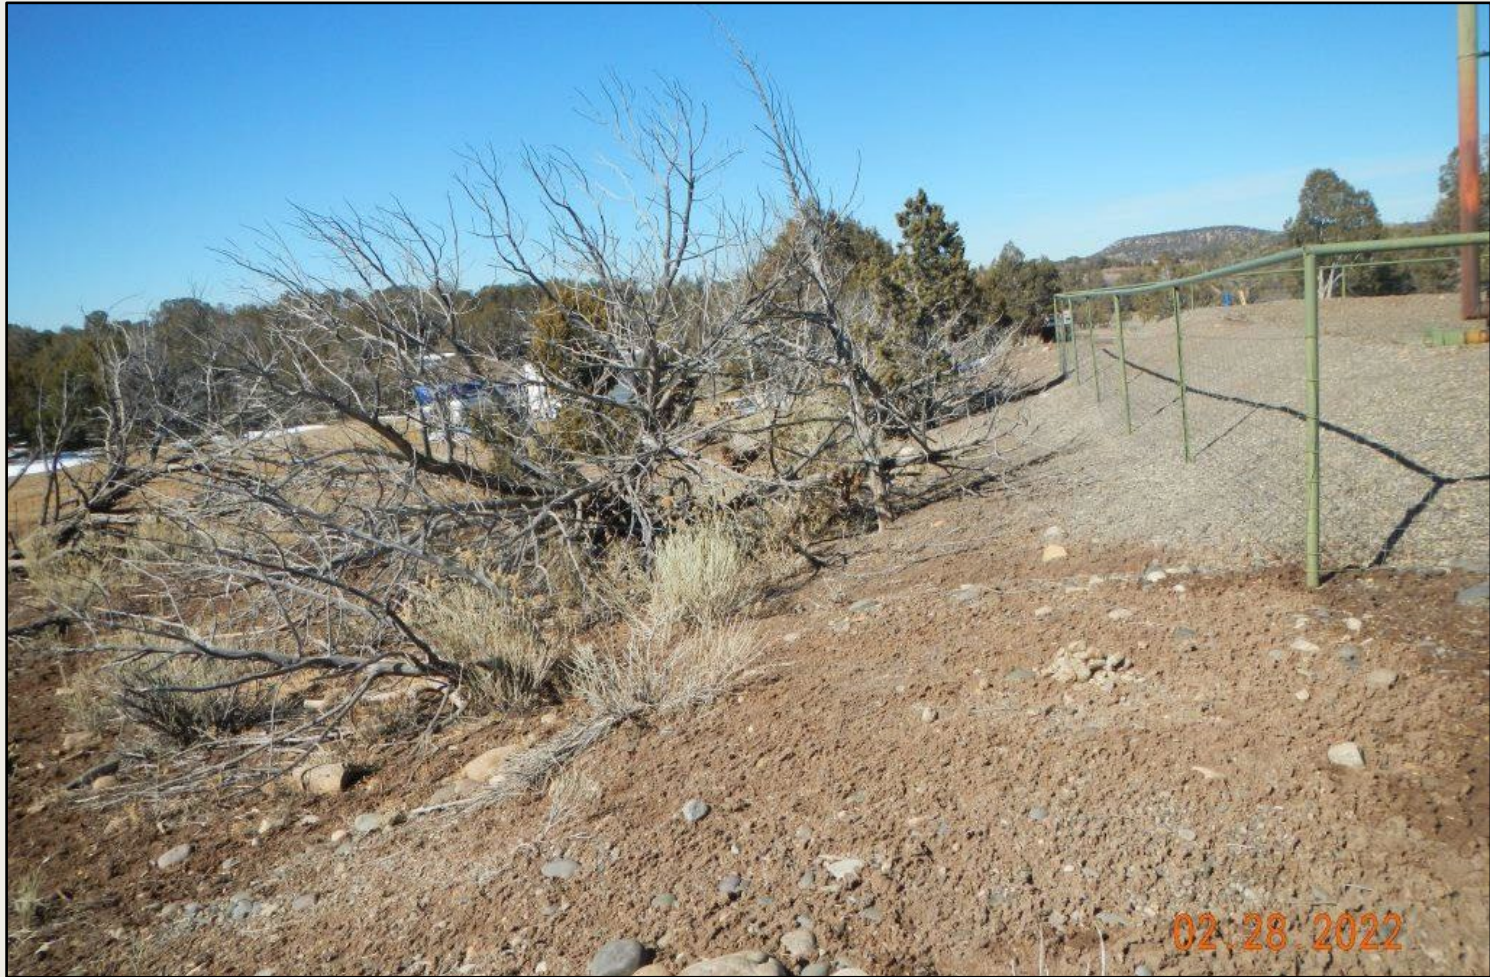
Photo 2. View of the southern project area from the southeastern corner facing westward. Revegetation such as rubber rabbitbrush, sand dropseed, and western wheatgrass observed.

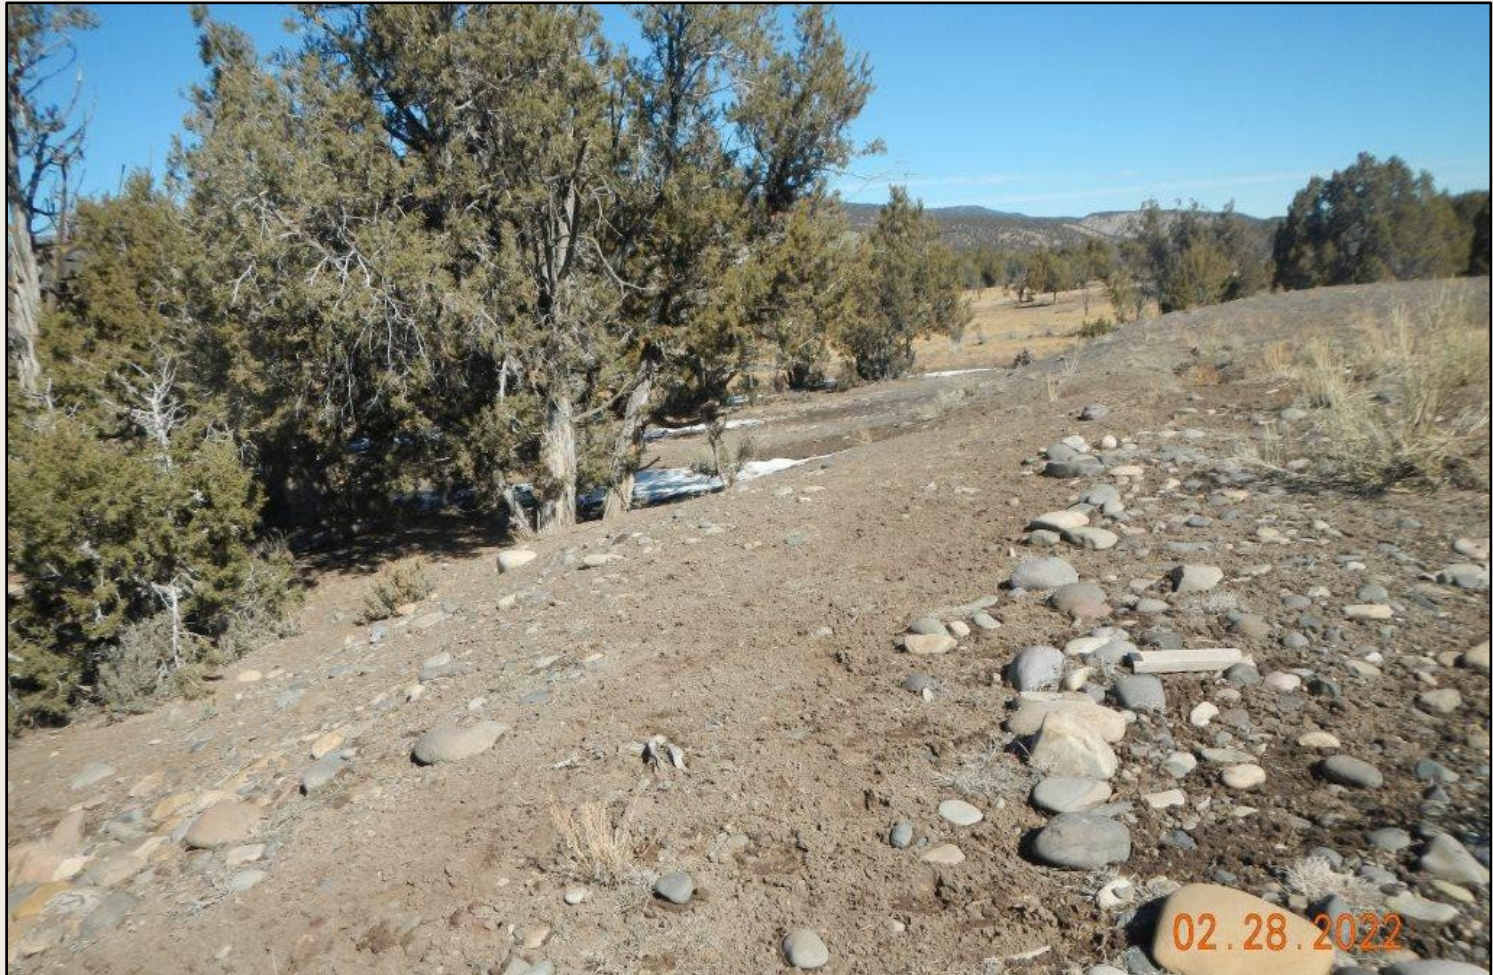
Photo 3. View of the western project area from the southwestern corner facing northward.

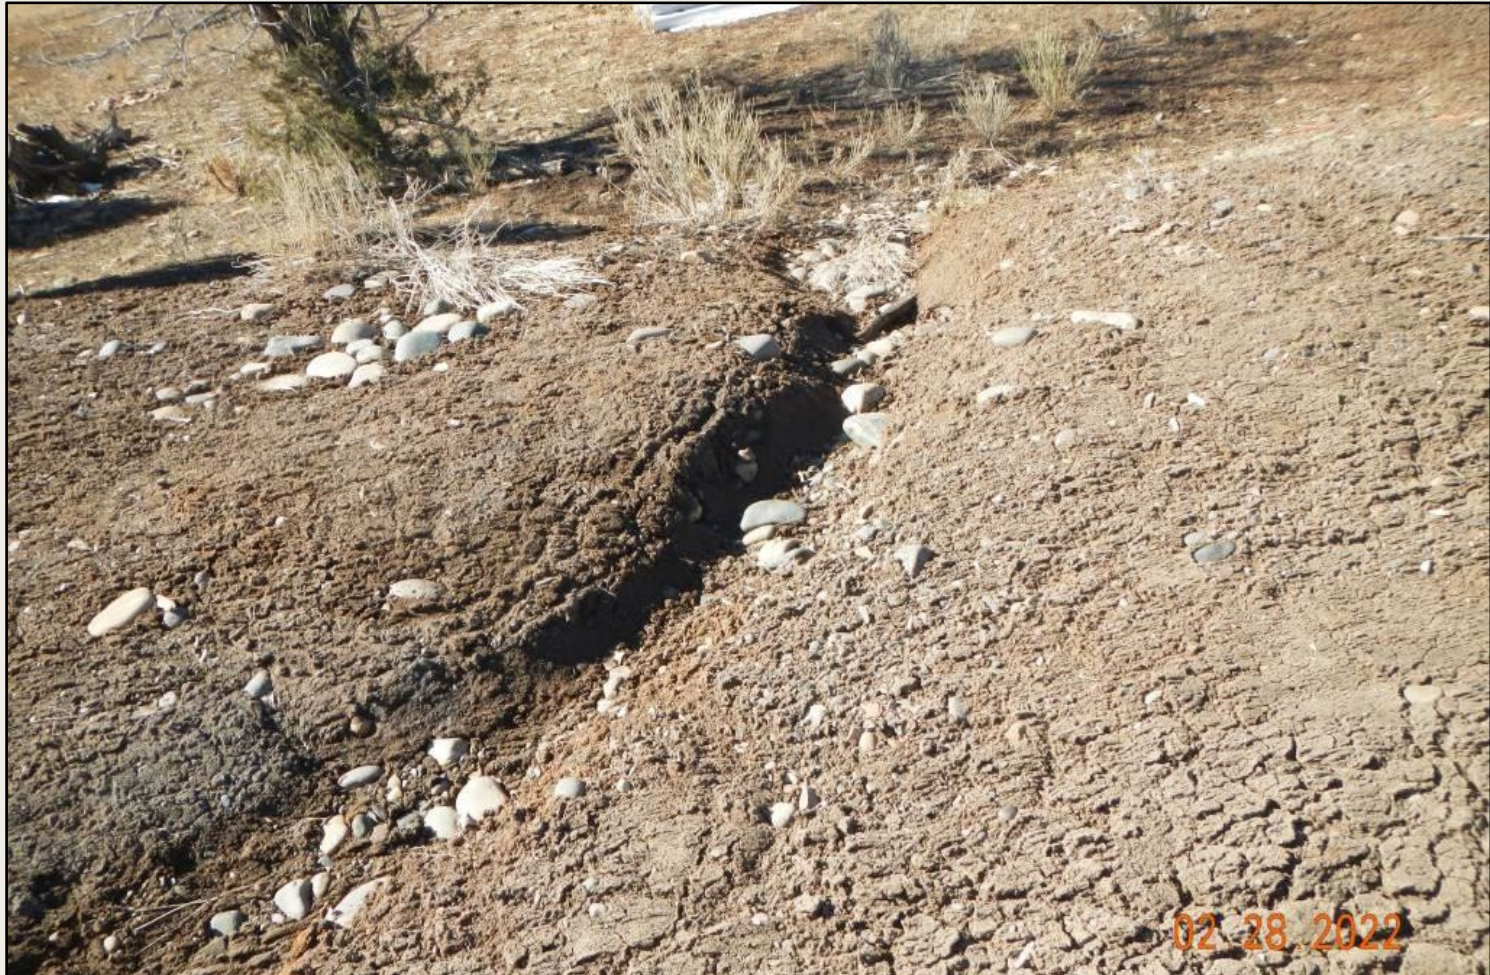
Photo 4. View of erosional channeling observed near the well pad entrance, approx. 12 inches wide and deep.

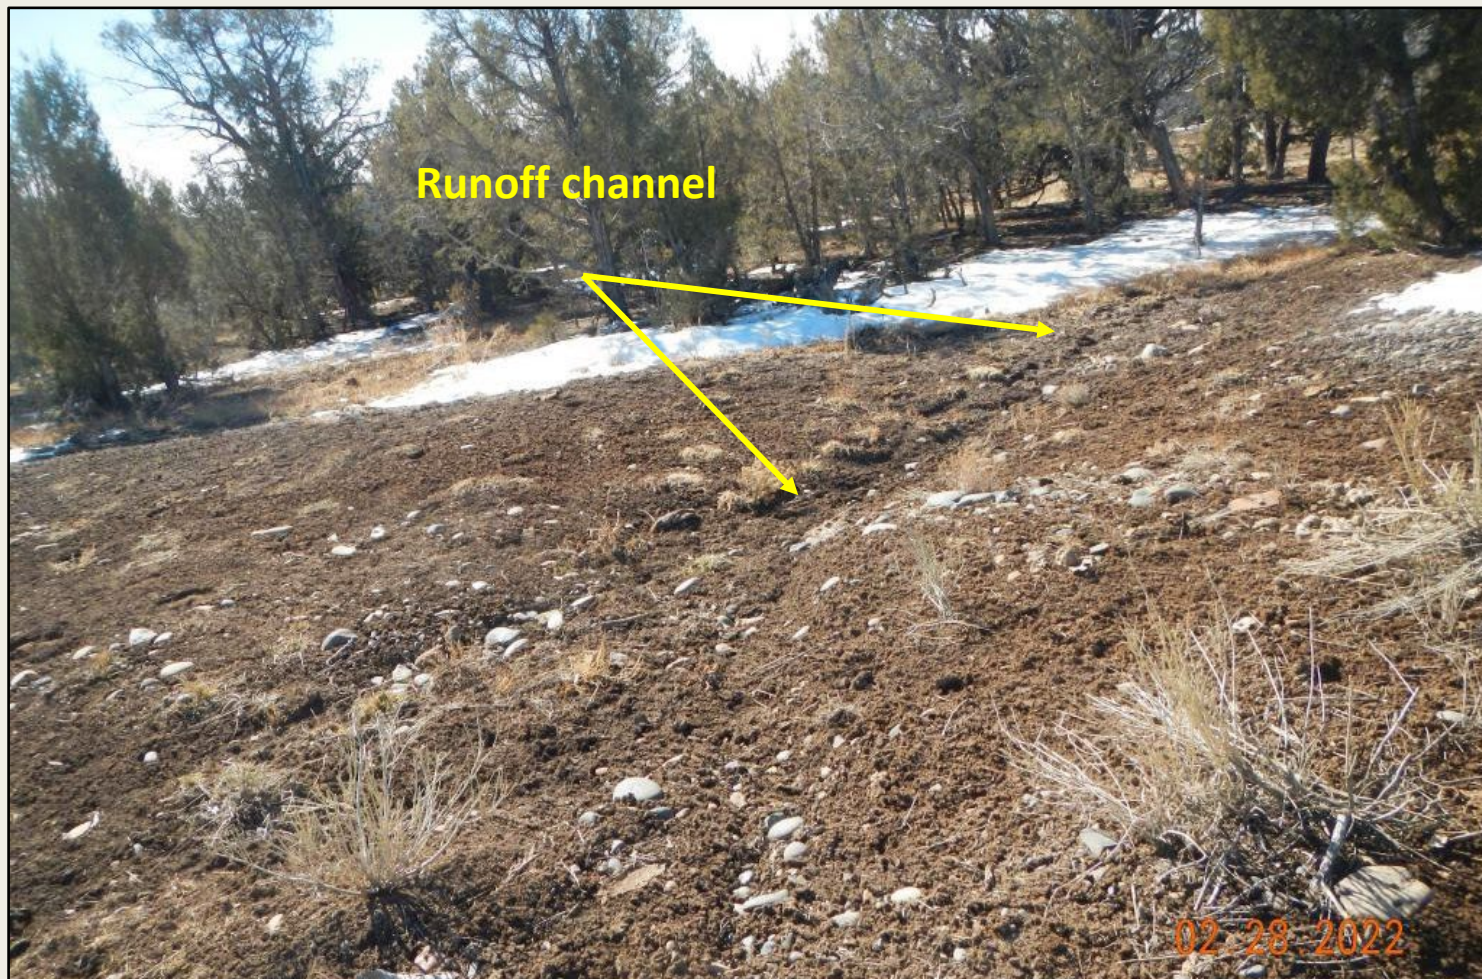
Photo 5. View of diversion channel in the southeastern project area, approx 12-15in wide and deep. BMPs are needed for stabilization.

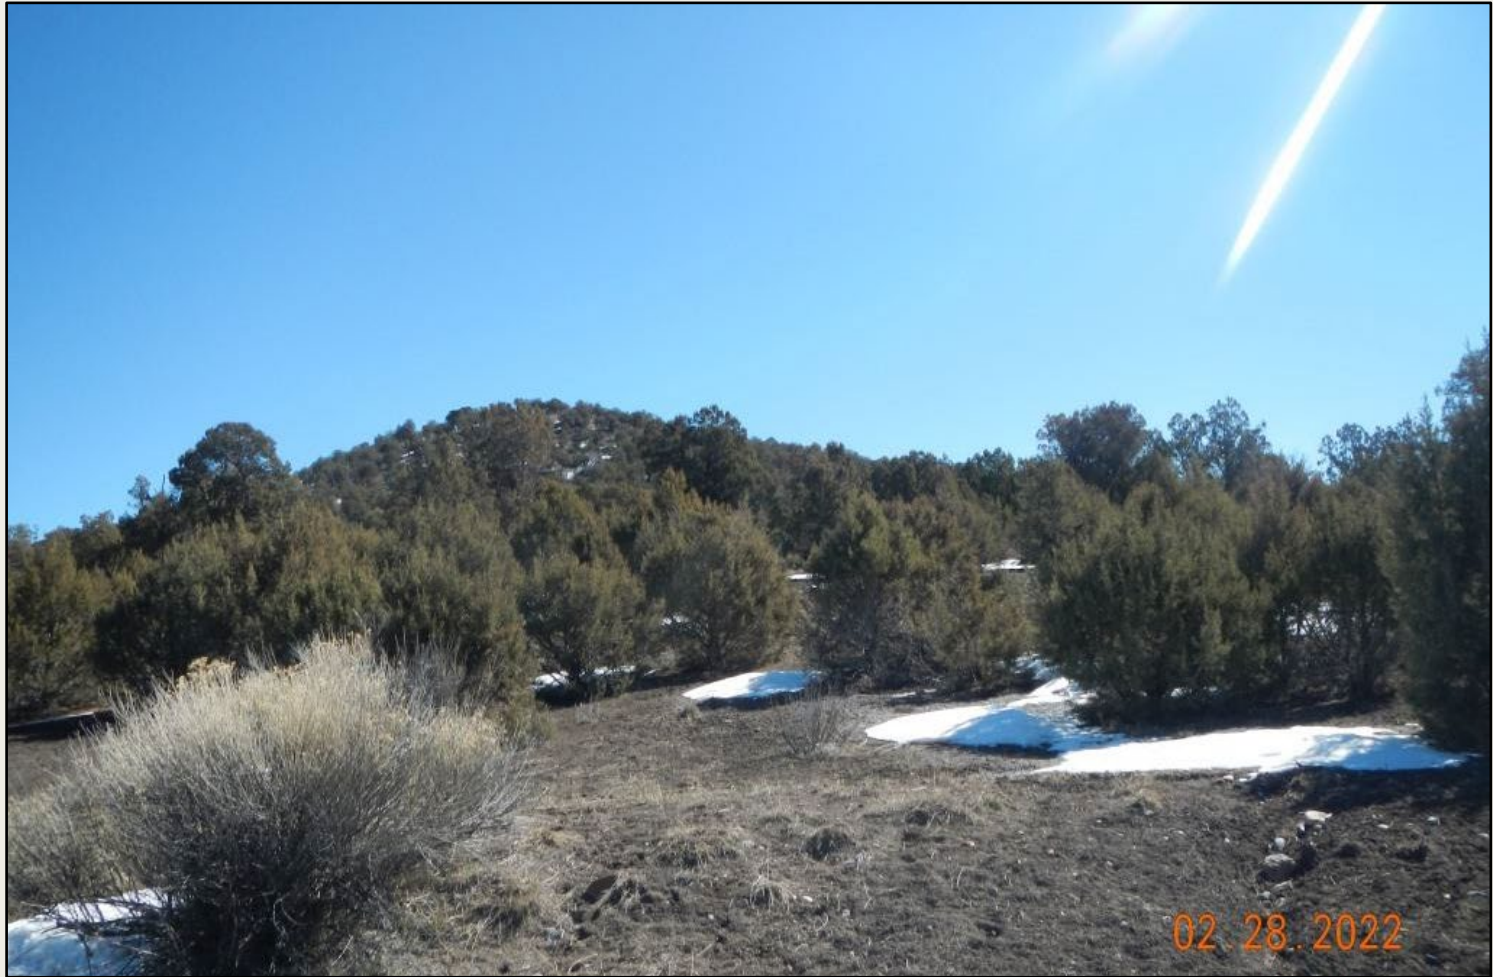
Photo 6. View of reference area comprised of pinyon and juniper woodland with sagebrush, blue grama, prickly pear, and snakeweed in the understory.
