Inspection Photos

03/09/2022

Operator: TEP ROCKY MOUNTAIN LLC - 96850

Location ID: 335177

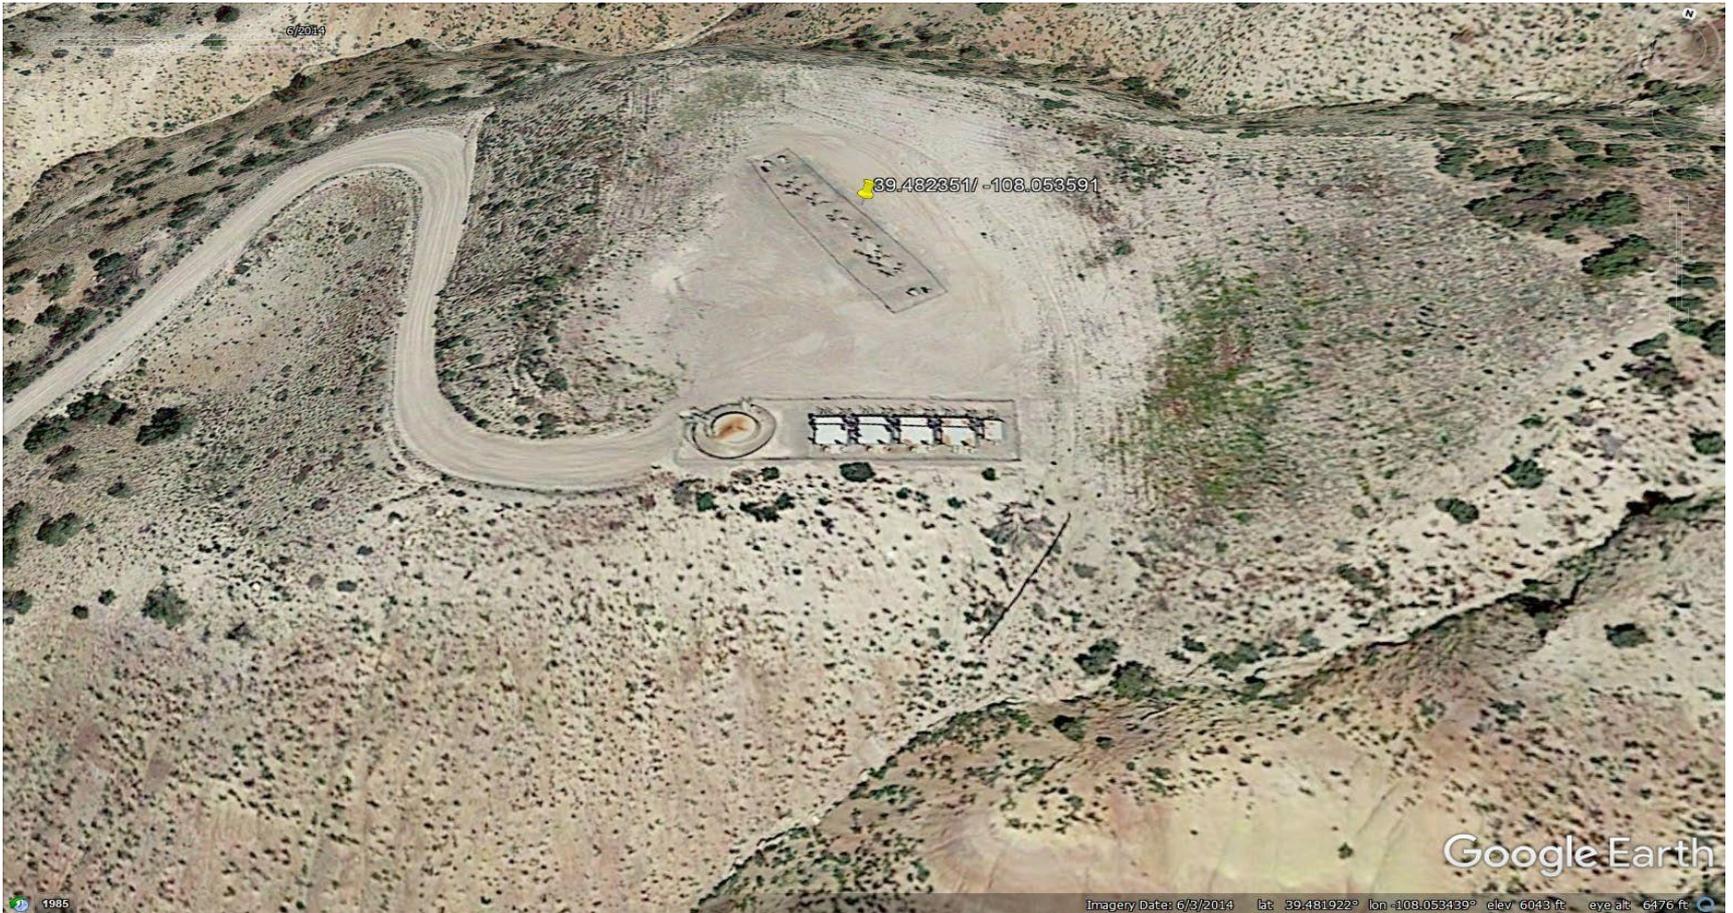
Photo 1: 2014 Google Earth Aerial image. Photo provides overview of the Location. Photo also shows that there is no evidence of erosion or potentially impacted soils on the southern slopes of the Location.

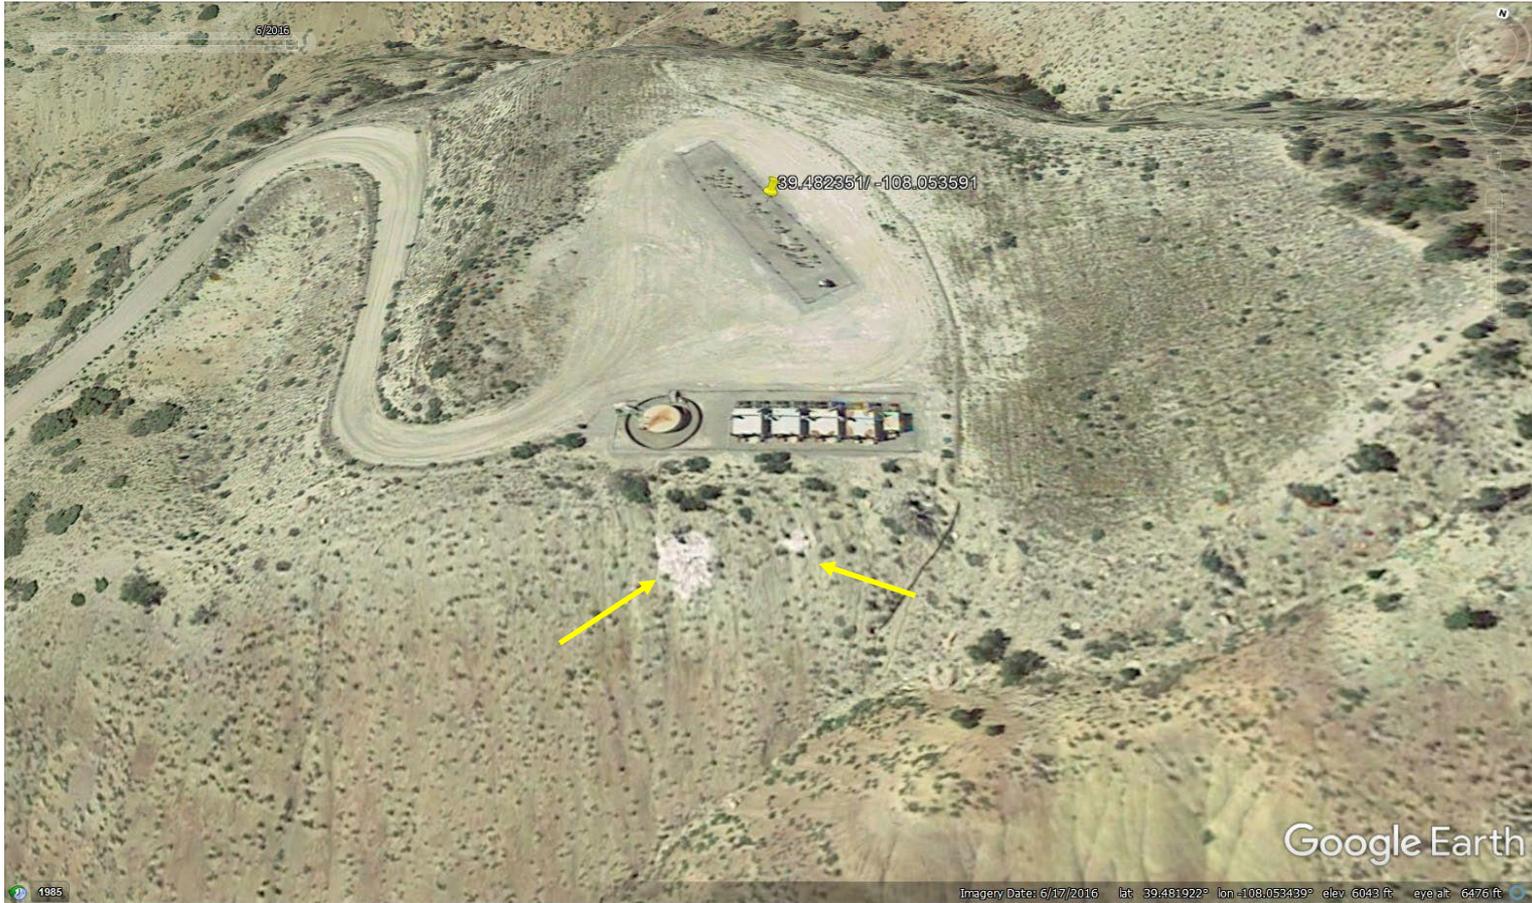
Photo 2: 2016 Google Earth Aerial image. Photo shows potentially impacted soils become evident on the southern slopes of the Location; Sloughing of slopes (see photos 3-6) not evident at this time.

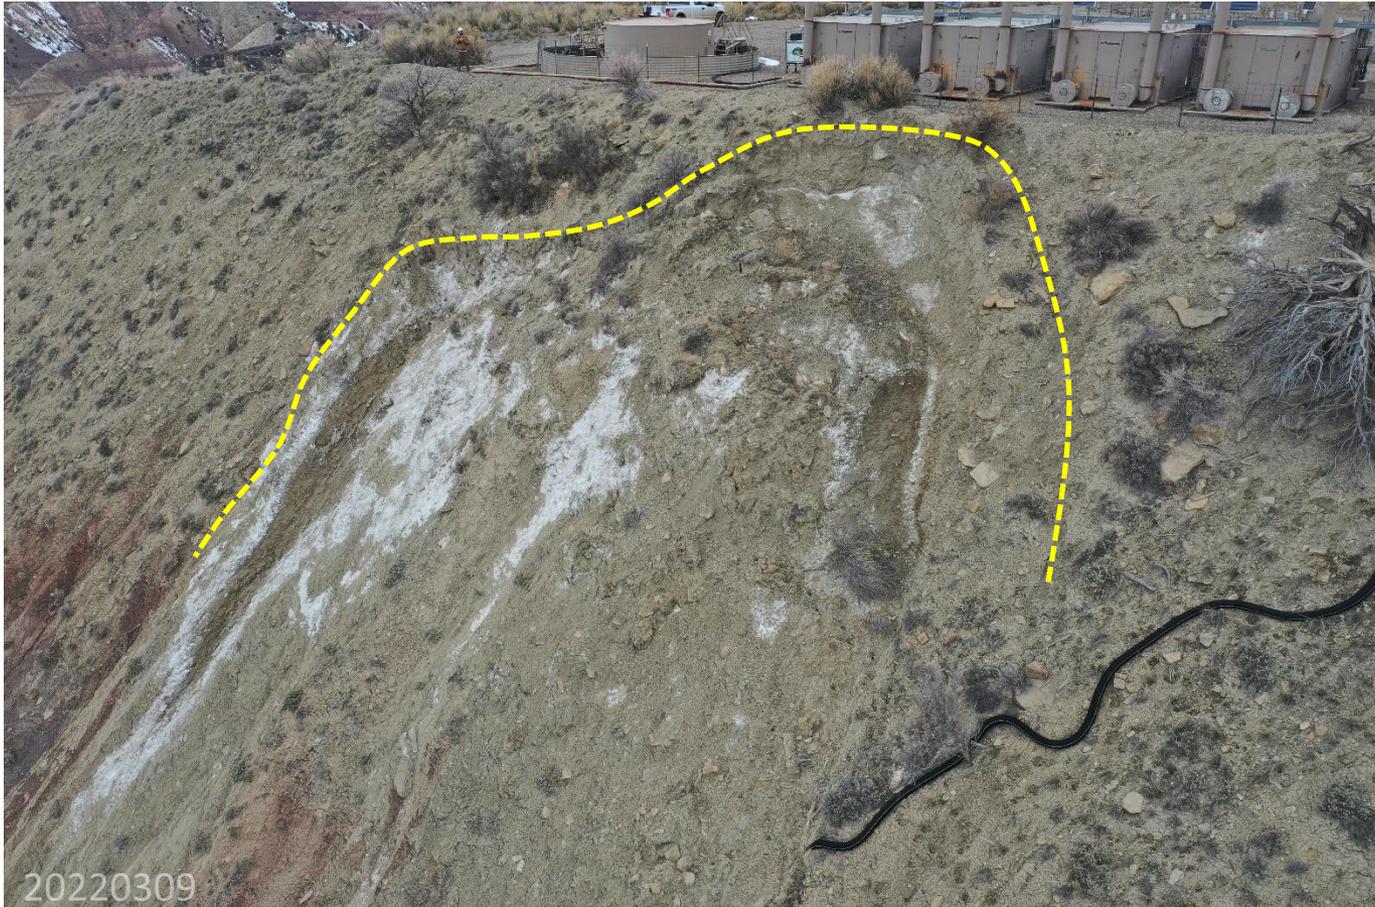
Photo 3: Photos 3-6 taken with use of a sUAS. Photos show large areas of the hillside on the south end of the Location have sloughed off. Photo also shows potential salt impacts; the apparent salt staining appears to be migrating down the slope towards an unnamed drainage. Observed potential salt impact suggests the possibility of a spill originating from below-ground dump-lines or flow-lines at the facility equipment. Additional investigative measures are required by TEP.

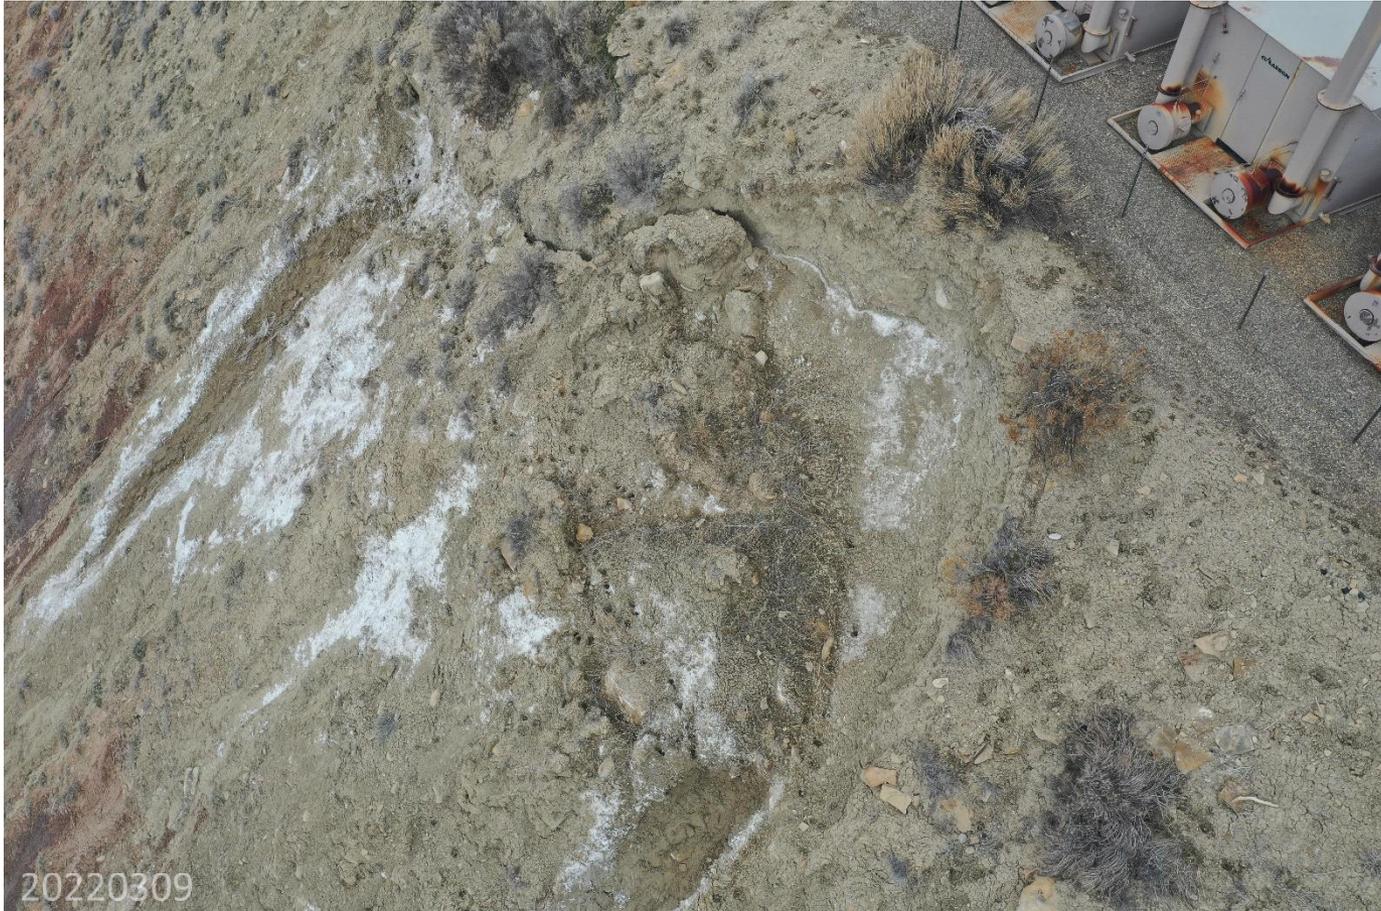
Photo 4: See comments under photo 3.

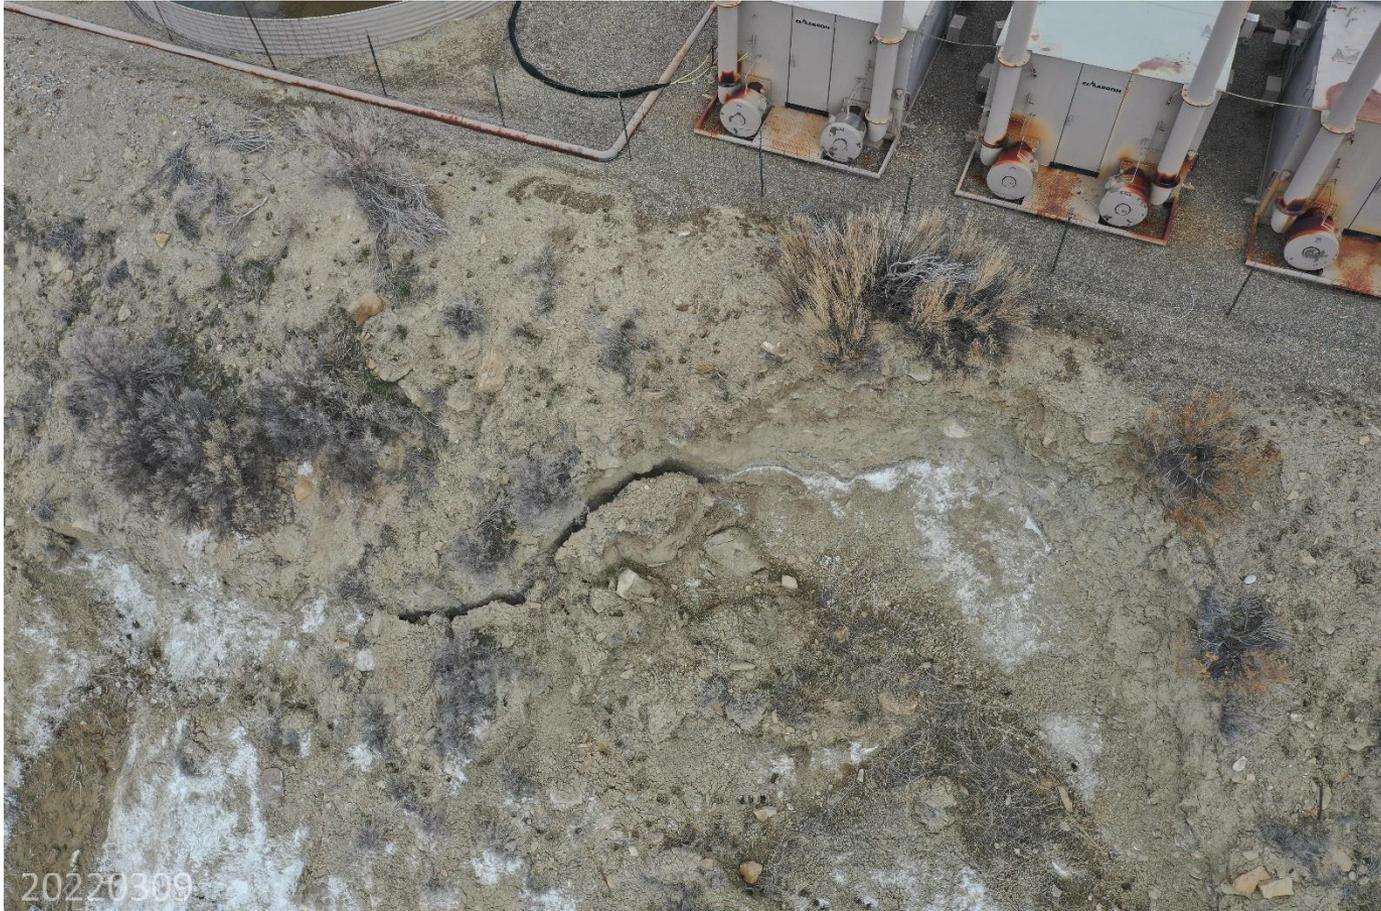
Photo 5: See comments under photo 3.

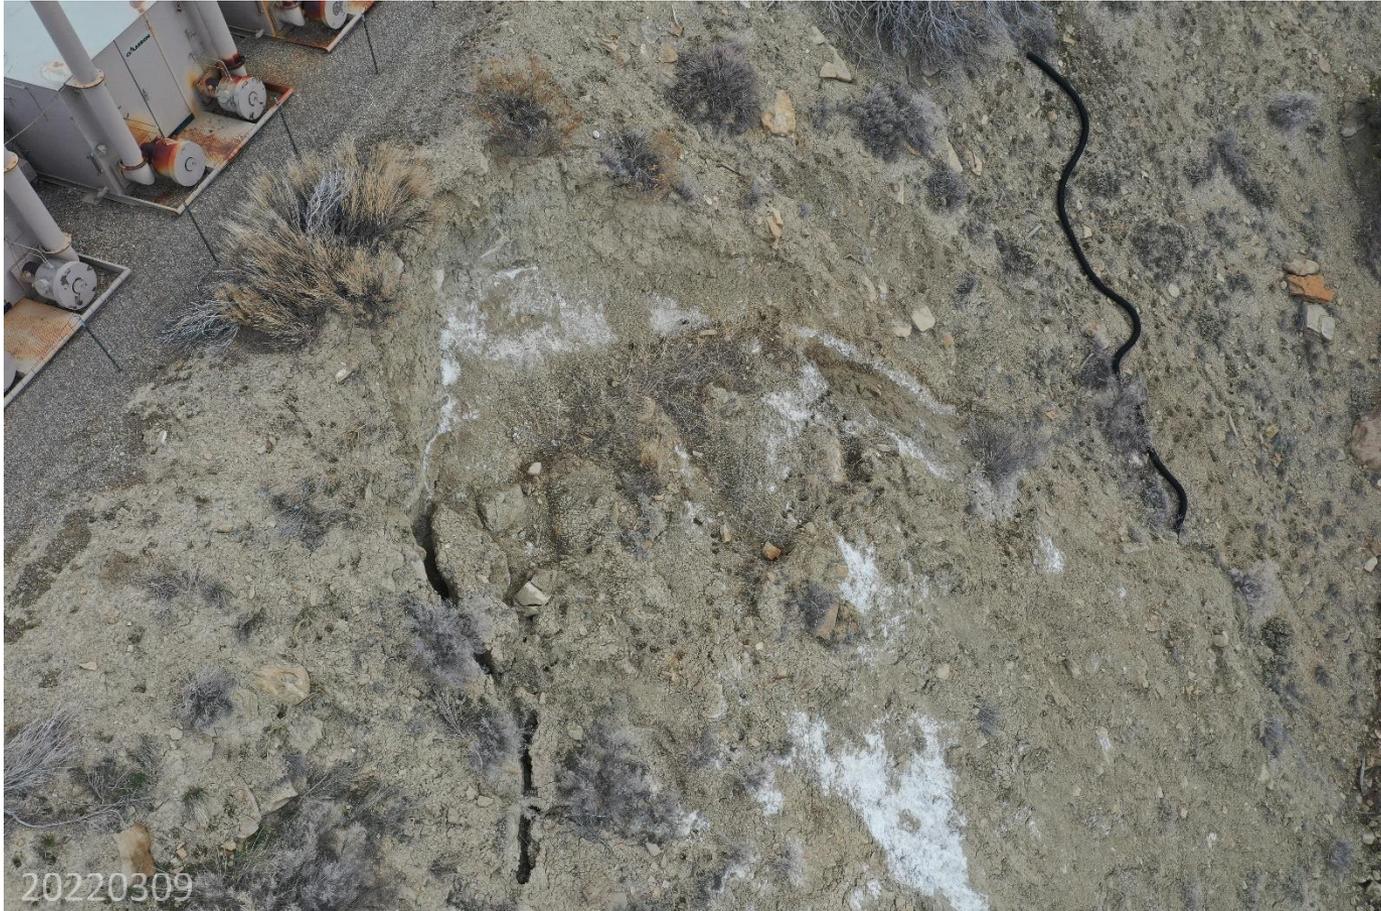
Photo 6: See comments under photo 3.

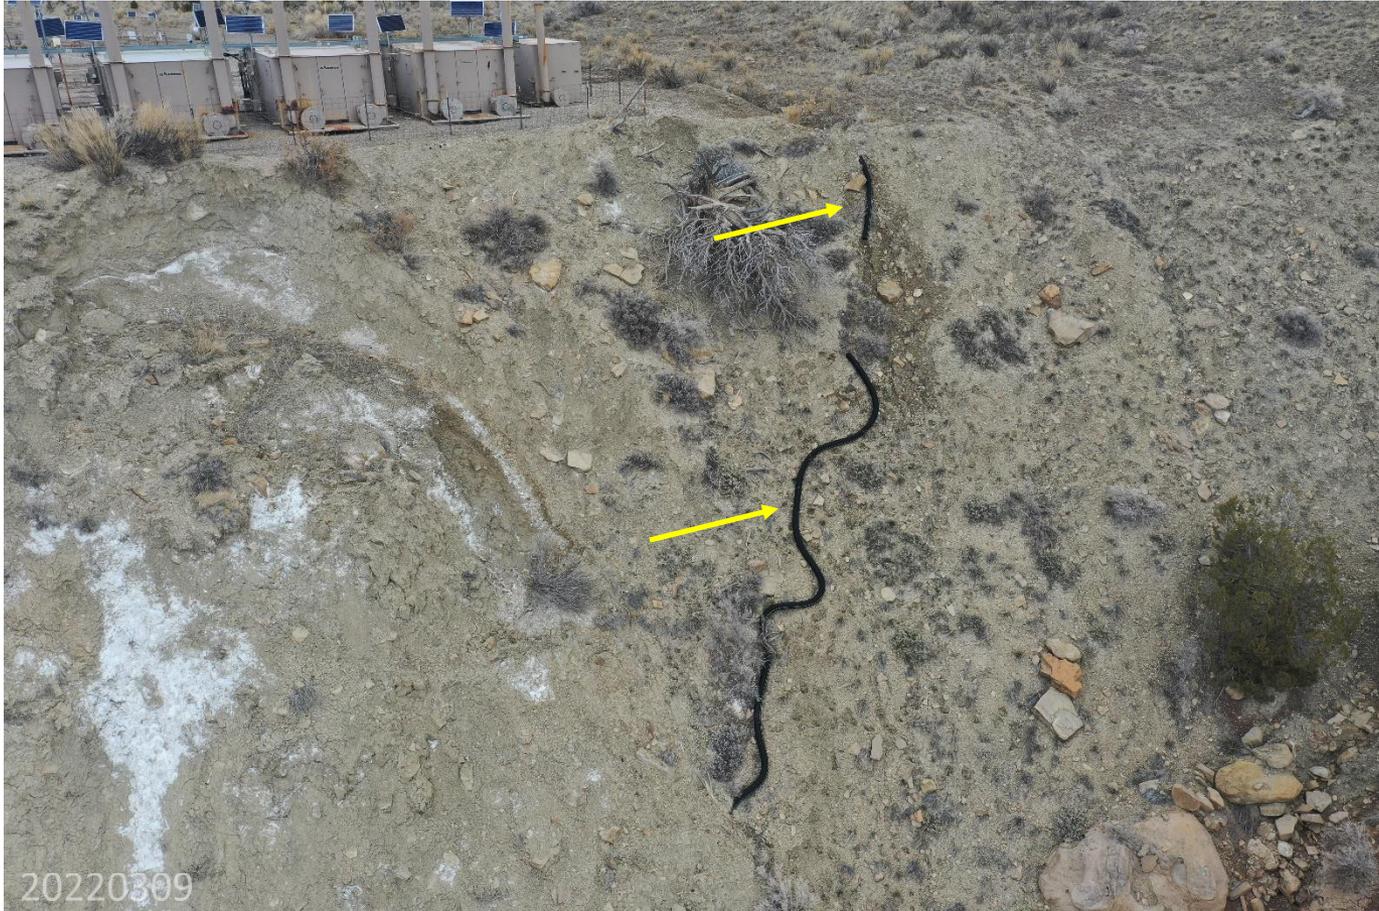
Photo 7: Photos taken with use of a sUAS. Photo shows slope drain on the south end of the Location; the slope drain has not been installed in accordance with good engineering practices, and is not in proper functioning condition; drain pipe has been cut halfway down slope; remaining pipe not in use is considered debris and requires removal. Slope drain has not been properly secured or constructed with an engineered outlet, which has resulted in stormwater degradation at the outlet. Stormwater and erosion control measures to allow for proper stormwater discharge, and to minimize off site degradation is missing or insufficient.

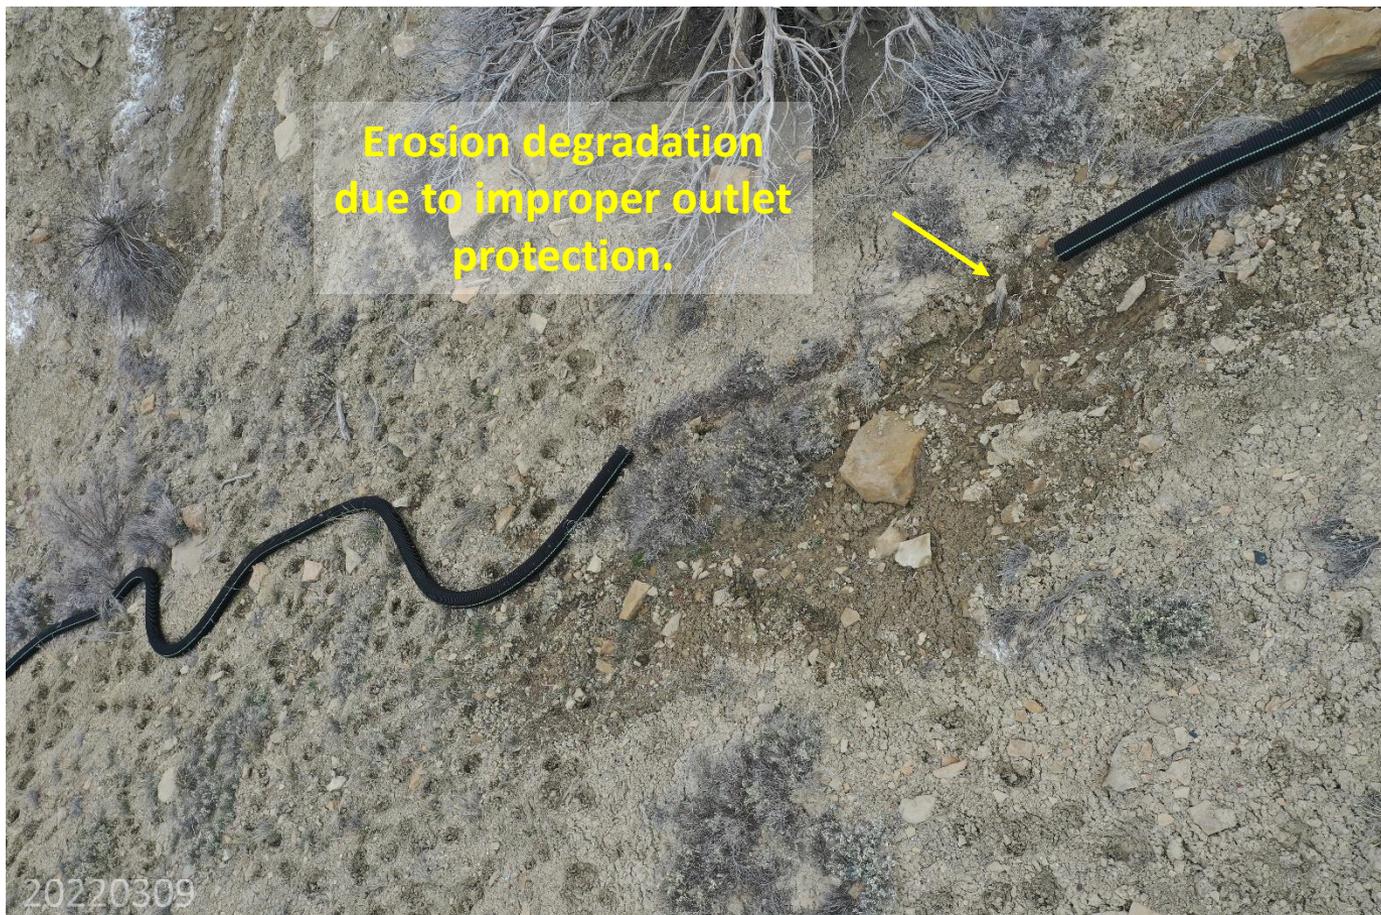
Photo 8: Continued from photo 7. Photo shows slope drain pipe has been cut halfway down slope. Photo also shows slope drain has not been properly secured or constructed with an engineered outlet (per good engineering practices), which has resulted in stormwater degradation at the outlet. Stormwater and erosion control measures to allow for proper stormwater discharge, and to minimize off site degradation is missing or insufficient.

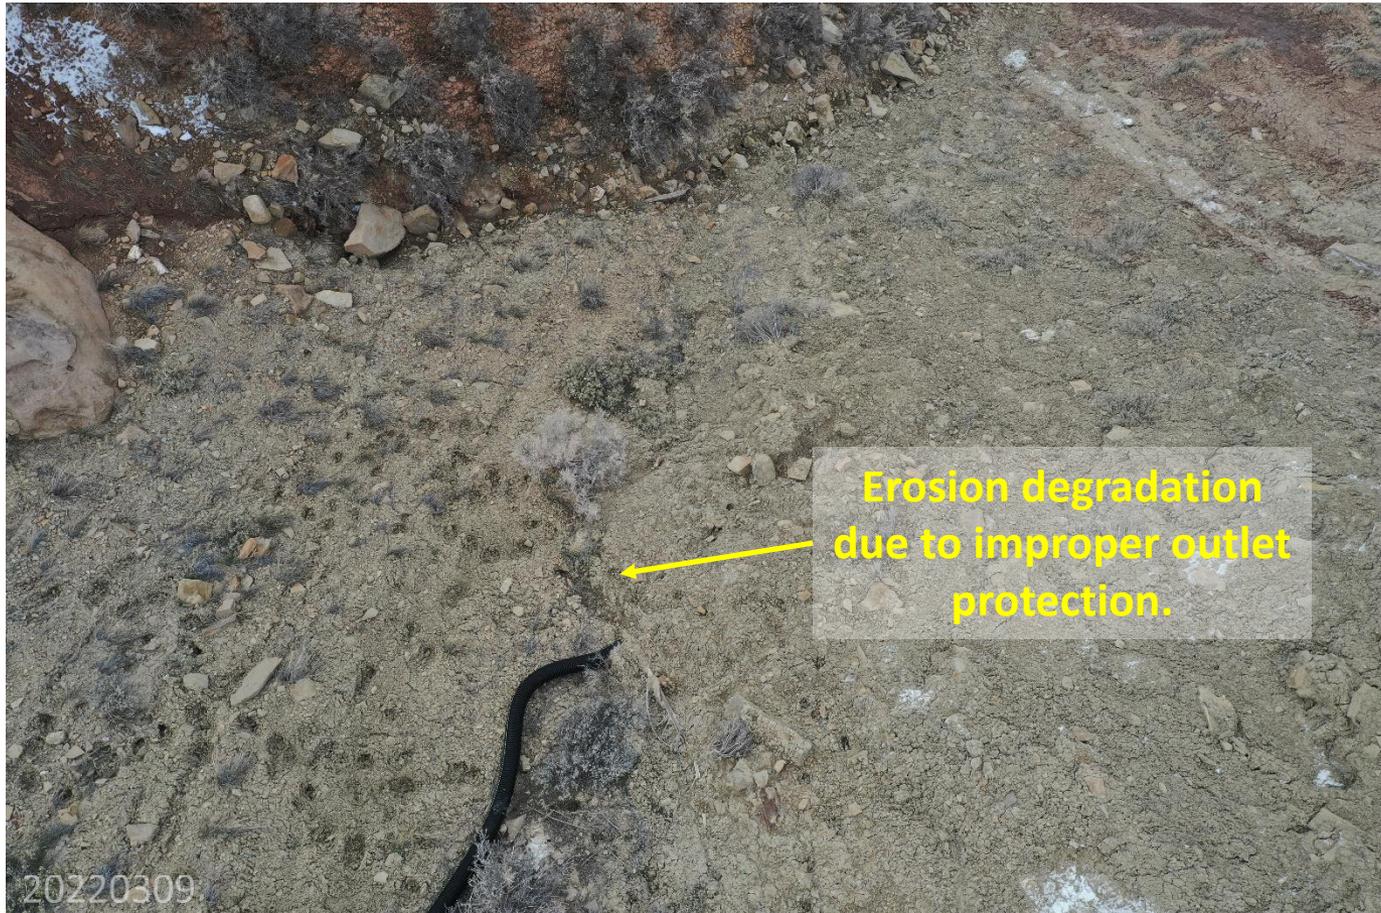
Photo 9: Continued from photo 8. Photo shows the outlet of the lower section of slope drain pipe that has been cut off; this section of pipe is now debris. Photo shows that a properly engineered outlet was also not constructed at this outlet, resulting in erosion degradation when this section of pipe was still in use. Stormwater and erosion control measures to allow for proper stormwater discharge, and to minimize off site degradation is missing or insufficient.

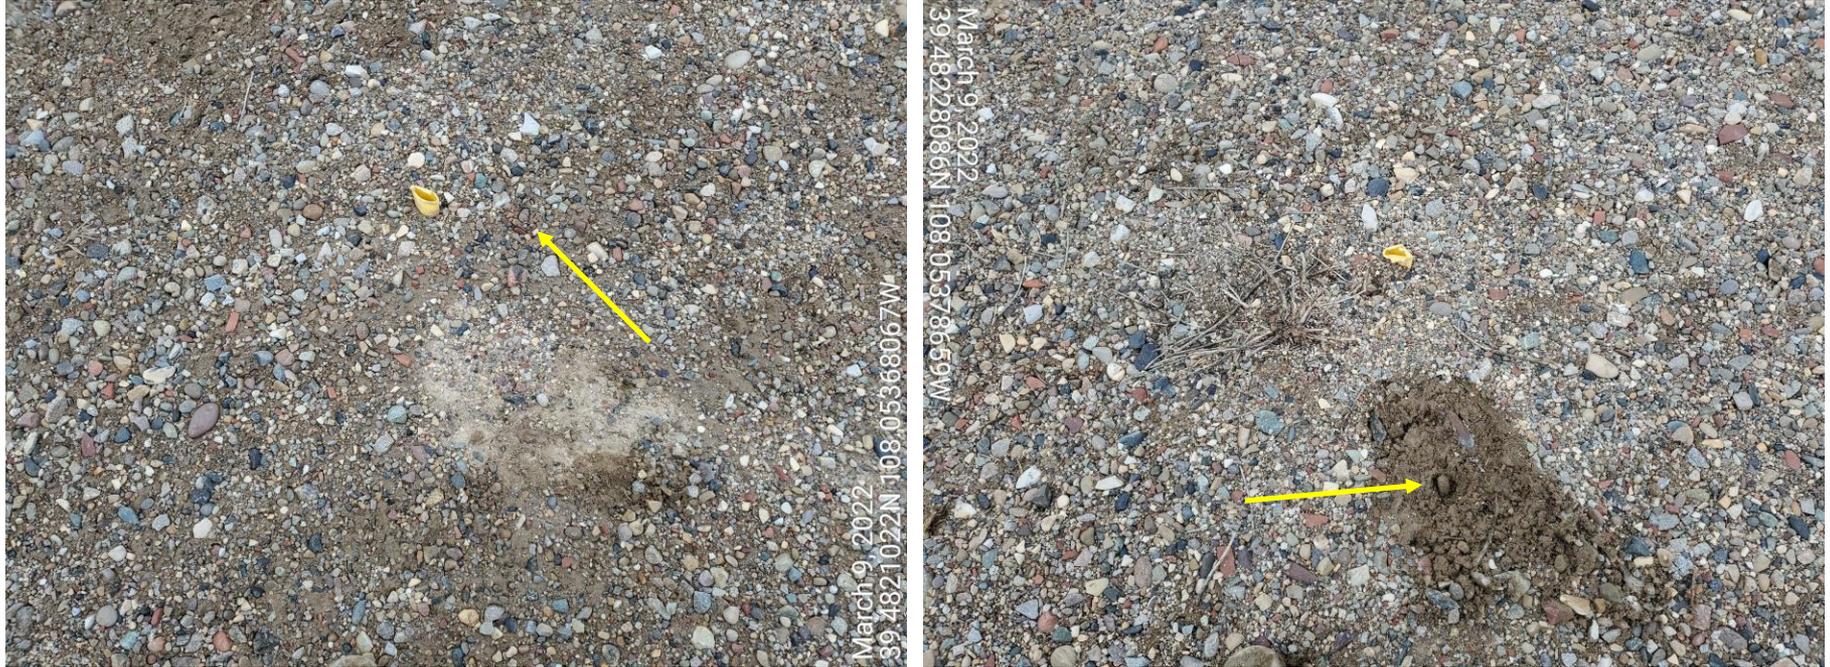
Photo 10: Photos taken from the working pad of the Location. Photos provide examples showing control measures to stabilize the working pad, minimize rutting, tracking and sediment transport remains missing or insufficient.
