Inspection Photos

API: 043-06196

Operator: JAVERNICK OIL

Inspection Date: 3/15/2022

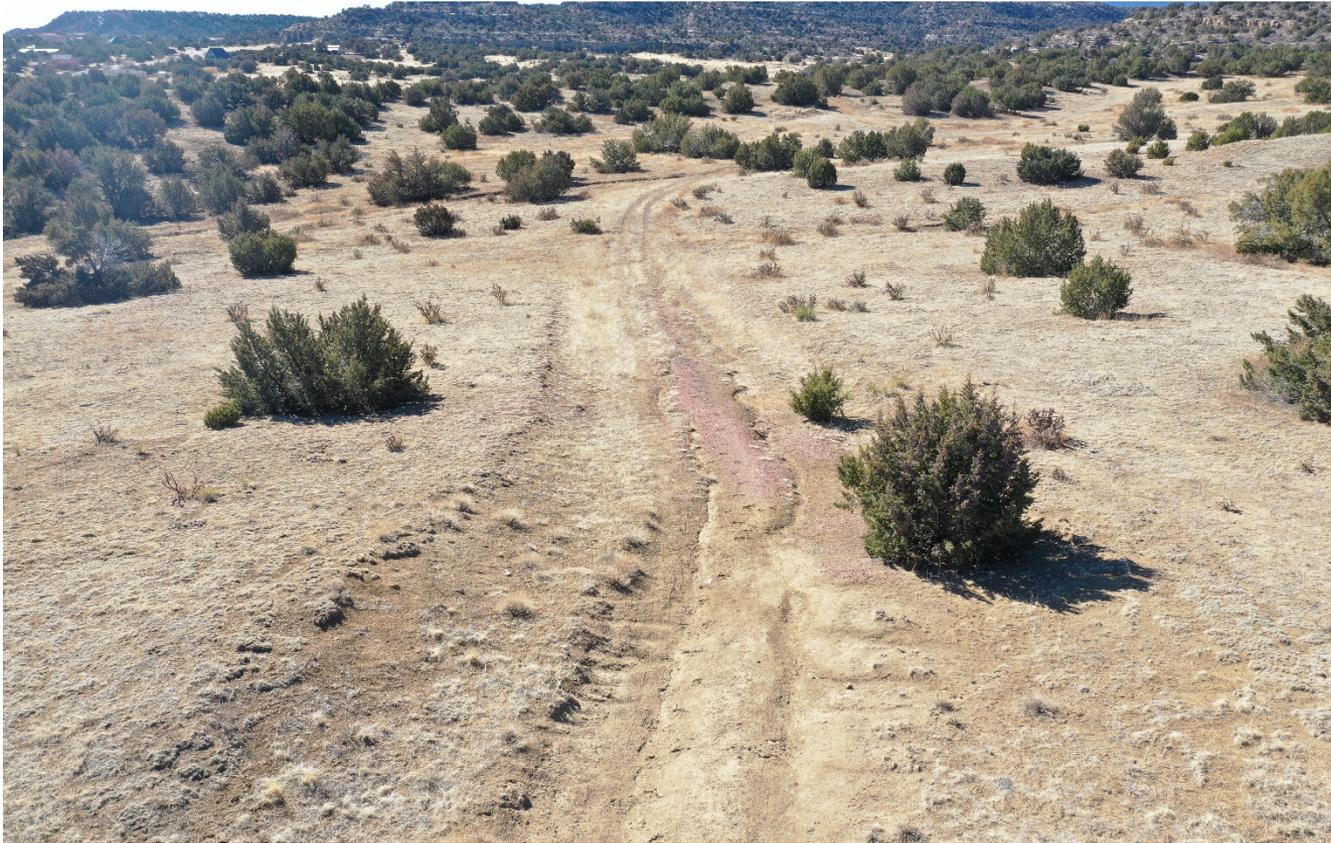
Photo 1. Drone aerial photo facing south along the access road. There is erosion along this area of the road which needs to be repaired and stabilized. Previous corrective action was not performed.

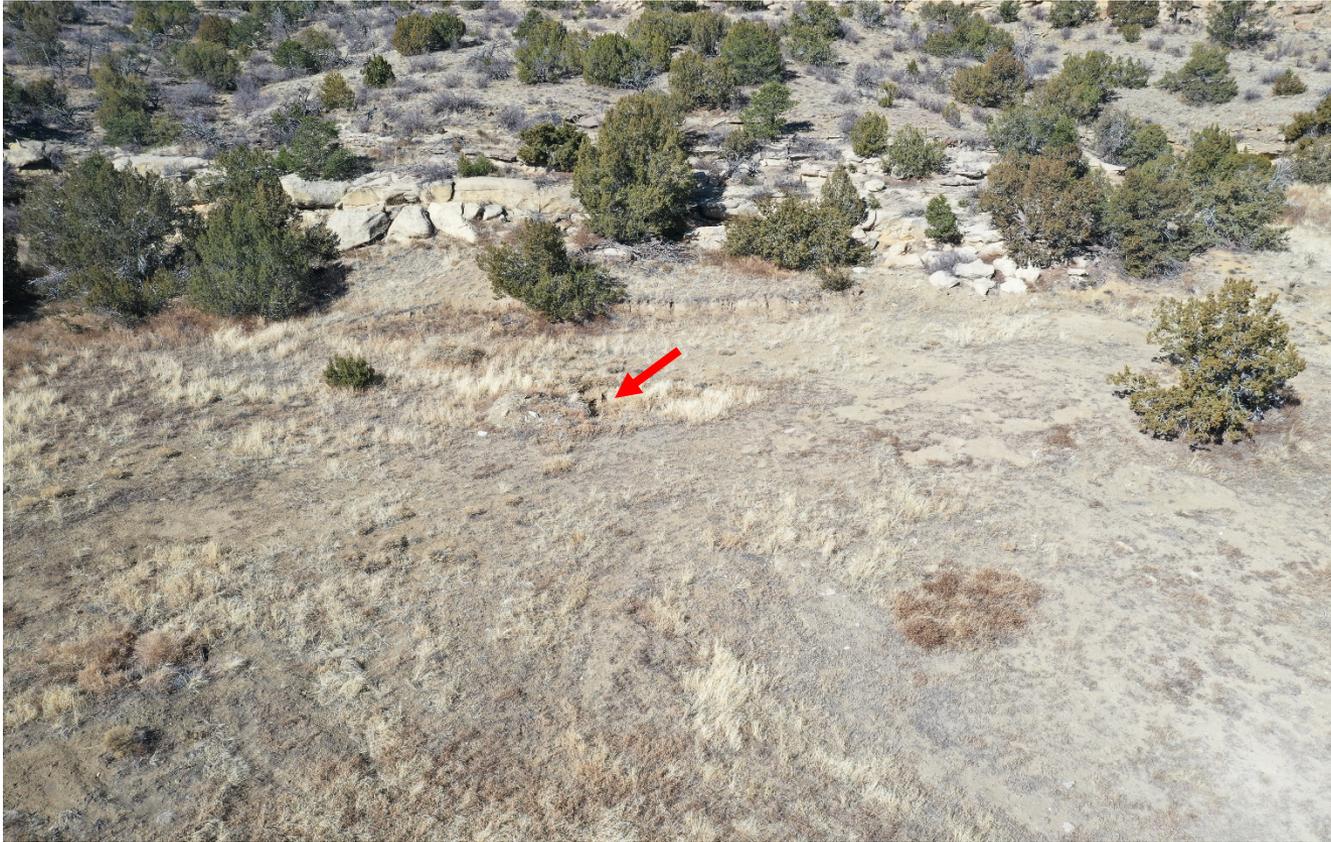
Photo 2. Drone aerial photo facing west toward the location. Most of the location is revegetated. The open hole shown at red arrow still remains.

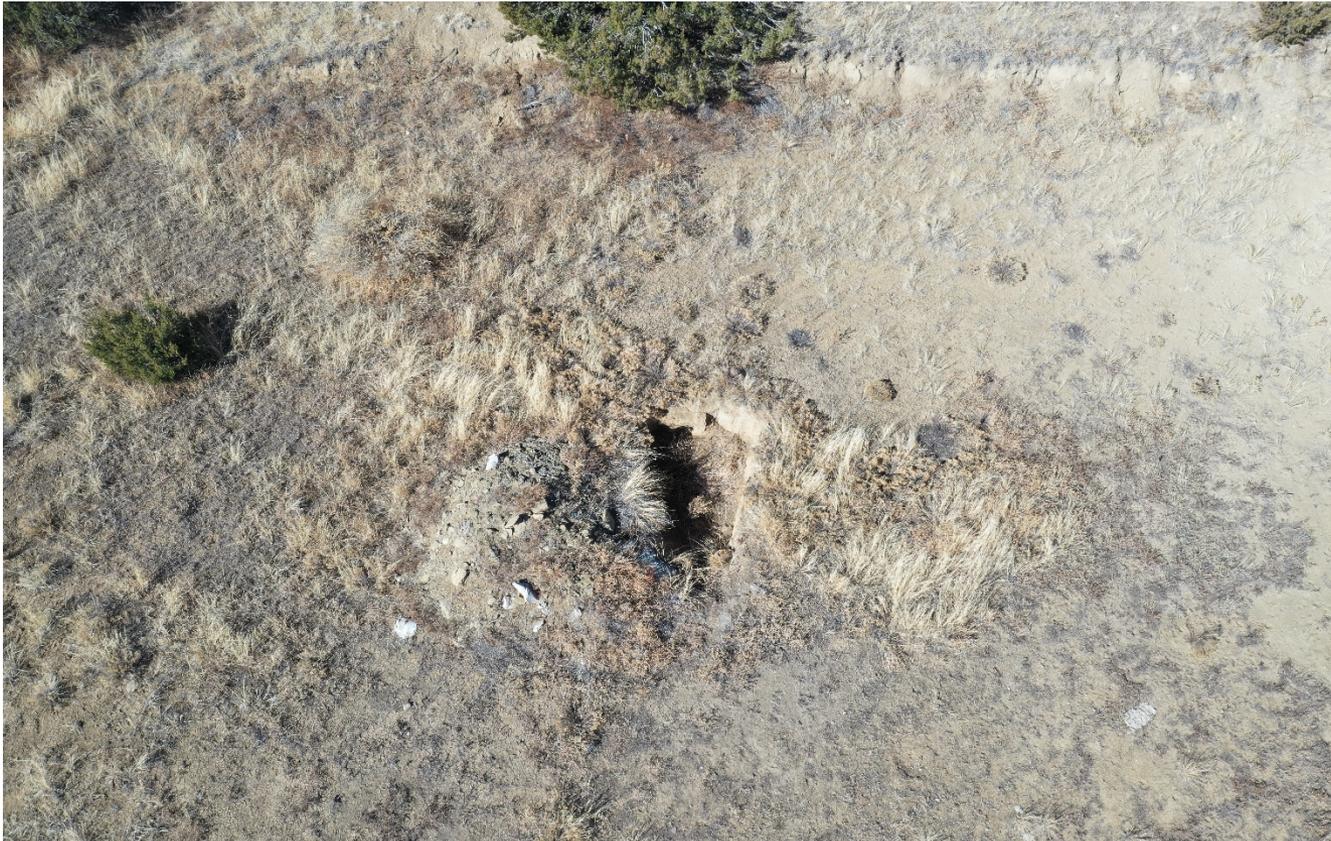
Photo 3. Facing down toward the open hole where the well was cut and capped. The open hole is about 4.5 ft. deep. There is cement debris next to the hole which appears to be from plugging of the well.

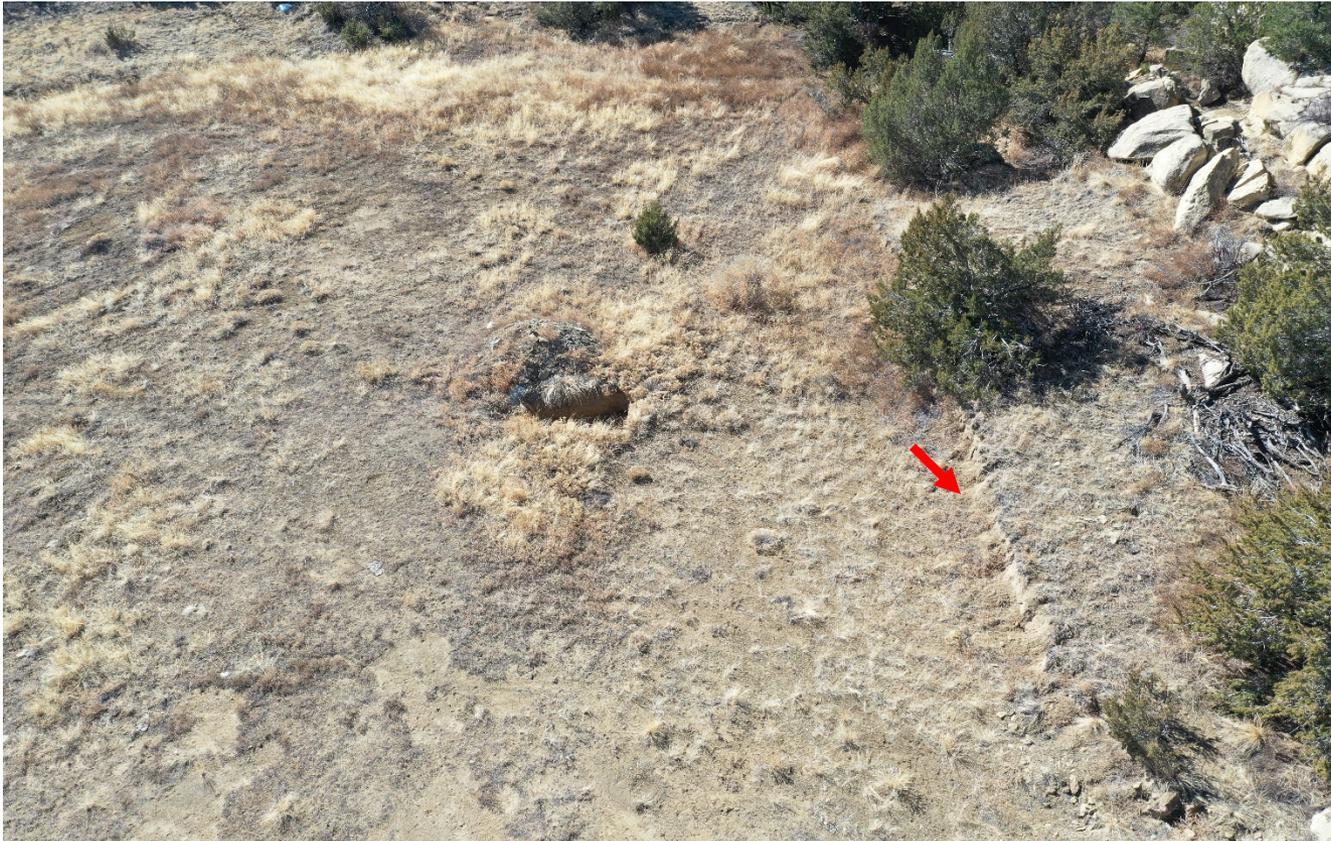
Photo 4. Facing south at the location. The cut slope is shown at red arrow which needs to be reclaimed. There are areas at the location that have not re-established vegetation.
