TEP  
RWF 311-15  
Location # 335571

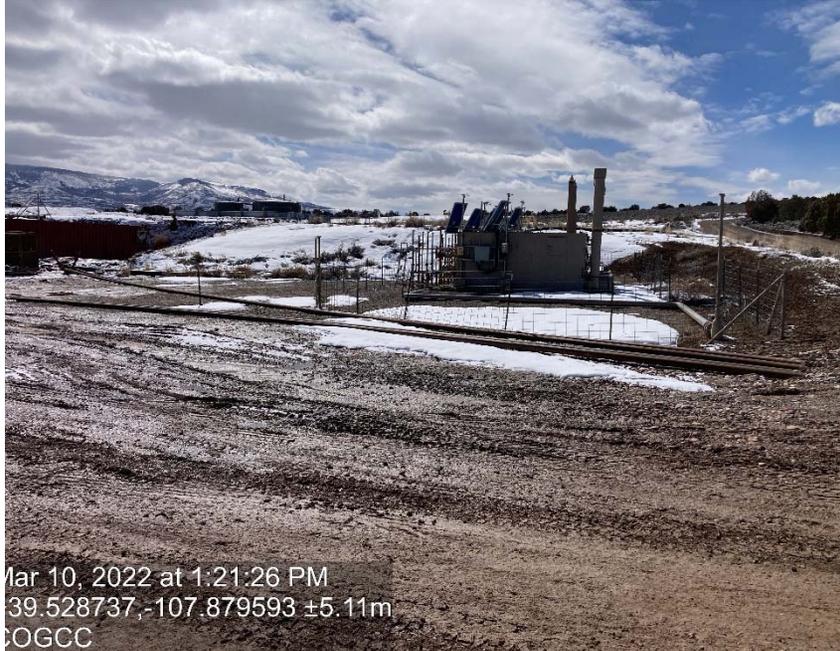
location

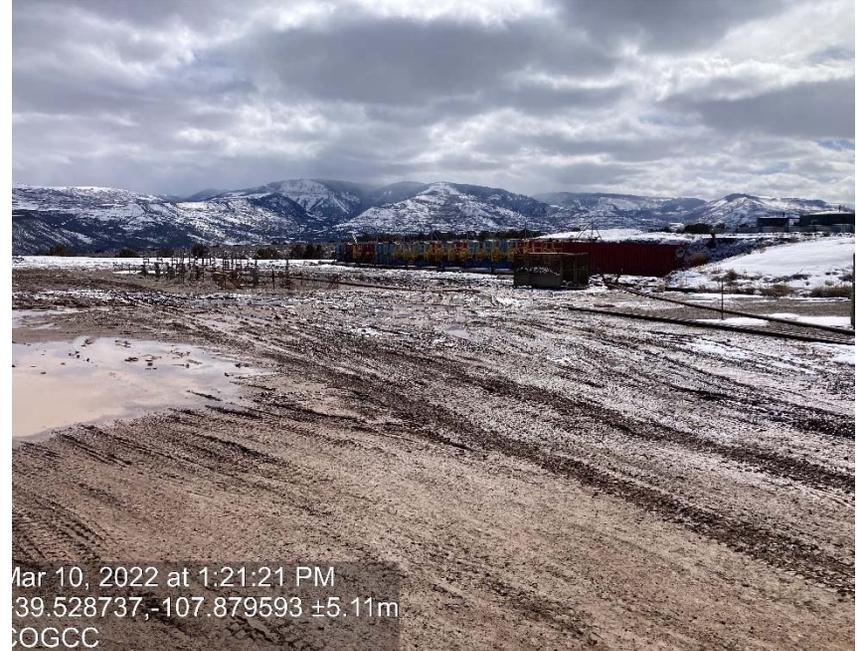
Location/ lack of stabilization-compaction

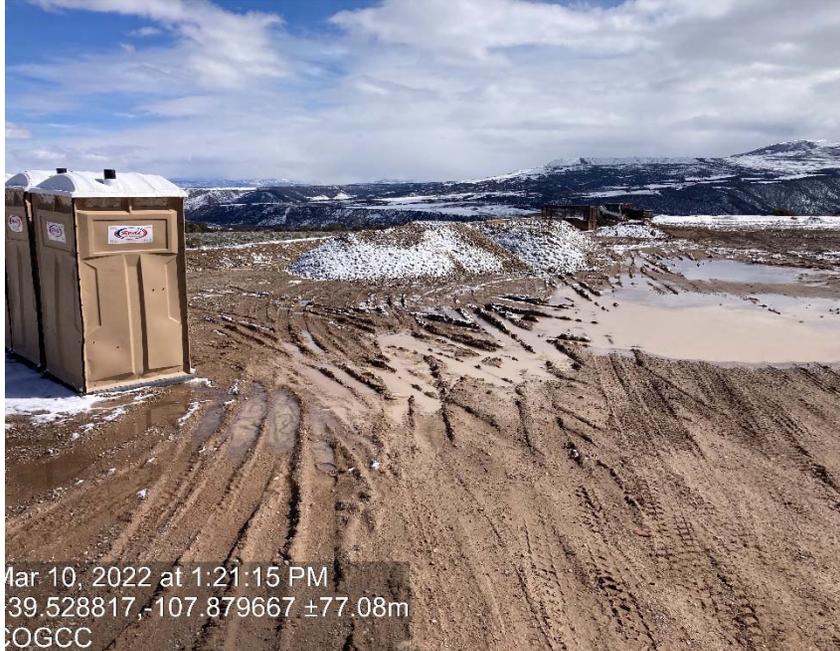
**Location/ lack of stabilization-compaction**

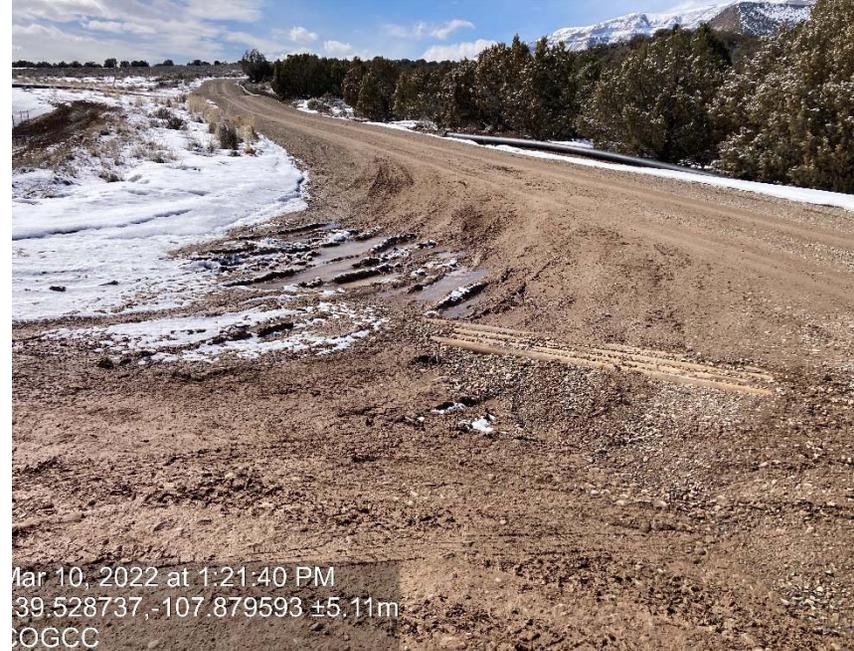
**Location/ lack of stabilization-compaction**

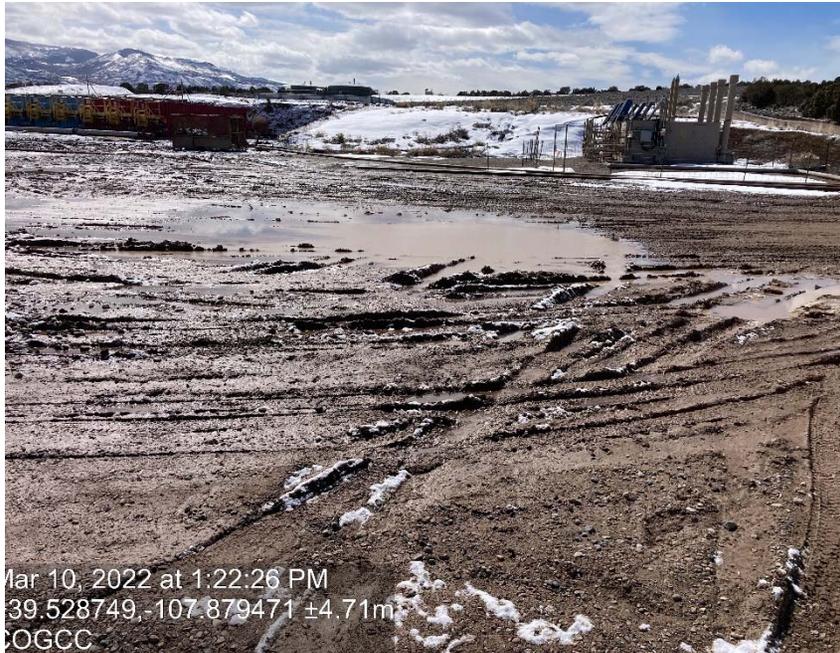
**Location/ lack of stabilization-compaction**

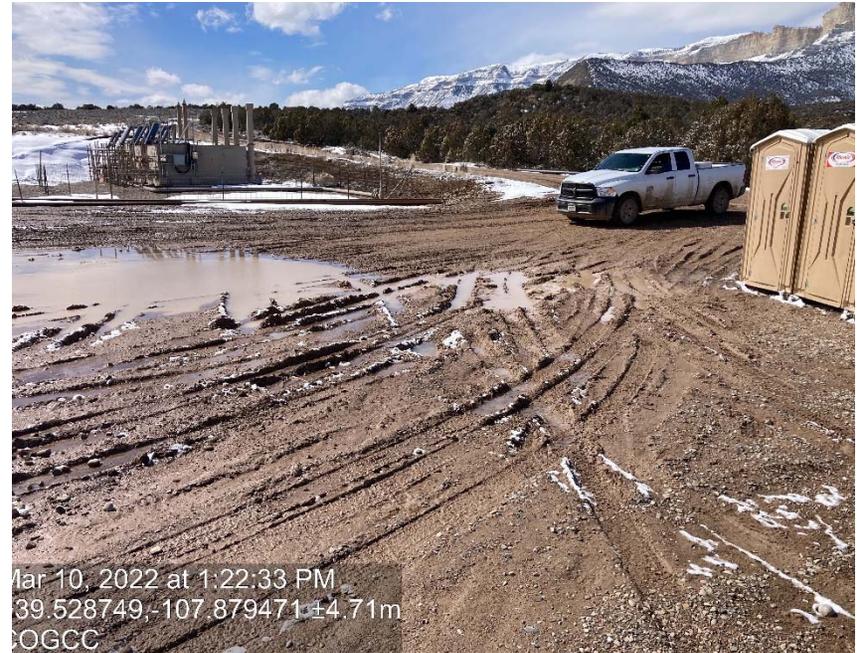
**Location/ lack of stabilization-compaction**

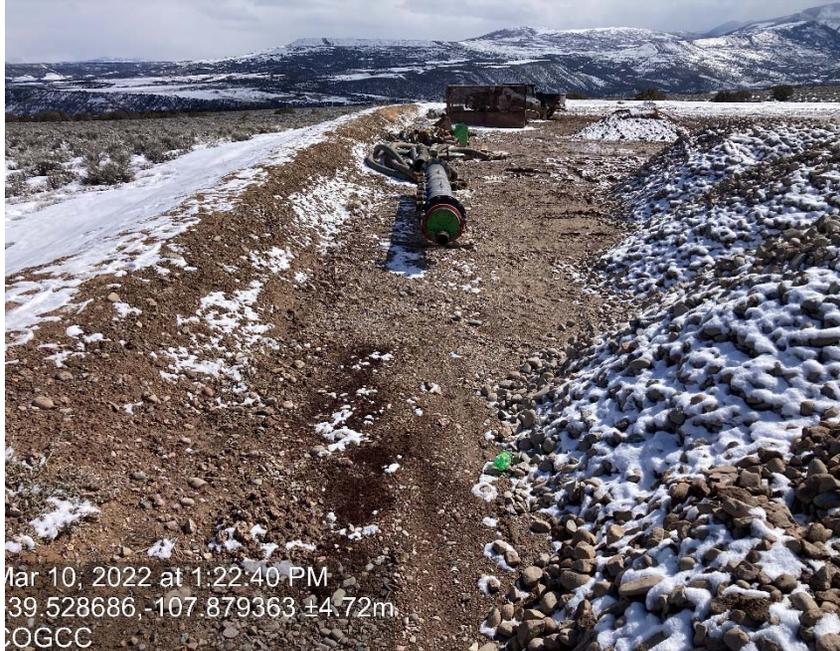
Stored equipment/ random debris

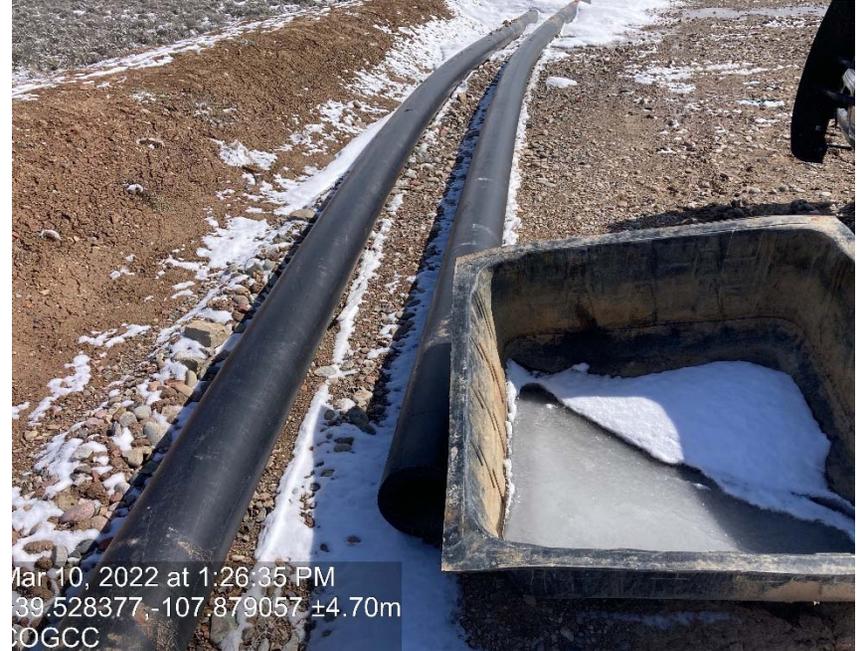
Stored equipment

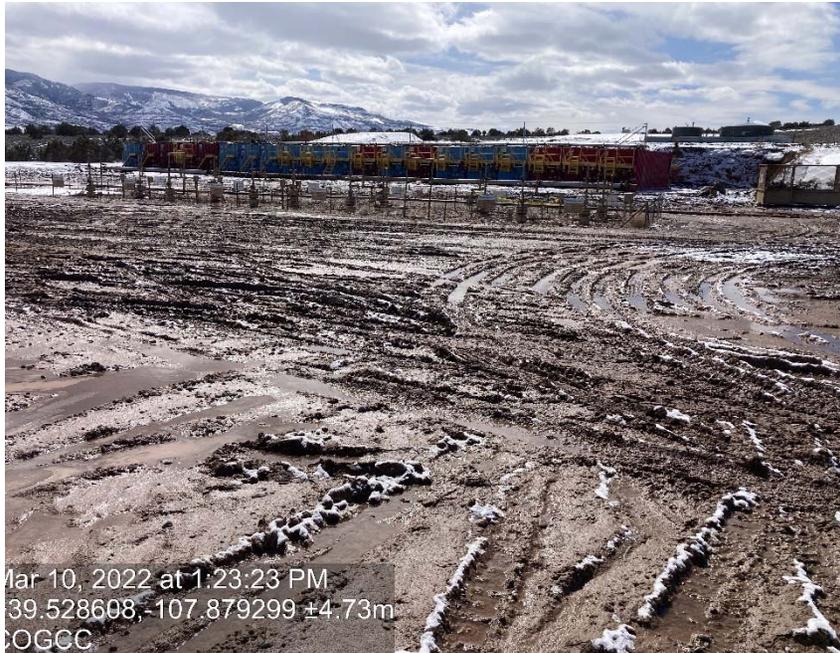
**Location/ lack of stabilization-compaction**

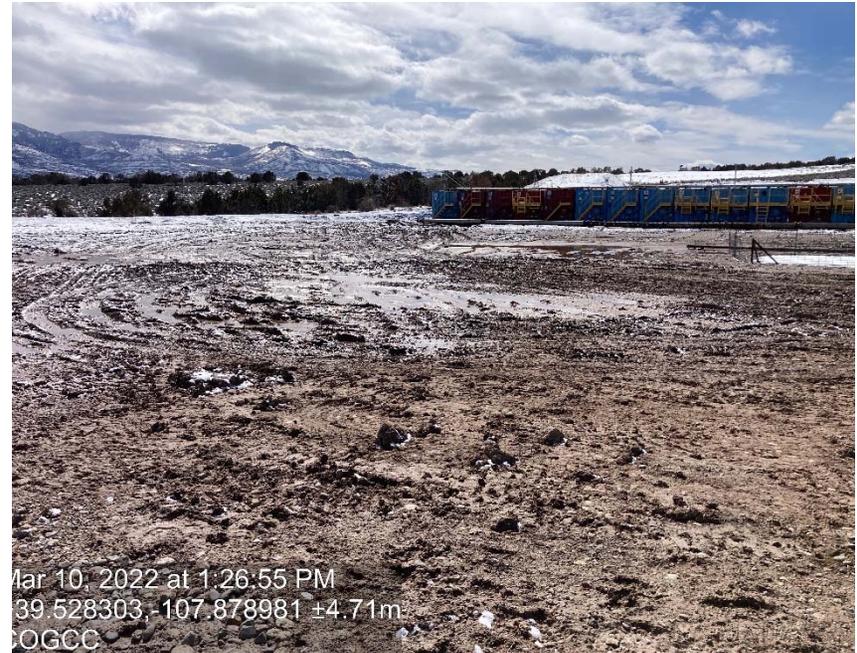
**location/ lack of stabilization-compaction**

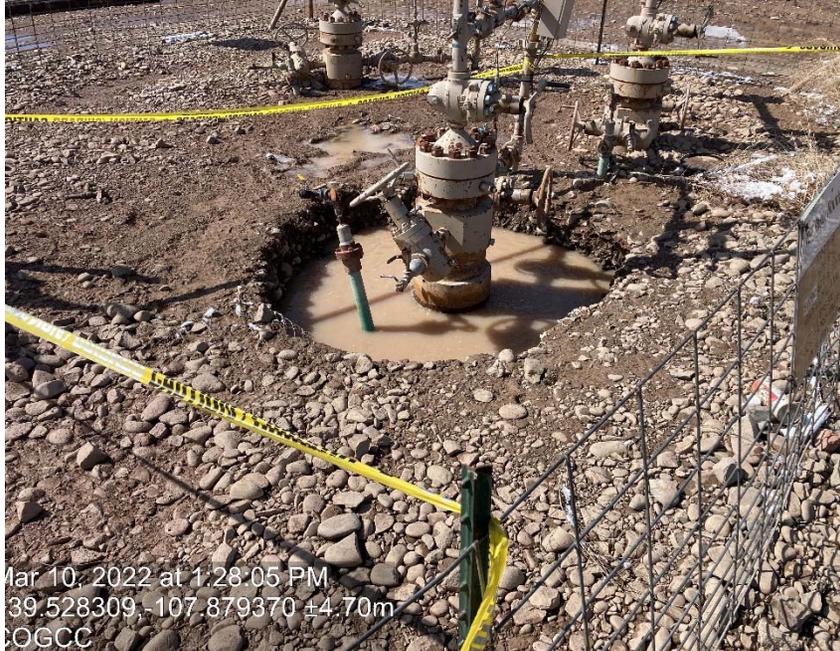
Well head leaking

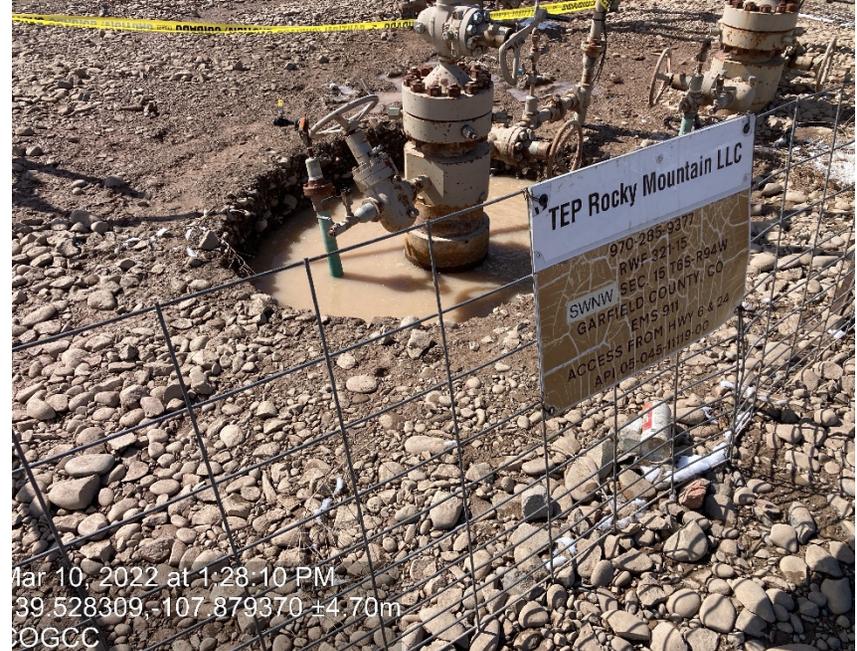
Well head leaking

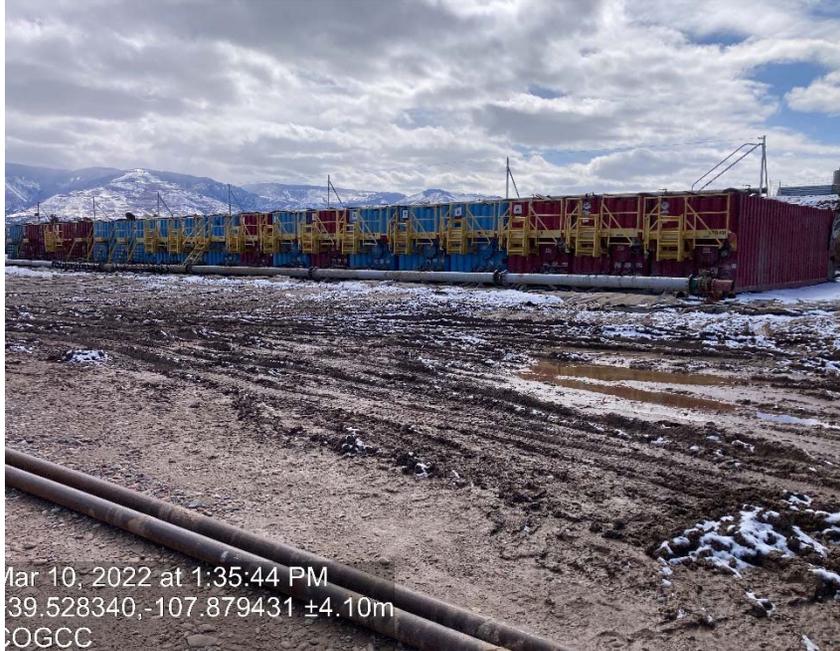
**Location/ lack of stabilization-compaction/ open hatches on tanks**

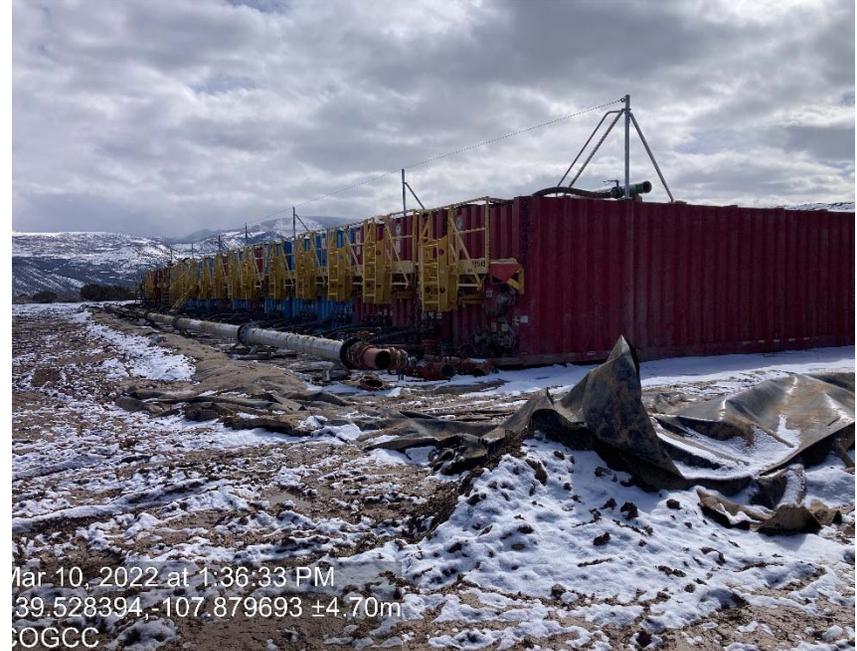
**location/ open piping and tank hatches**

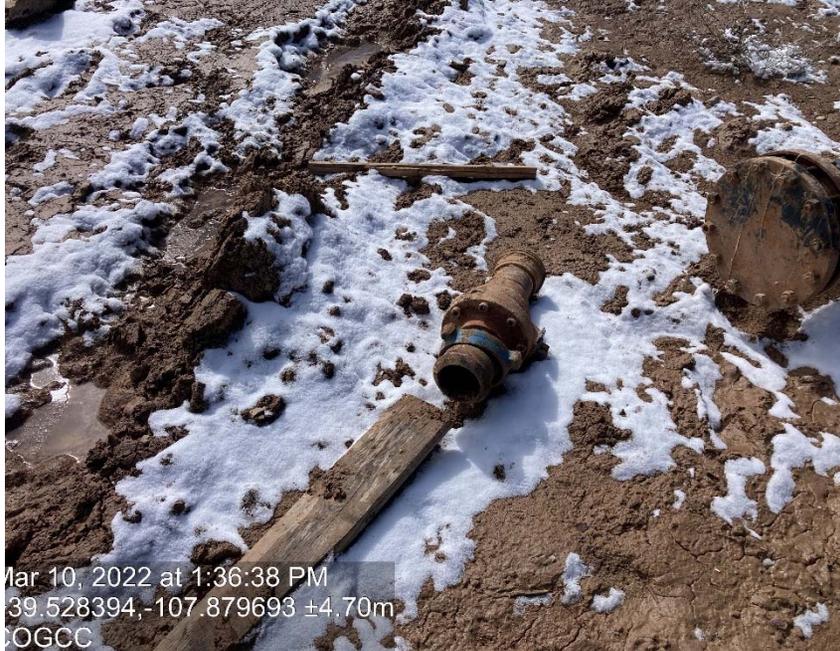
**Debris**

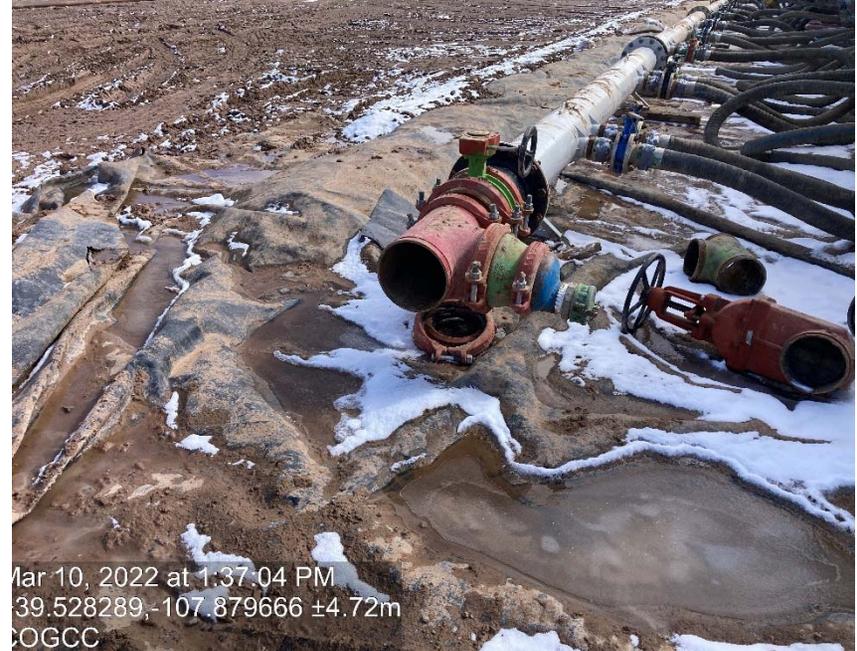
**Open ended piping**

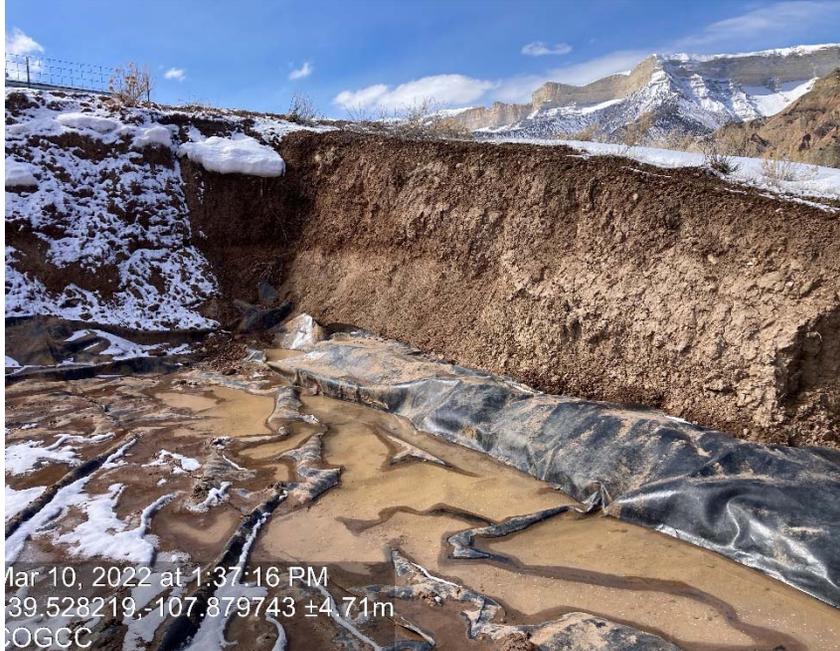
**Cut slope lack of stabilization**

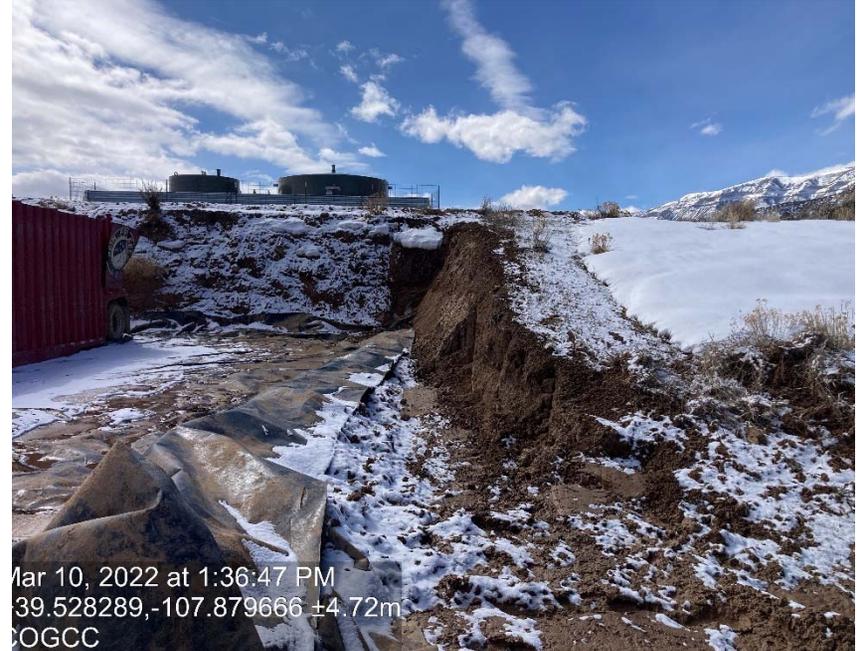
**Cut slope lack of stabilization**

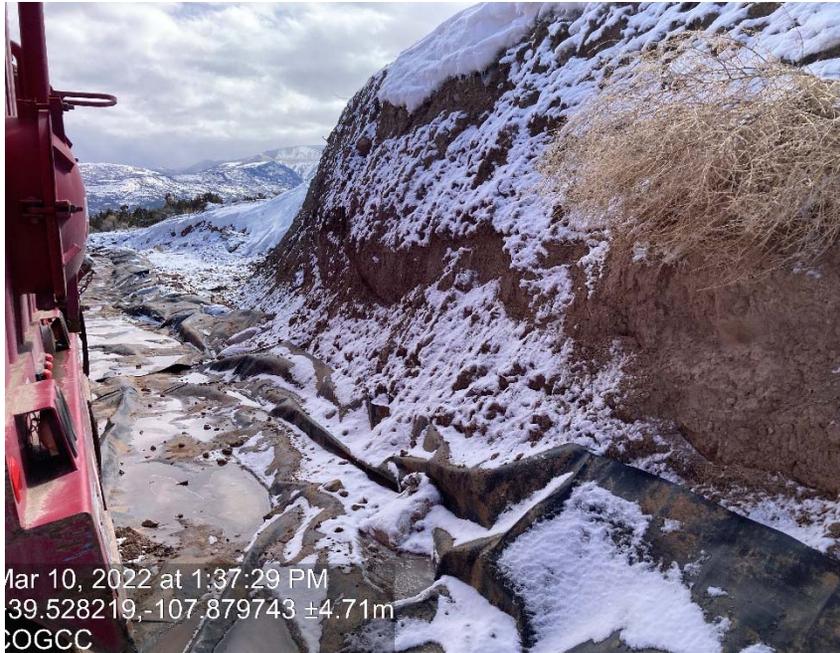
**Cut slope lack of stabilization**

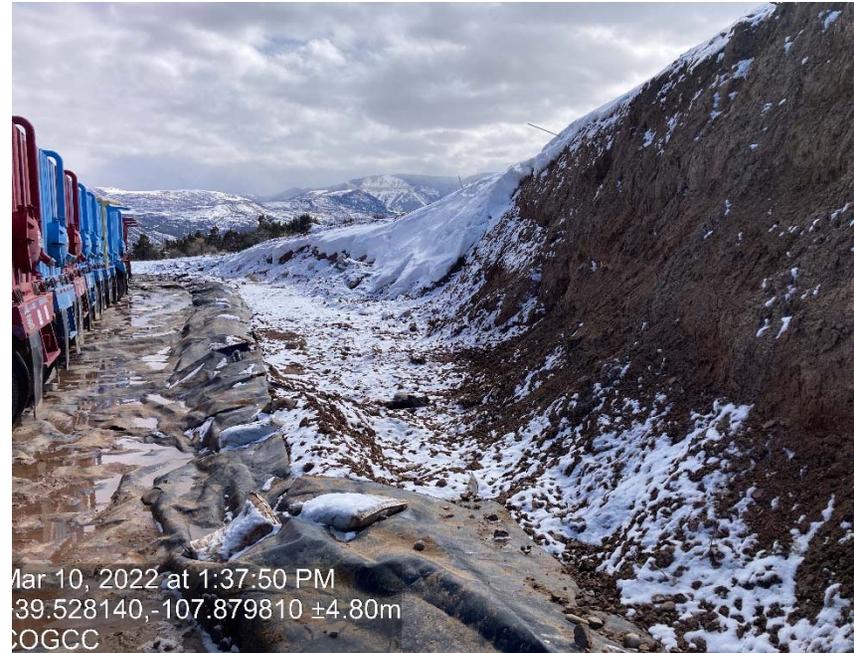
**Cut slope lack of stabilization**
