Inspection Photos  
Operator: Enduring  
API: 067-07841  
Date: 5/13/2022

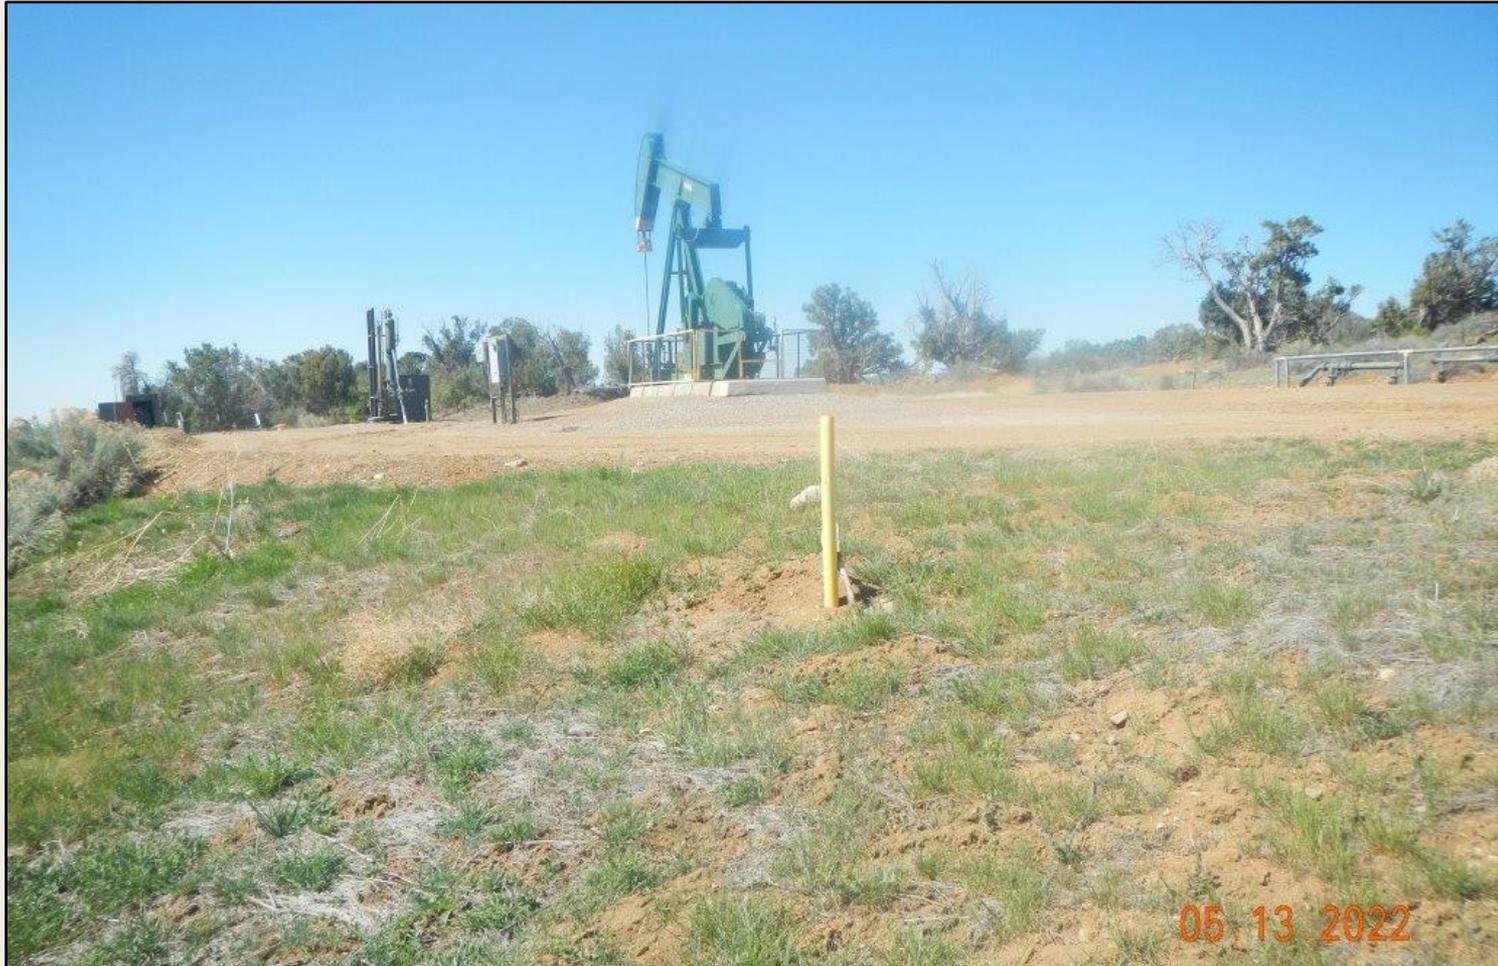
Photo 1. View of the project area from the northeastern corner facing center.

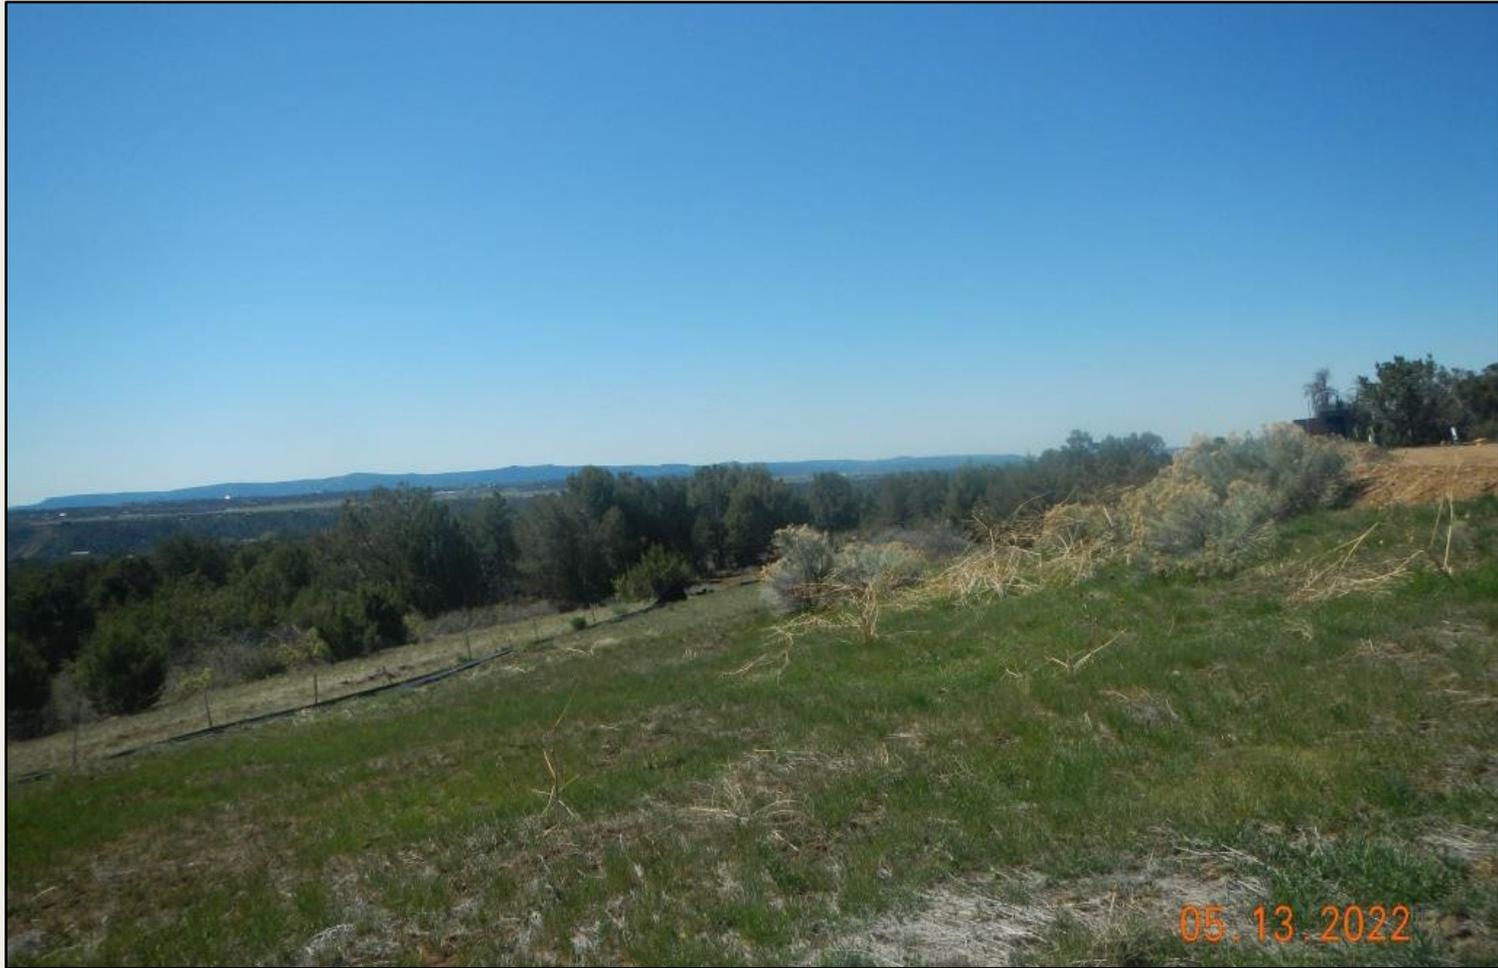
Photo 2. View of the eastern fill slope from the northeastern corner facing southward. Vegetation within the eastern project area remains dominated with annual weeds such as cheatgrass and jointed goatgrass. This needs to be assessed and managed until desirable perennial vegetation is established.

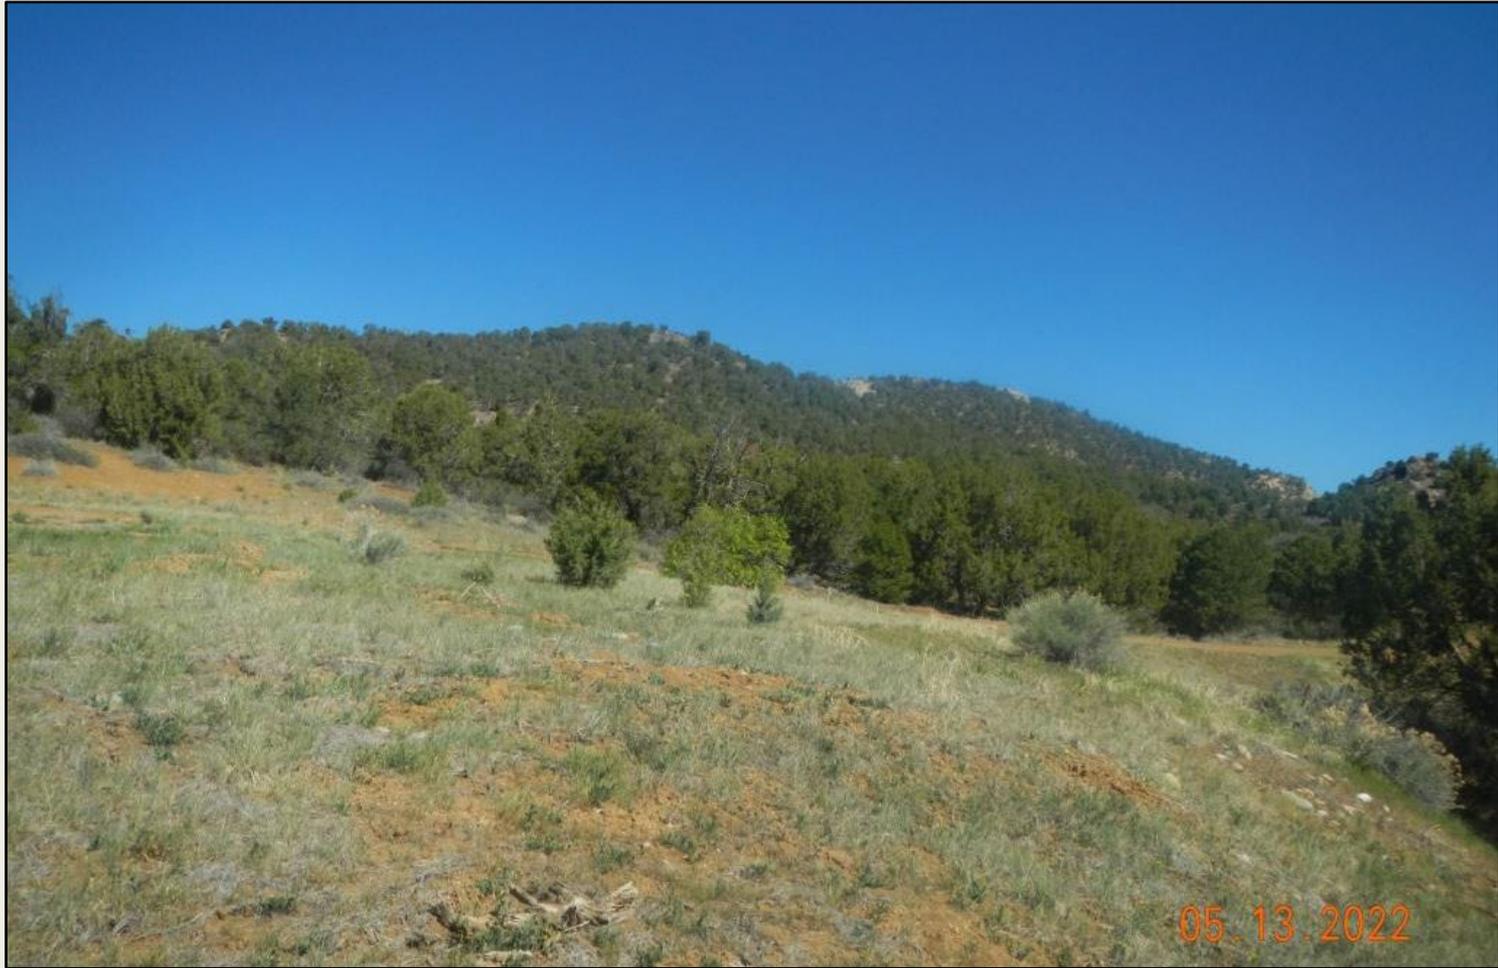
Photo 3. View of the northern project area from the northeastern corner facing westward.

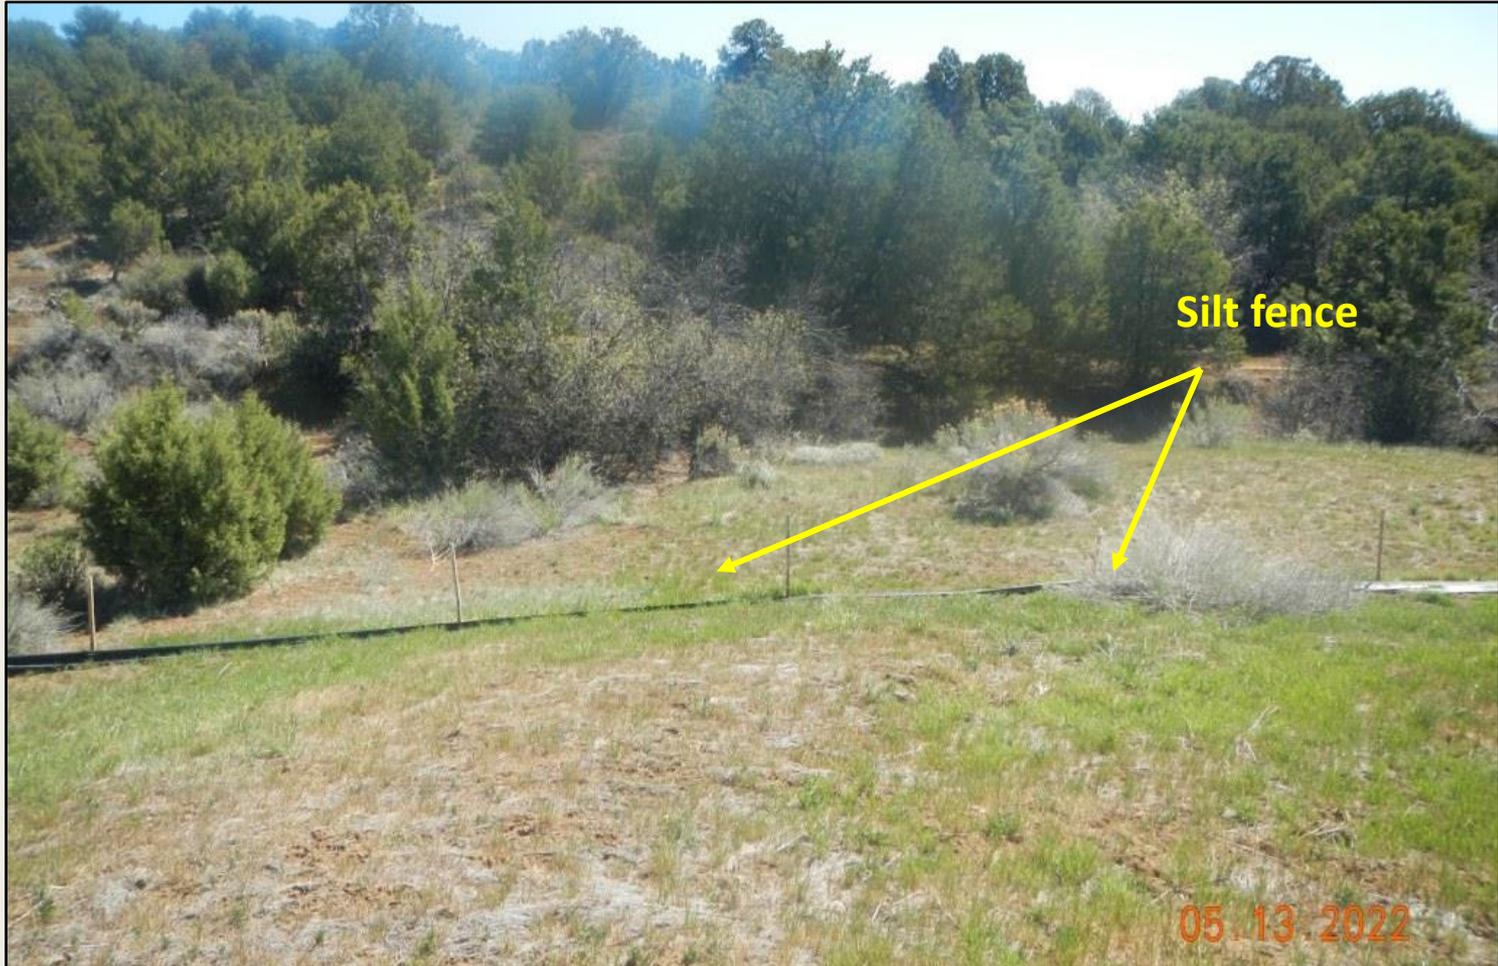
Photo 4. View of perimeter silt fence that is no longer functioning and needs to be repaired or removed.
