Inspection Photos
Operator: Simcoe
API: 067-06546
Date: 5/27/2022

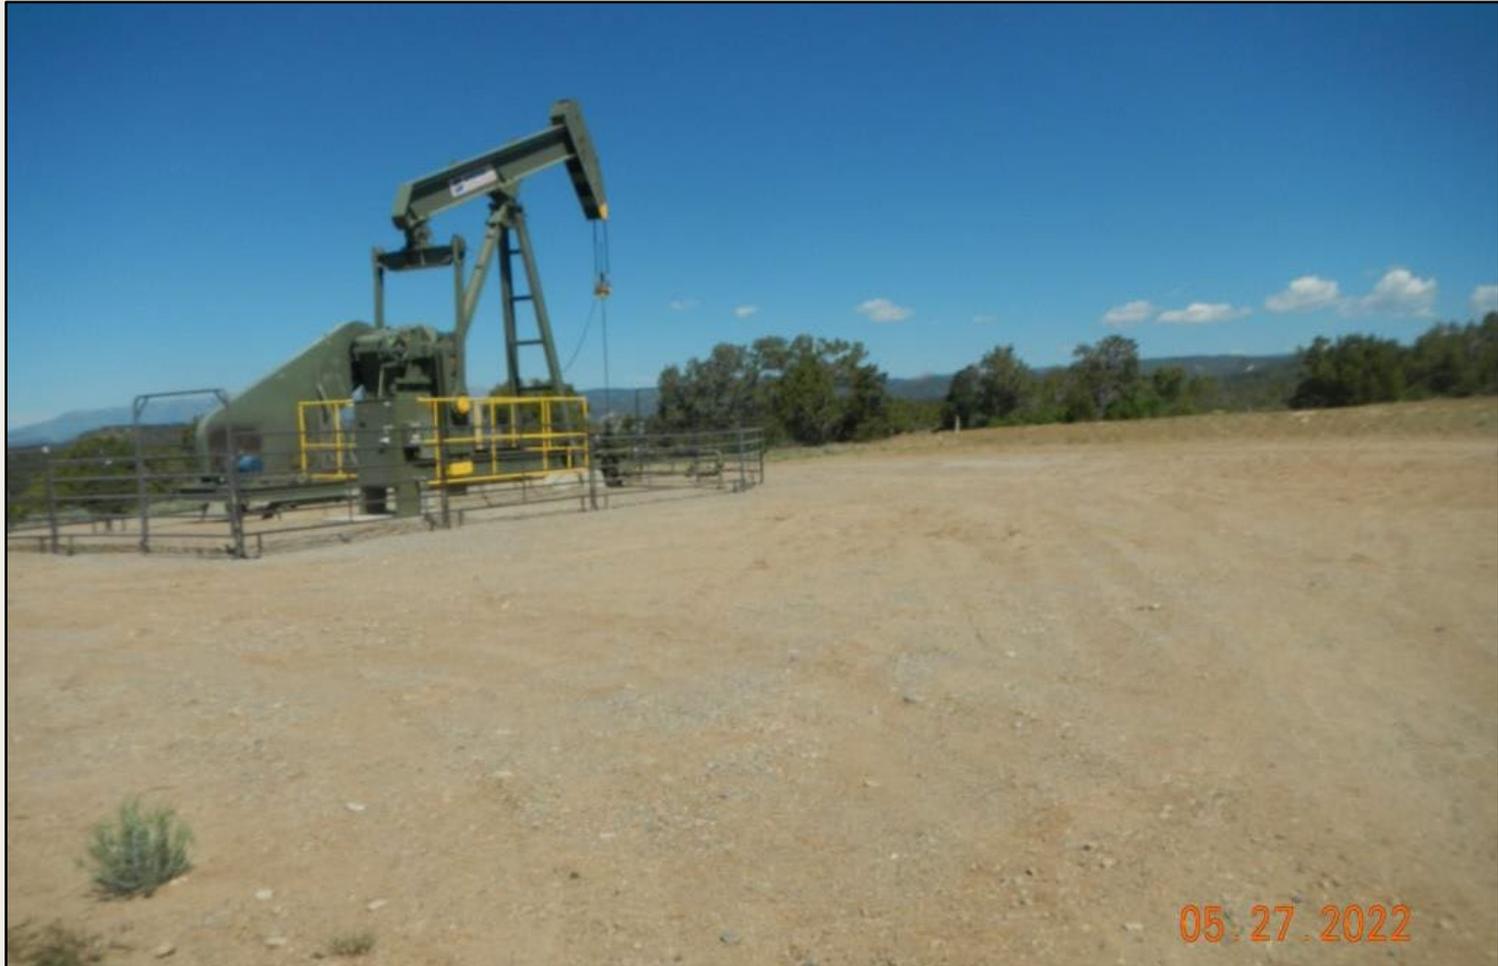
Photo 1. View of the project area from the southeastern corner facing center.

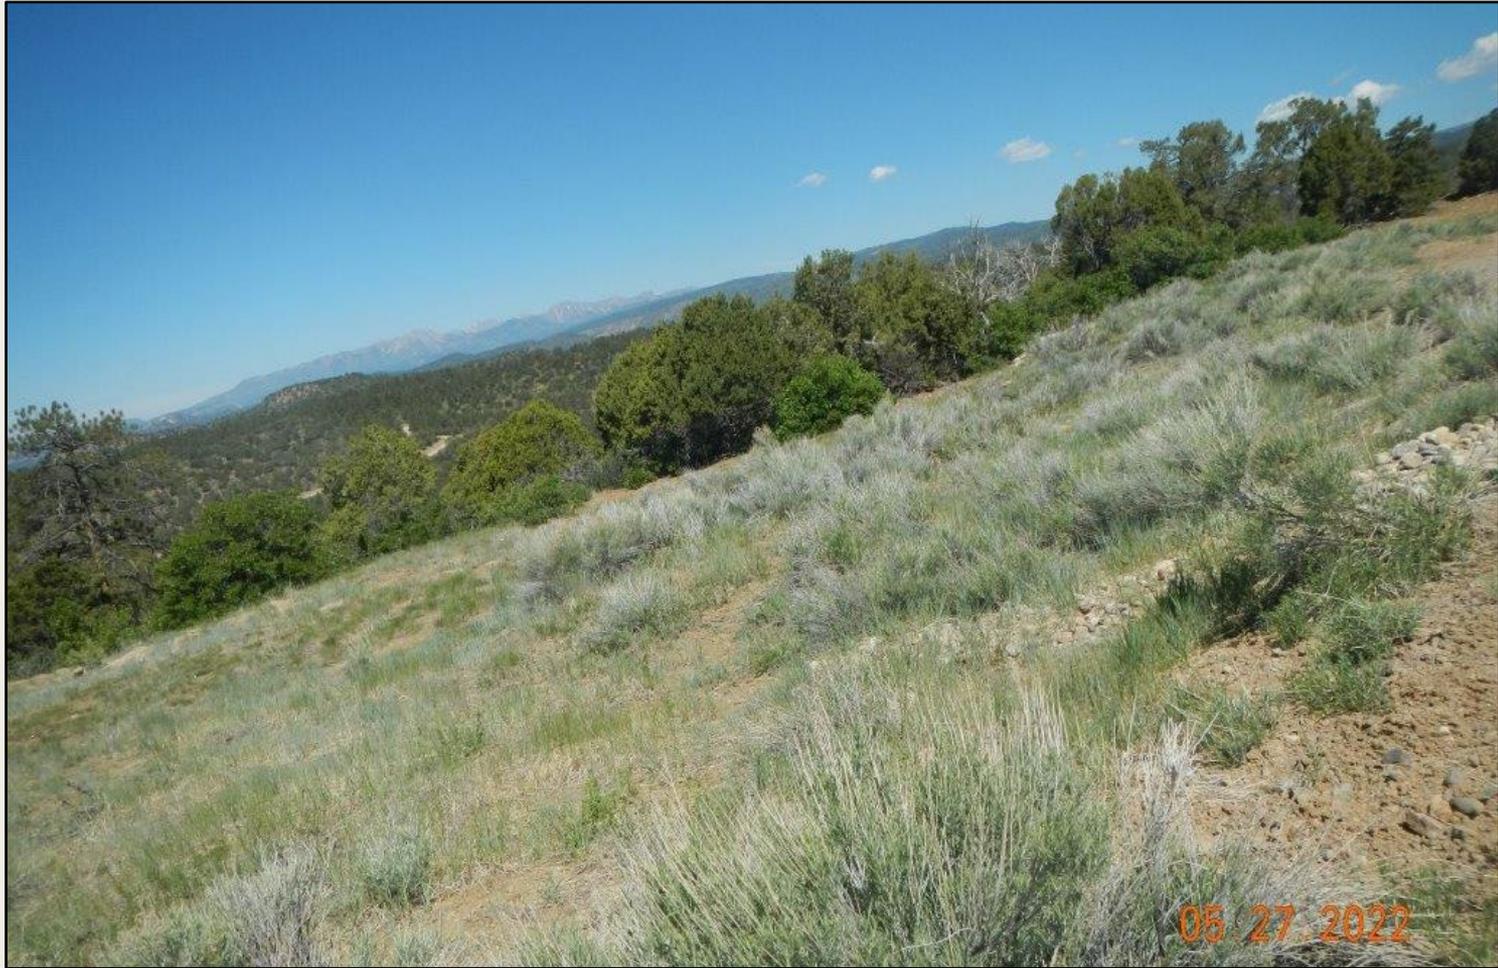
Photo 2. View of the western project area from the southwestern corner facing northward. Revegetation is progressing within the project area with western wheatgrass, smooth brome, rubber rabbitbrush, and sand dropseed.

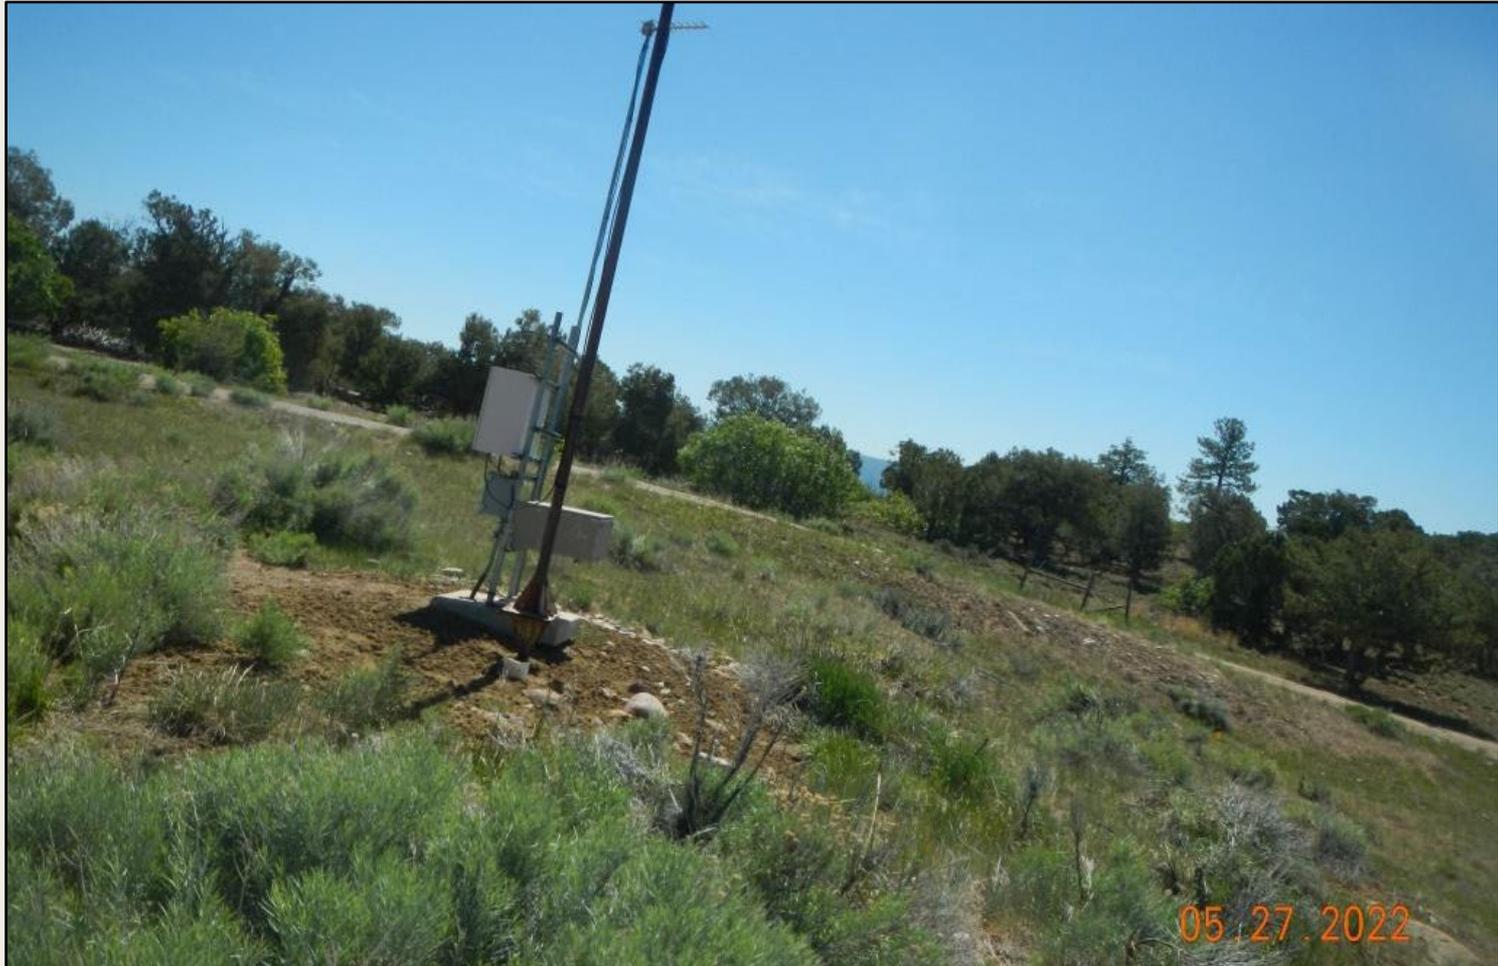
Photo 3. View of the southern project area from the southwestern corner facing eastward.

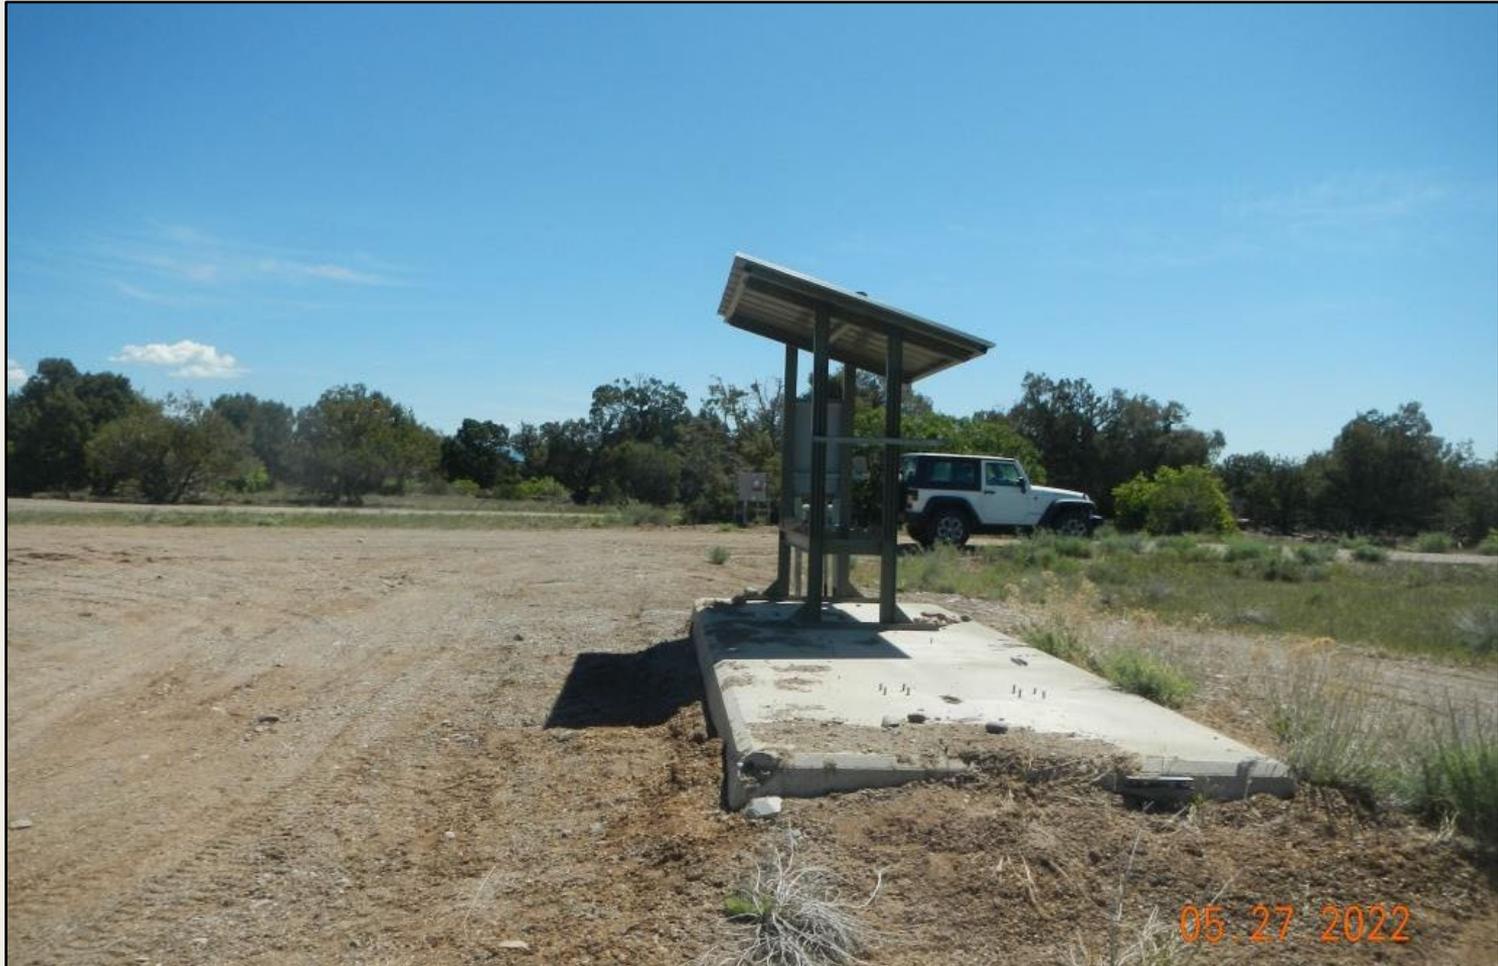
Photo 4. View of cement block and electrical housing that do not appear to be in use.

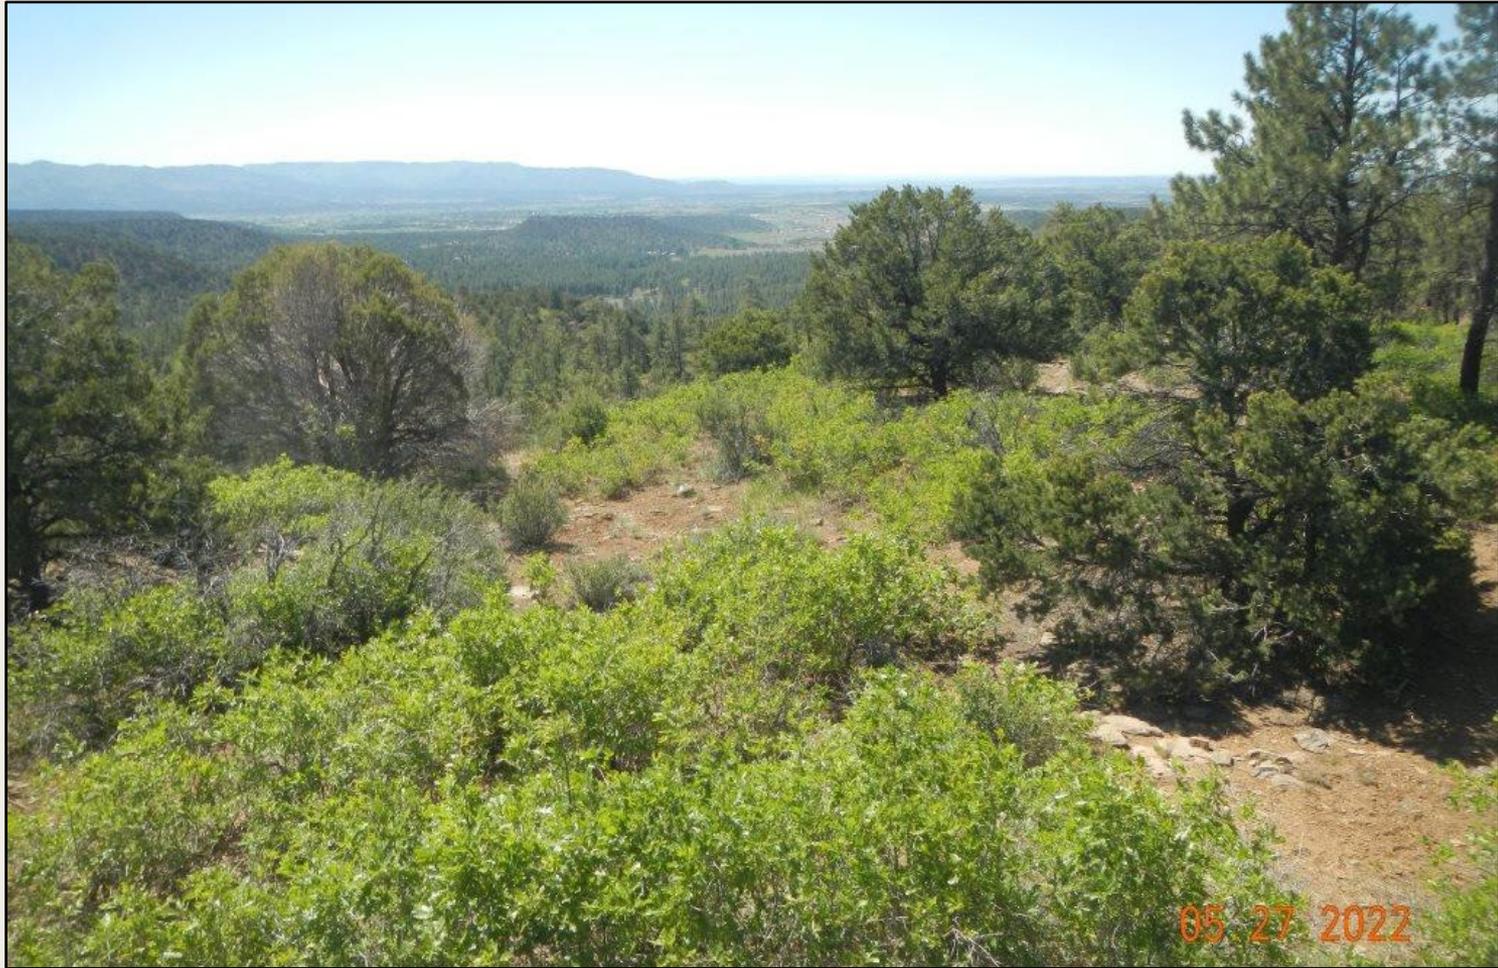
Photo 5. View of reference area comprised of ponderosa pine woodland with gambel oak, antelope bitterbrush, sandberg bluegrass, black sage, and mules ears in the understory.
