Inspection Photos
Operator: Simcoe
API: 067-09503
Date: 5/27/2022

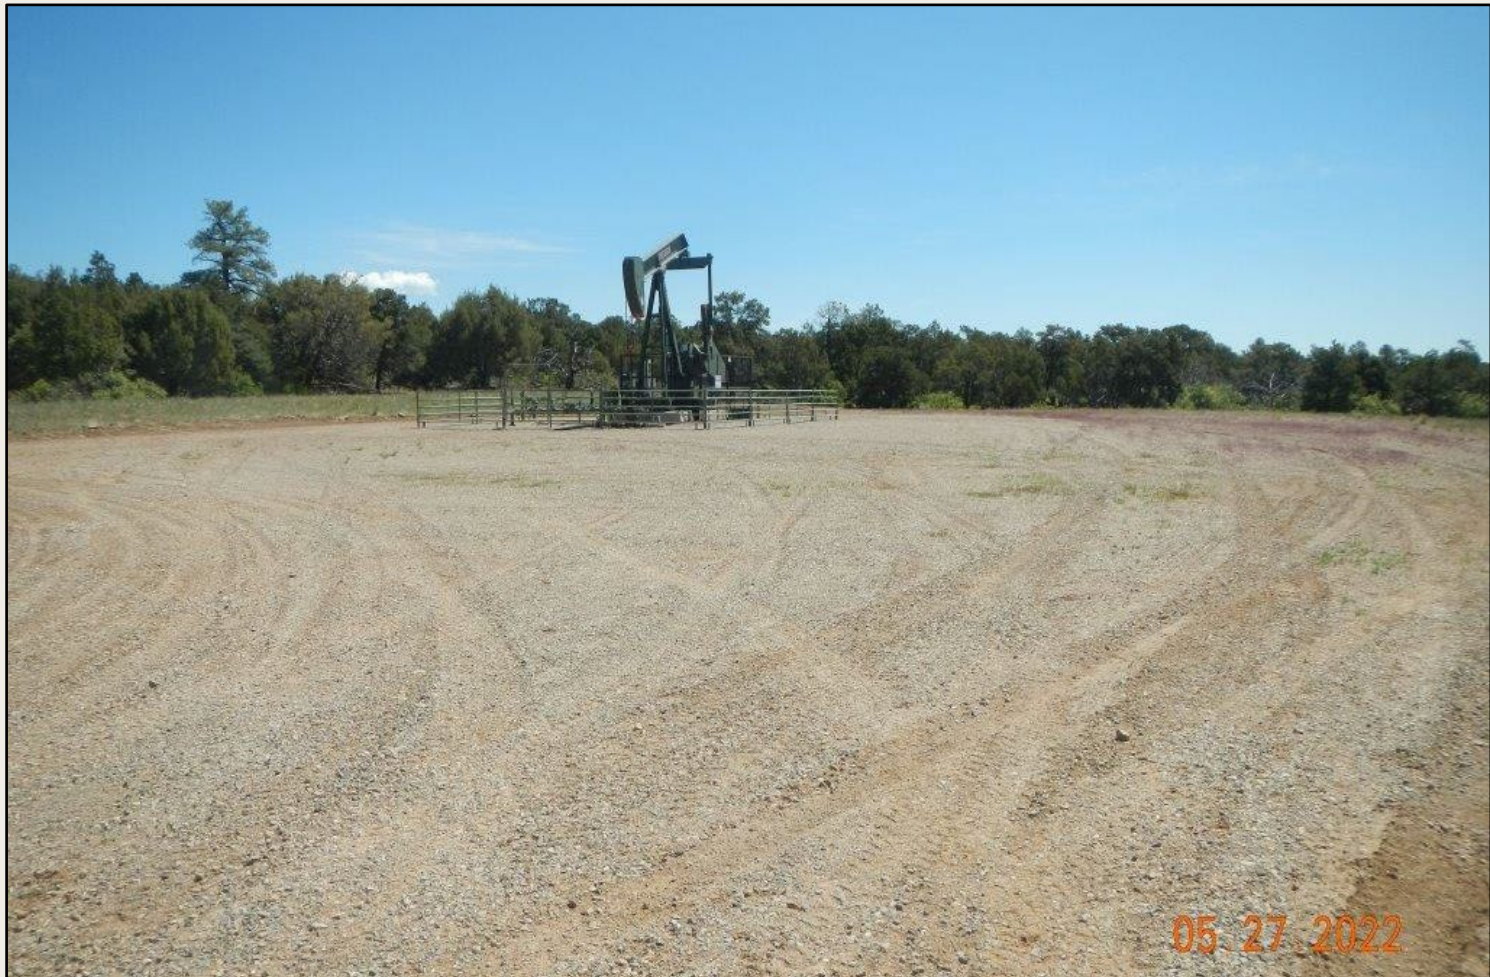
Photo 1. View of the project area from the well pad entrance facing center.

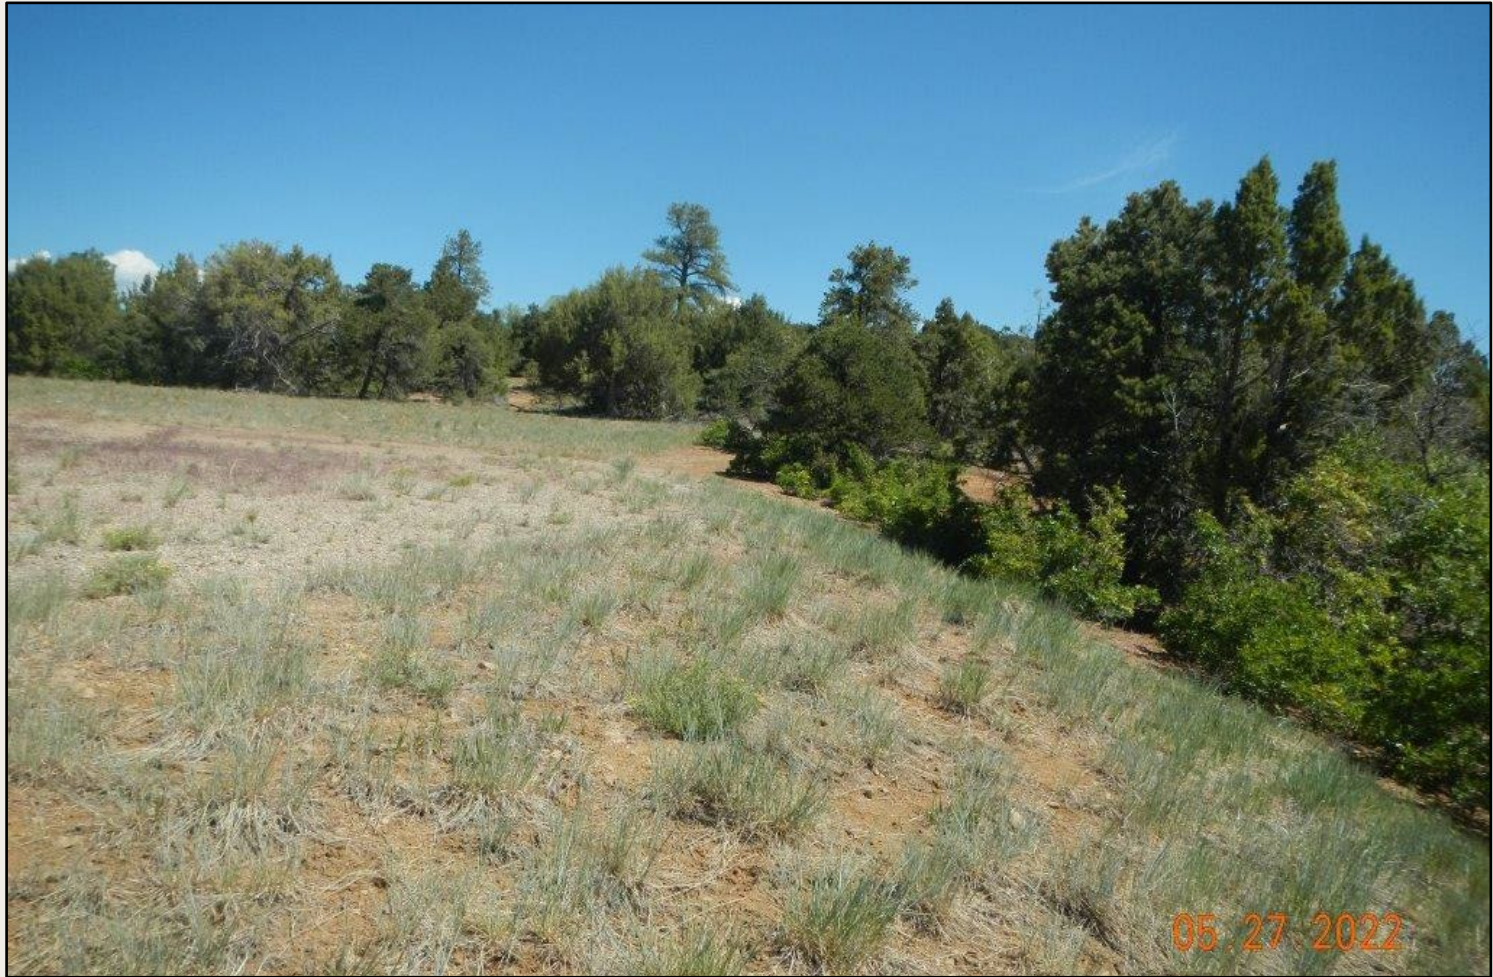
Photo 2. View of the eastern project area from the southeastern corner facing northward. Revegetation is progressing within the project area with western wheatgrass, smooth brome, and sand dropseed.

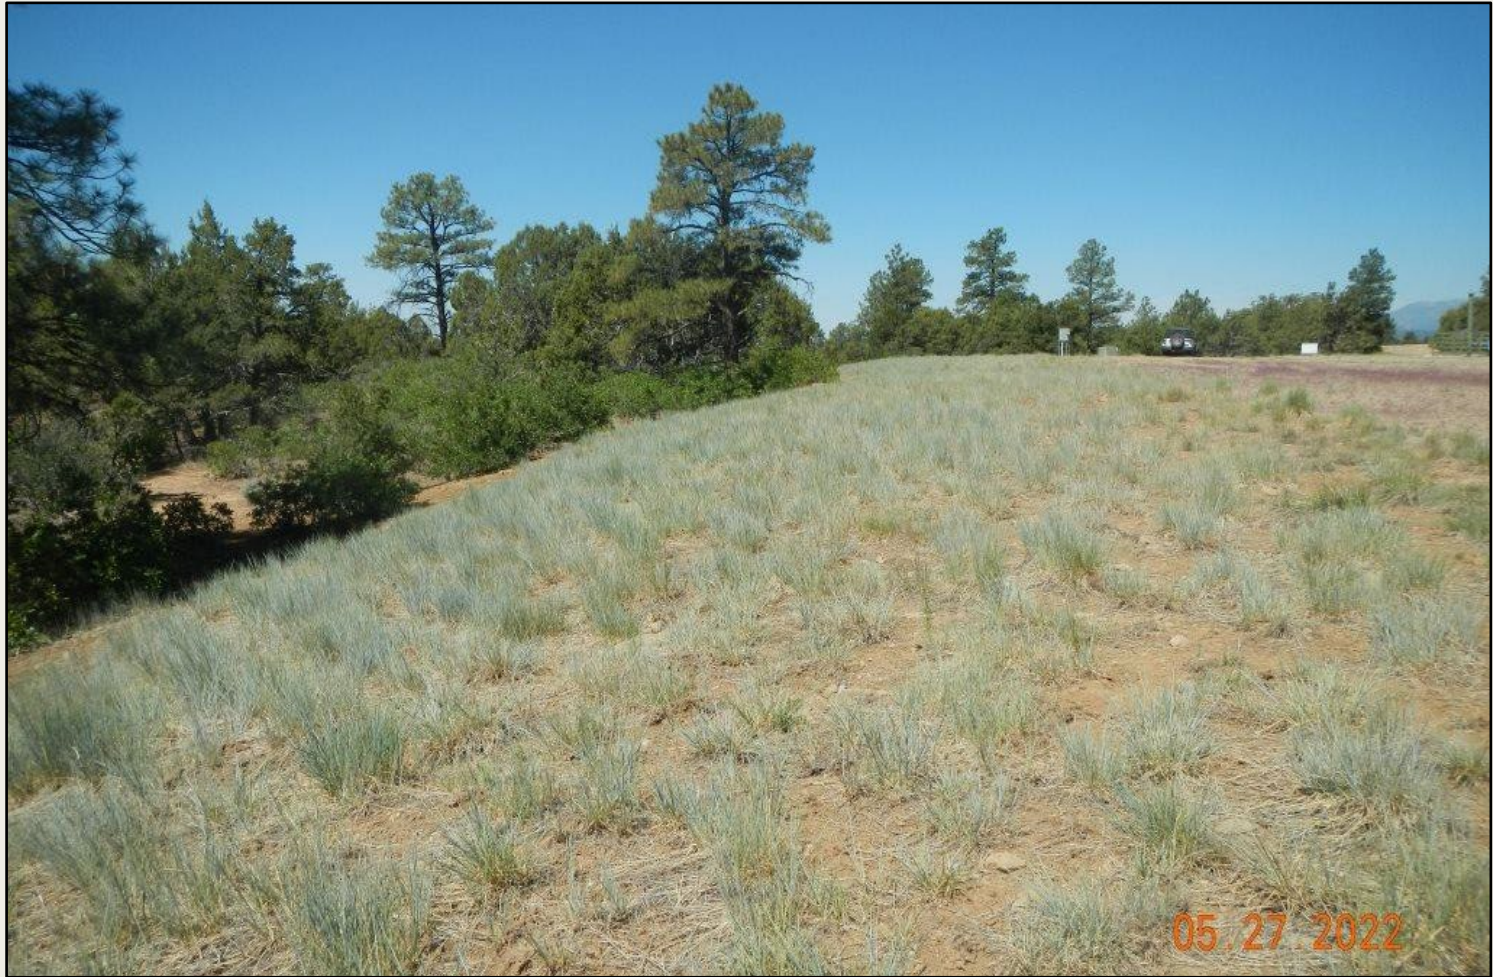
Photo 3. View of the southern project area from the southeastern corner facing westward.

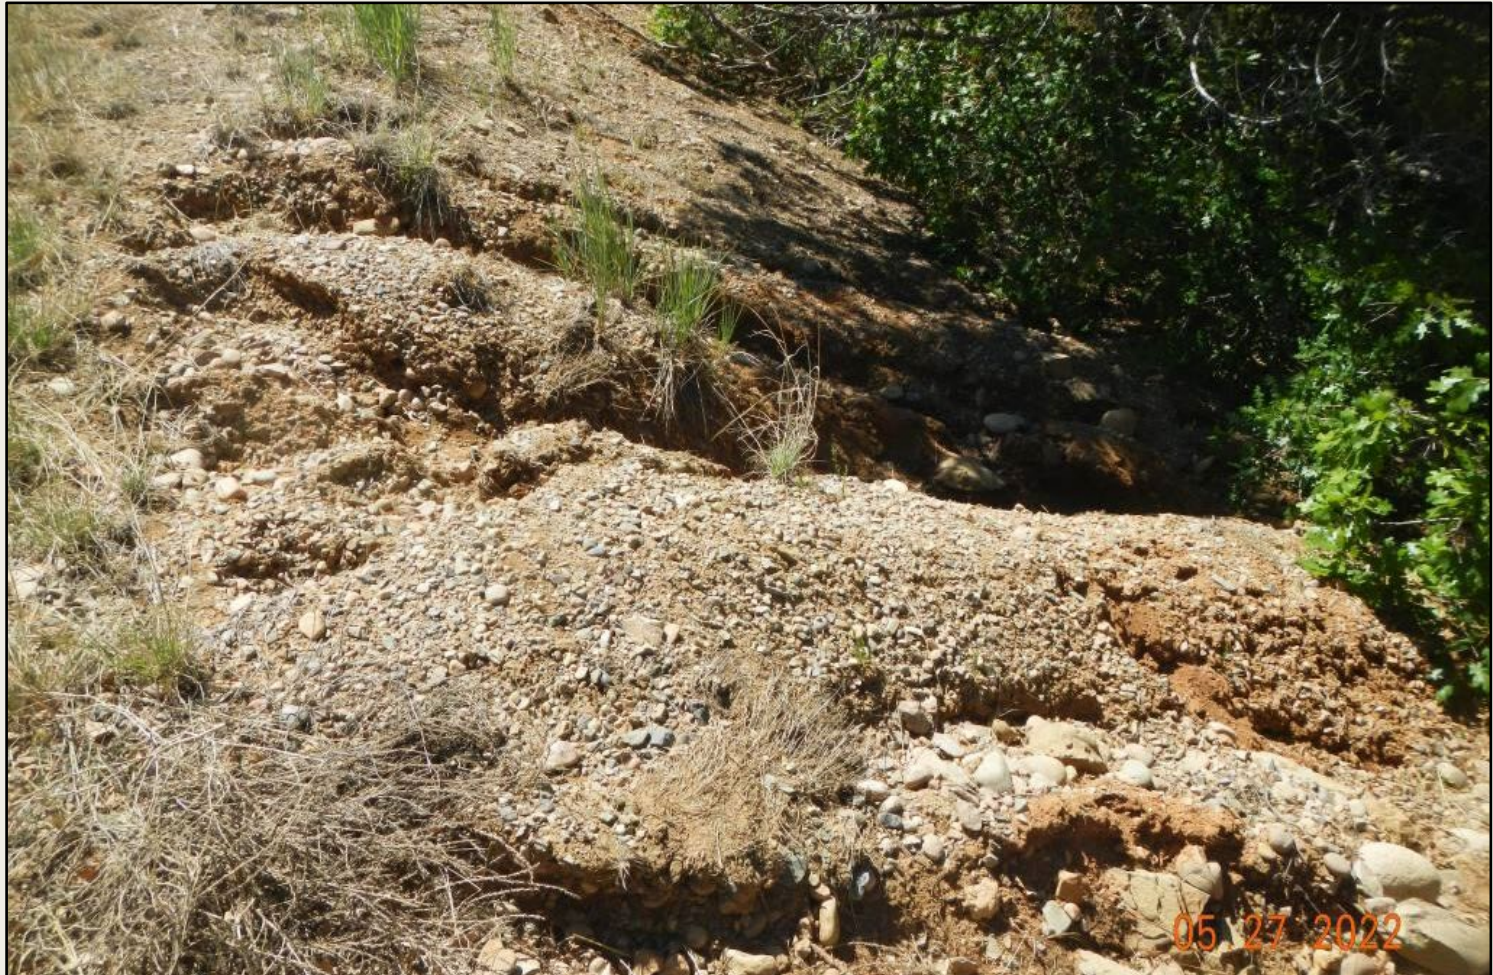
Photo 4. View of erosional channeling in the southern fill slope, approximately 1-2ft wide and deep.

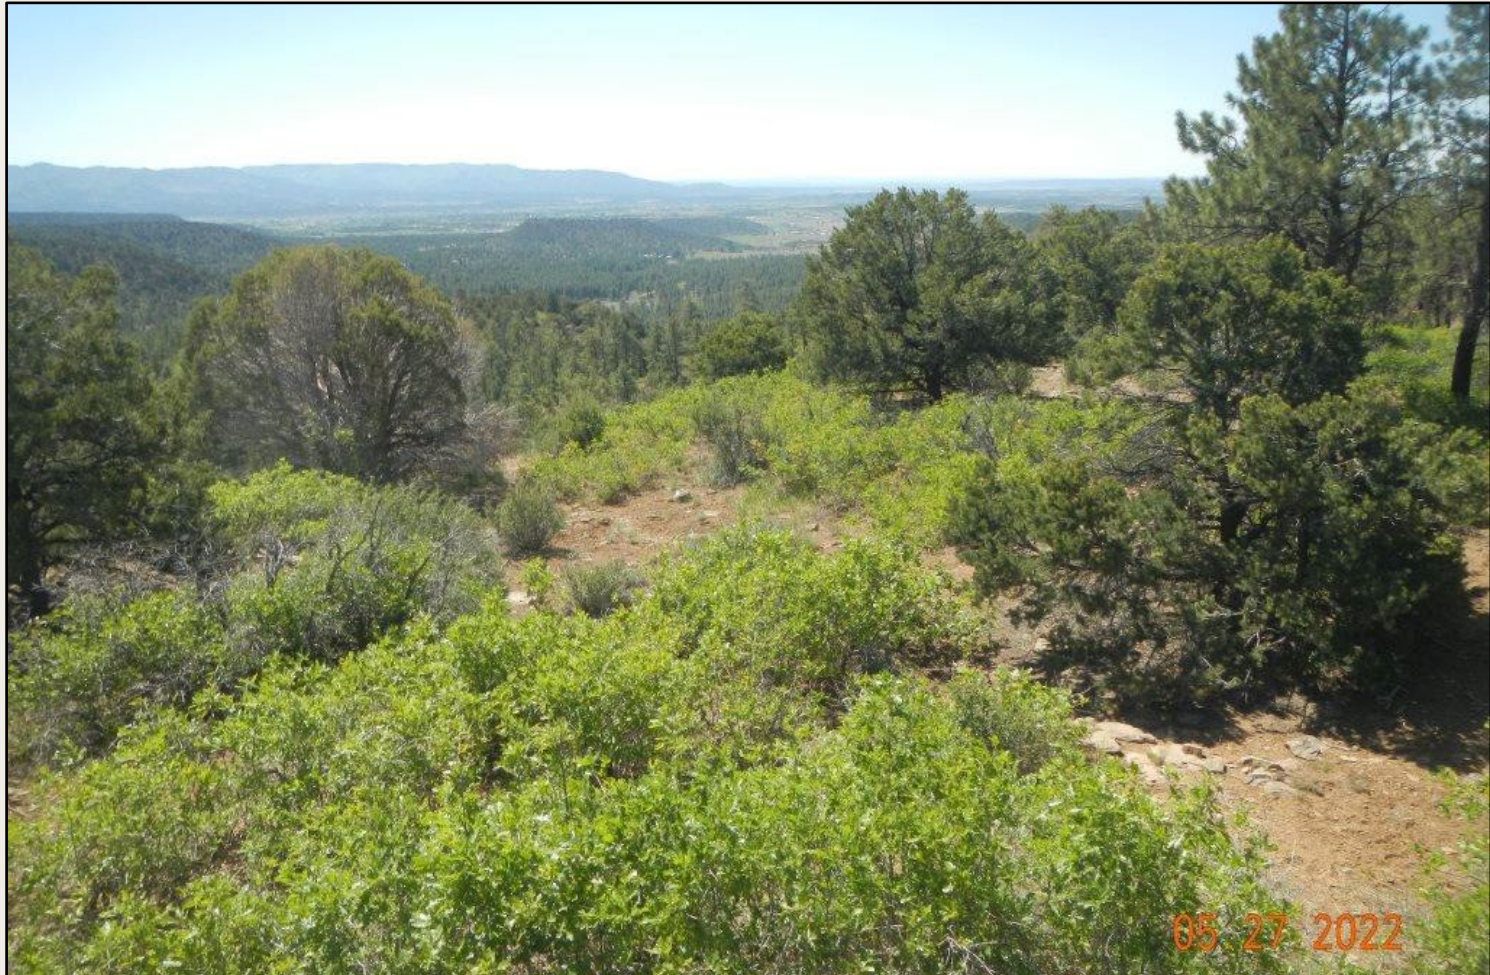
Photo 5. View of reference area comprised of ponderosa pine woodland with gambel oak, antelope bitterbrush, sandberg bluegrass, black sage, and mules ears in the understory.
