Inspection Photos
Location Name: M and M 6
Location ID: 325619

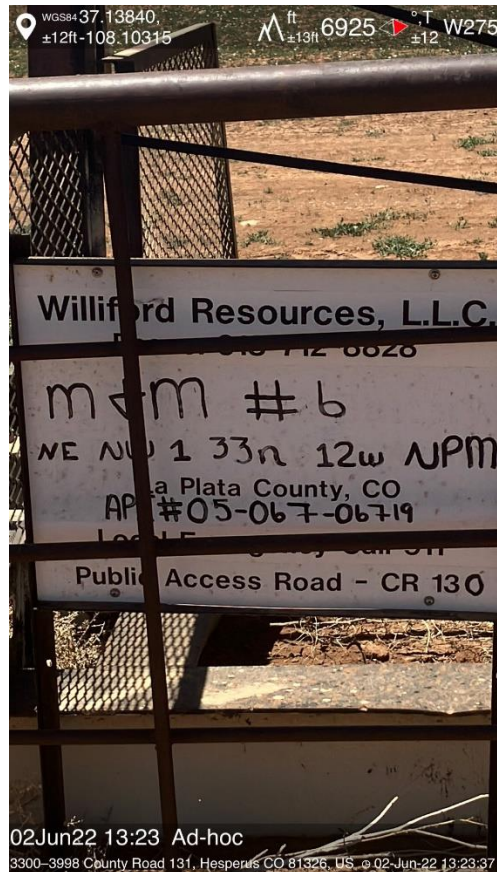
IMG 01
Well sign

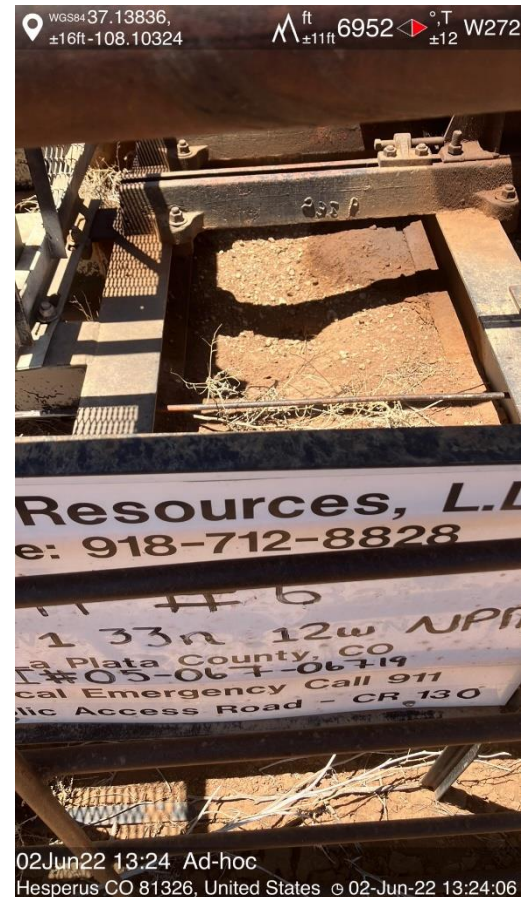
IMG 02
Well sign

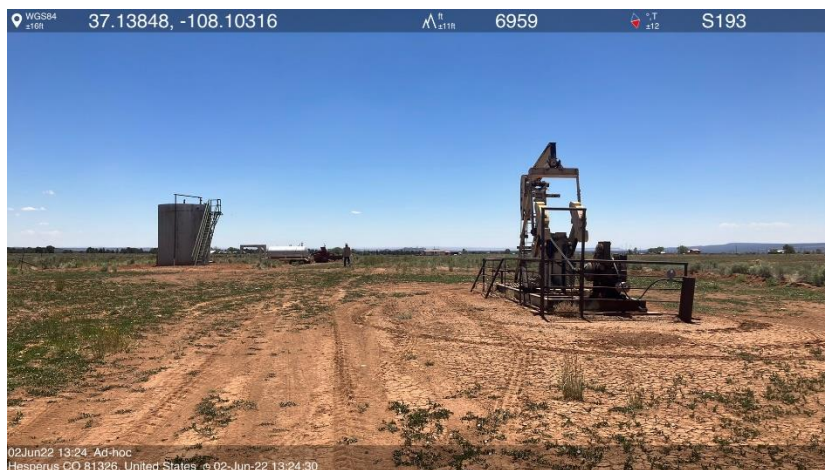
IMG 03
Site overview

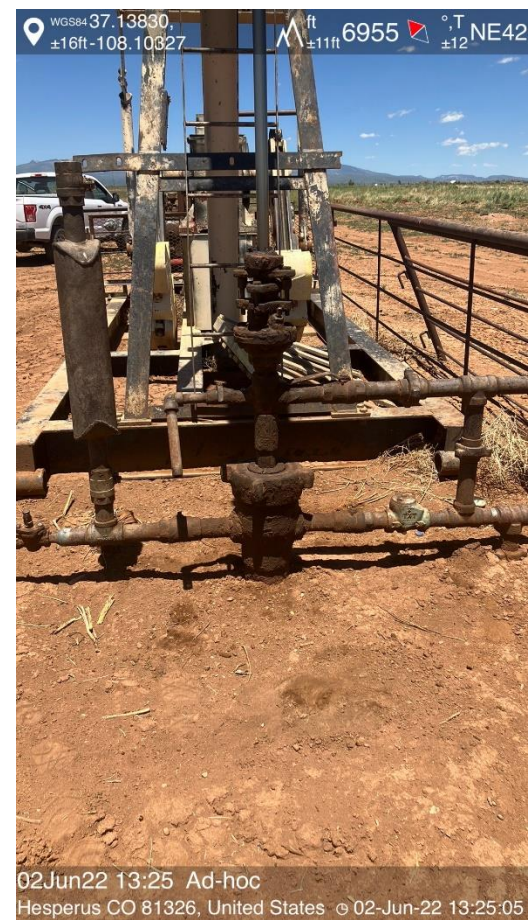
IMG 04
Wellhead

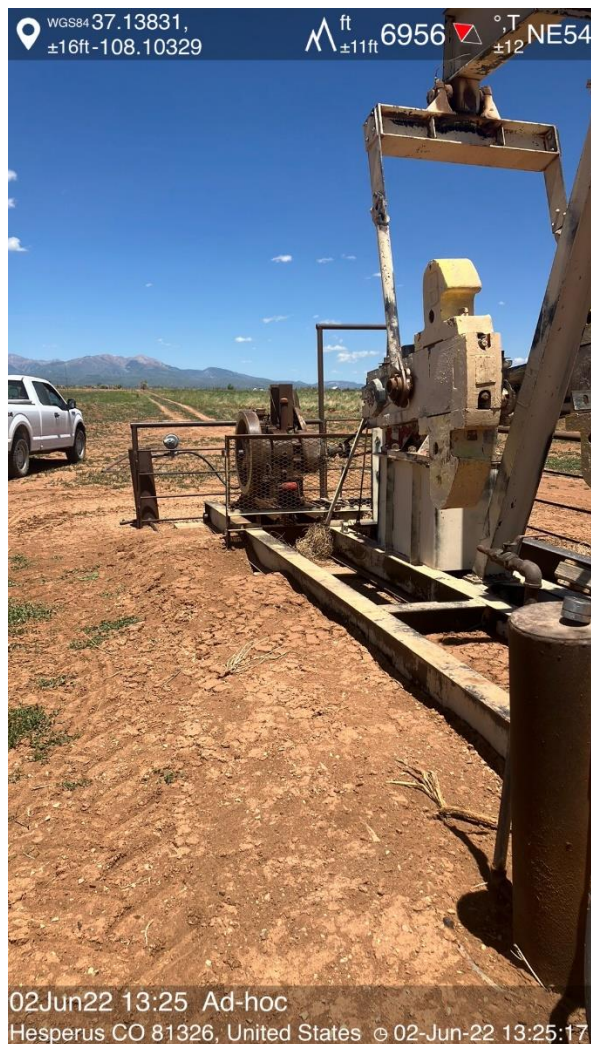
IMG 05

Pump jack and prime mover

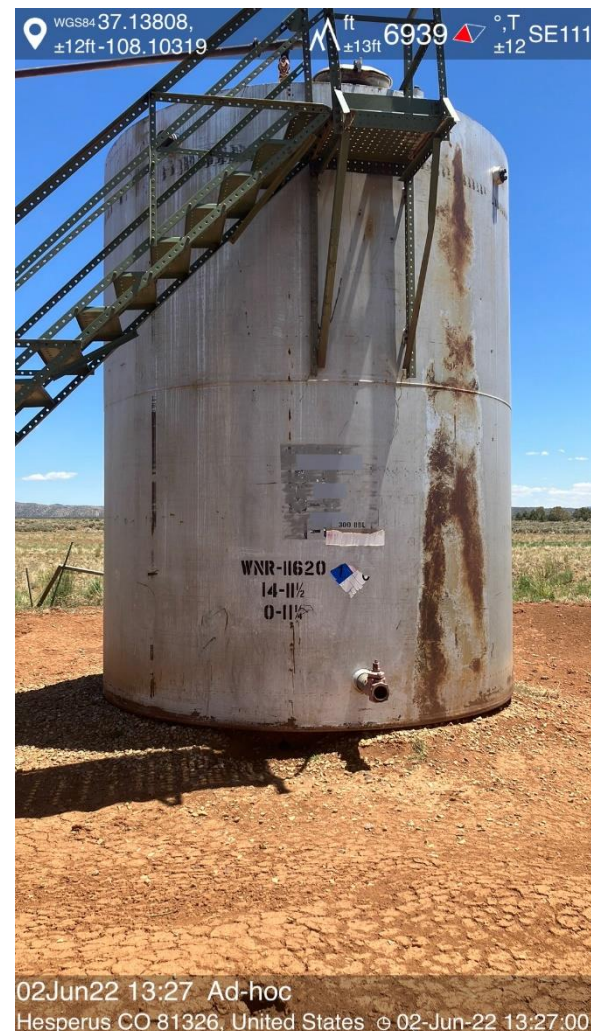
IMG 06

Tank with faded paint and no sign

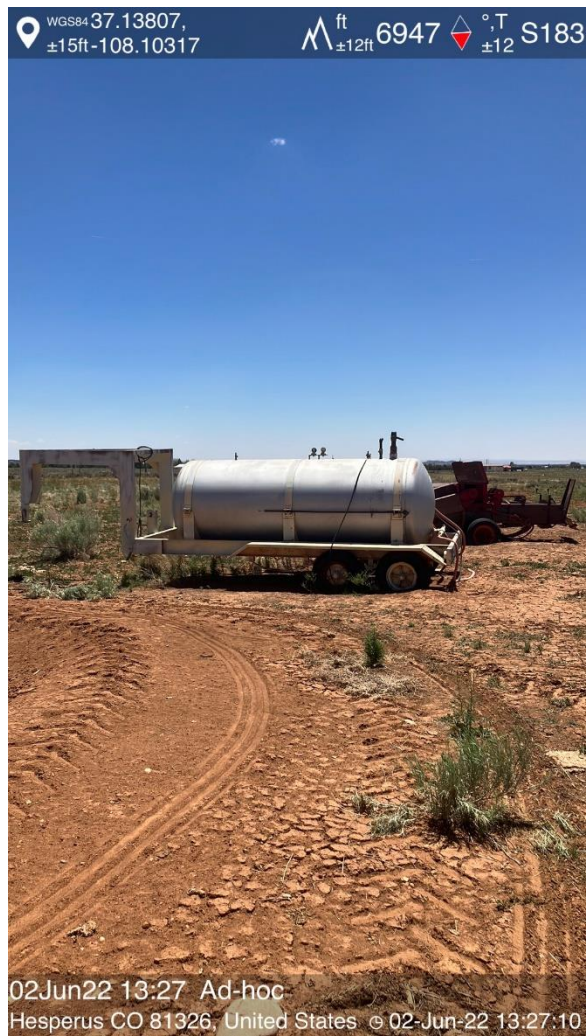
IMG 07

Trailer is on edge of location

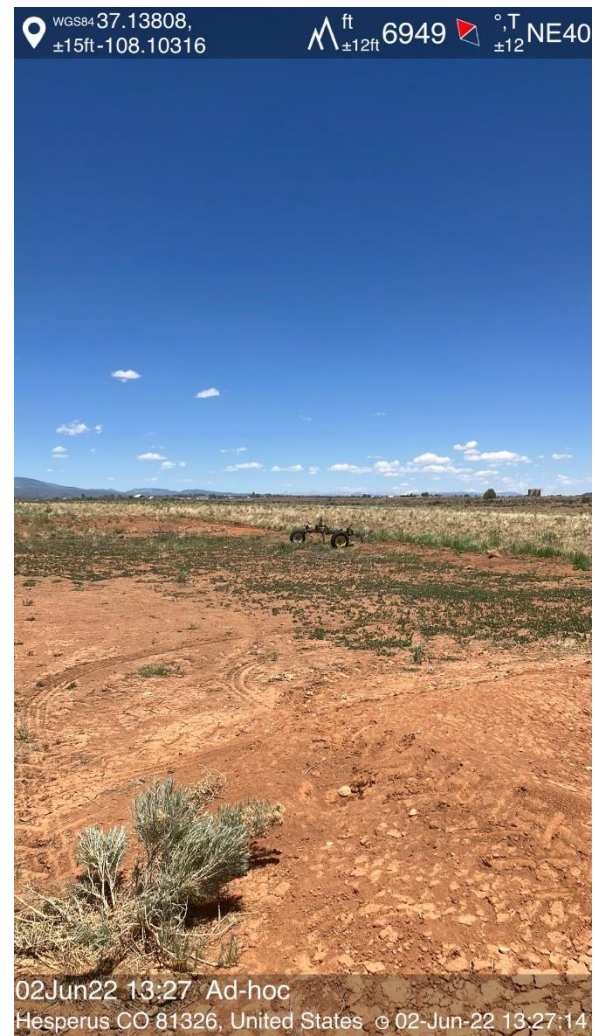
IMG 08

Equipment on edge of location

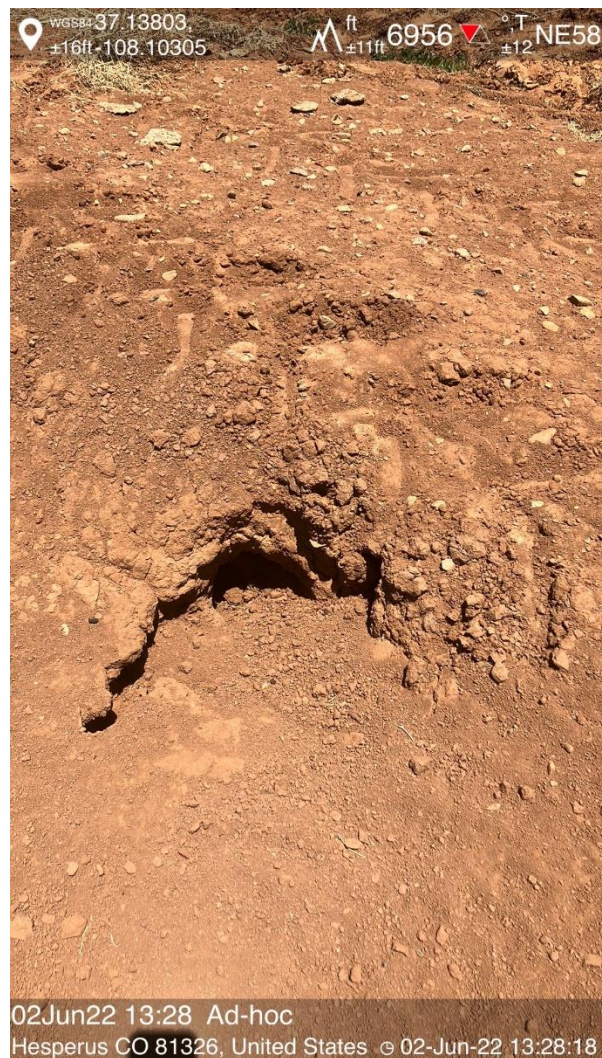
IMG 09

Burrows in secondary containment

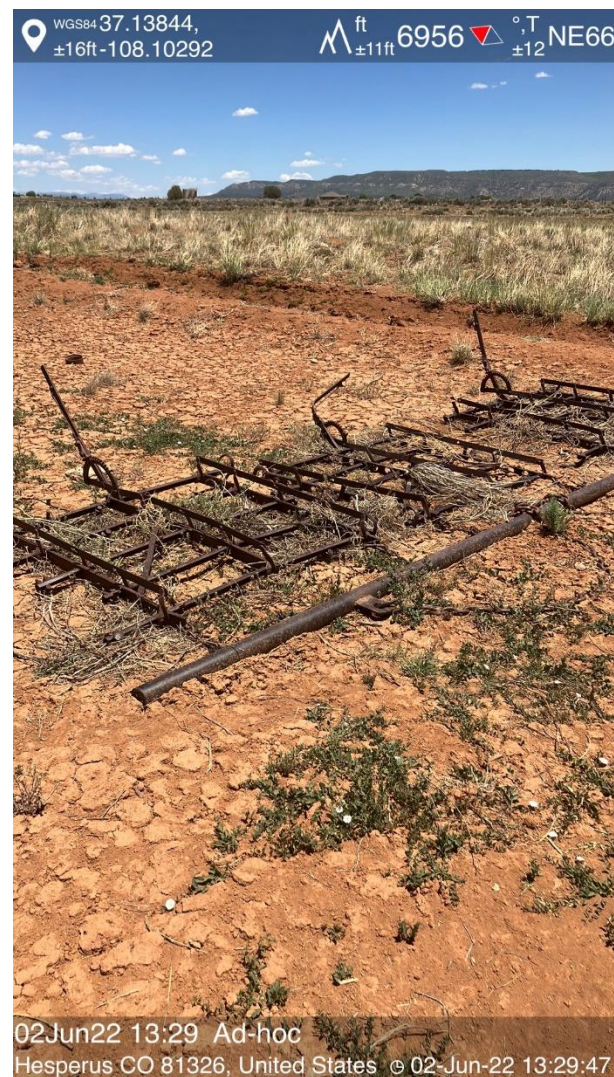
IMG 10

Equipment on edge of location

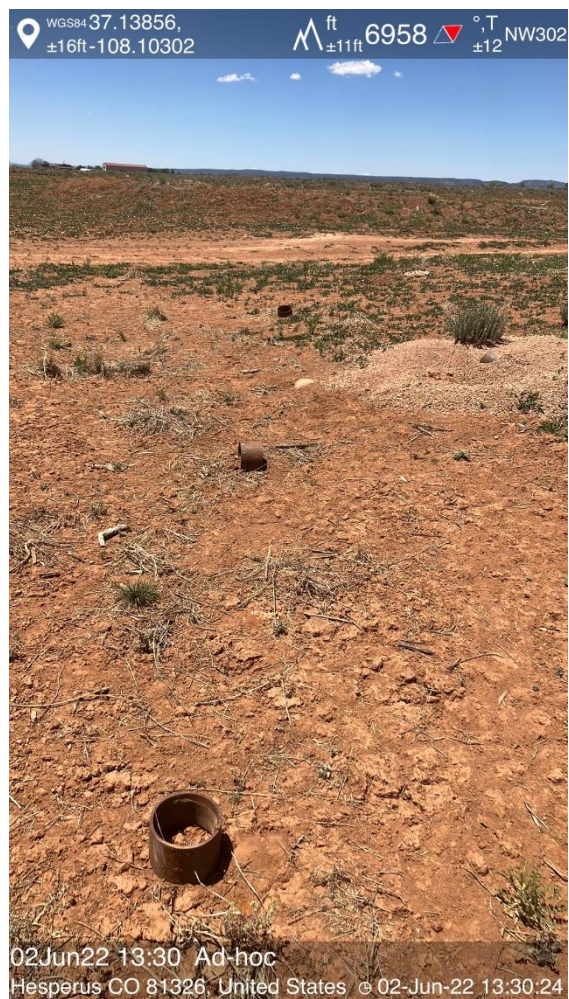
IMG 11
Debris

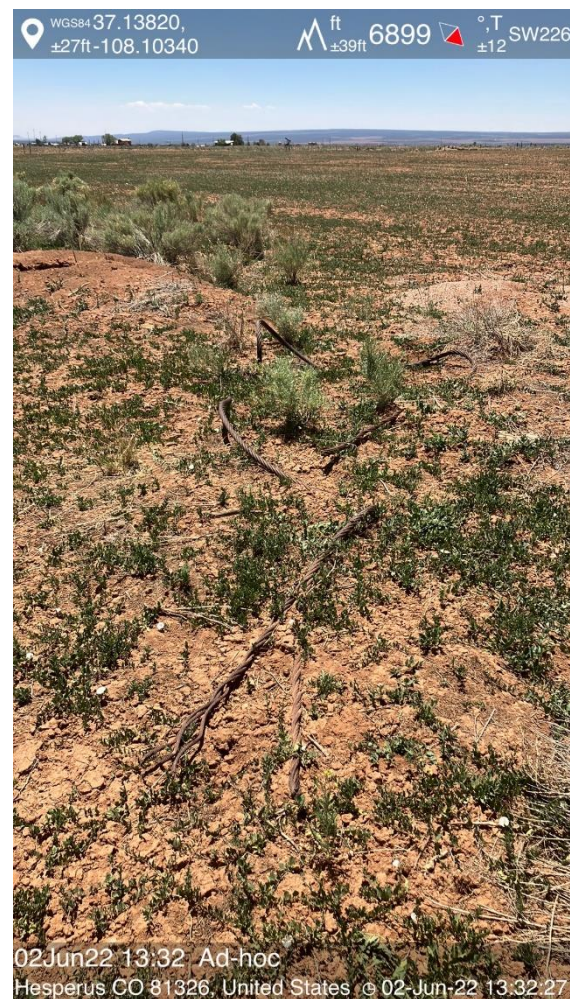
IMG 12
Debris

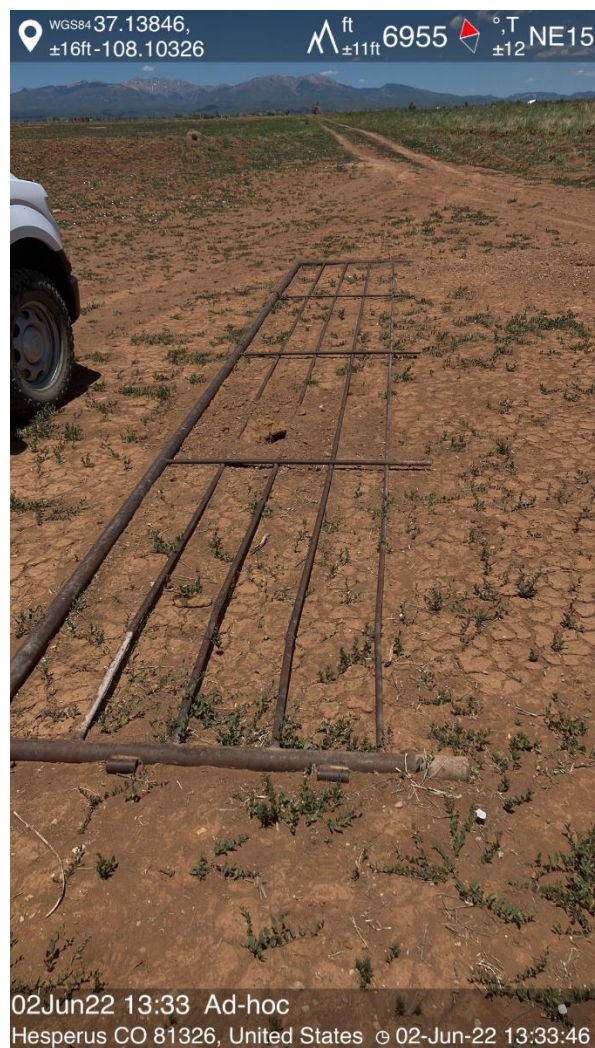
IMG 13
Fence panel not in use

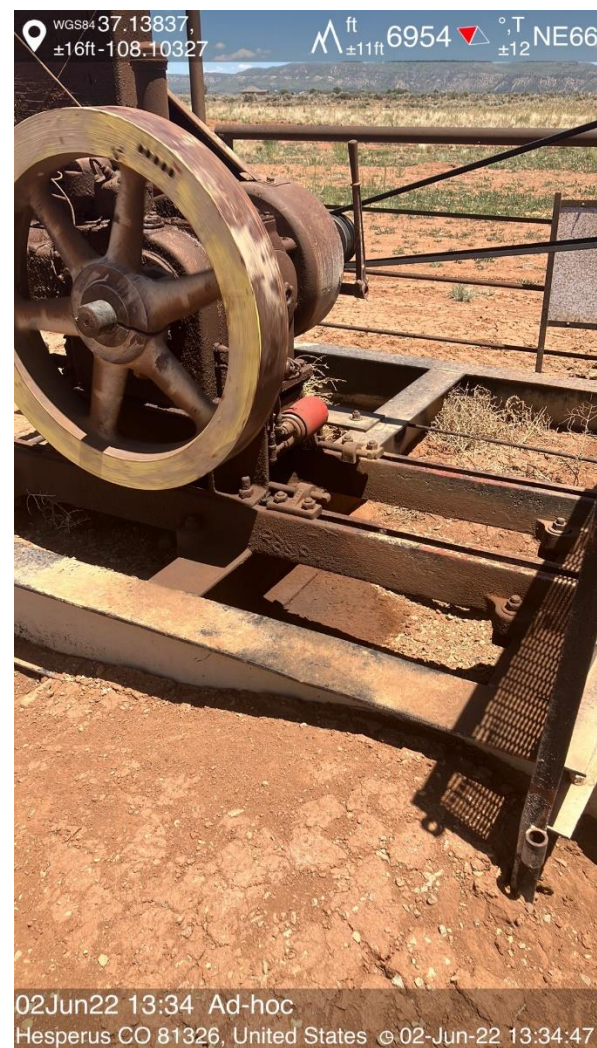
IMG 14
Oily residue has impacted material

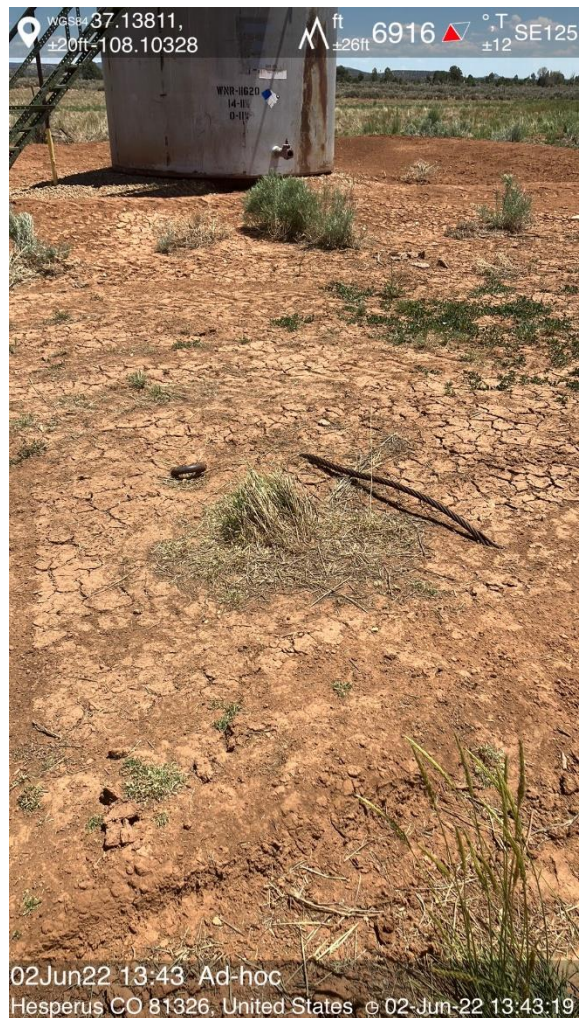
IMG 15
Unmarked rig anchor
