# Inspection Photos and Issue Report

7/11/2022

Operator: CAERUS PICEANCE LLC #10456

Location ID: 334183

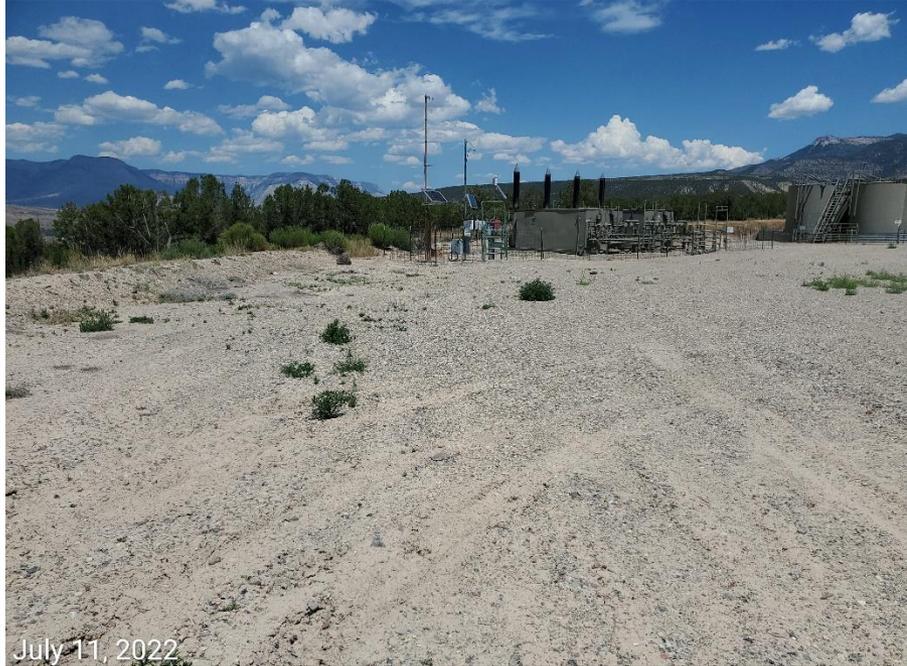
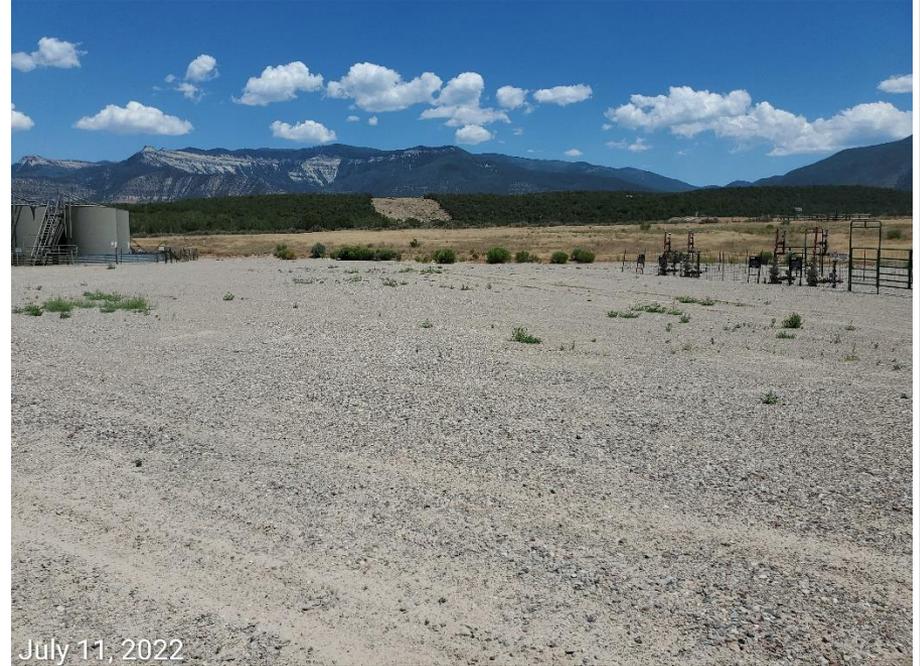
**Photo 1:** Photos 1-2 taken from the northwest end of the Location. Photos provide an overview of the working pad from east, southeast south to southwest

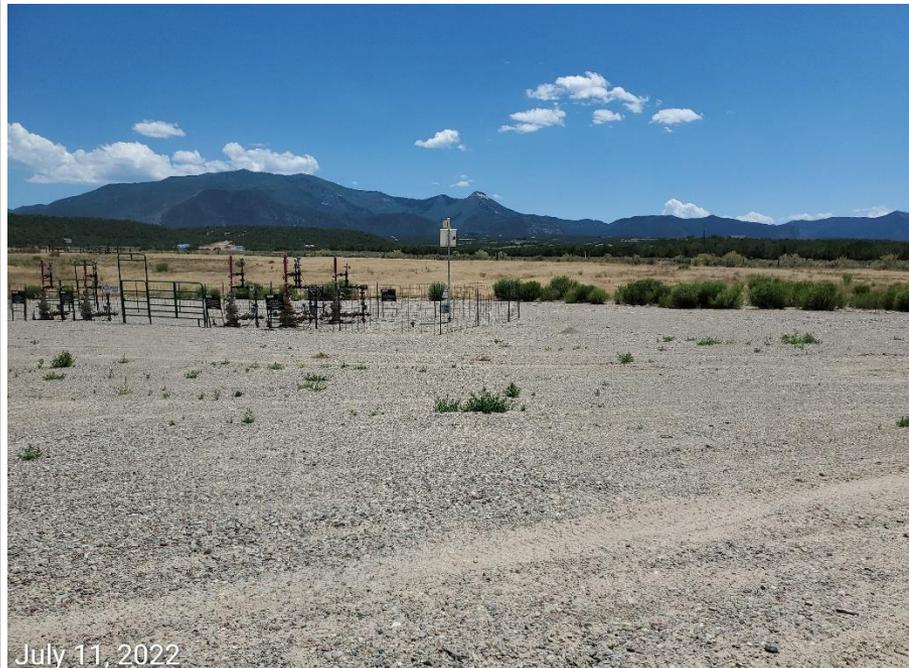
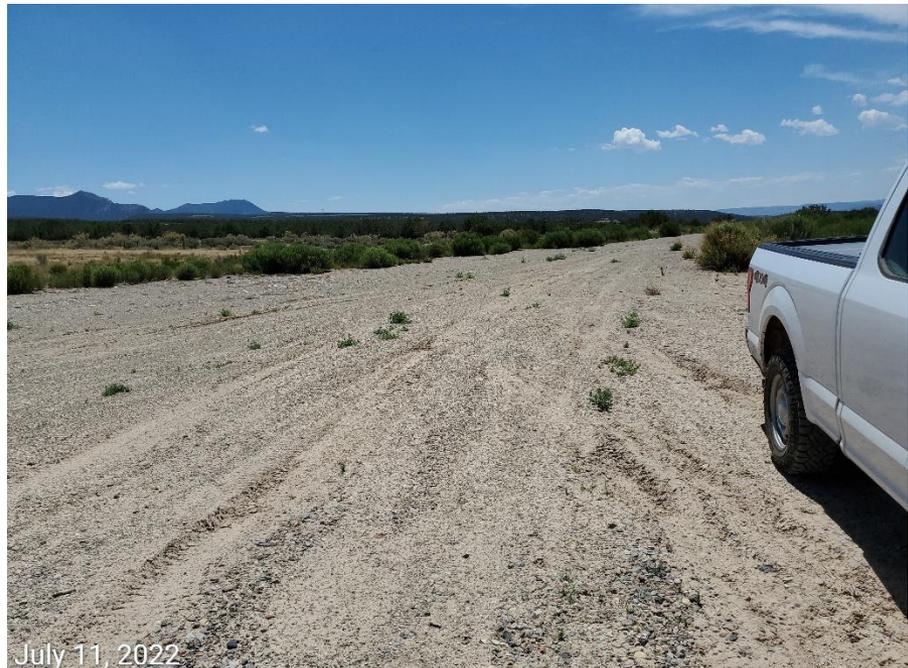
**Photo 2:** See comments under photo 1.

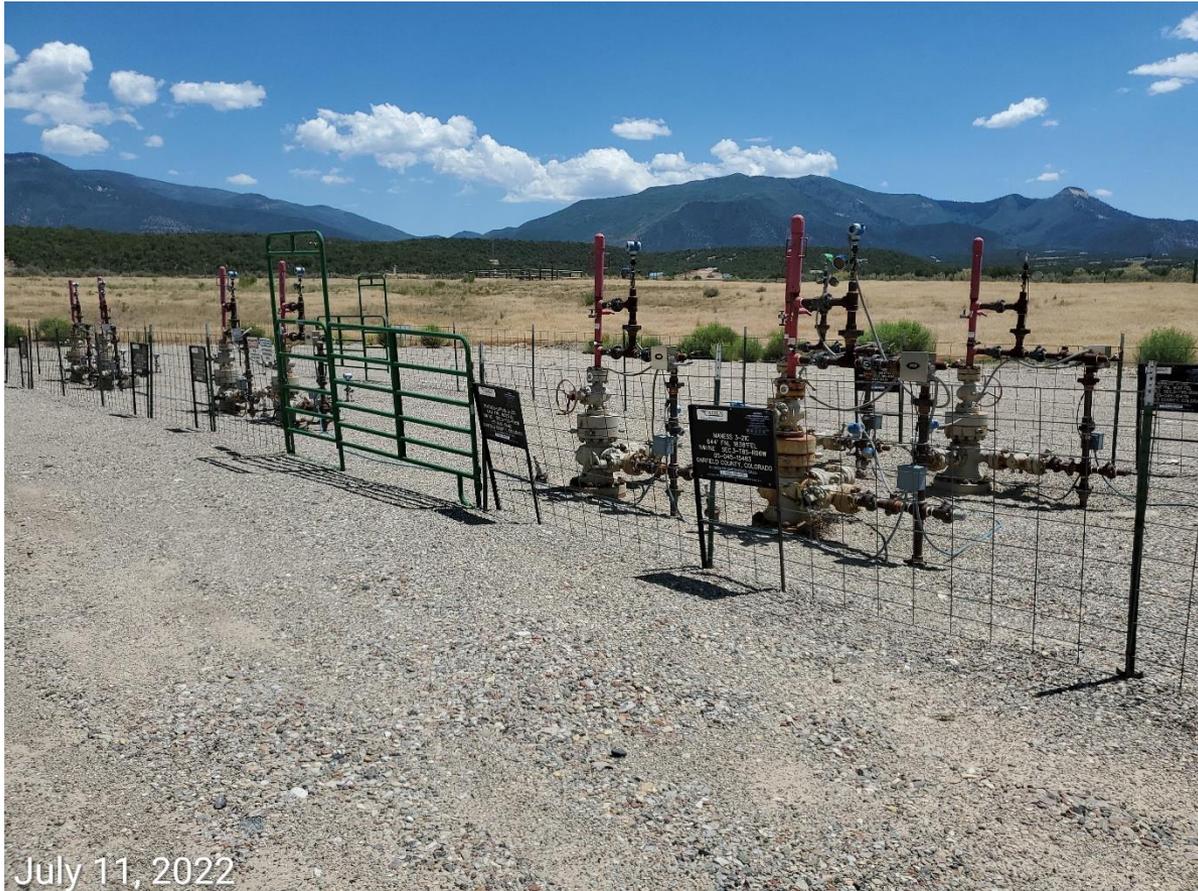
**Photo 3:** Wells on the Location.

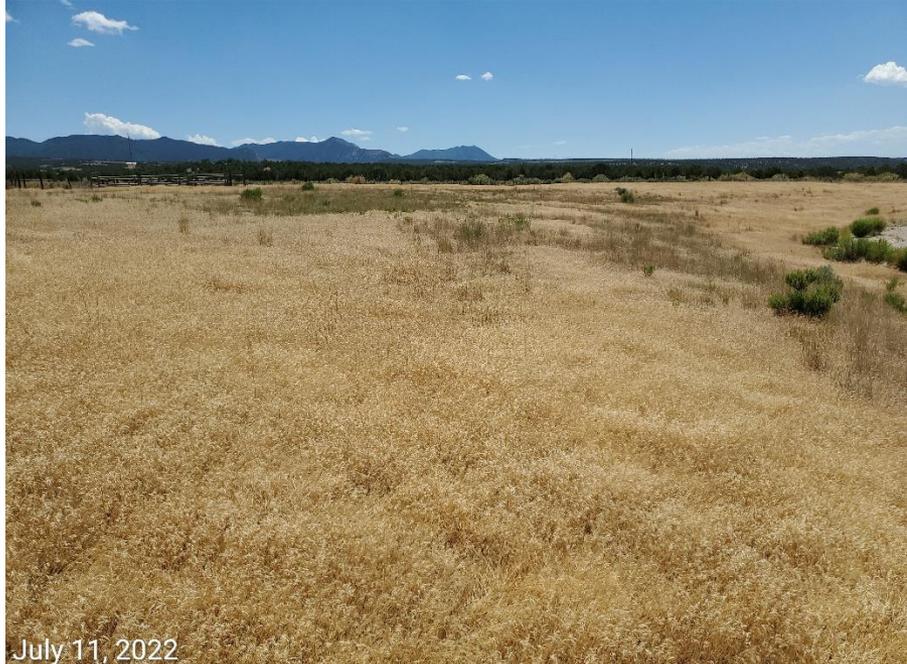
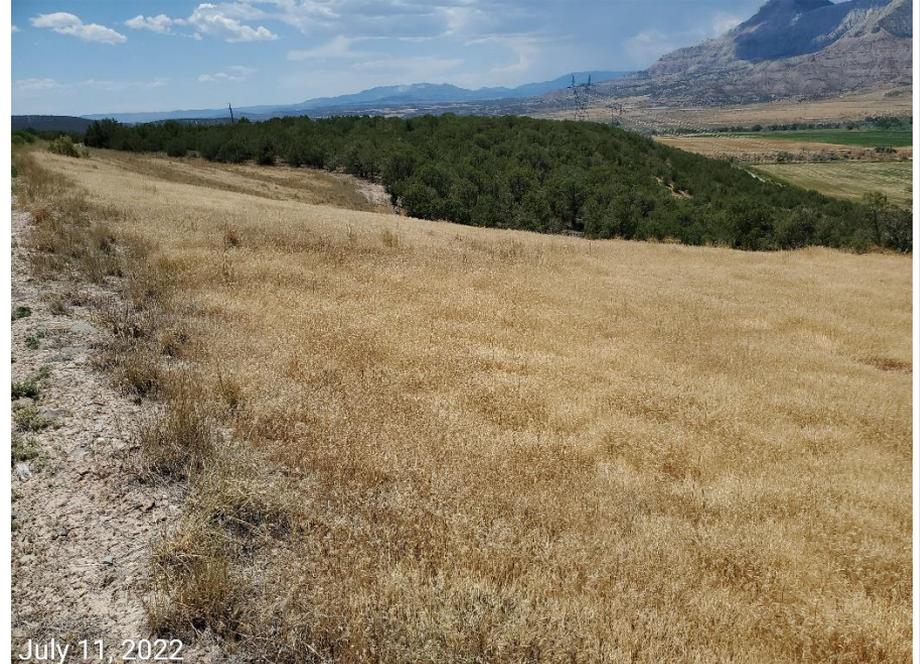
**Photo 4:** Photo left taken from the southeast end of the Location, facing east. Photo right taken from the northwest end of the Location, facing west. Photos provide an overview of the Interim areas of the Location; interim areas are predominantly an annual cheat grass monoculture with pockets of perennial wheatgrass species

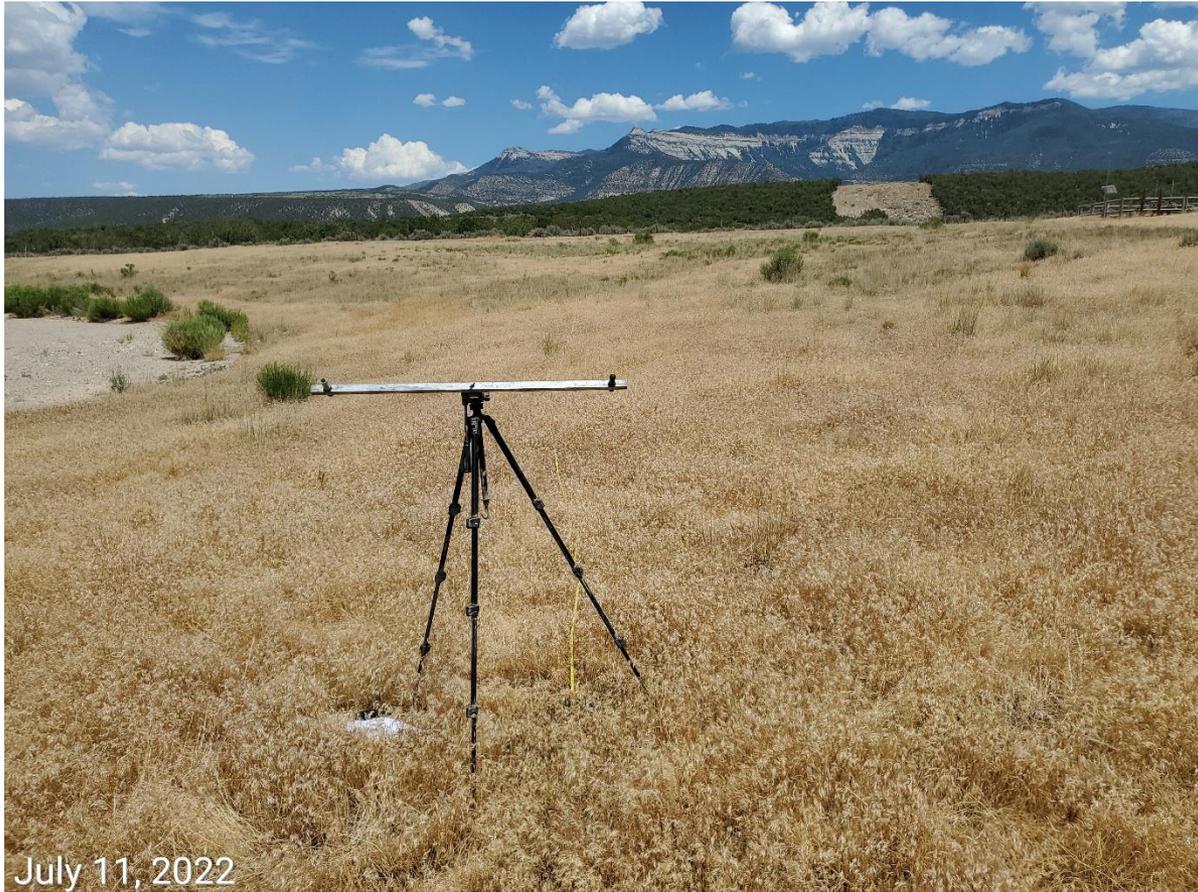
**Photo 5:** Photo shows starting point of the “Disturbance 1” (D1) transect on the southern interim areas of the Location, facing east.

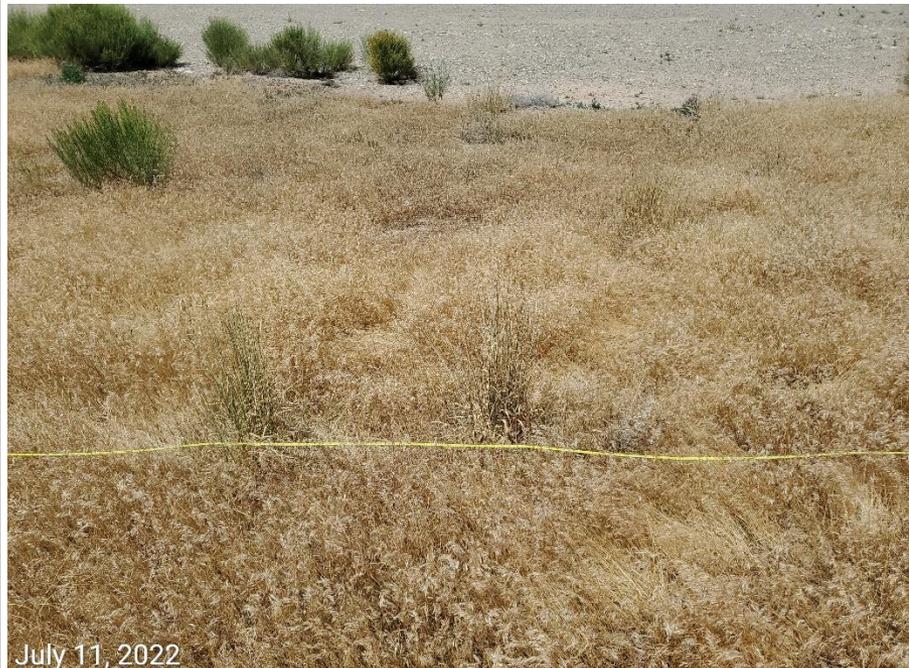
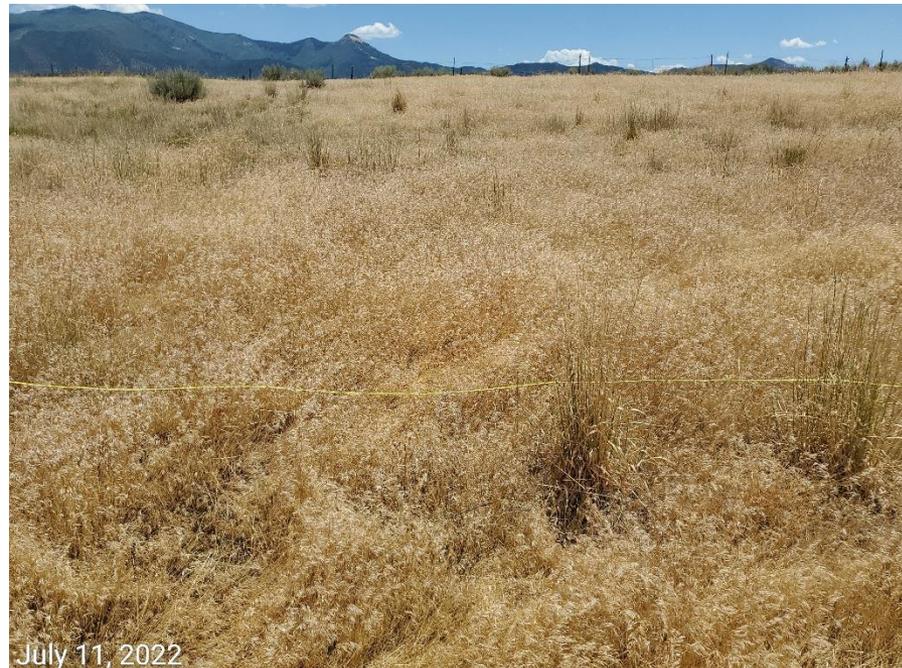
**Photo 6:** Photos show the interim areas of the location at the 50<sup>th</sup> point of the D1 transect, facing north and south.

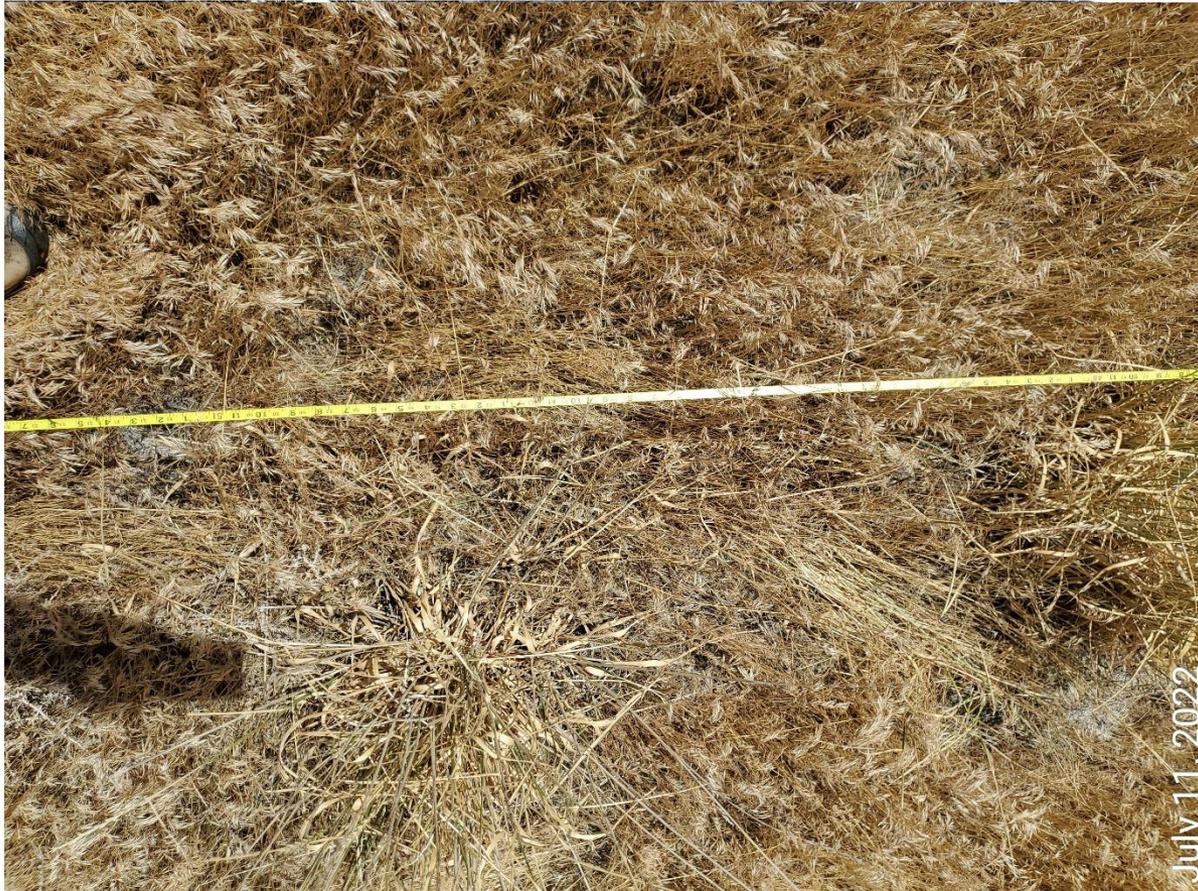
**Photo 7:** Interim areas surface at the 50<sup>th</sup> point of the D1 transect.

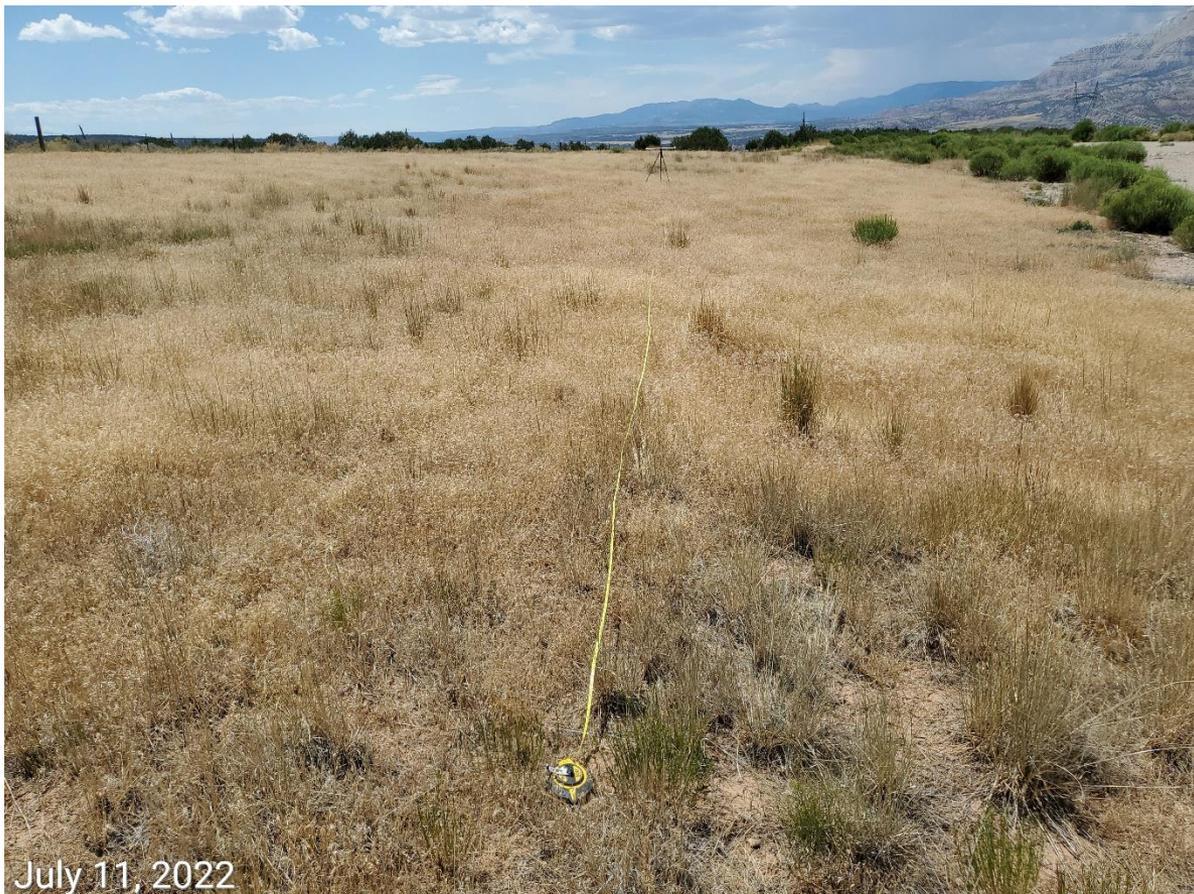
**Photo 8:** Photo shows the end point of the “Disturbance 1” (D1) transect on the southern interim areas of the Location, facing west.

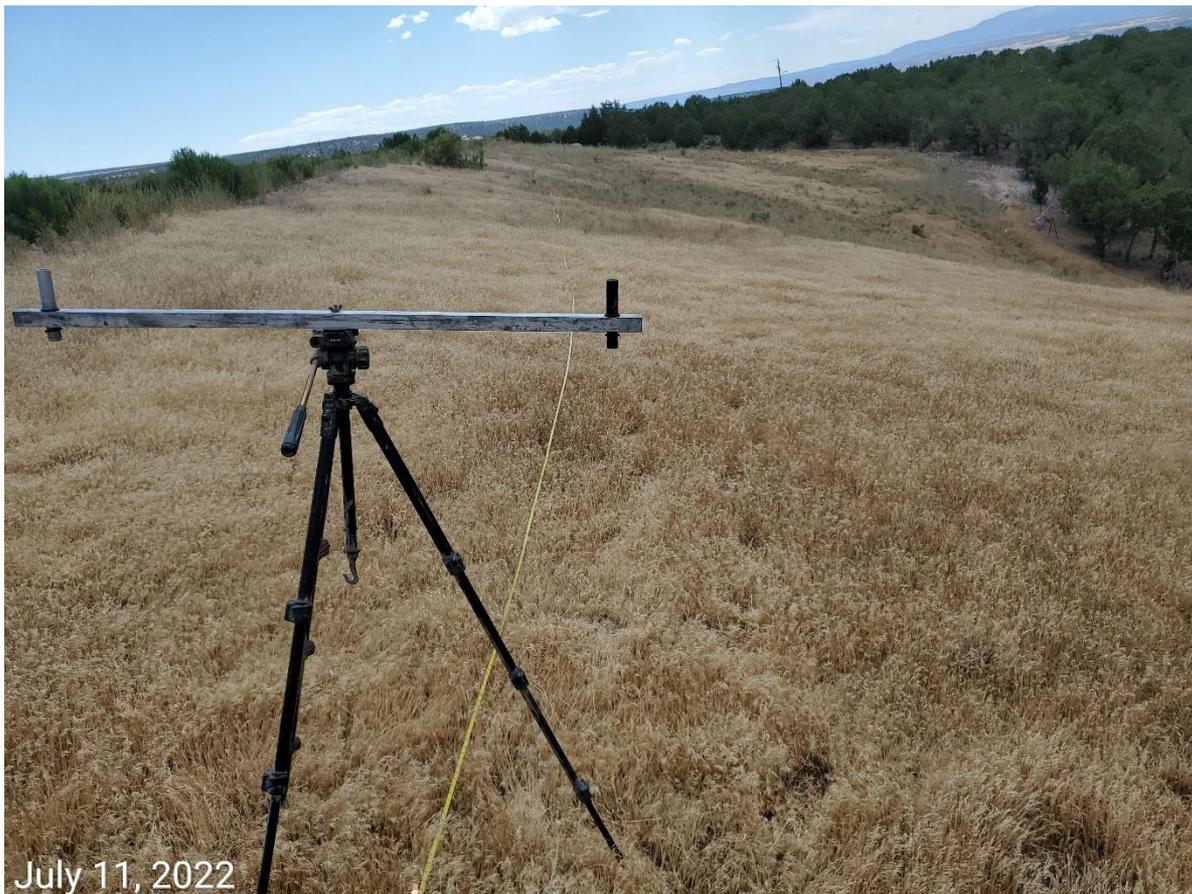
**Photo 9:** Photo shows starting point of the “Disturbance 2” (D2) transect on the northwestern interim areas of the Location, facing southwest

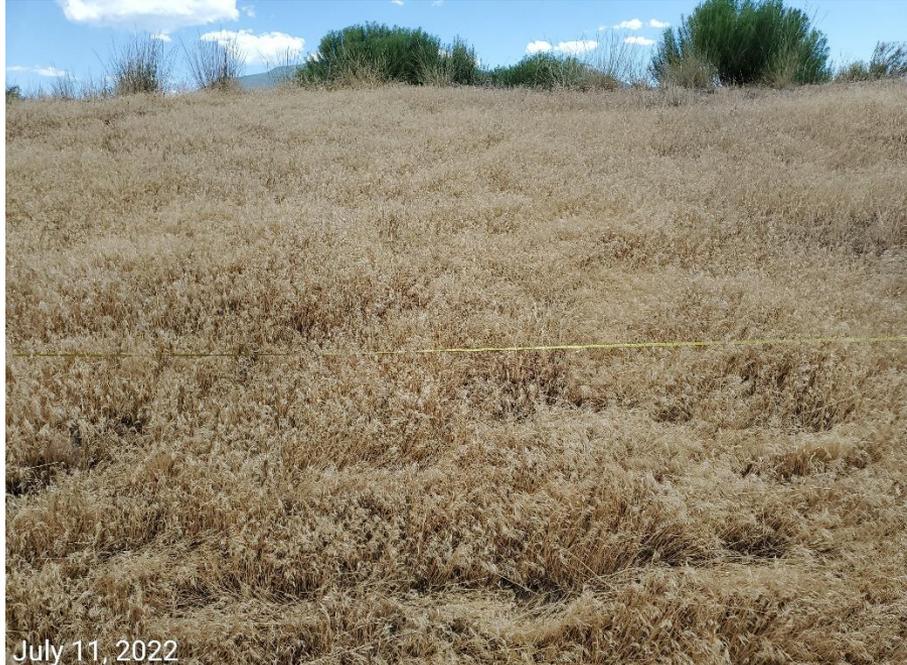
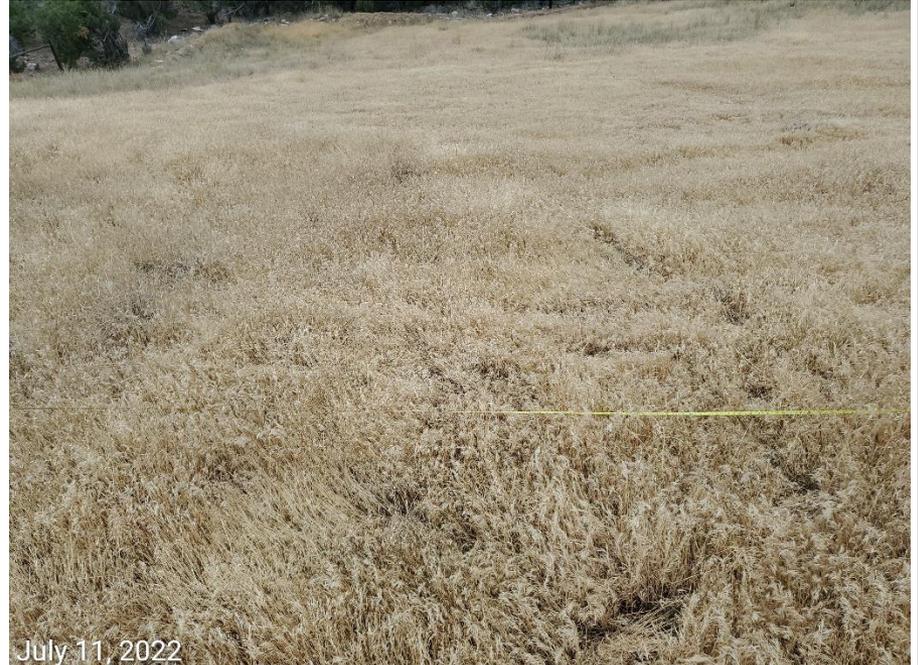
**Photo 10:** Photos show the interim areas of the location at the 50<sup>th</sup> point of the D2 transect, facing southeast and northwest.

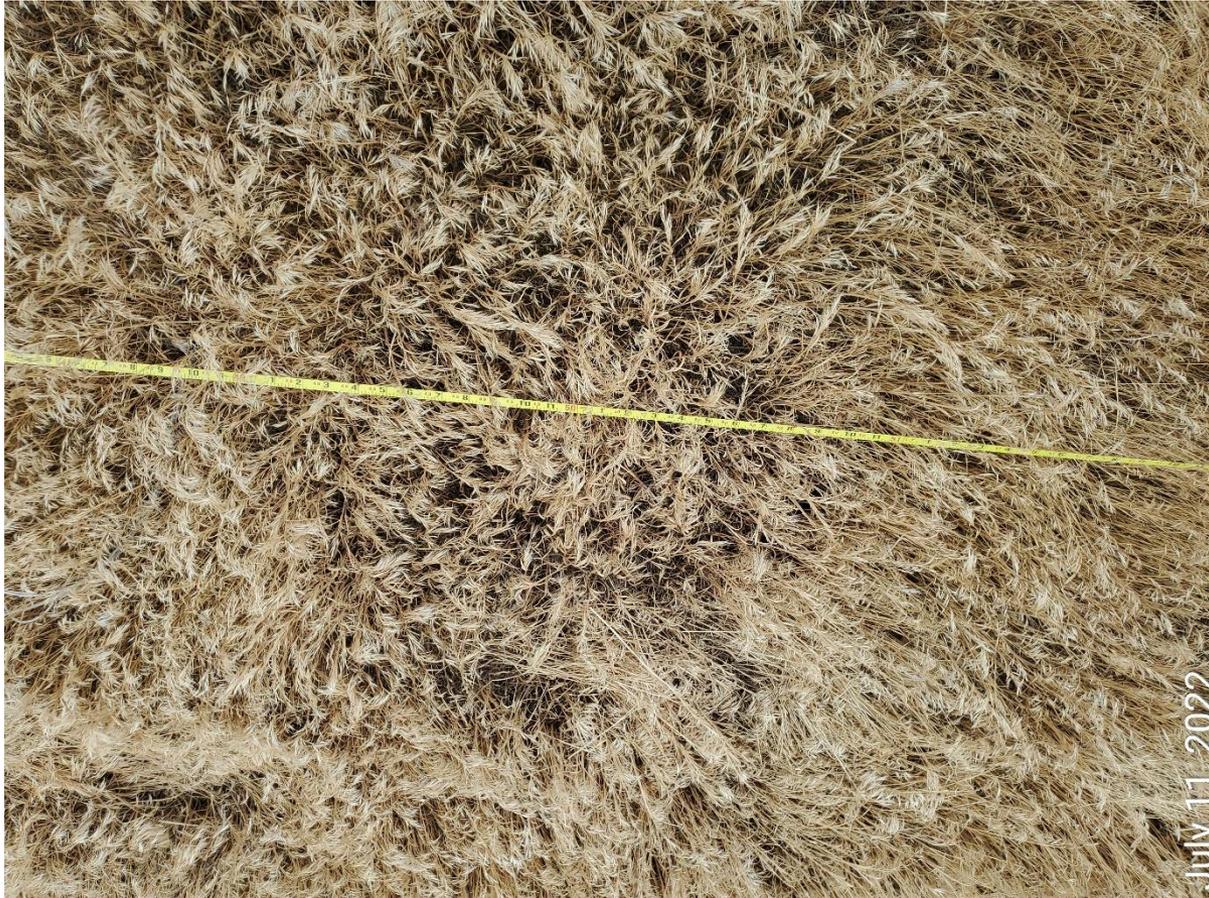
**Photo 11:** Interim areas surface at the 50<sup>th</sup> point of the D2 transect

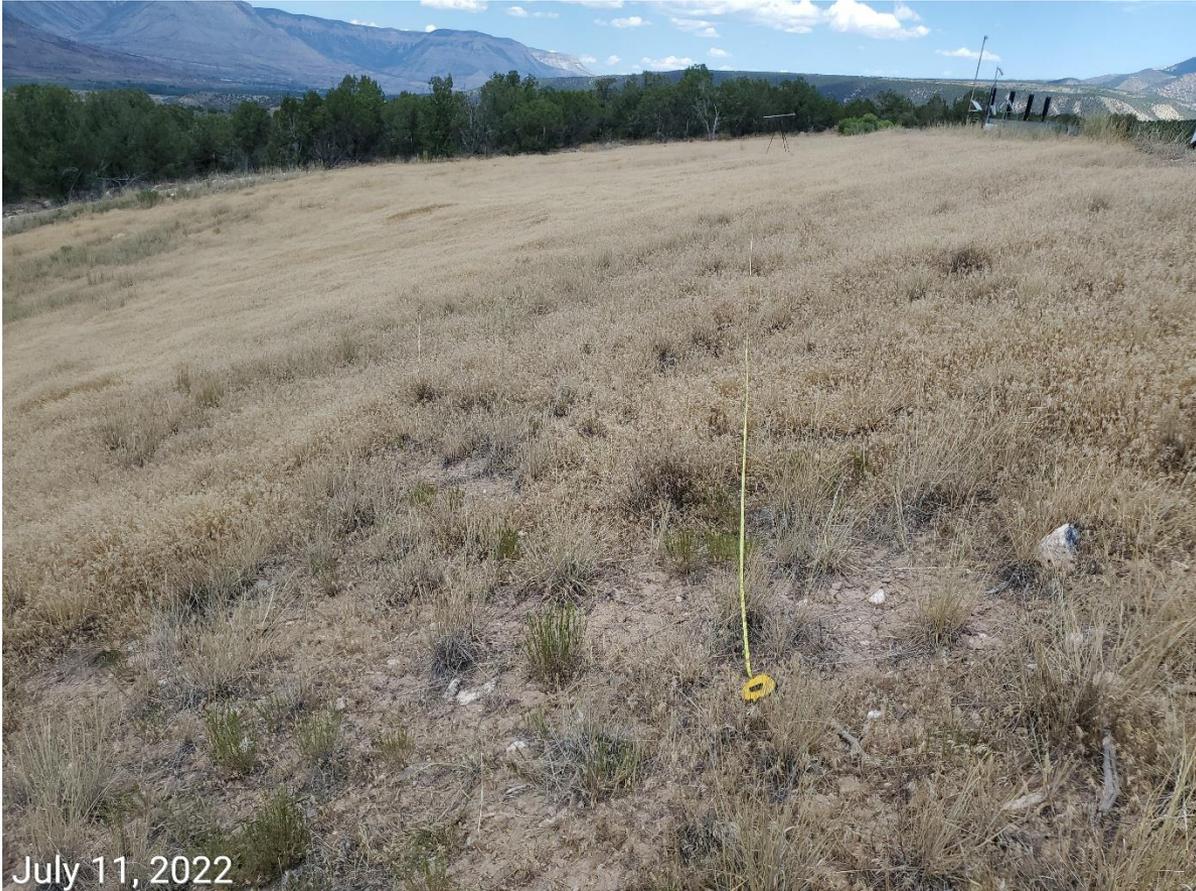
**Photo 12:** Photo shows end point of the “Disturbance 2” (D2) transect on the northwestern interim areas of the Location, facing northeast.

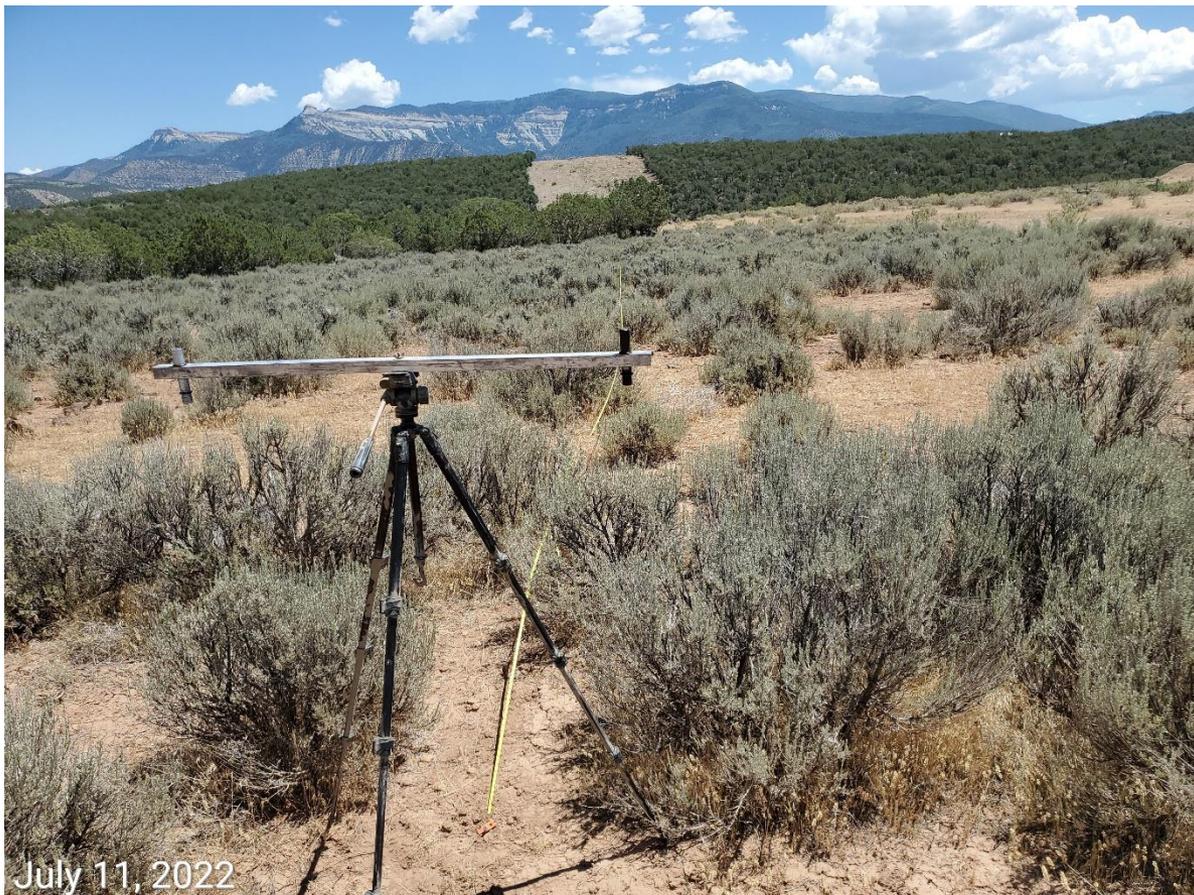
**Photo 13:** Photo shows starting point of the “Reference Area” transect east of the Location, facing east.

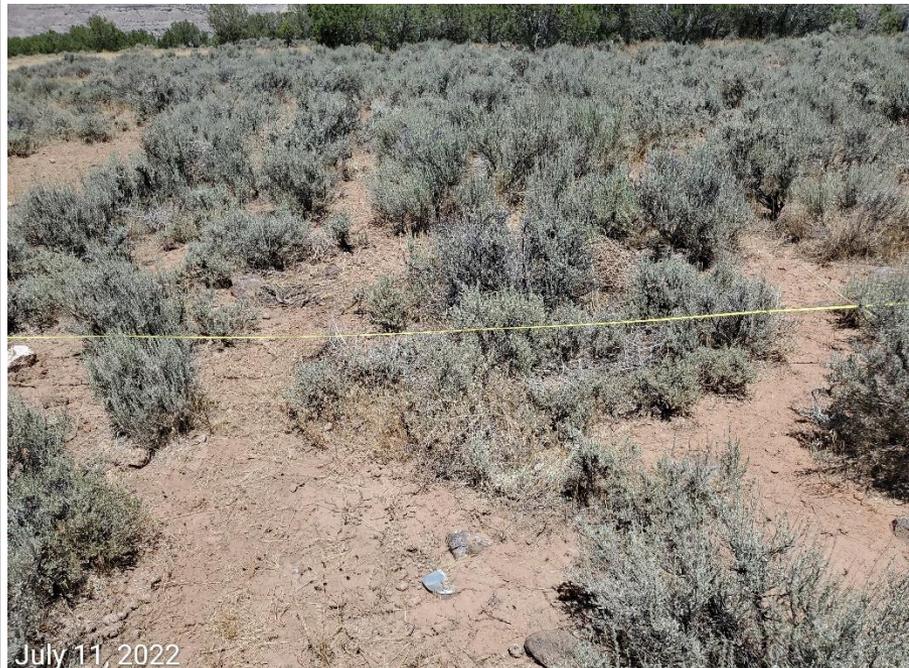
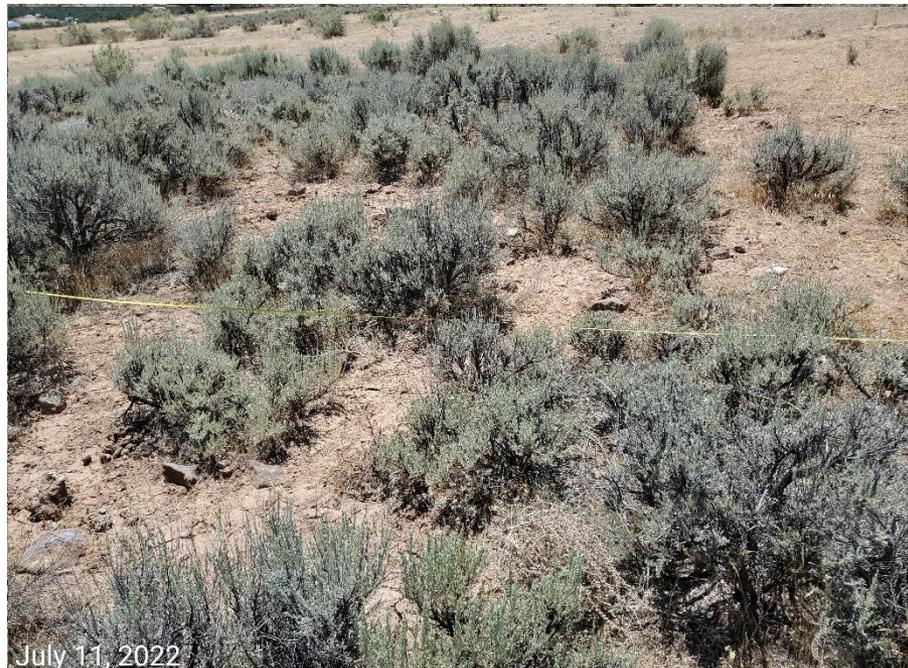
**Photo 14:** Photos shows at the 50<sup>th</sup> point of the Reference Area transect, facing North and South.

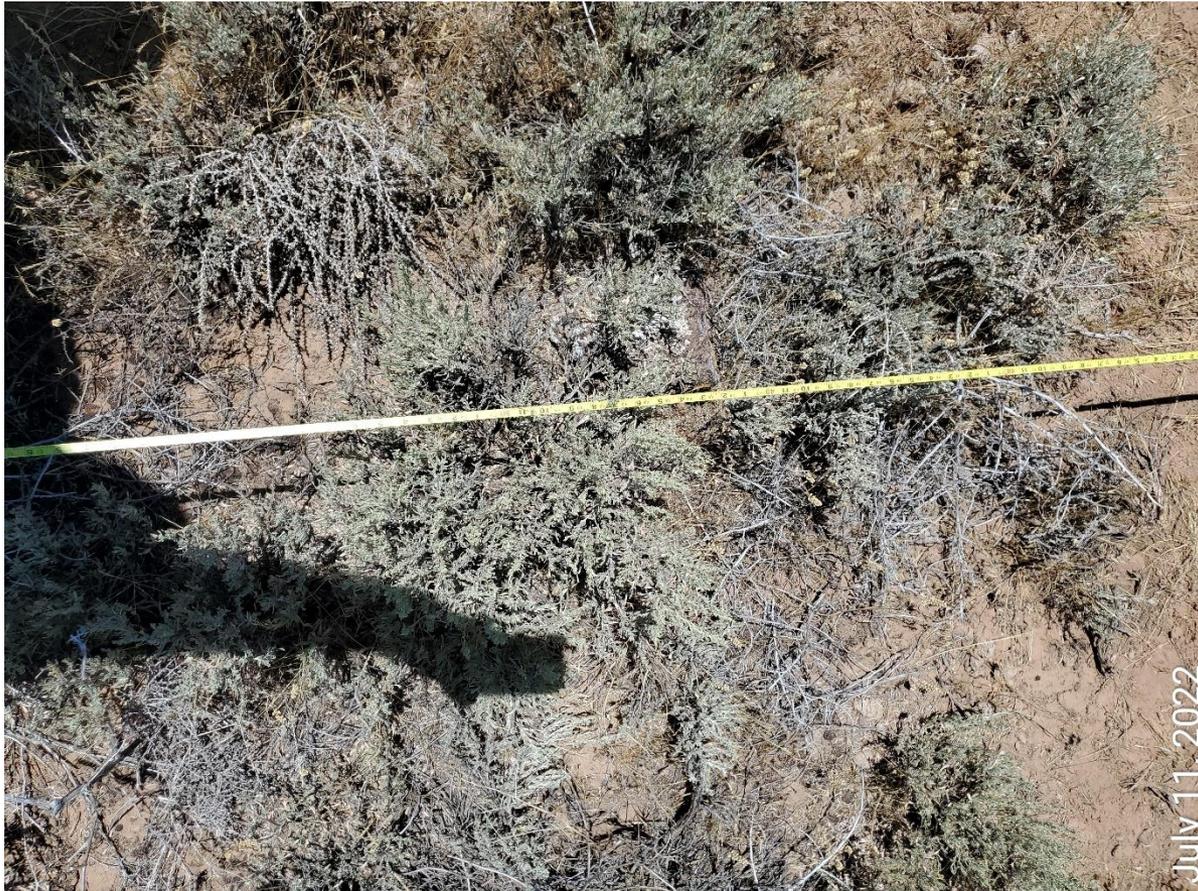
**Photo 15:** Surface at the 50<sup>th</sup> point of the Reference Area transect

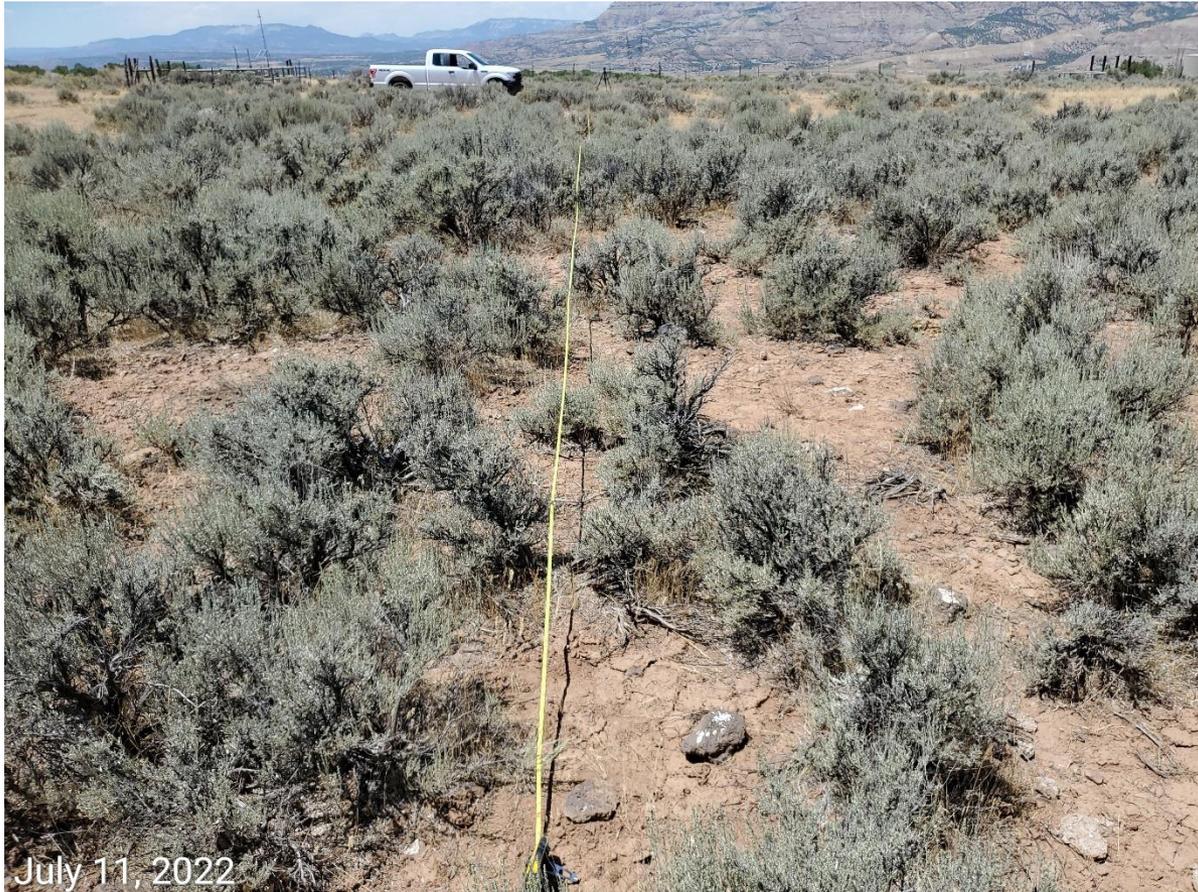
**Photo 16:** Photo shows the end point of the “Reference Area” transect north of the Location, facing west.
