# Inspection Photos and Issue Report

8/17/2022

Operator: CAERUS PICEANCE LLC #10456

Location #479149

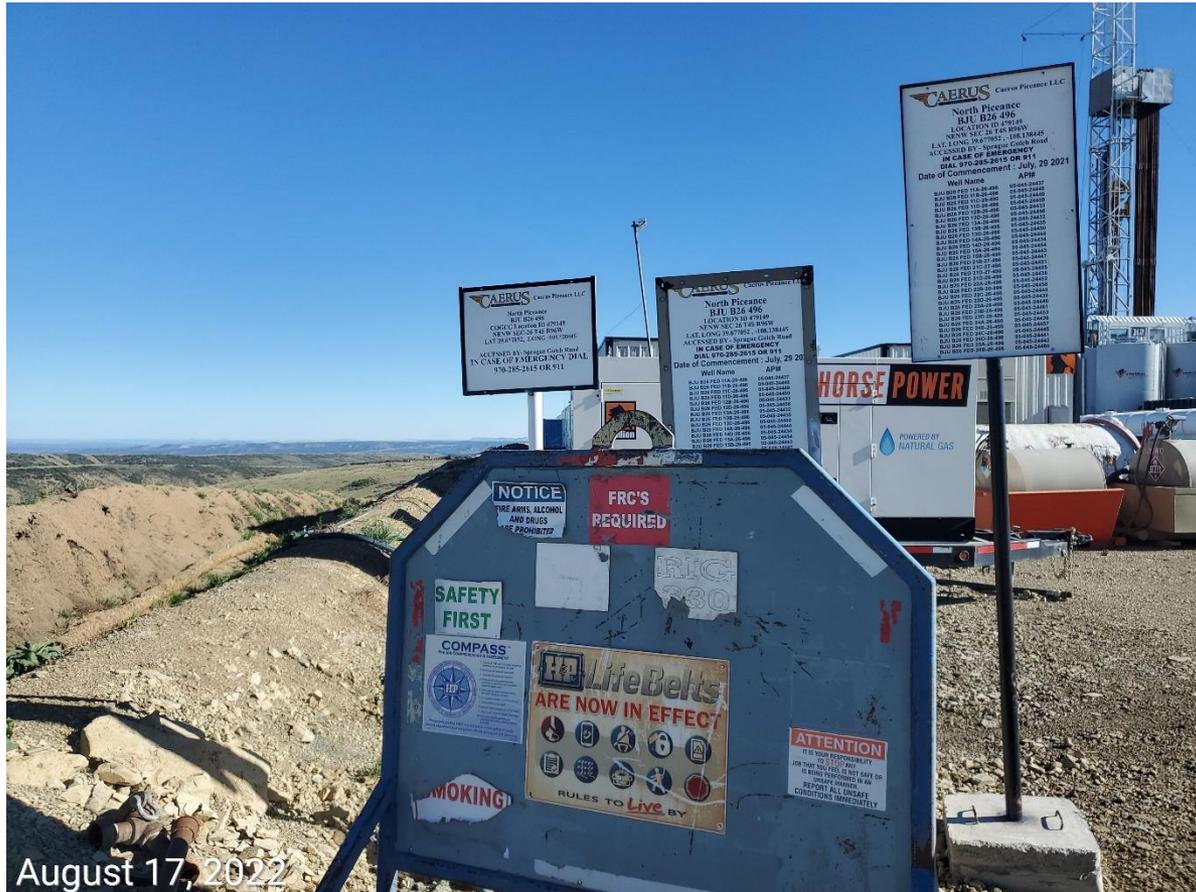
**Photo 1:** Photo shows signage at Location entrance.

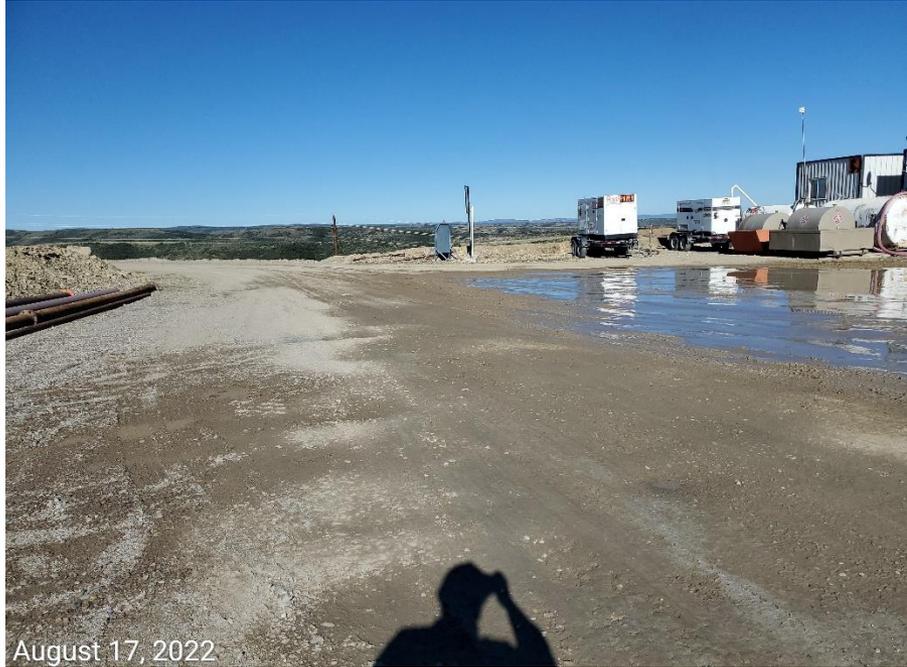
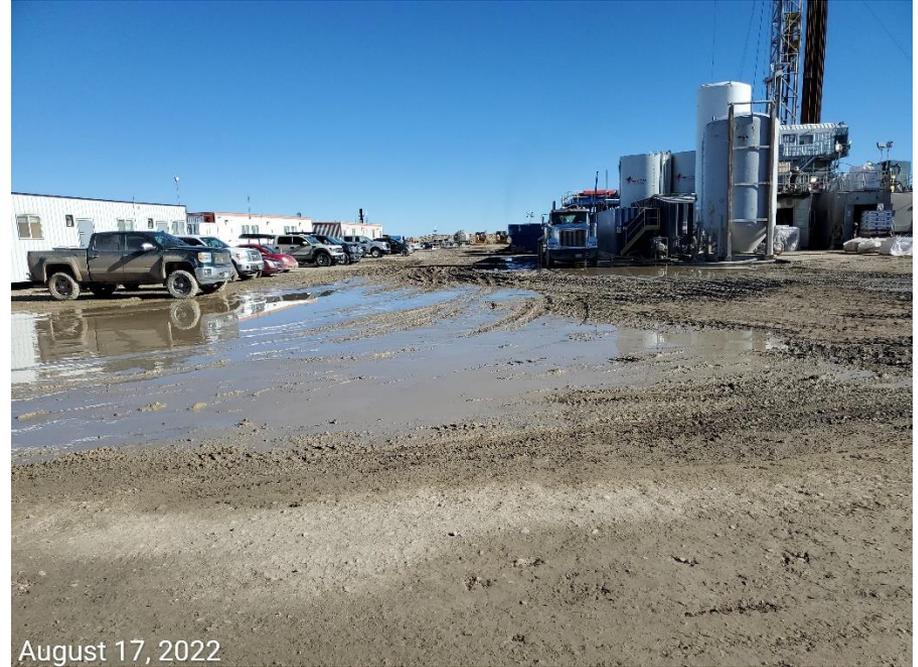
**Photo 2:** Photos examples showing stormwater ponding on the production area, as well as tracking issues; BMPs insufficient to stabilize working pad area, and to minimize vehicle tracking and sediment transport.

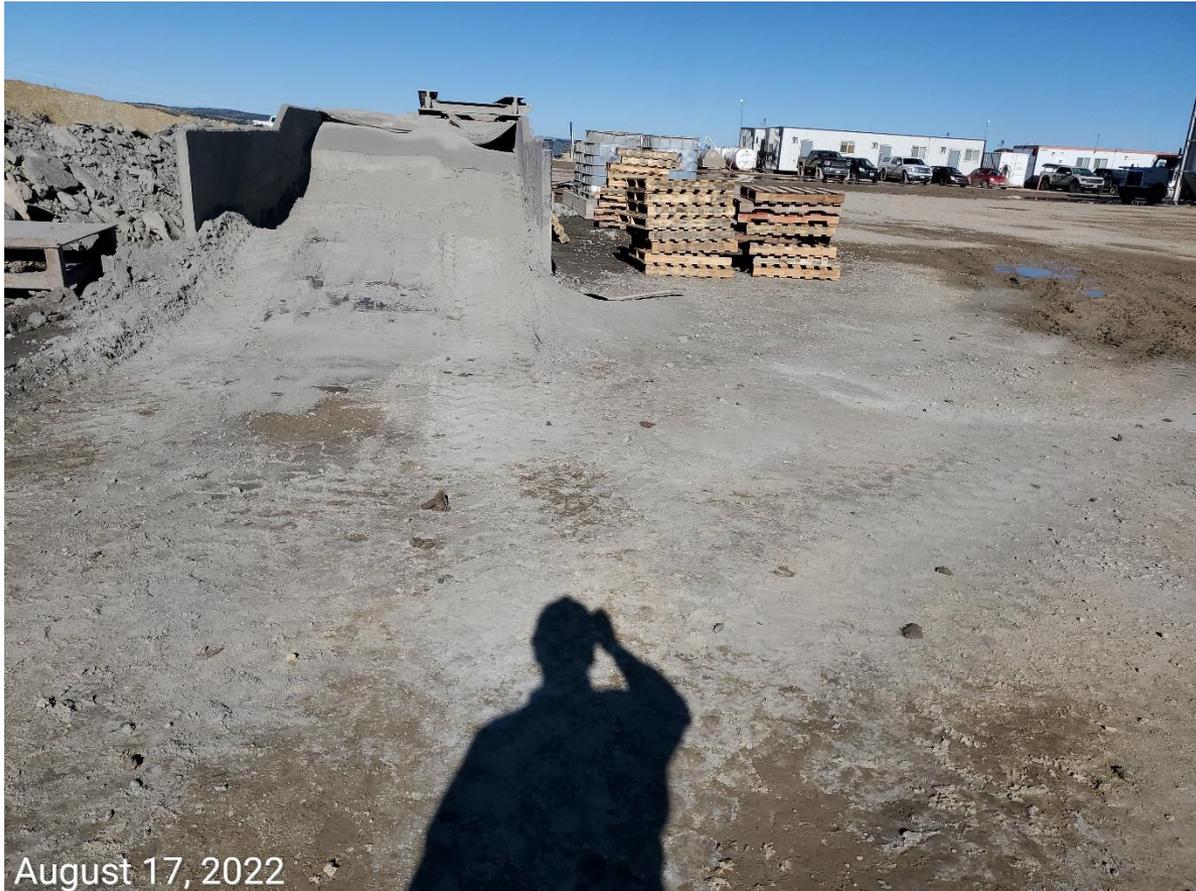
**Photo 3:** Previous inspection observed what appeared to be cement material spilling out of containment and upon the working pad surface. Inspection required spill to be cleaned and BMPs installed. Photo shows spill has not been cleaned. Additionally, it was observed that stormwater has come in contact with the material, and has hardened it in areas.

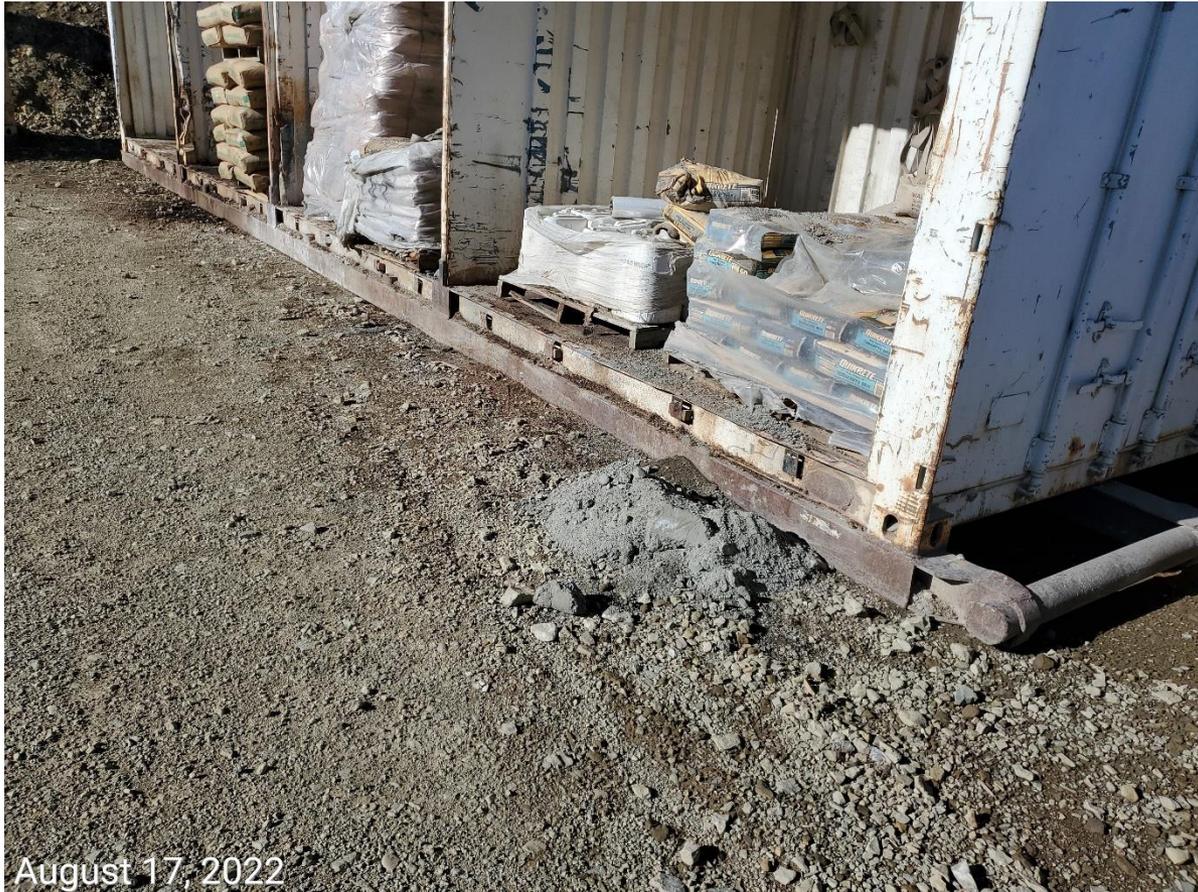
**Photo 4:** Photo shows various spills remain evident on the south end of the Location.

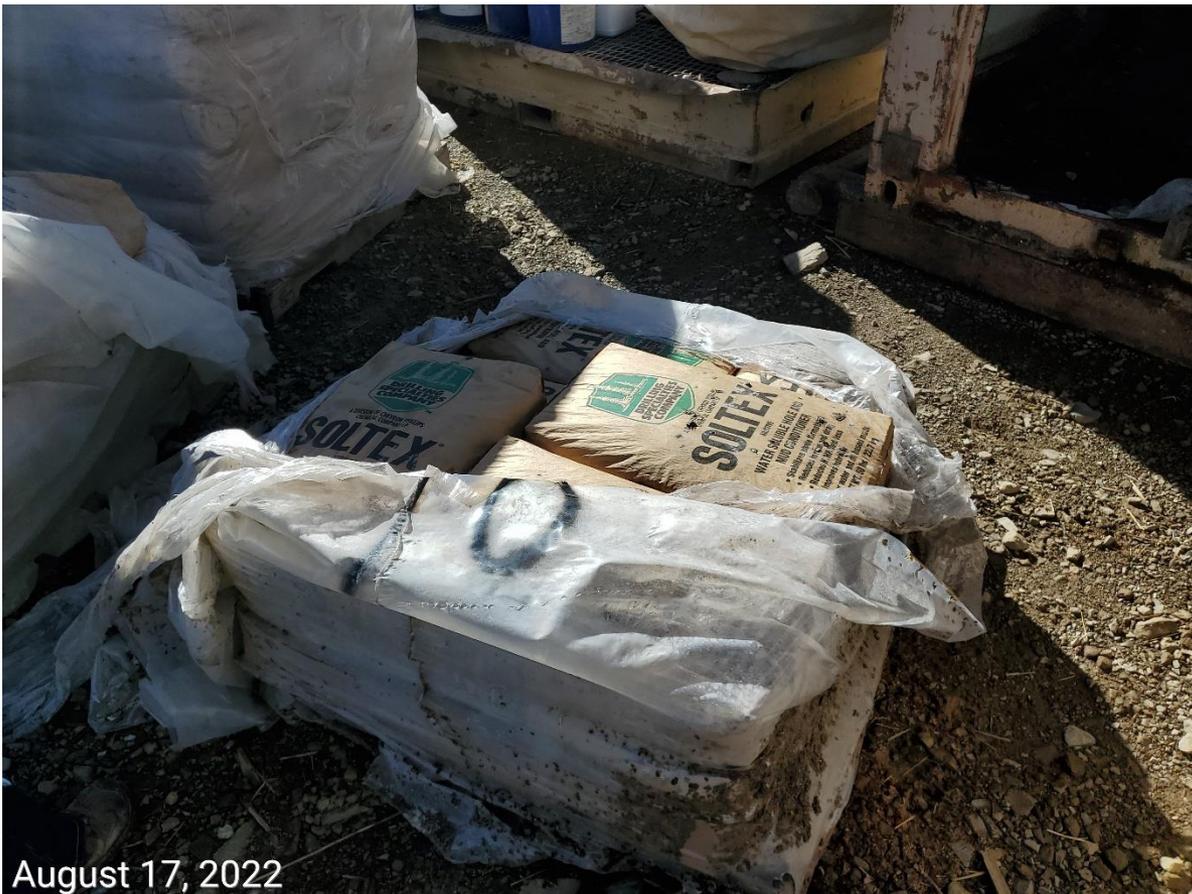
**Photo 5:** Photo shows improper covering BMPs resulting in precipitation/stormwater contact with materials

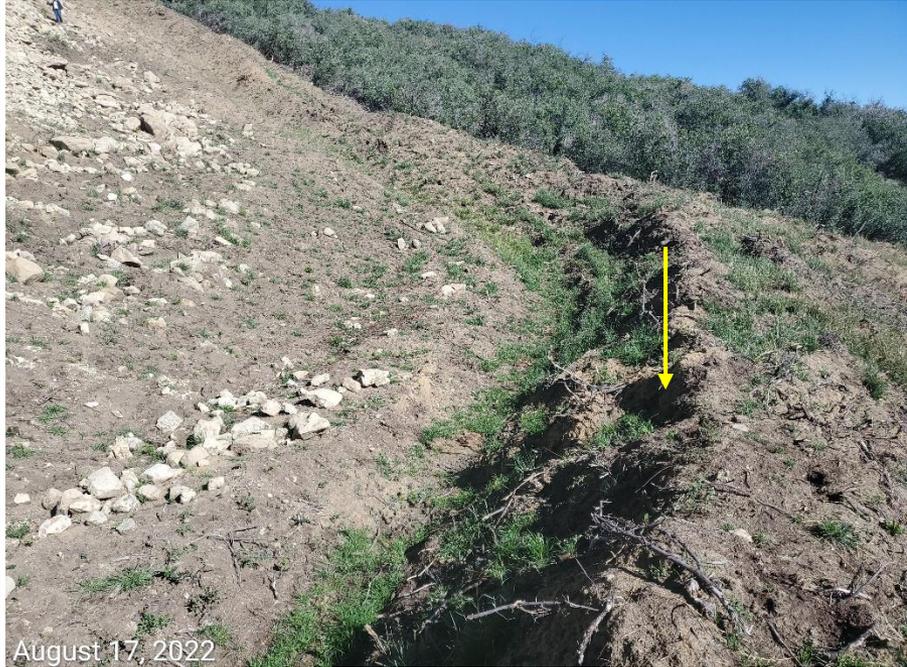
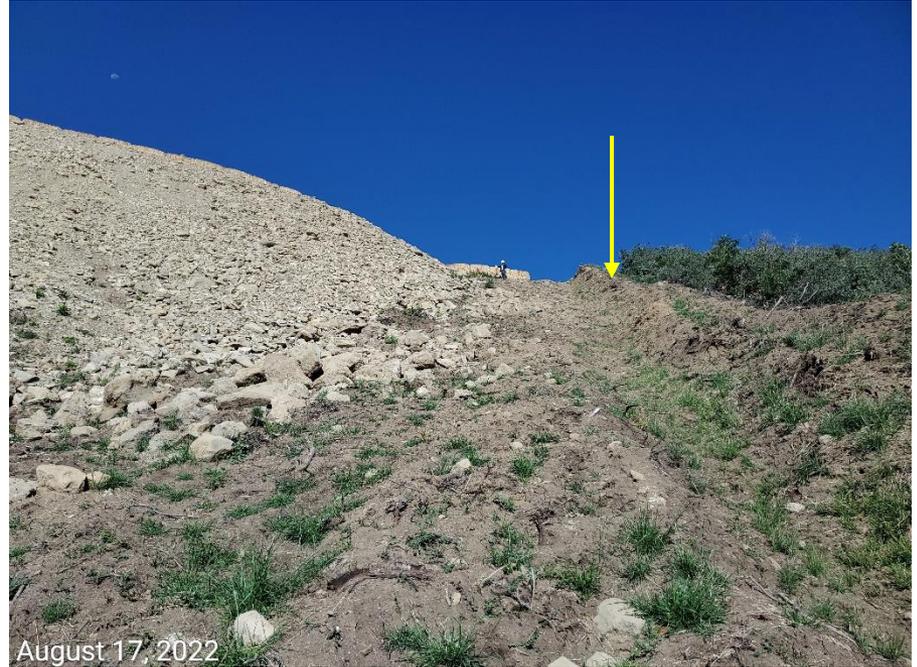
**Photo 2:** Photos examples showing topsoil remains in use as part of the Location's perimeter stormwater controls, specifically, one of the three sediment traps/basins on the Location, and berm.

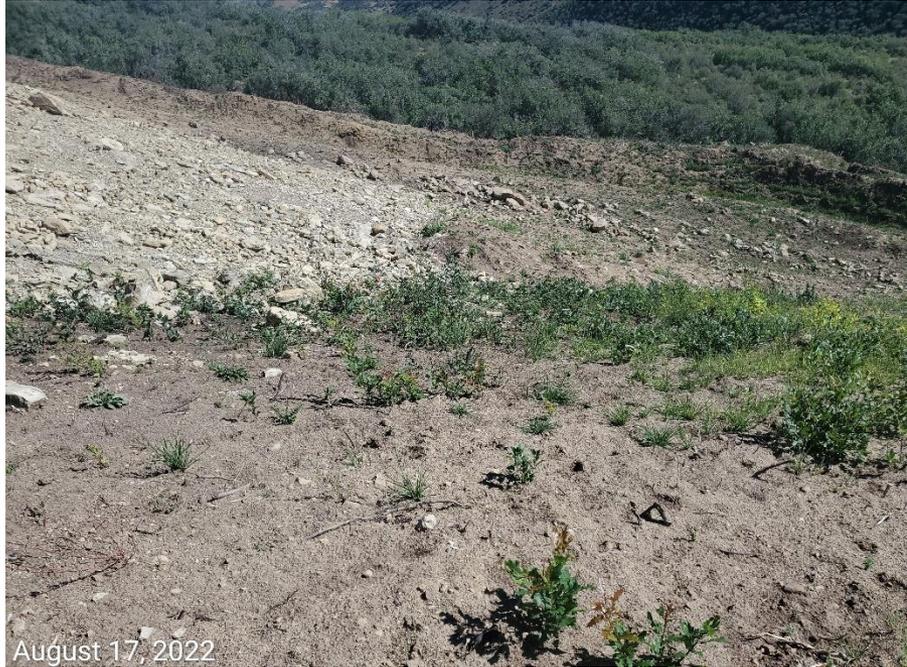
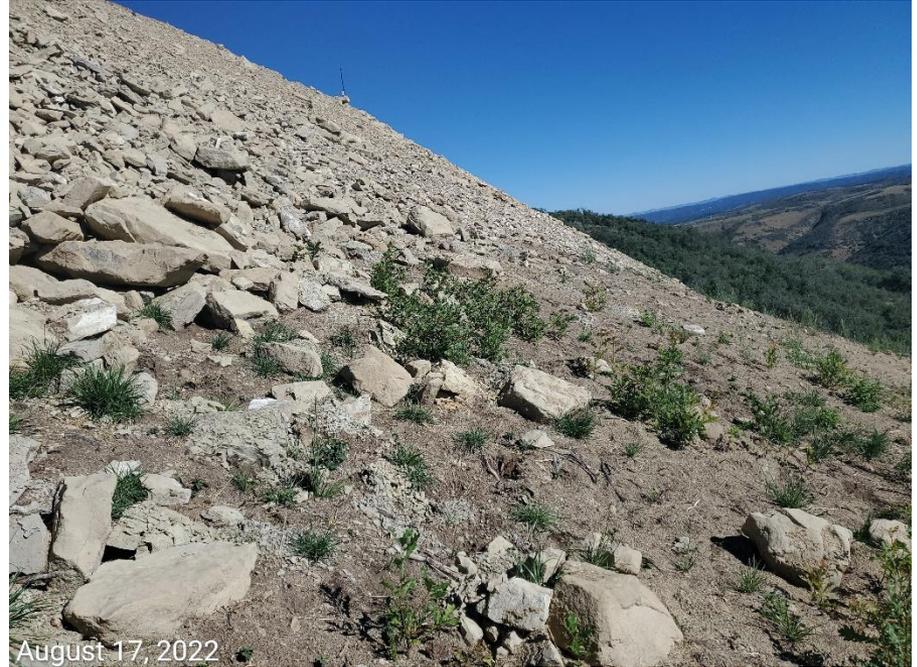
**Photo 4:** Photo taken from the base of the fill material. Photo shows areas where vegetation such as Scrub Oak, Lupine, etc.. is growing within soils beneath the fill material, and soils between the fill and the topsoil stockpiles, indicating that not all of the topsoil was segregated and stored during soil salvage operations.
