Inspection Photos

Location Name: MUSTANG RESOURCES LLC MEAD-66S94W /23SESE

Location ID: 323783

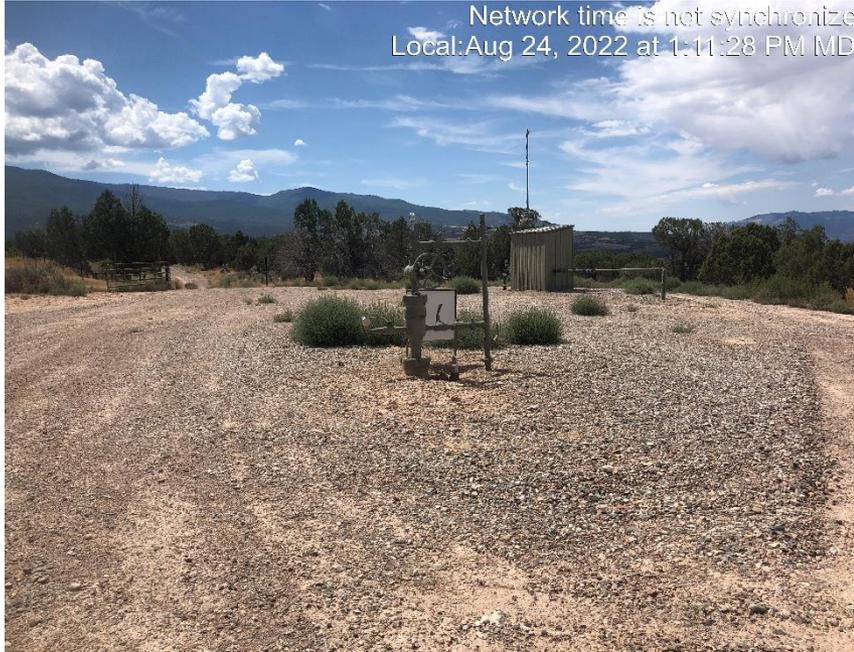
Photo #7549 from entrance to location.

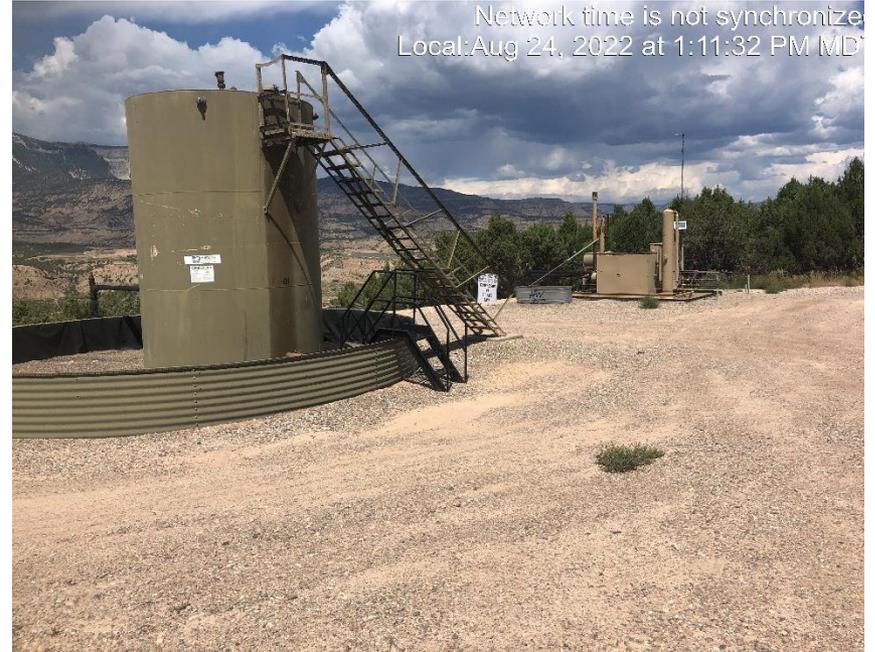
Photo #7550 from entrance to location.

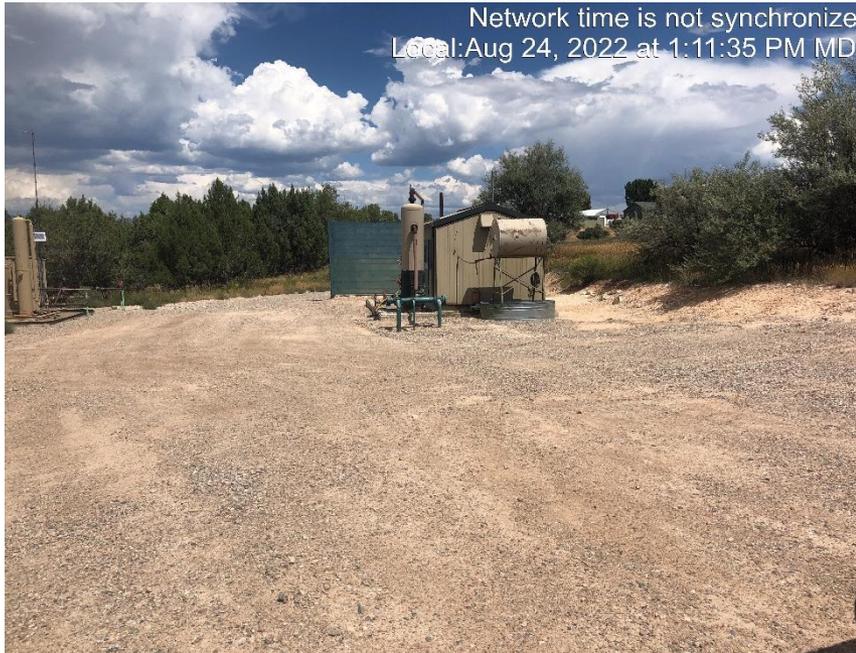
Photo #7551 from entrance to location.

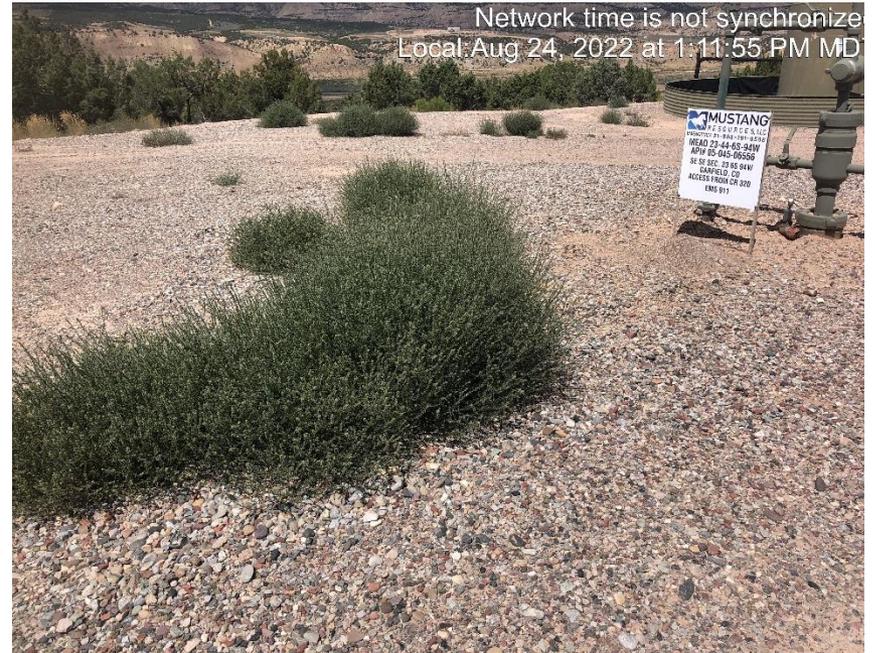
Photo #7552 Multiple places with undesirable plant species.

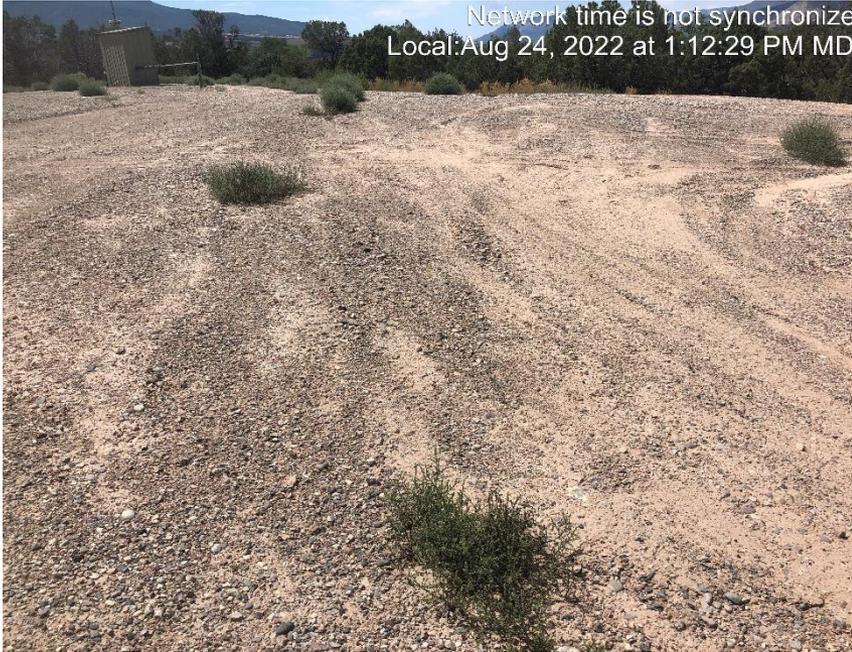
Photo #7554 Multiple places with undesirable plant species

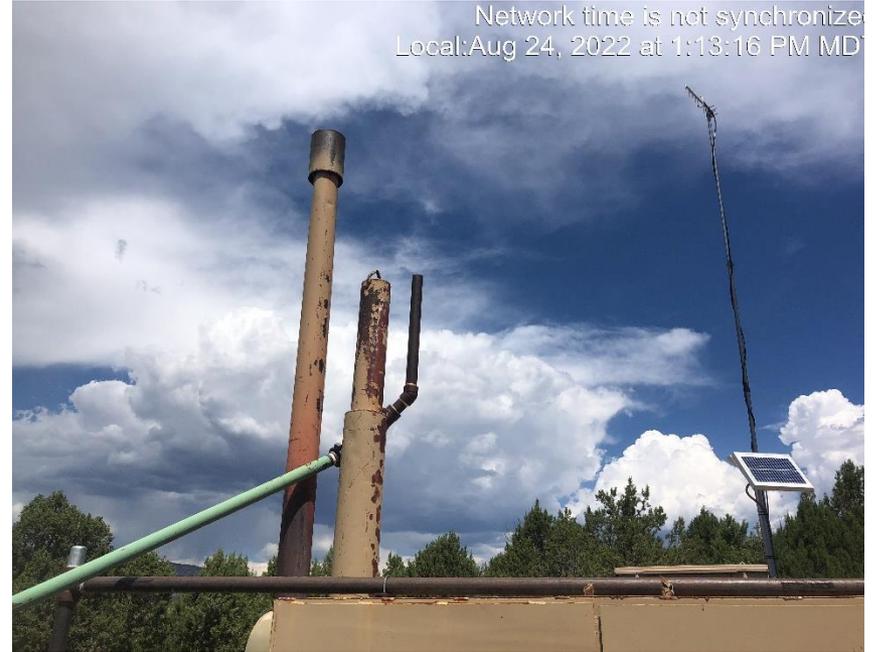
Photo #7556 Vent pipe on separator open ended.

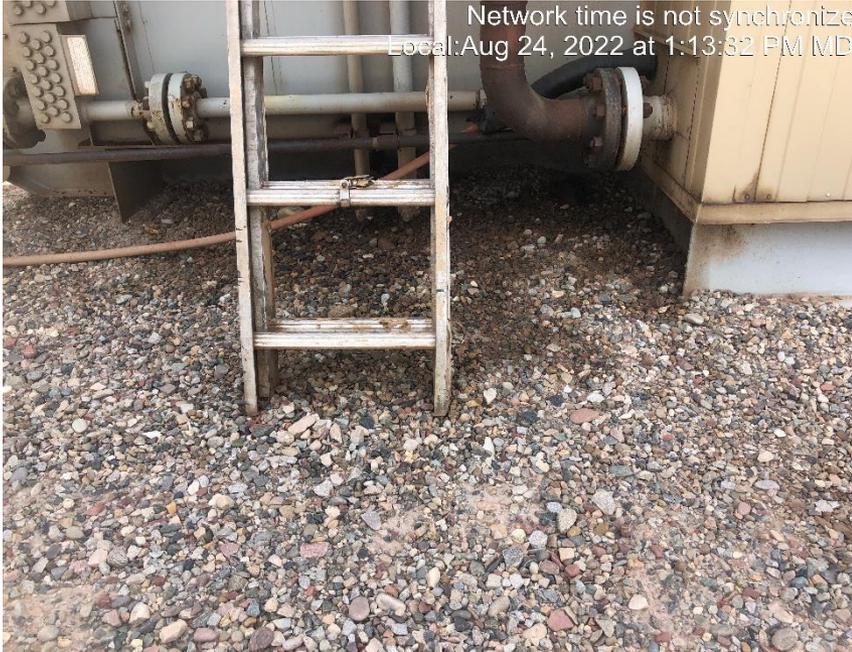
Photo #7557 Multiple places with stained soils on location.

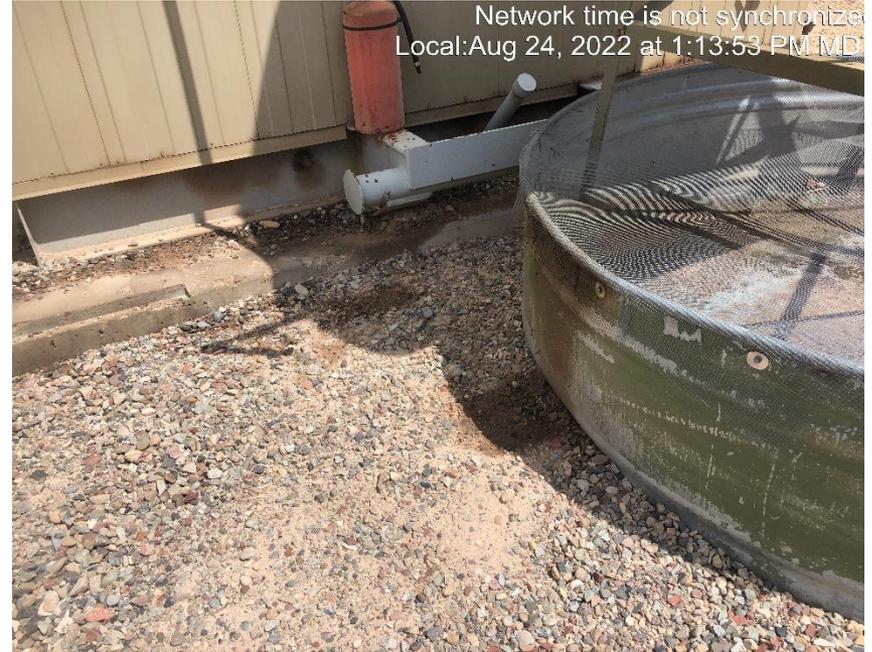
Photo #7558 Multiple places with stained soils on location.

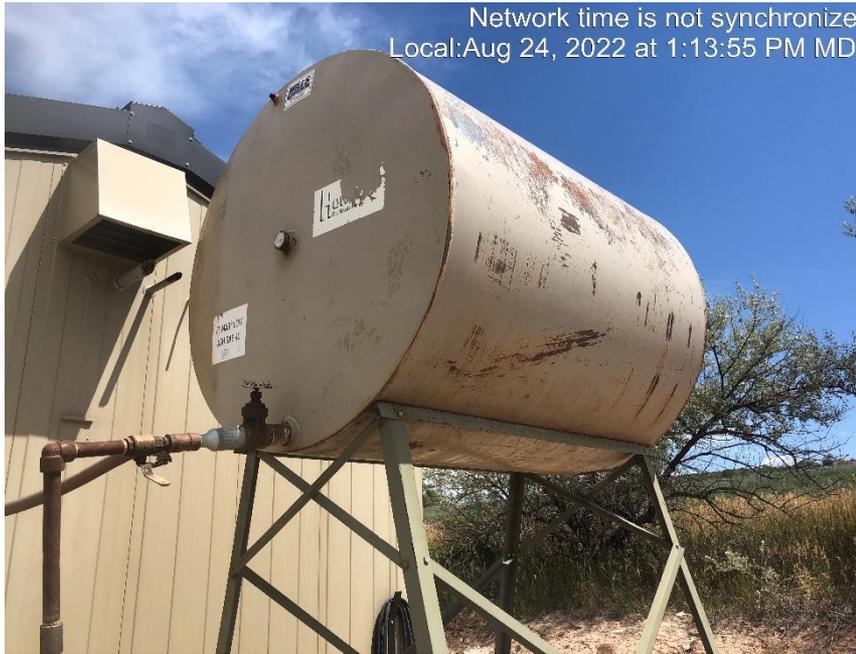
Photo #7559 Tank missing required information.

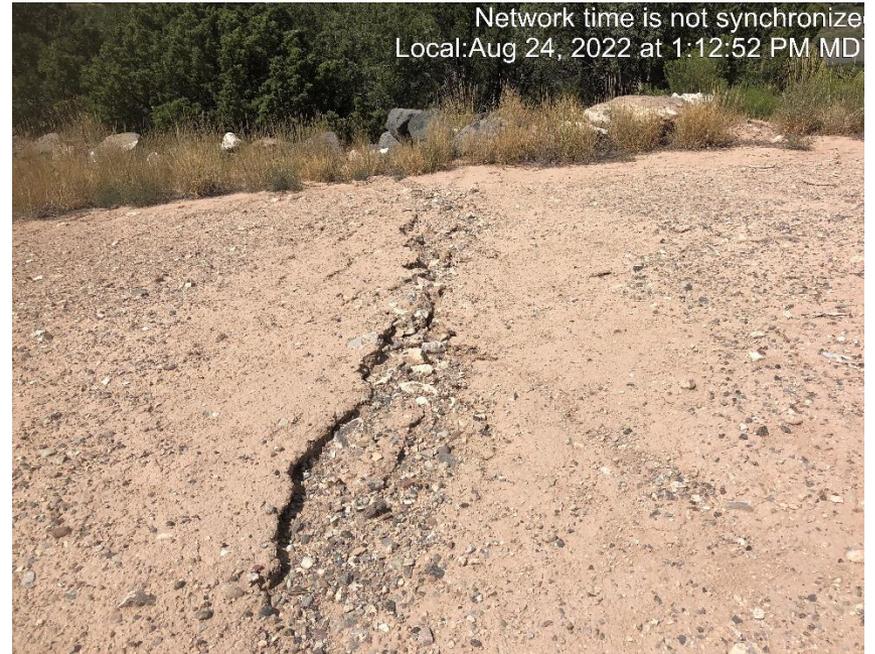
Photo #7555 Rill erosion occurring on North West side of location.
