Inspection Photos

Location Name: TEP ROCKY MOUNTAIN LLC CLOUGH-66S94W /21NESE

Location ID: 324180

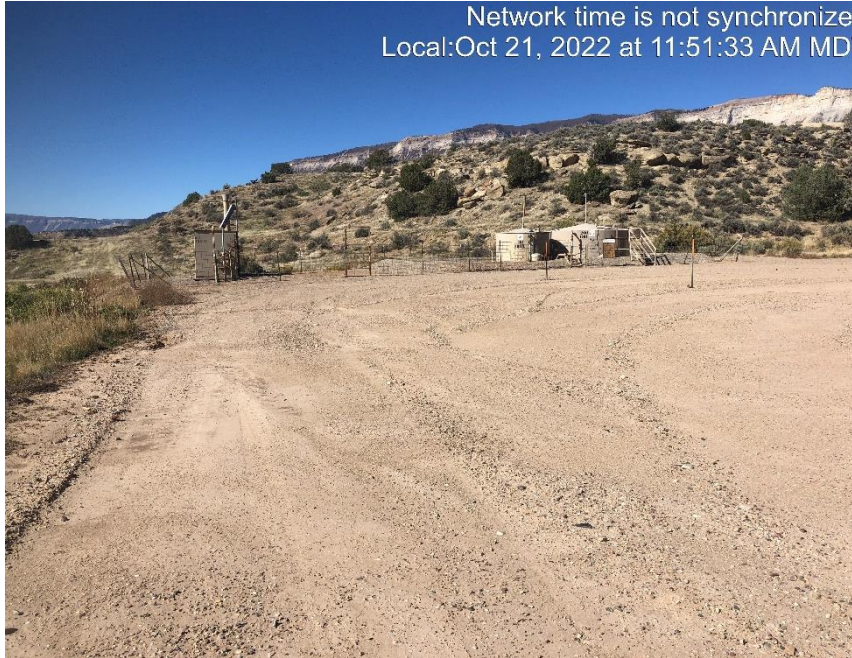
Photo #8126 From entrance to location.

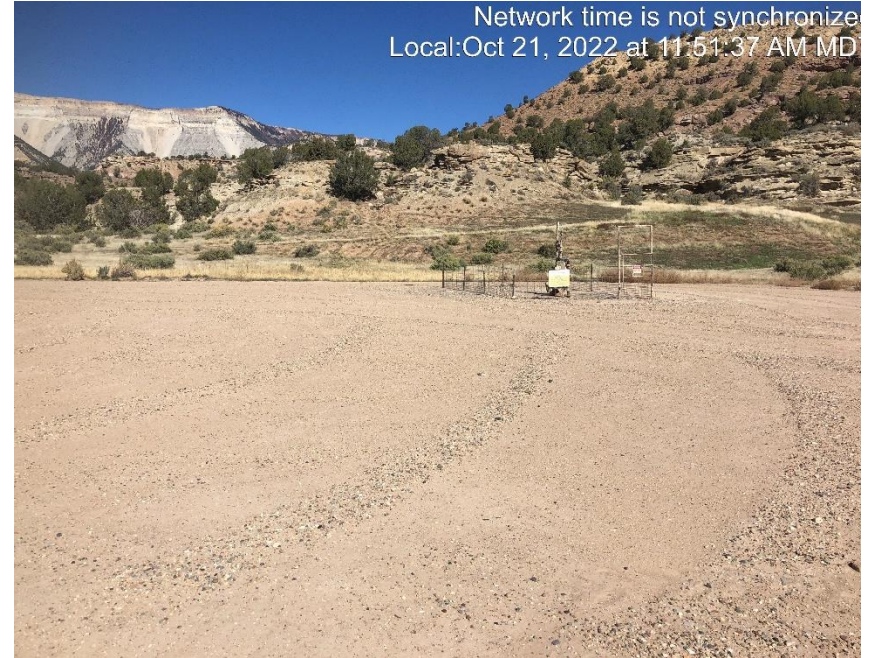
Photo #8127 From entrance to location.

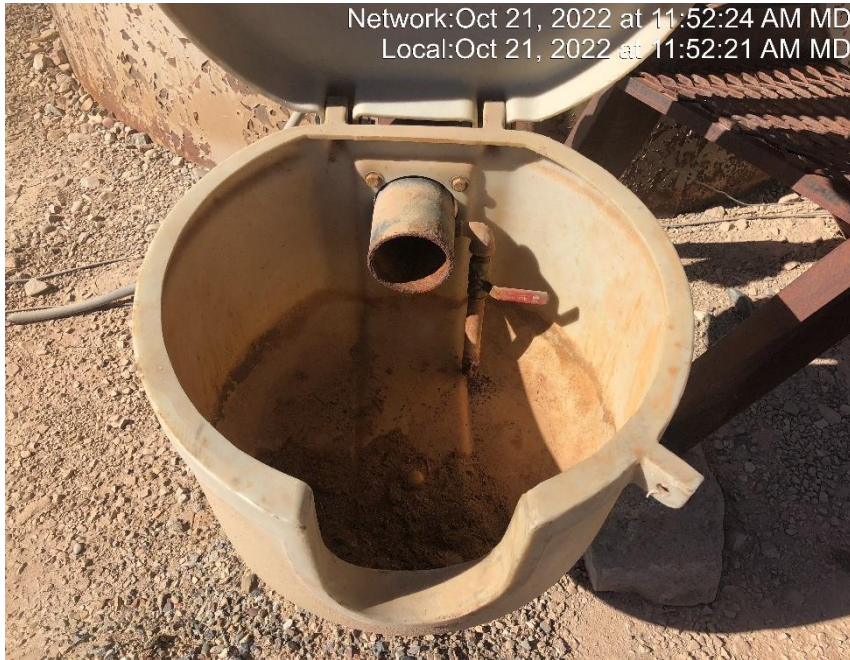
Photo #8128 Multiple loadline open ended.

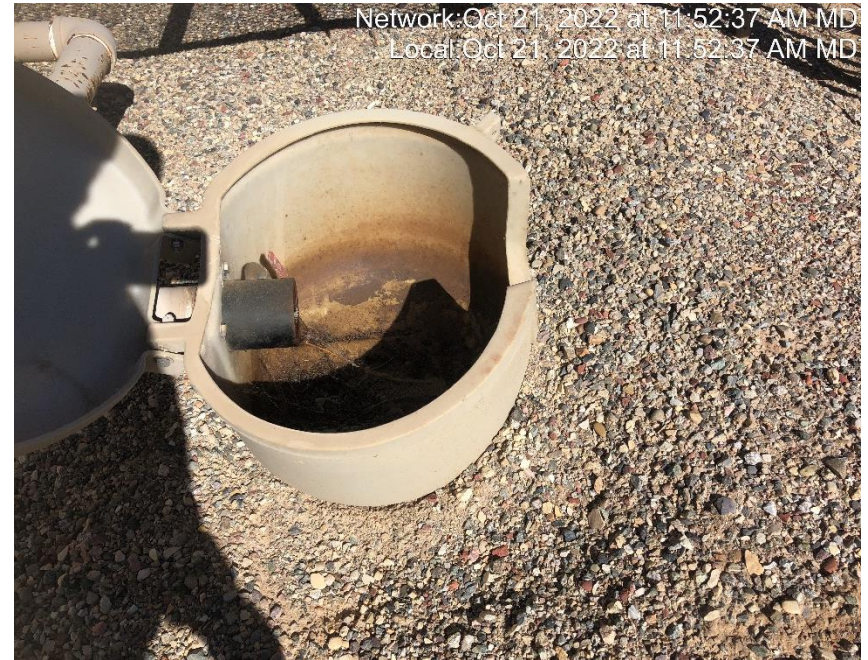
Photo #8129 Multiple loadline open ended.

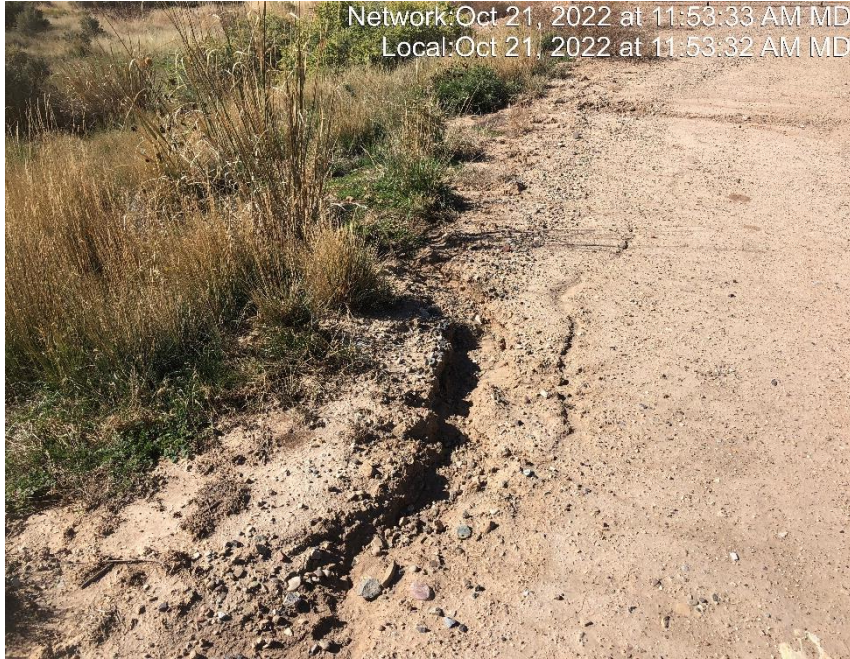
Photo #8131 Rill erosion occurring on location.

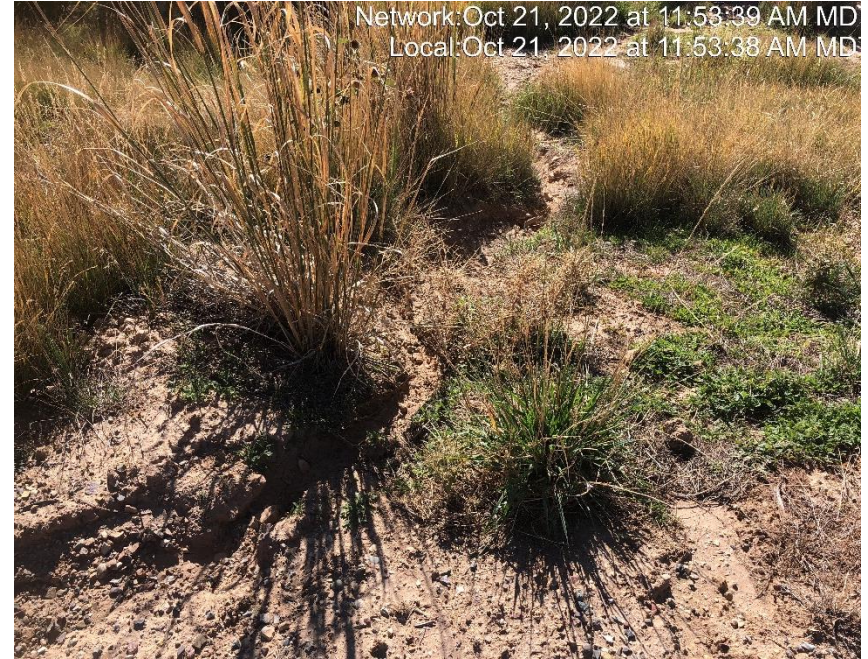
Photo #8132 Run off of location is not being controlled.

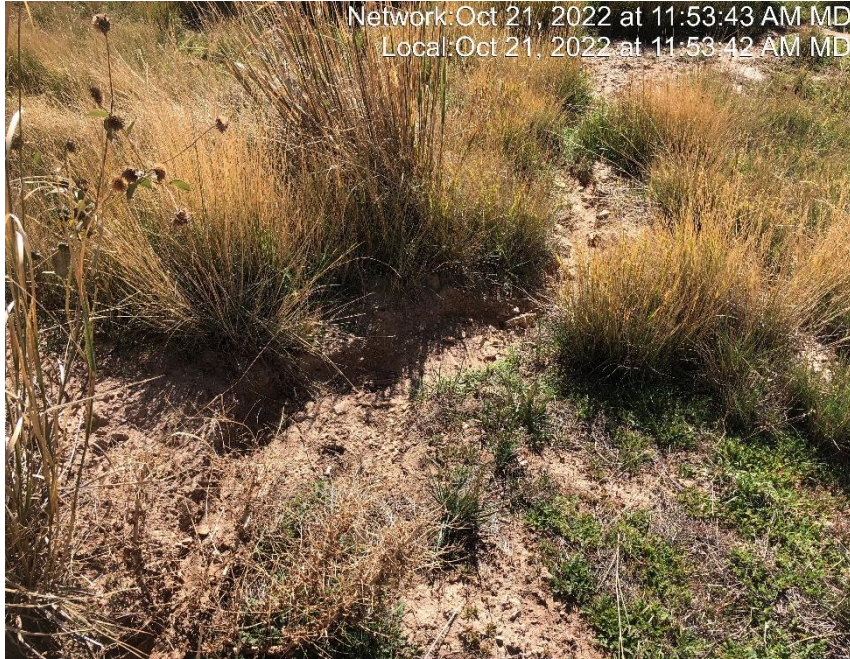
Photo #8133 Sediment migrating off location.

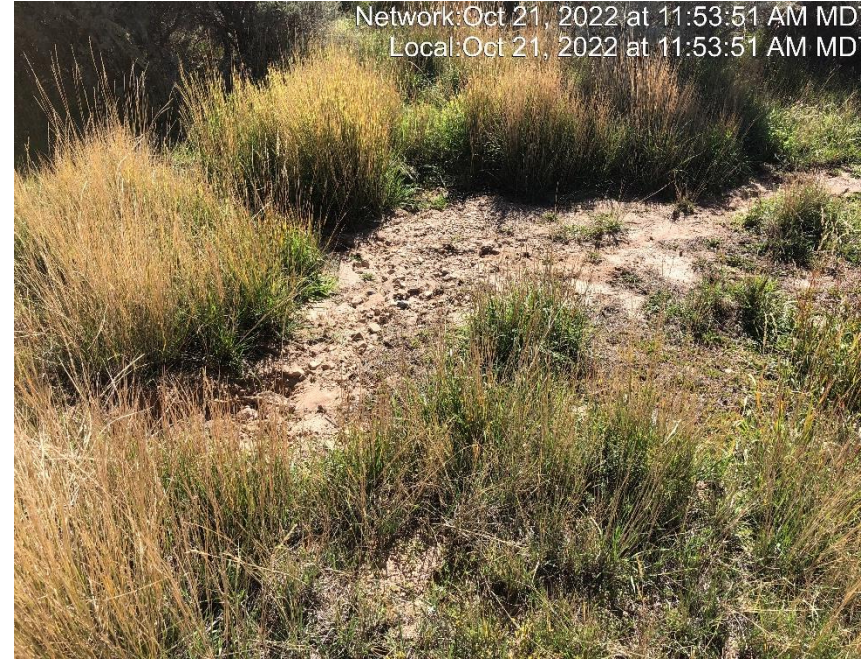
Photo #8134 Sediment is choking off vegetation.
