Inspection Photos

Location Name: CAERUS PICEANCE LLC BOULTON-66S92W /33SWSE

Location ID: 323968

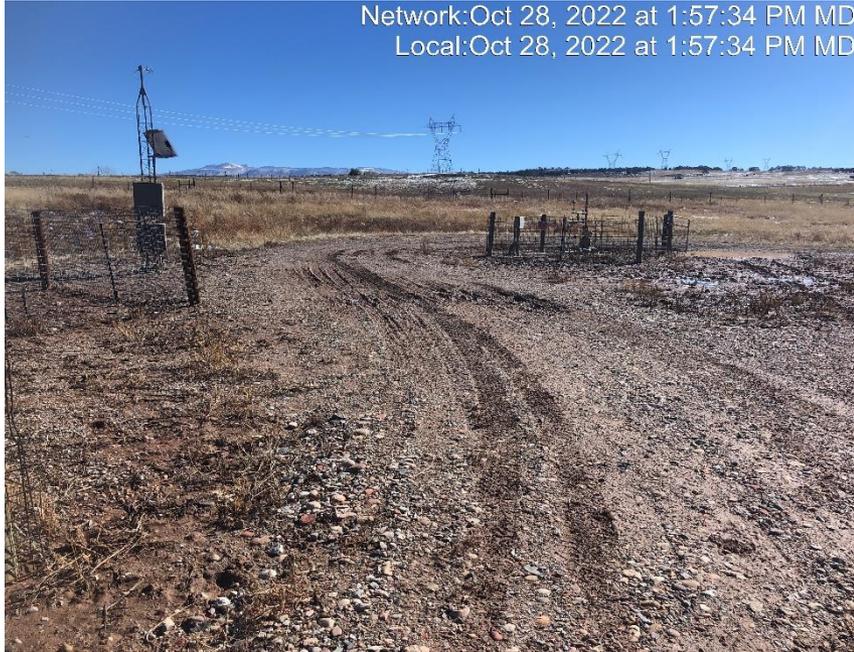
Photo #8230 From entrance to location.

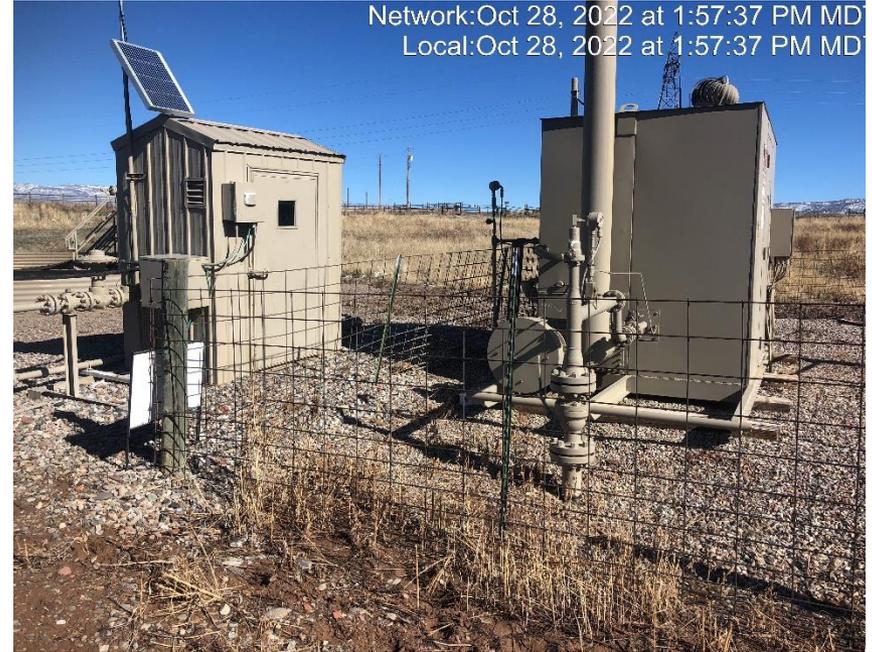
Photo #8231 From entrance to location.

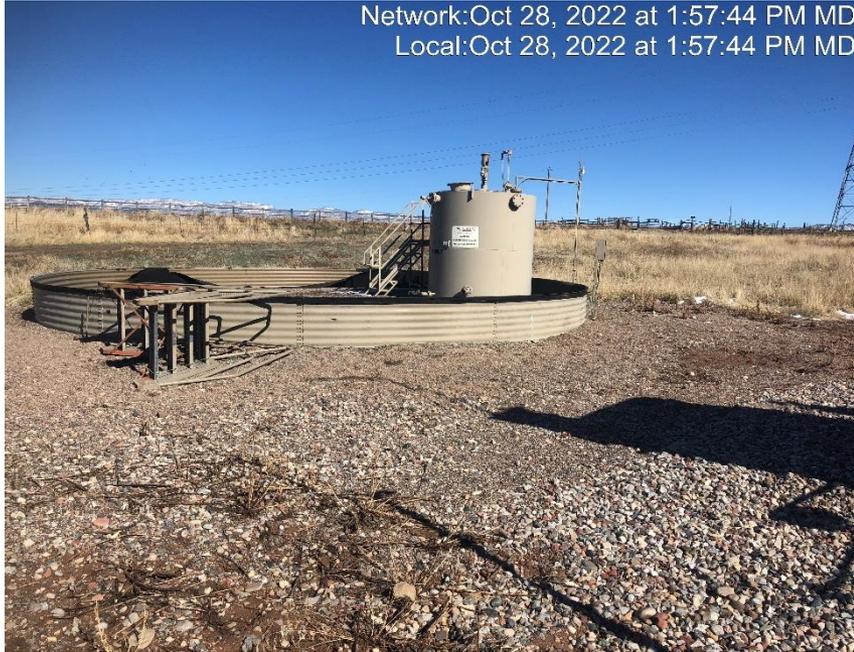
Photo #8232 From entrance to location.

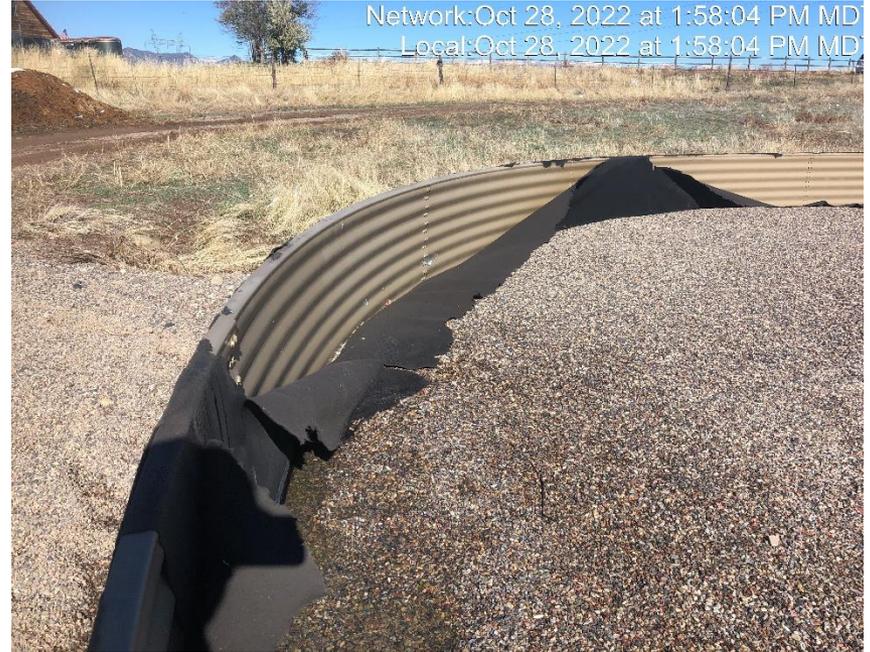
Photo #8233 Secondary containment needs repaired.

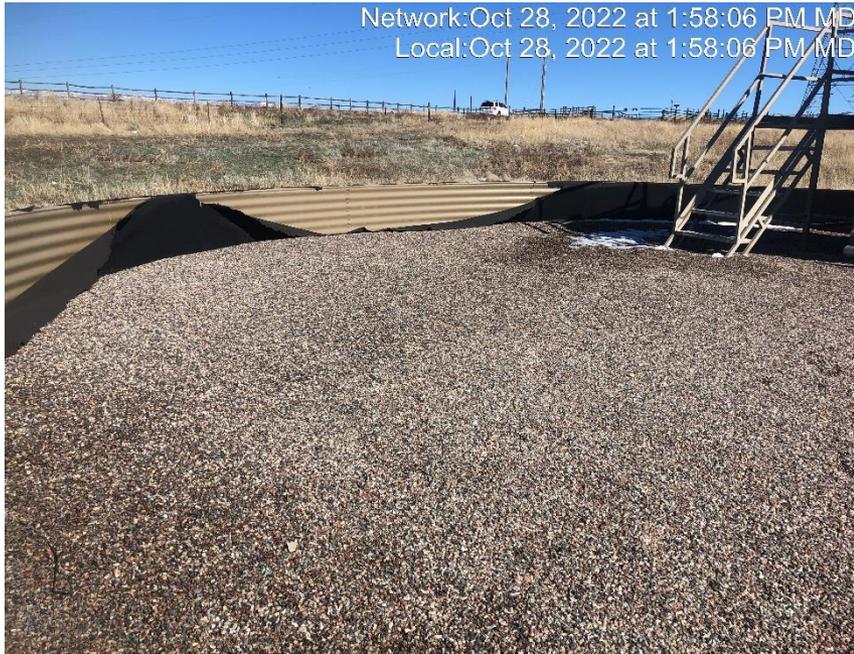
Photo #8233 Secondary containment needs repaired.

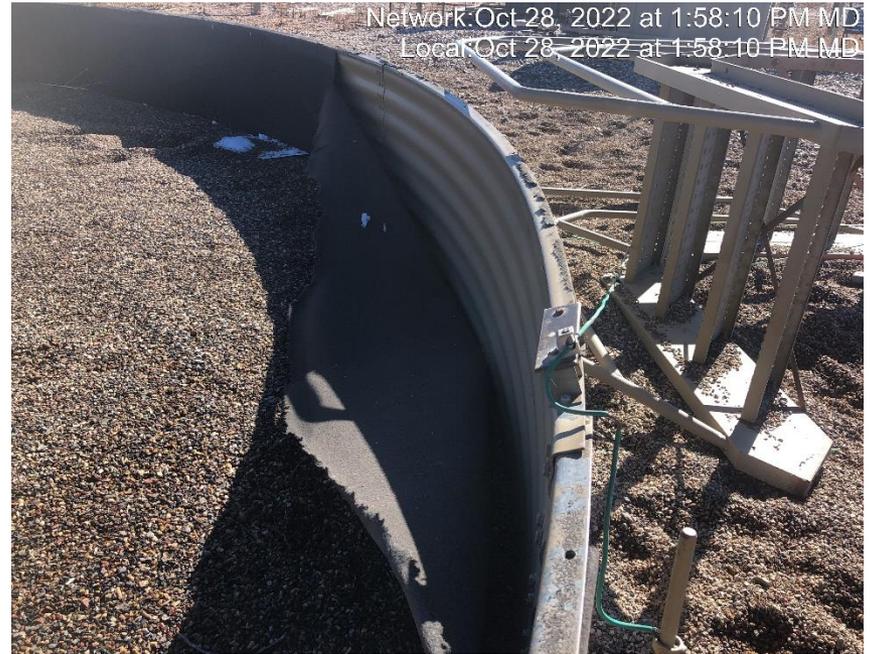
Photo #8235 Secondary containment needs repaired.
