Inspection Photos

Operator: Argali Exploration Company - #3975

Location Name: SPETTER-68N90W/8SWNW

Inspection Document #: 702800867

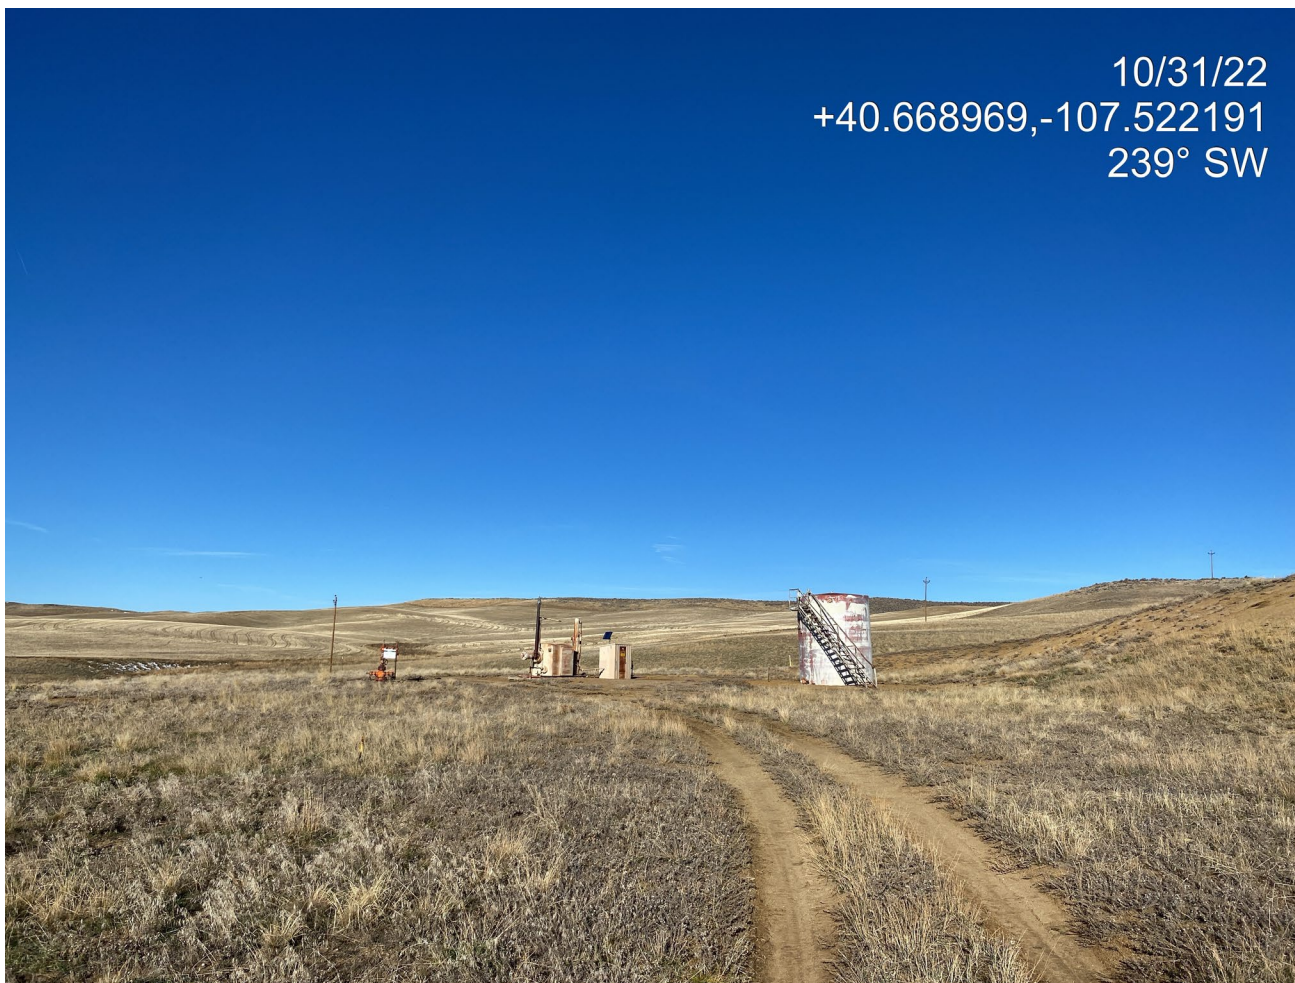
Photo 1. Photo taken from the east shows an overview of the Location.

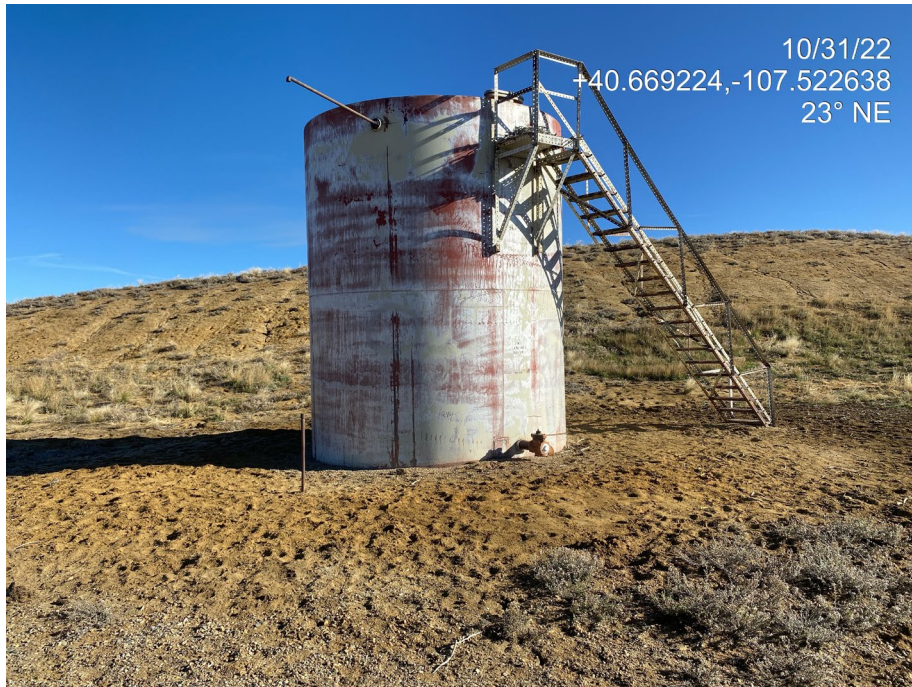
Photo 2. Photo shows a tank with no label and no secondary containment. Tank battery signage is absent. Tank is unused equipment.

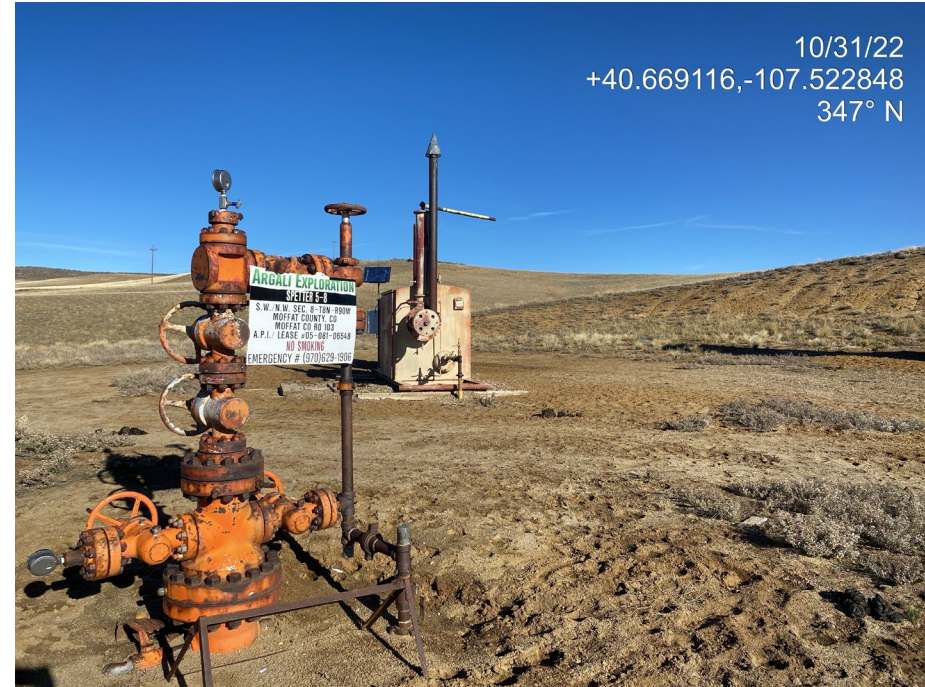
Photo 3. Photo shows production equipment. The wellhead sign does not comply with Rule 605.d(2).

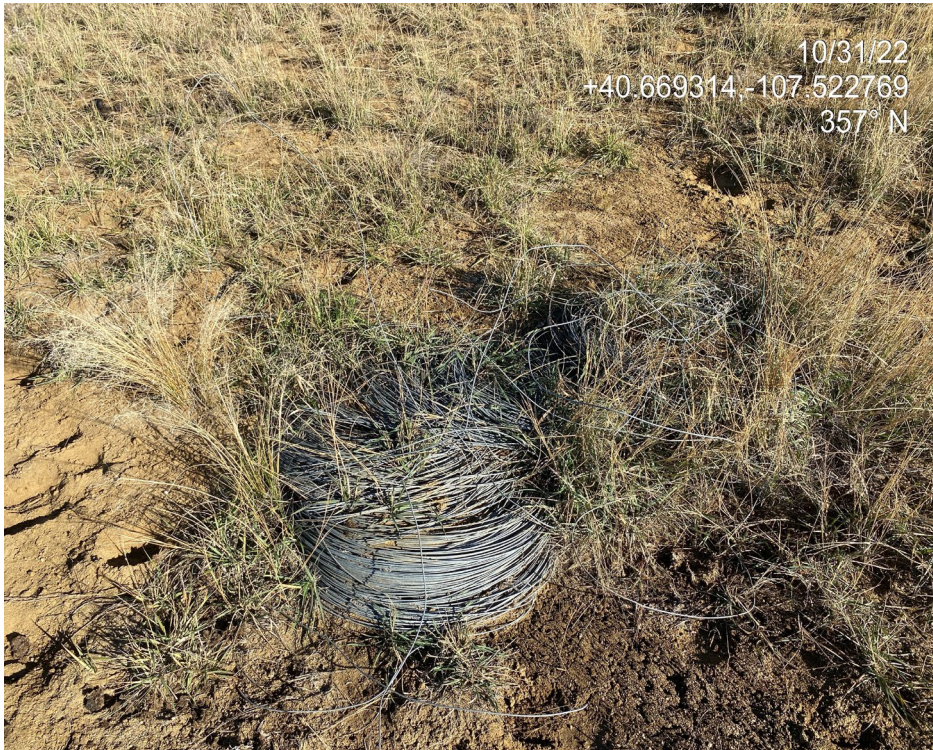
Photo 4. Photo shows trash (fence wire) on Location.

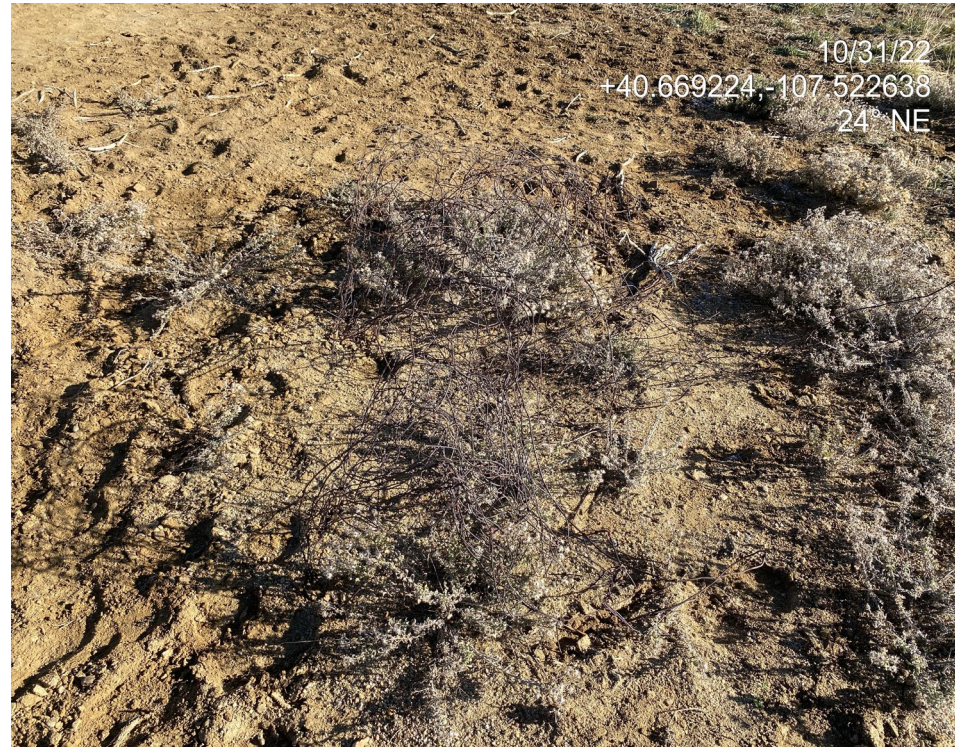
Photo 5. Photo shows trash (fence wire) on Location.

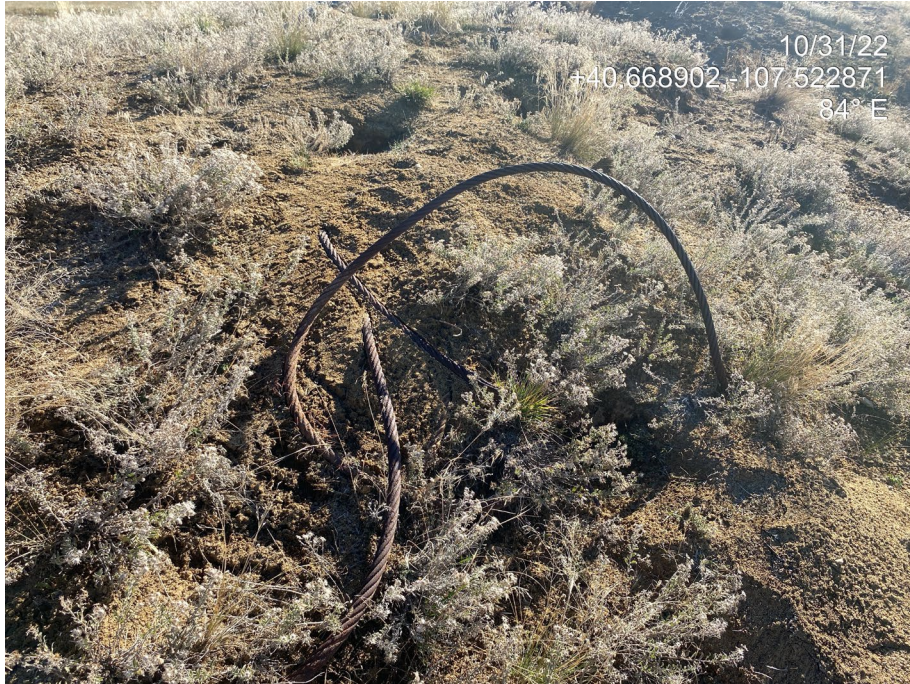
Photo 6. Photo shows trash (metal cable) present in the fill slope.

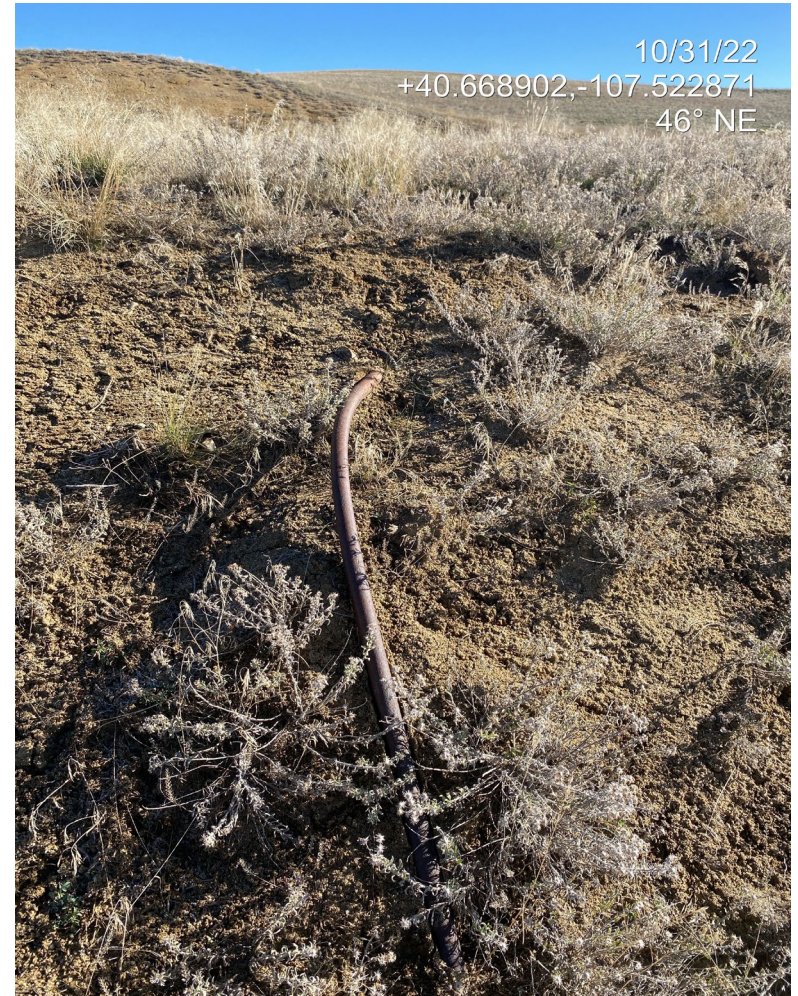
Photo 7. Photo shows trash (metal pipe) present in the fill slope.

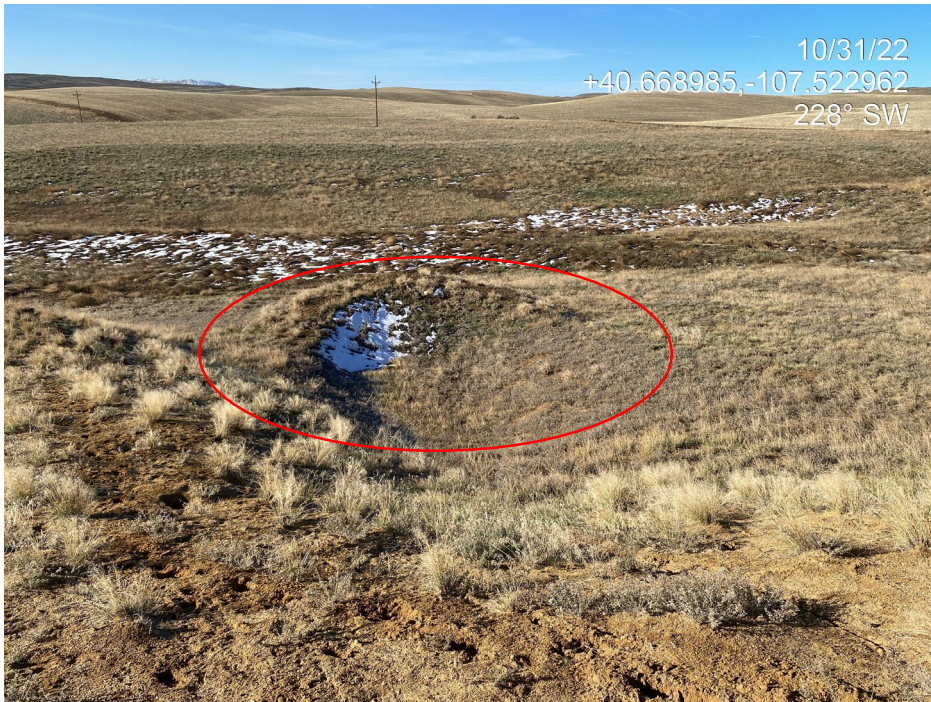
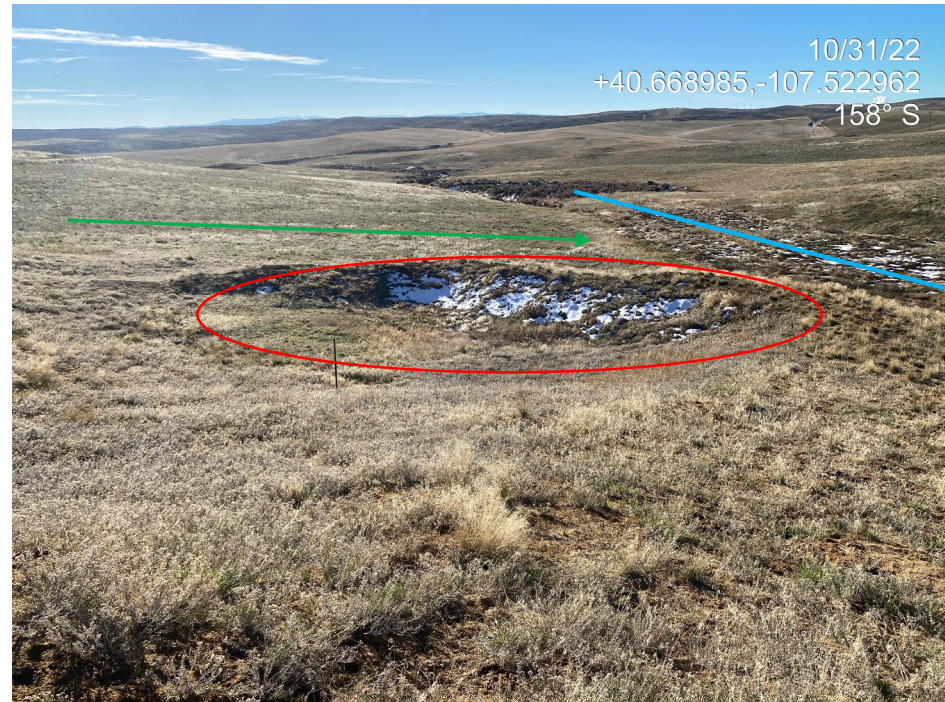
Photo 8. Photos show two pit overflow areas at the southwest of the Location. Pits have not been properly reclaimed; recontouring is required. Note natural contour of reference area; hillside gradually slopes down toward intermittent stream. Pits must be reclaimed per 1003 Rules.

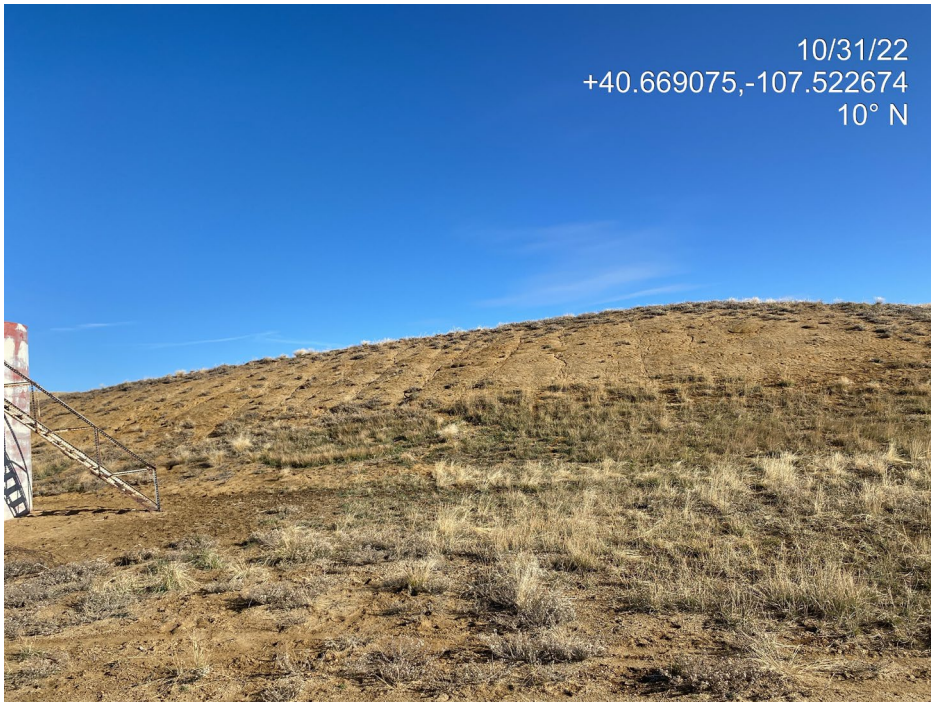
Photo 9. Photo shows an overview of the eroding cut slope at the north of the Location. Note, the base of the cut slope is vegetated and stable. Erosion is occurring in largely unvegetated areas.

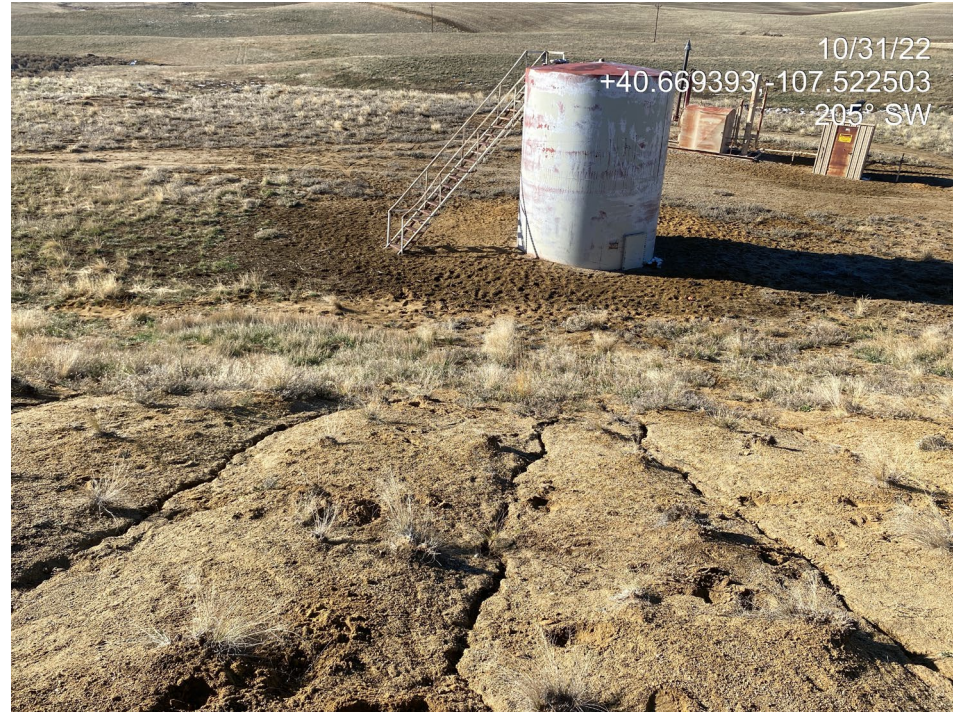
Photo 10. Photo shows rill erosion on the cut slope at the north of the Location. Erosion is occurring in areas which are largely unvegetated.

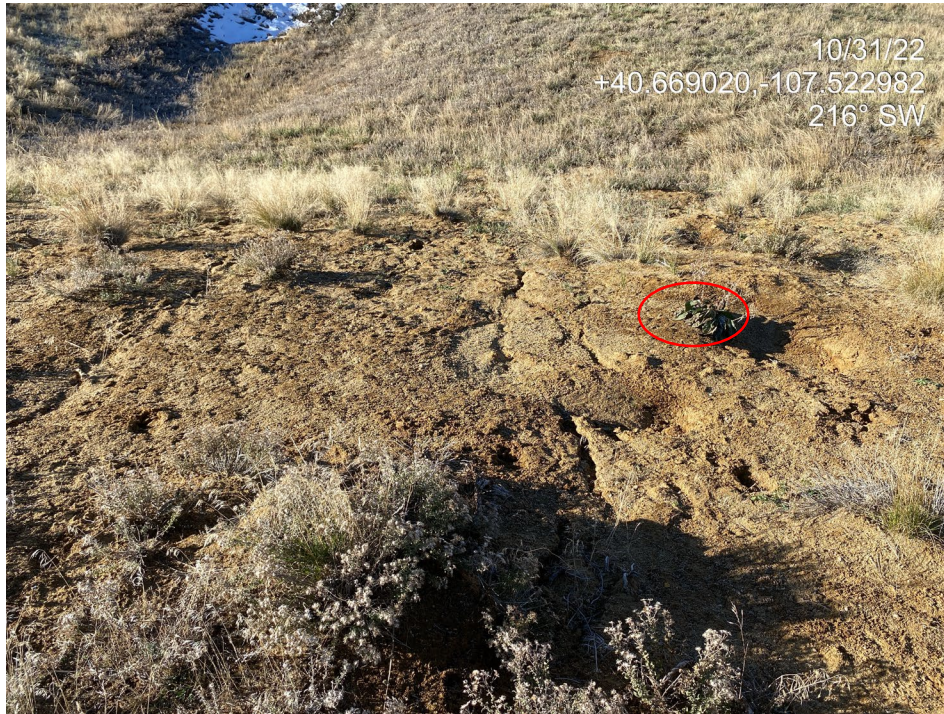
Photo 11. Photo shows rill erosion occurring on bare areas of the cut slope. Red circle indicates houndstongue (List B Noxious).

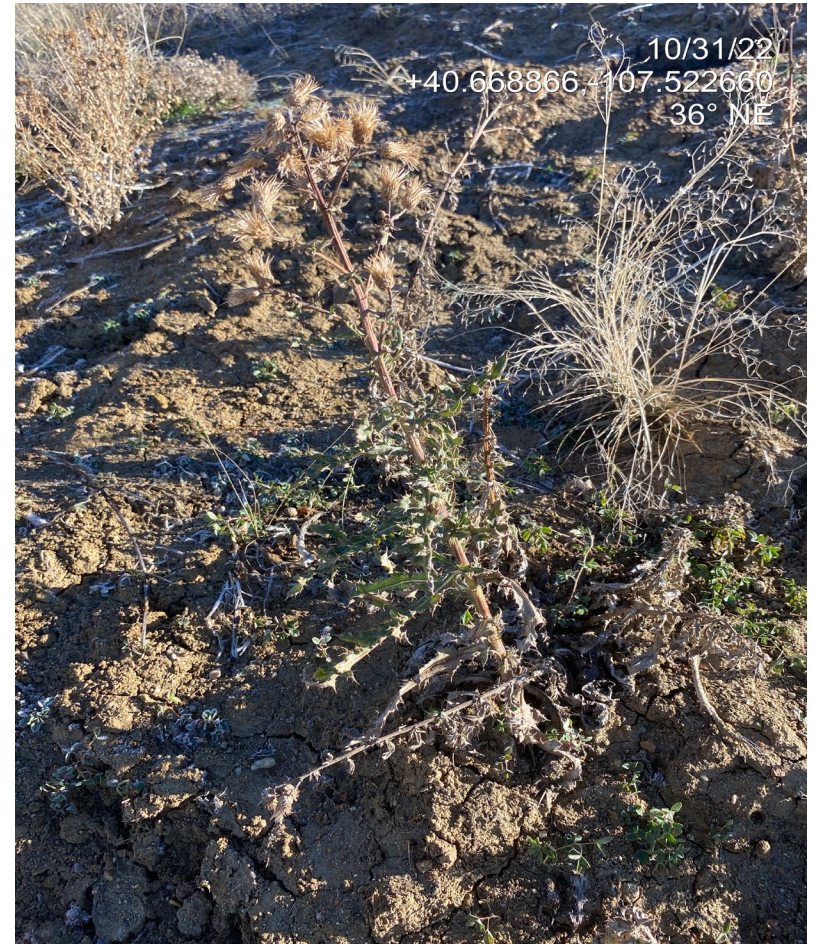
Photo 12. Photo shows Canada thistle (List B Noxious) on the pad surface. Canada thistle was also common on the fill slope.

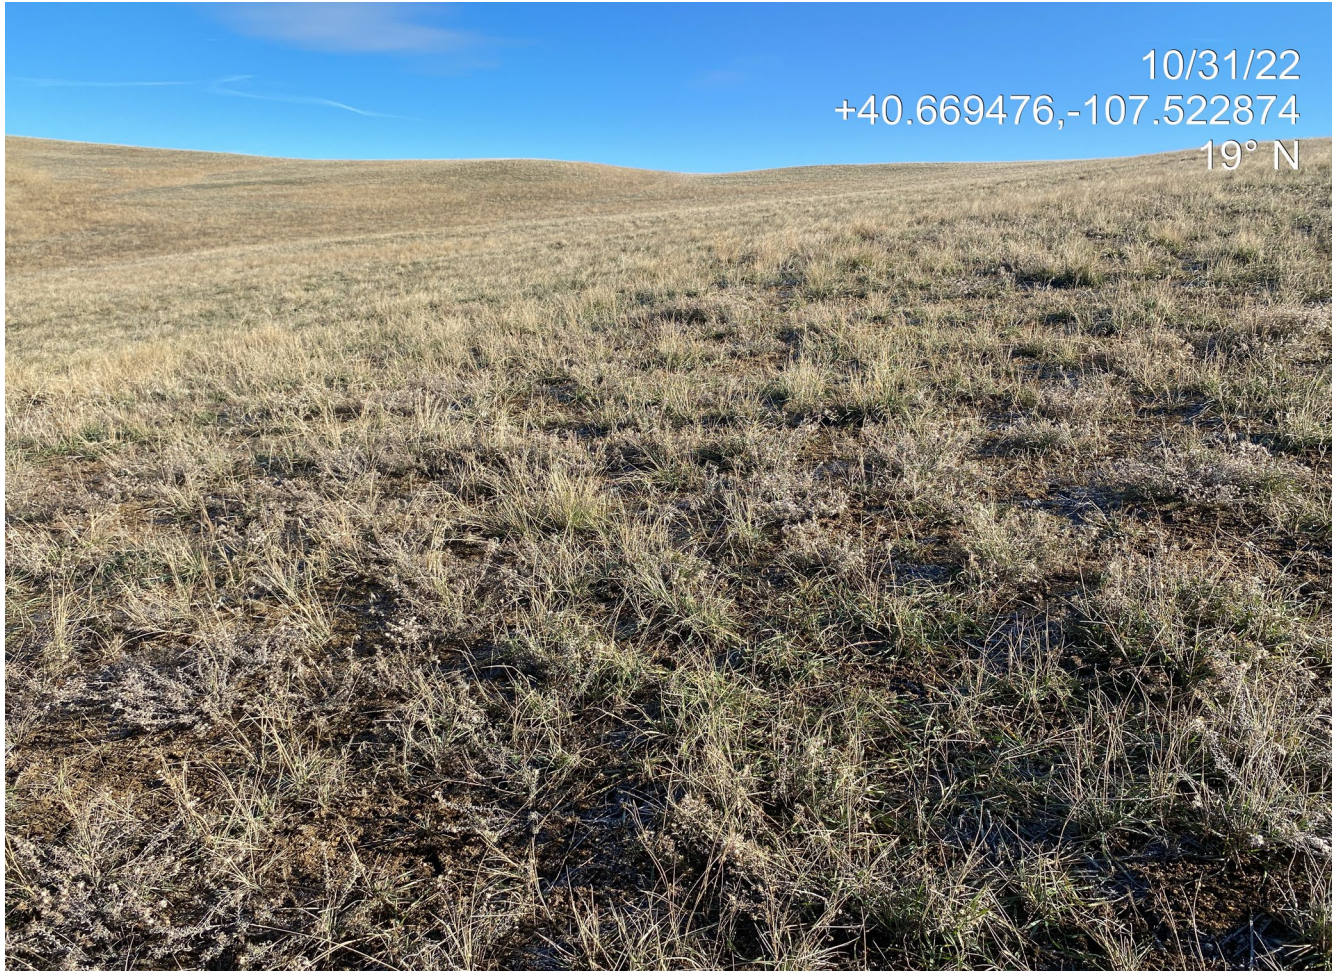
Photo 13. Photo shows reference areas to the north of the Location are densely vegetated and stabilized with perennial grasses.
