Inspection Photos and Issue Report

11/1/2022

Operator: GUNNISON ENERGY LLC - 10515

Location #453805

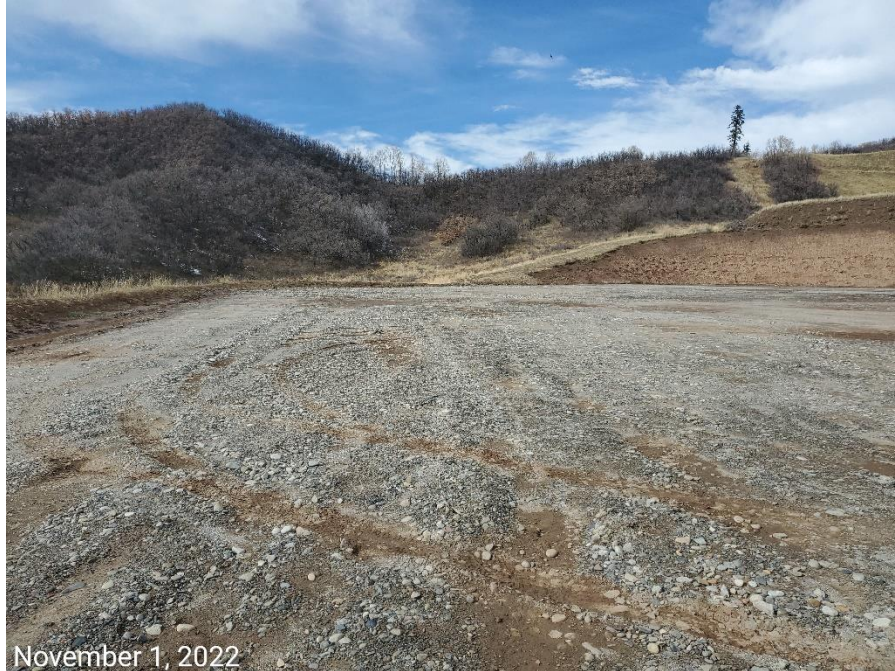
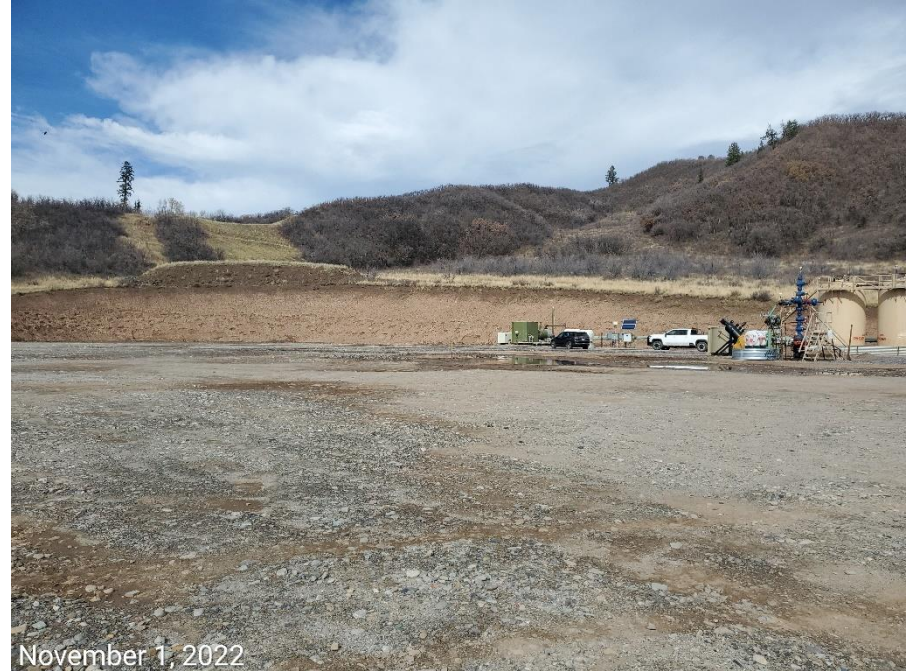
Photo 1: Photos 1-2 taken from the west end of the current production pad area. Photos provide an overview of the Location from north, northeast, southeast to south.

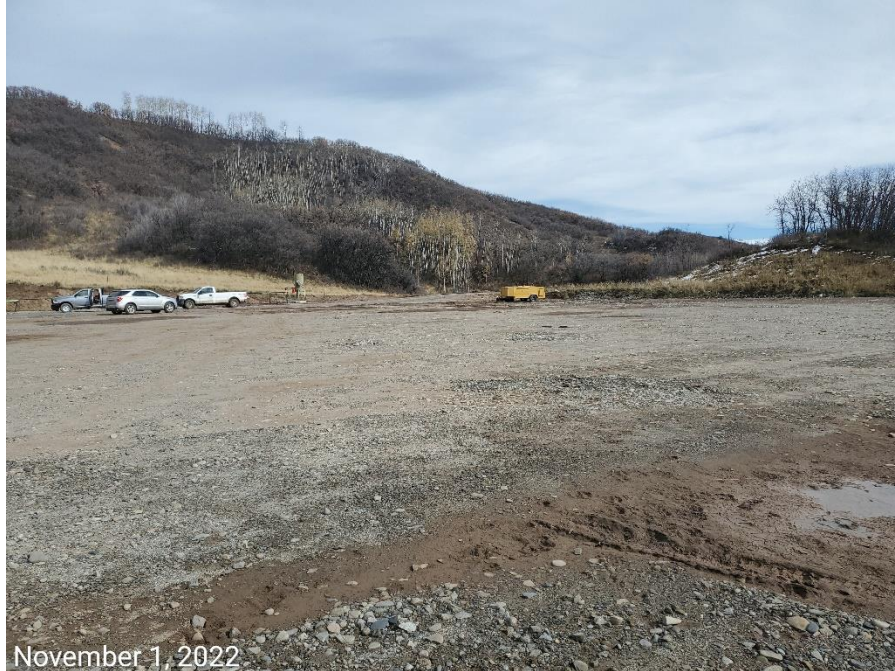
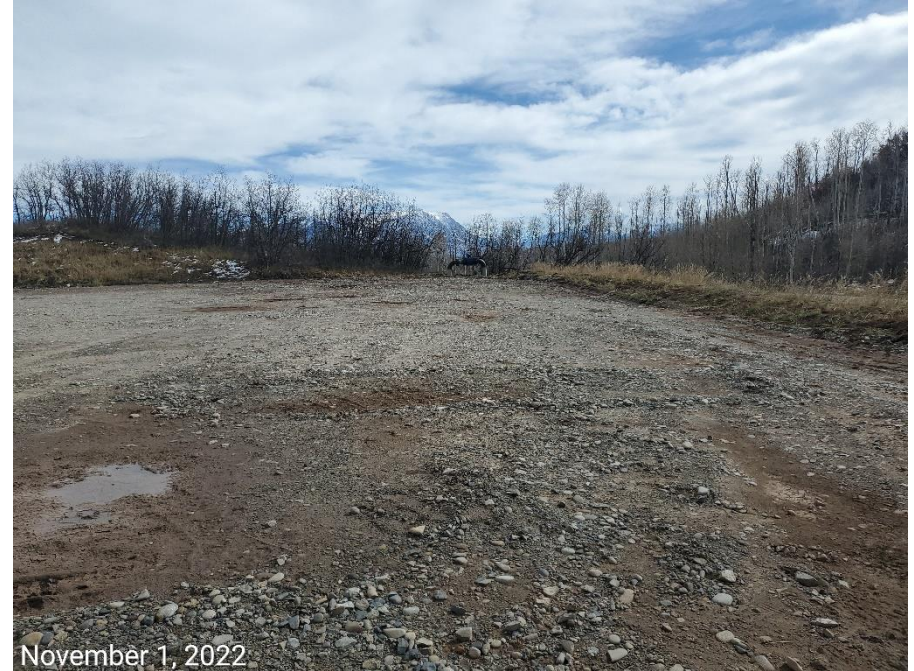
Photo 2: See comments under photo 1.

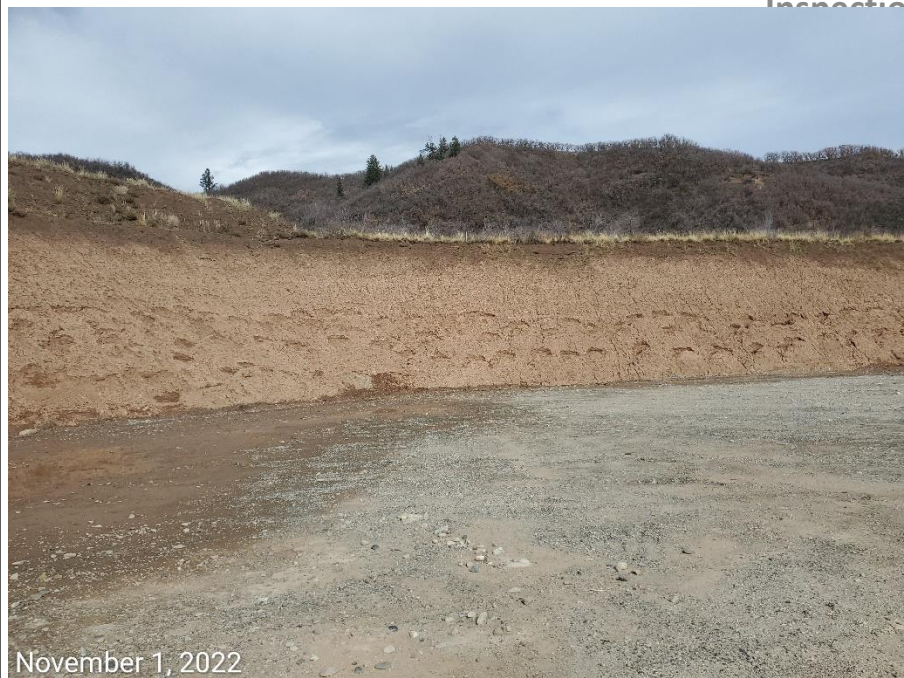
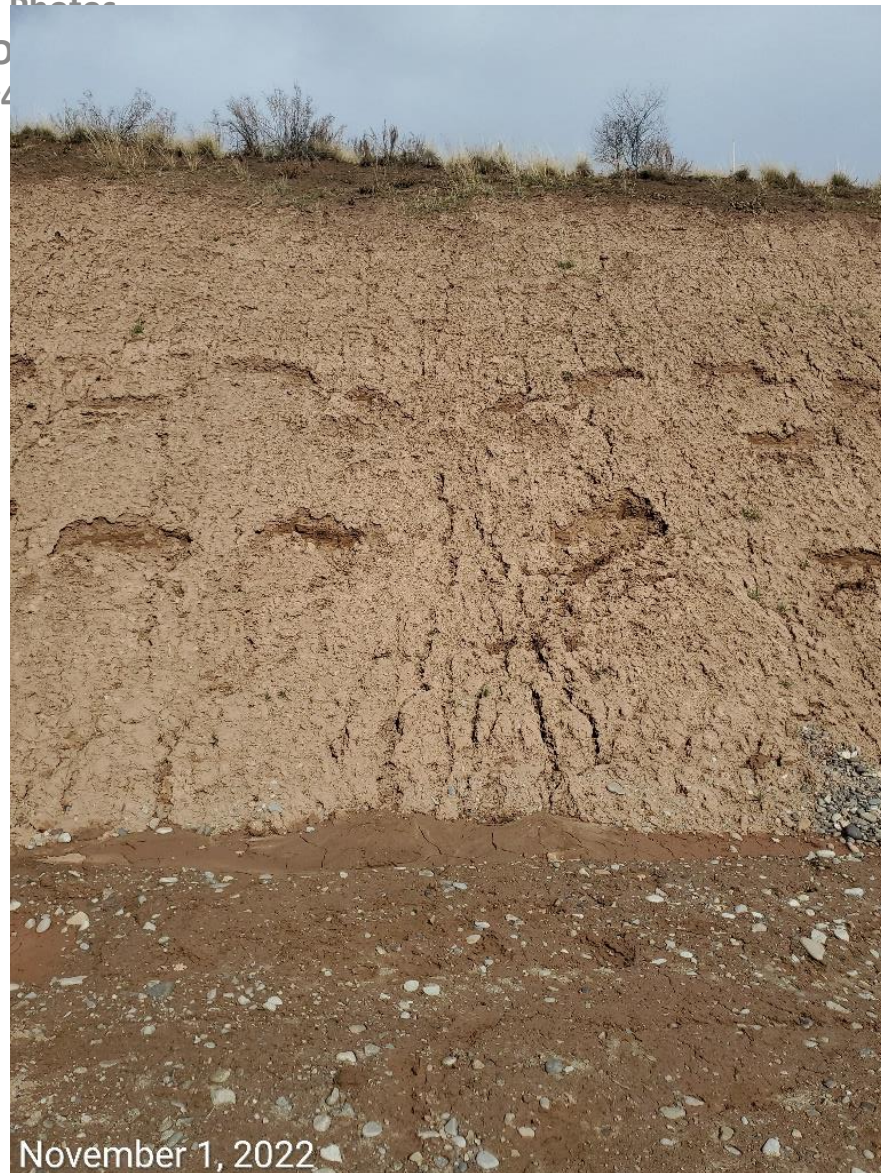
Photo 3: Photo taken from the cut slopes of the Location. Photos examples showing Operator implemented “potholing” at cutslopes; BMP observed to be inadequate for the site’s conditions, and per good engineering practices in order to minimize erosion/degradation, and to protect/stabilize the cutslopes; erosion degradation and sediment transport has persisted.

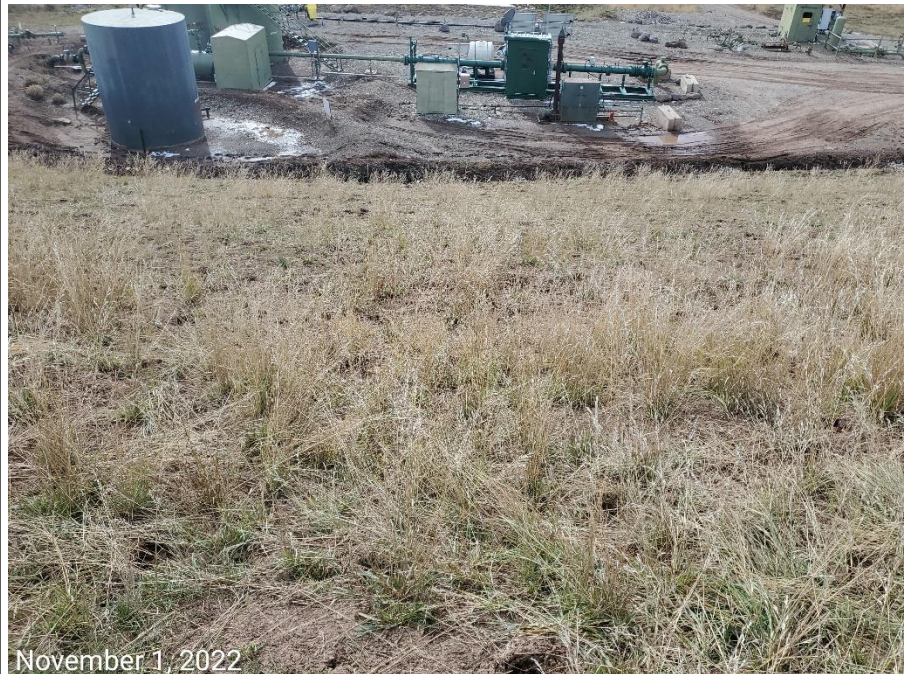
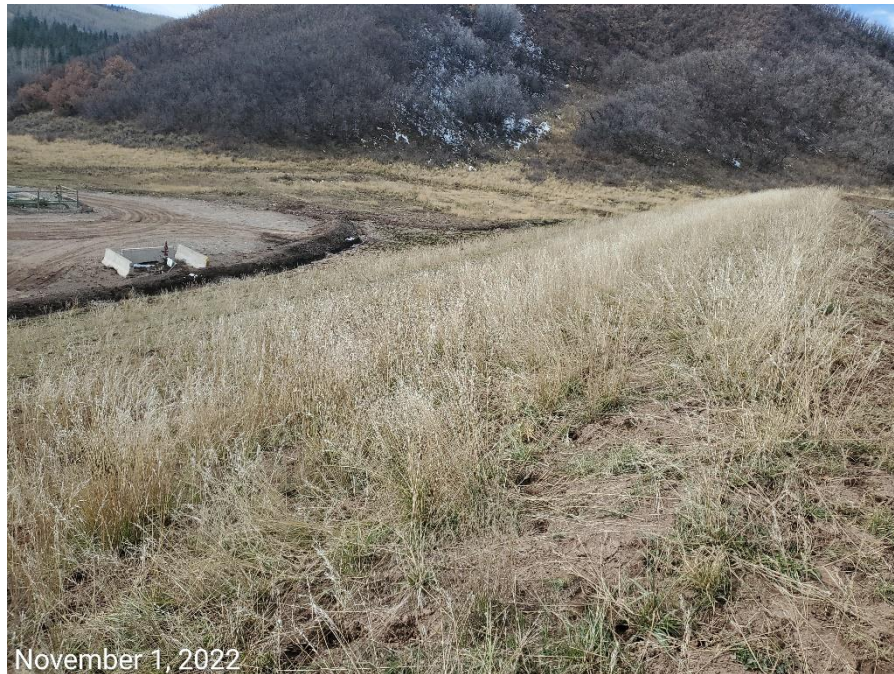
Photo 4: Photos taken from the fill slopes on the west end of the Location. Photos show Operator appears to have repaired erosion observed on the fill slopes, applied straw mulch that was tracked in place in conjunction with seeding. Slopes appear stabilized at time of inspection, and is considered “in process”. Ensure BMPs are maintained in proper functioning condition.

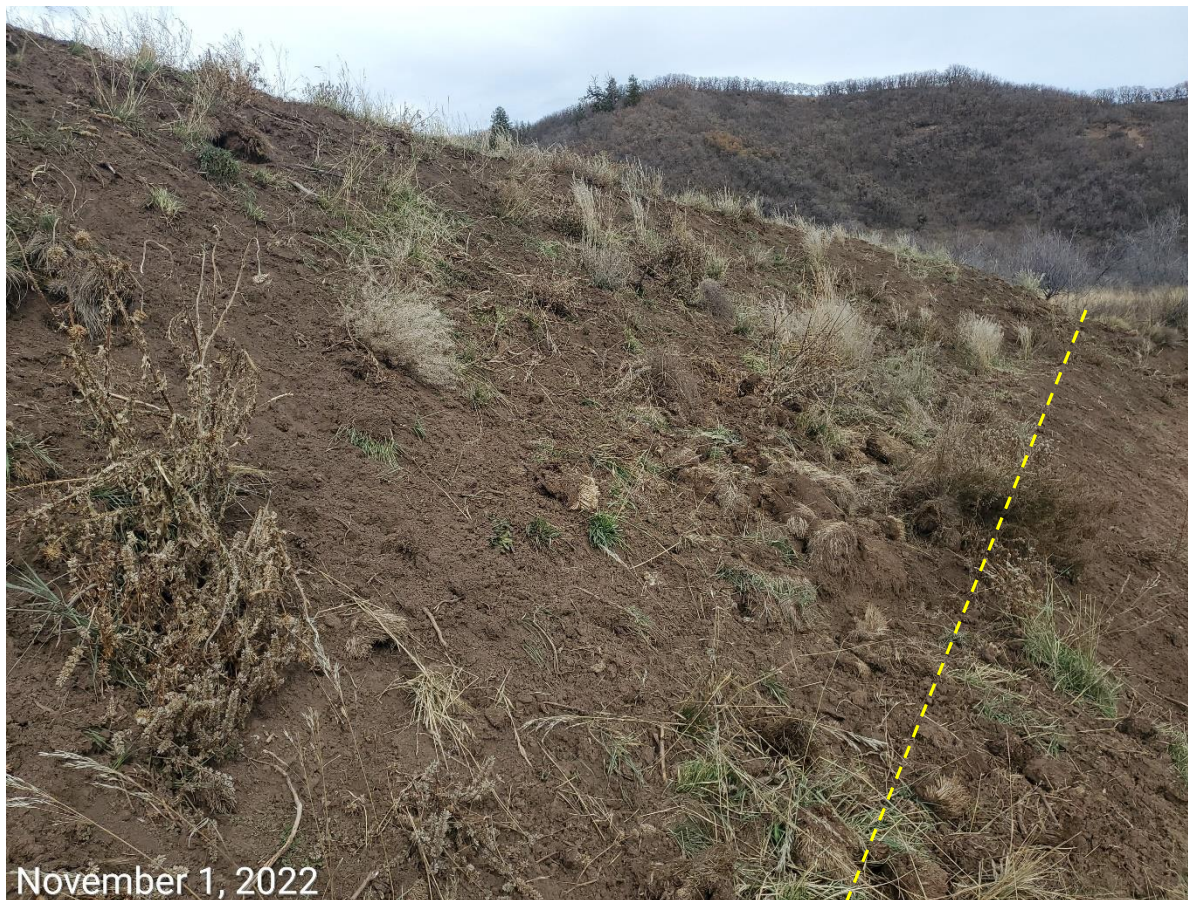
Photo 5: Photo taken from the topsoil stockpile on the north end of the Location. Photo shows large areas of the soil stockpile with bare soil at risk to wind and water erosion; control measures to minimize erosion, degradation at the stockpile, and BMPs to manage runoff and minimize sediment transport along the perimeter of the soil stockpile remain missing or insufficient. Yellow line represents top of the cut slope/base of the stockpile.

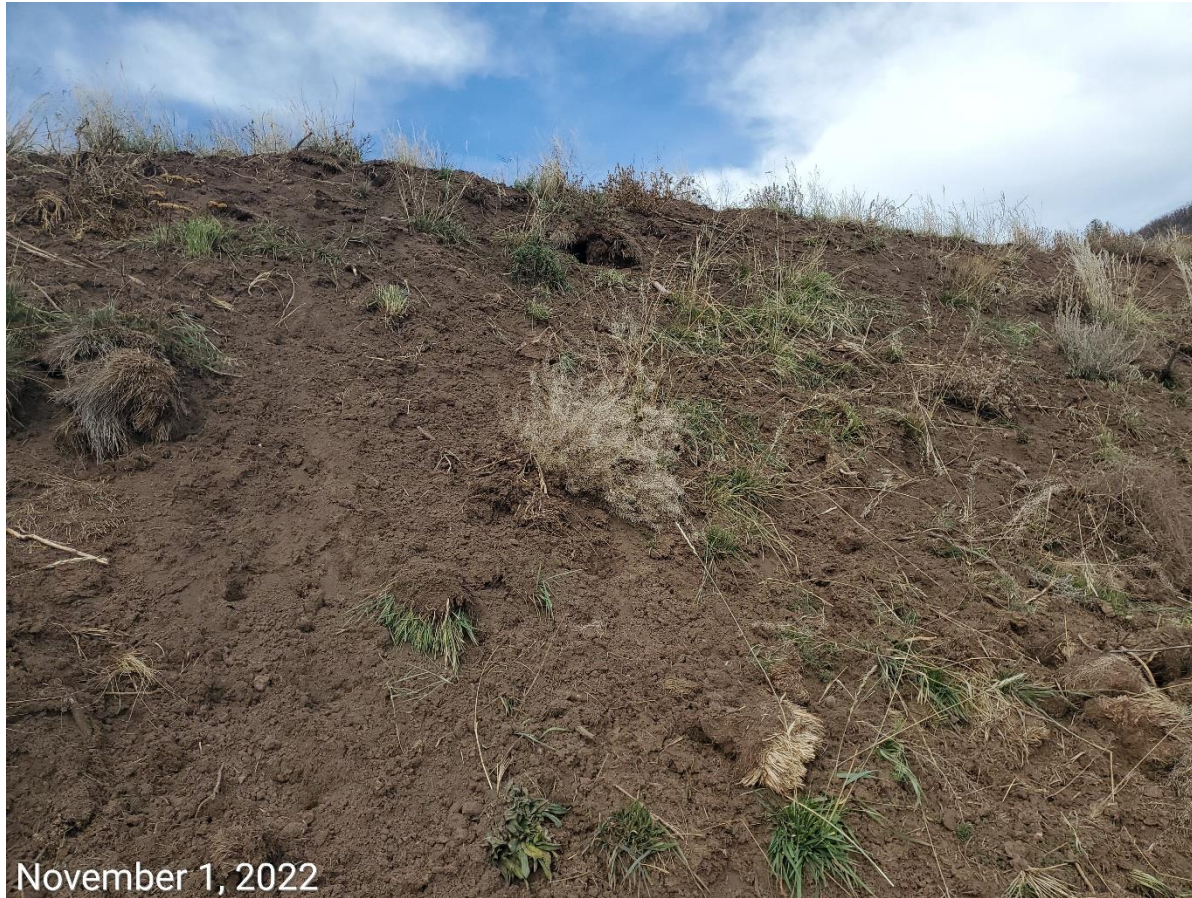
Photo 6: Continued from photo 5. Photo example showing areas of the topsoil stockpile that remains bare, and at risk to wind and water erosion; BMPs to minimize erosion, degradation and sediment transport remain missing or insufficient.

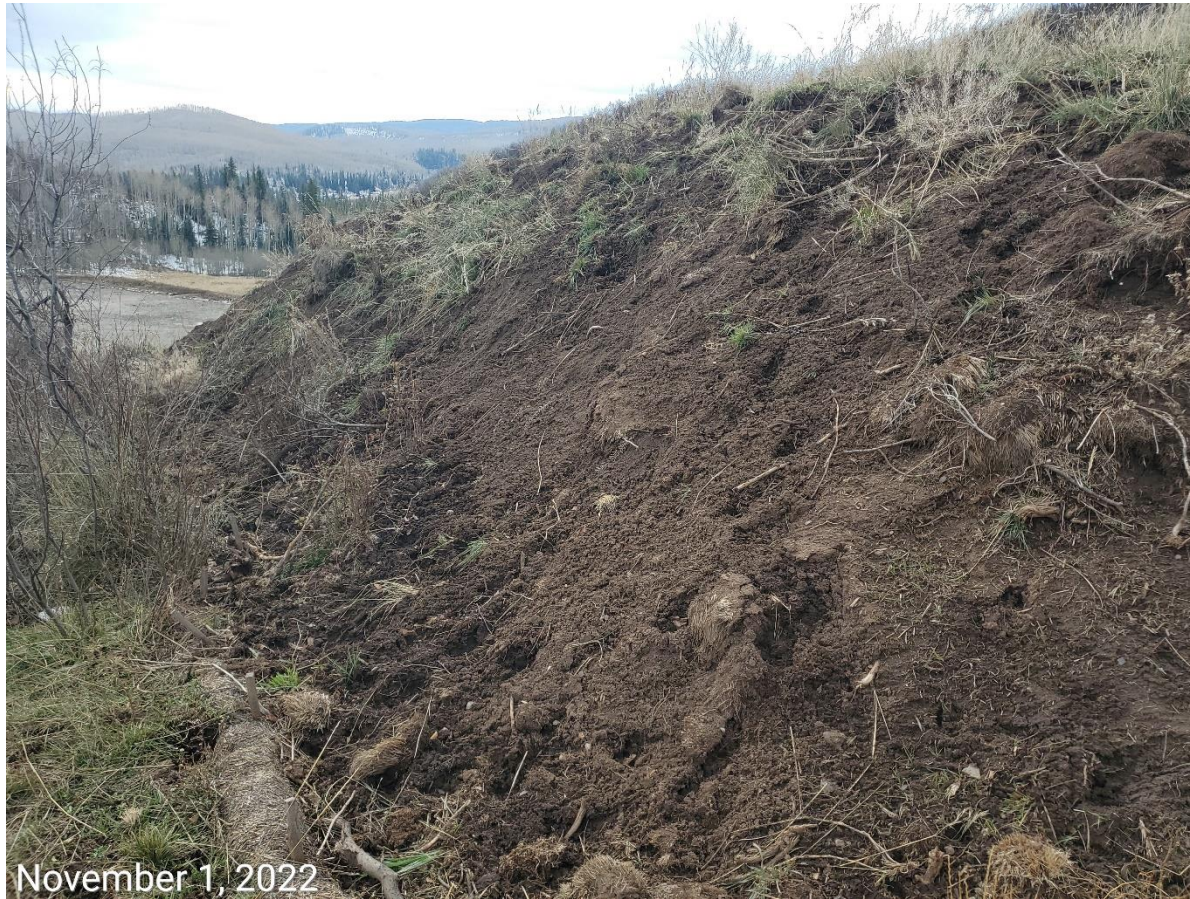
Photo 7: Continued from photo 5. Photo example showing areas of the topsoil stockpile that remains bare, and at risk to wind and water erosion; BMPs to minimize erosion, degradation and sediment transport remain missing or insufficient.

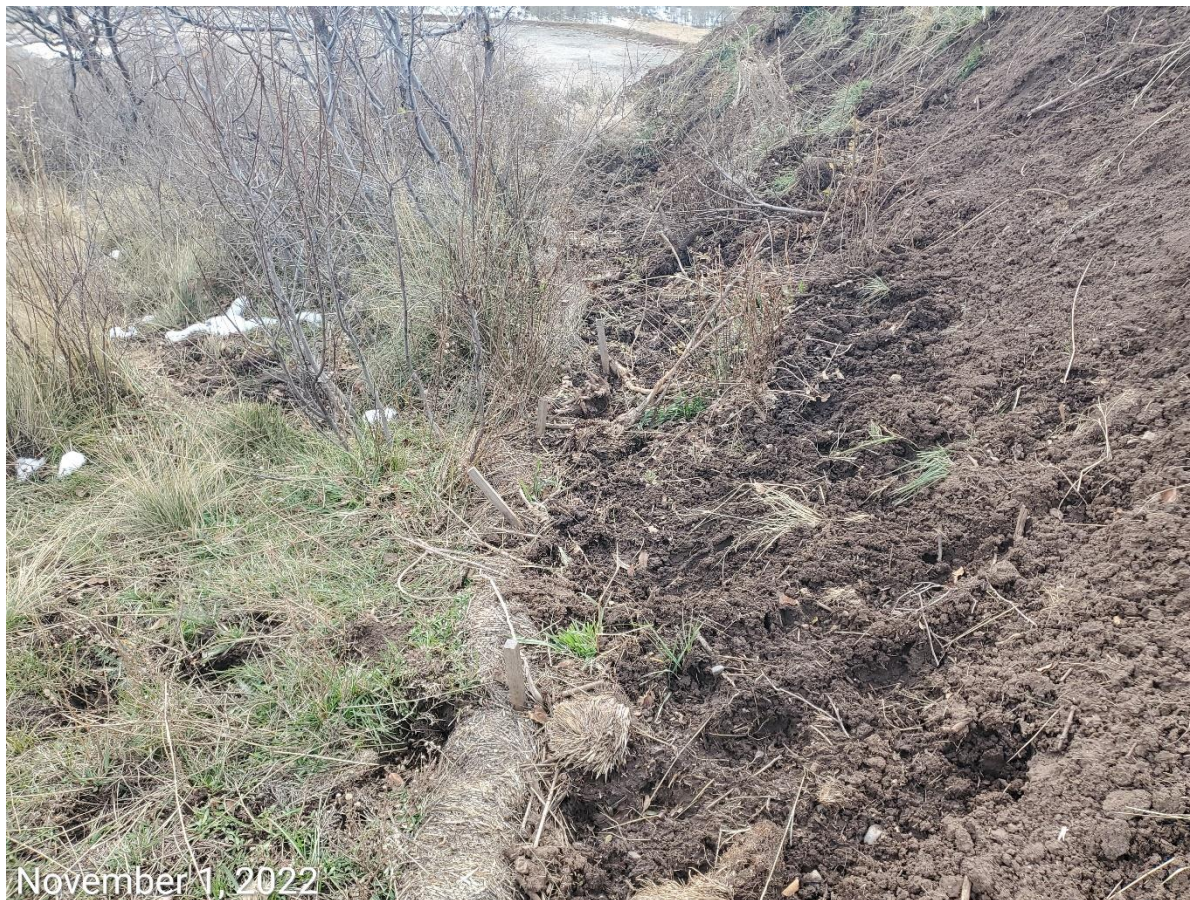
Photo 8: Photo shows Operator implemented a single row of erosion log (straw wattle) along the eastern, northern and southern perimeter of the topsoil stockpile (perimeter BMPs along the southern perimeter remains missing, see photo 5). Photo shows erosion log is not in proper functioning condition; BMP partially buried by sediment along areas of the stockpile, or flattened.

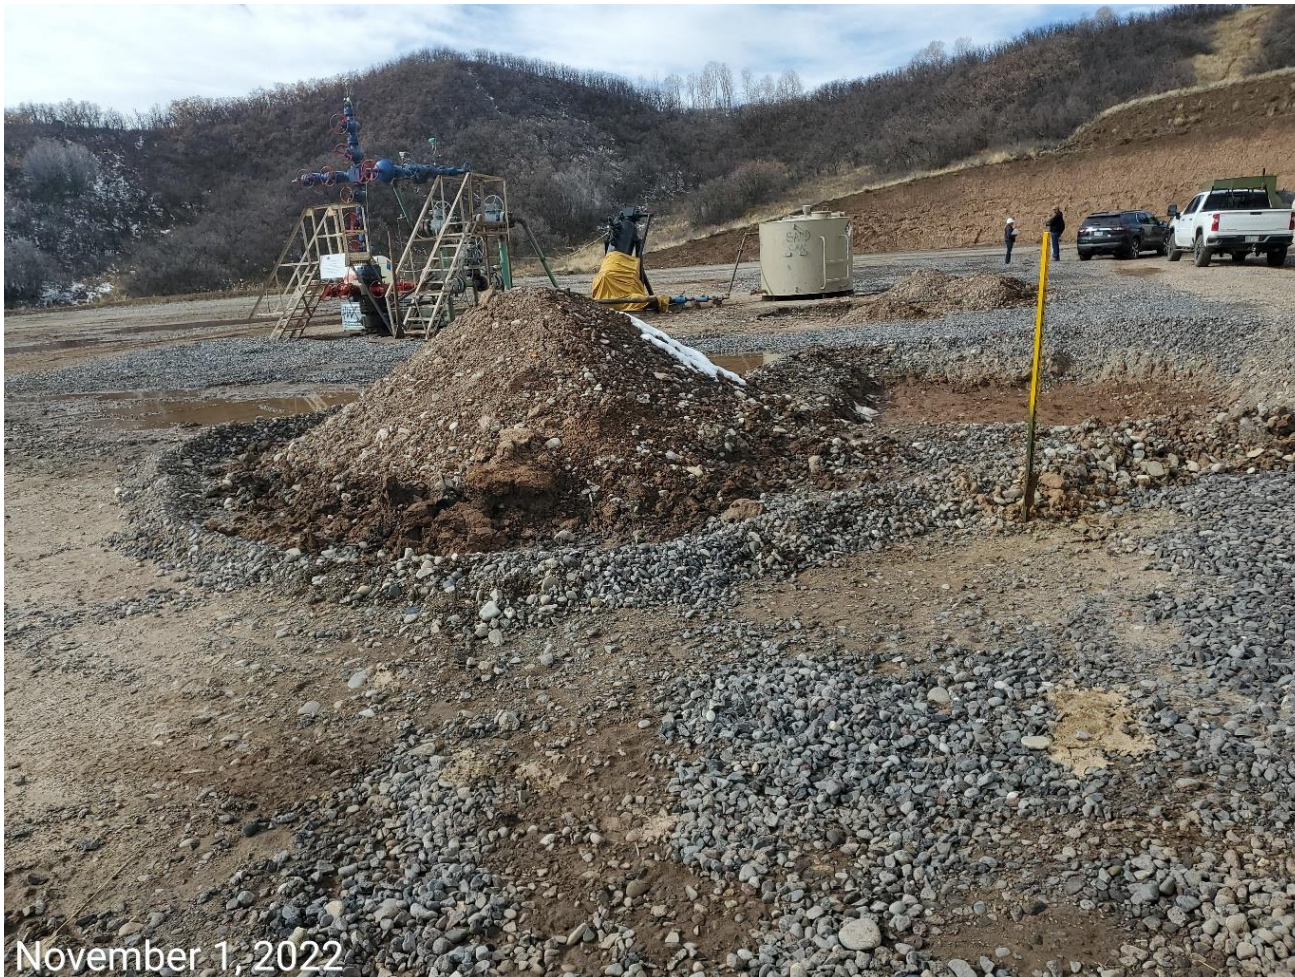
Photo 9: Photo example showing 1 of 4 stockpiles observed where Operator has conducted excavation operations to collect soil samples (see remediation proj. #23148). BMPs to protect the stockpiled soils, and to minimize erosion and sediment transport from the potentially impacted soil stockpiles are missing or insufficient. Stockpile shown in photo an example where Operator installed a berm at its base- Berms observed are unconsolidated, permeable, and have not been installed per good engineering practices

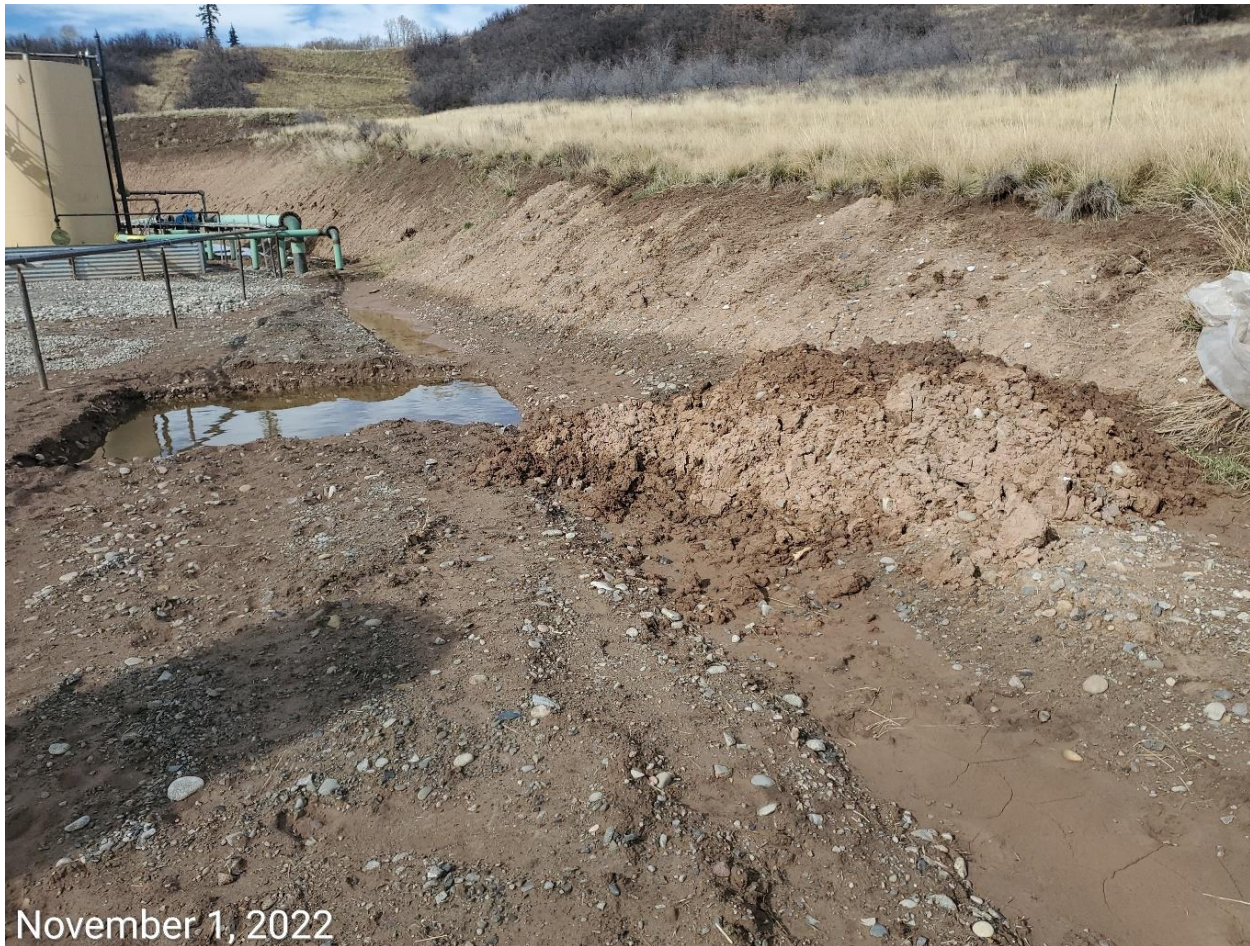
Photo 10: Photo example showing 1 of 4 stockpiles observed where Operator has conducted excavation operations to collect soil samples (see remediation proj. #23148). Photo example showing 1 of the 2 areas where Operator excavated, and placed potentially impacted soils within the perimeter stormwater diversion ditch along the east end of the working pad. In addition to missing BMPs to prevent sediment transport from the soil stockpiles, BMPs to prevent stormwater runoff from entering, or discharging from the sample pits within the ditch are also missing or insufficient, potentially increasing the risk of stormwater contamination, and contaminated discharge from the Location.

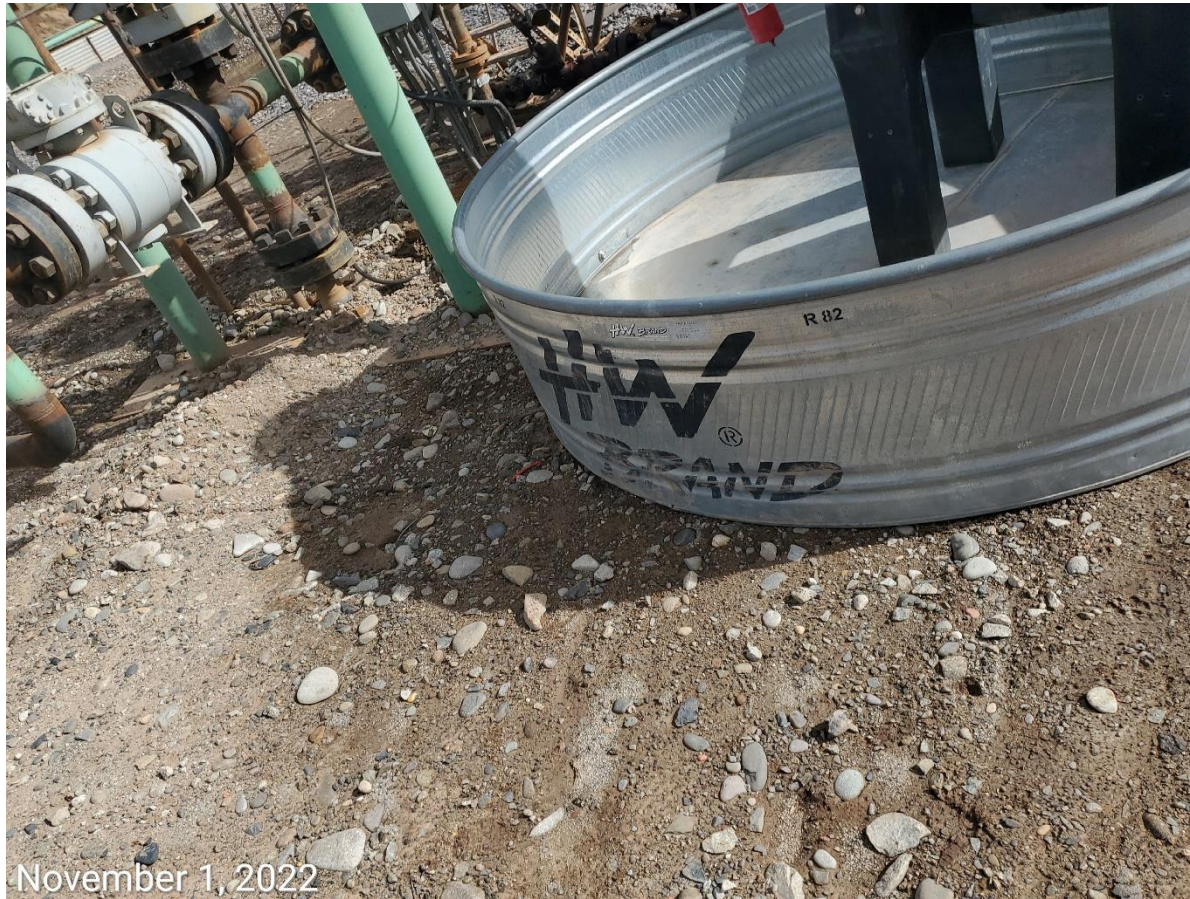
Photo 11: Photo taken from the methanol tank adjacent to the well. BMPs to prevent wildlife access were observed to be missing at the secondary containment BMP
