Environmental Inspection

November 22, 2022

Operator: WESTERN OPERATING CO - #95620

Location ID: 312292

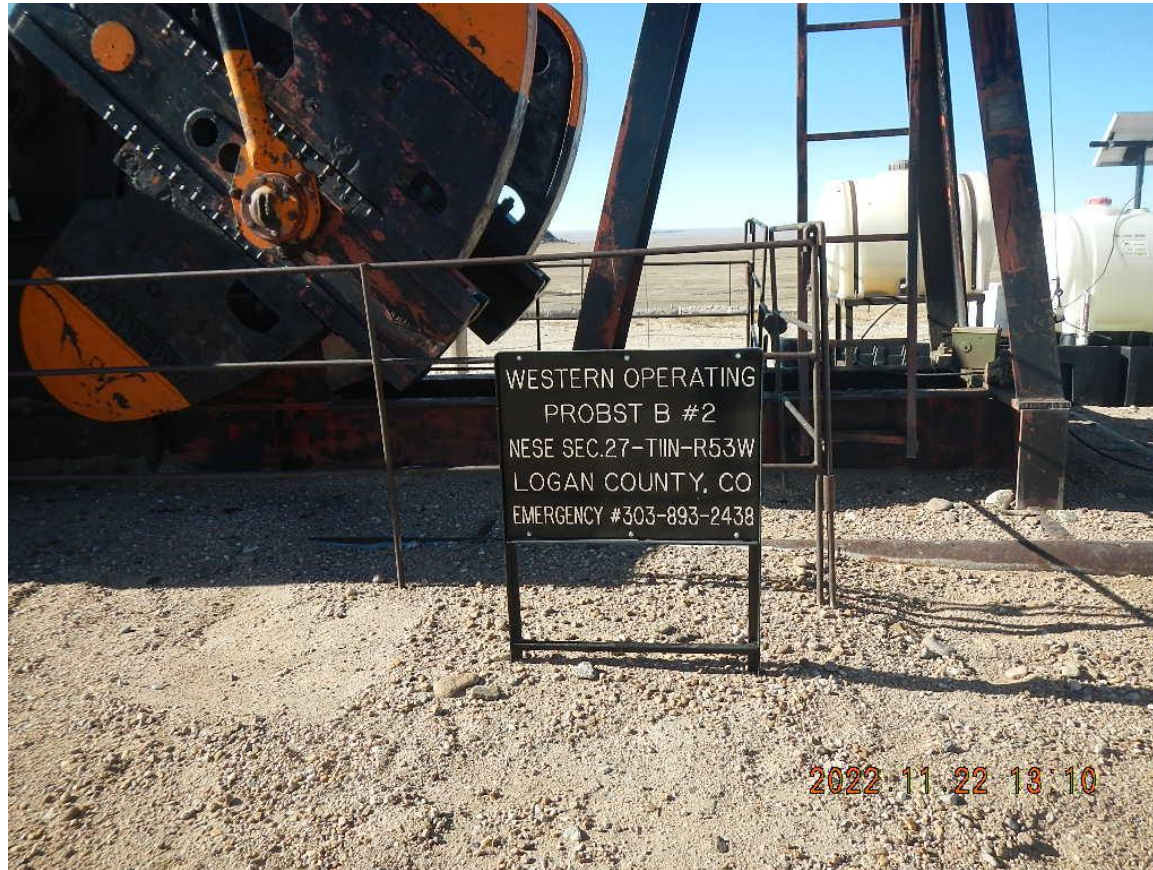
Photo 1. Sign at pumping unit.

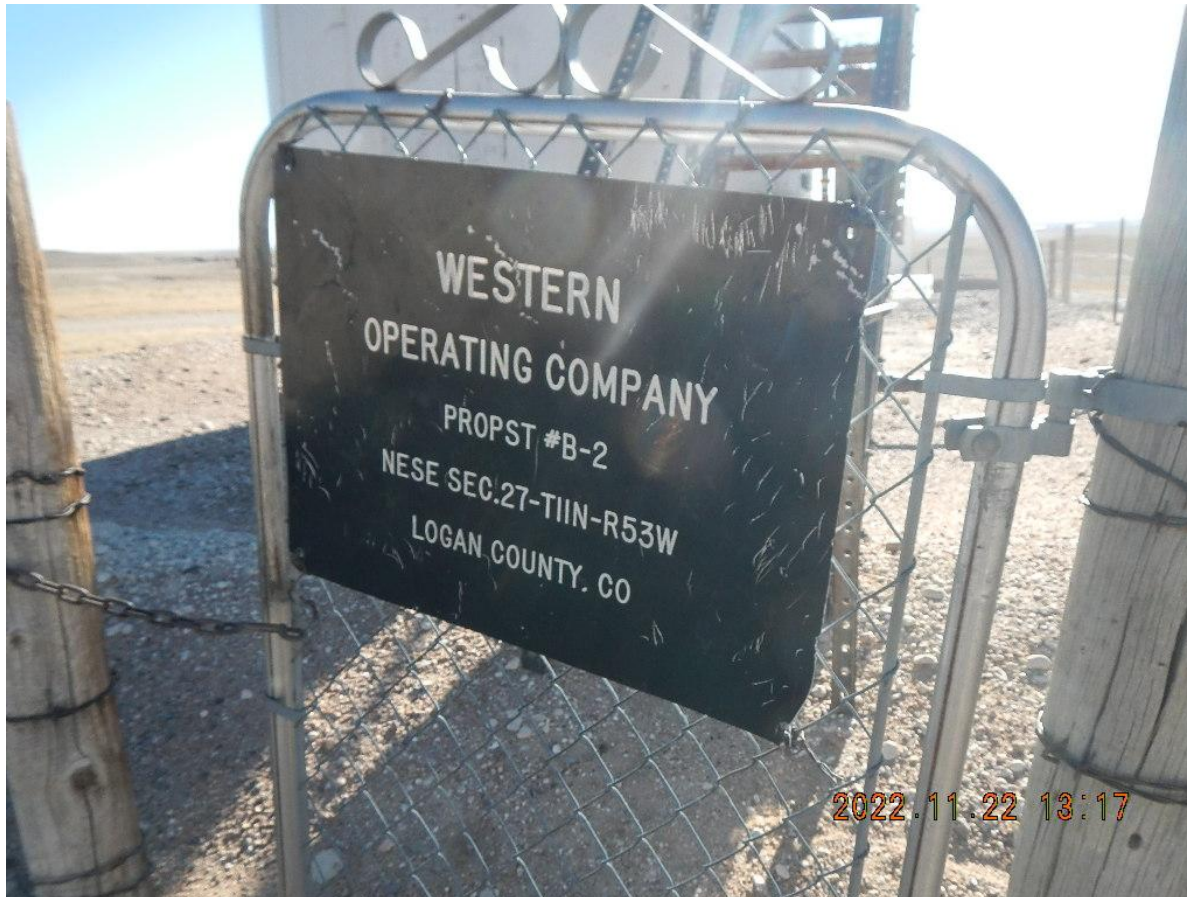
Photo 2. Sign at tank battery.

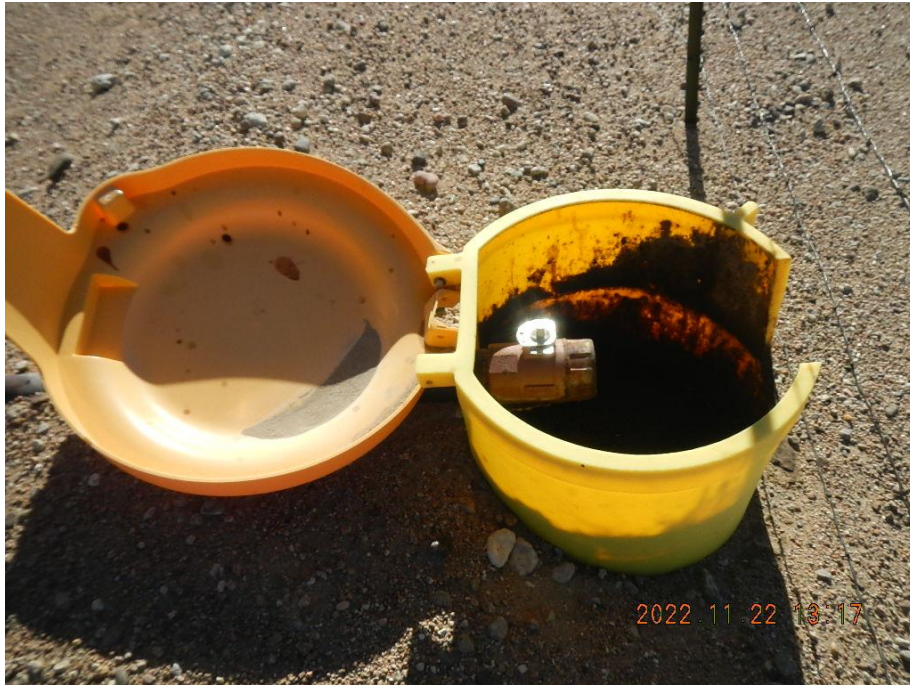
Photo 3. Loadout containment basin found open.

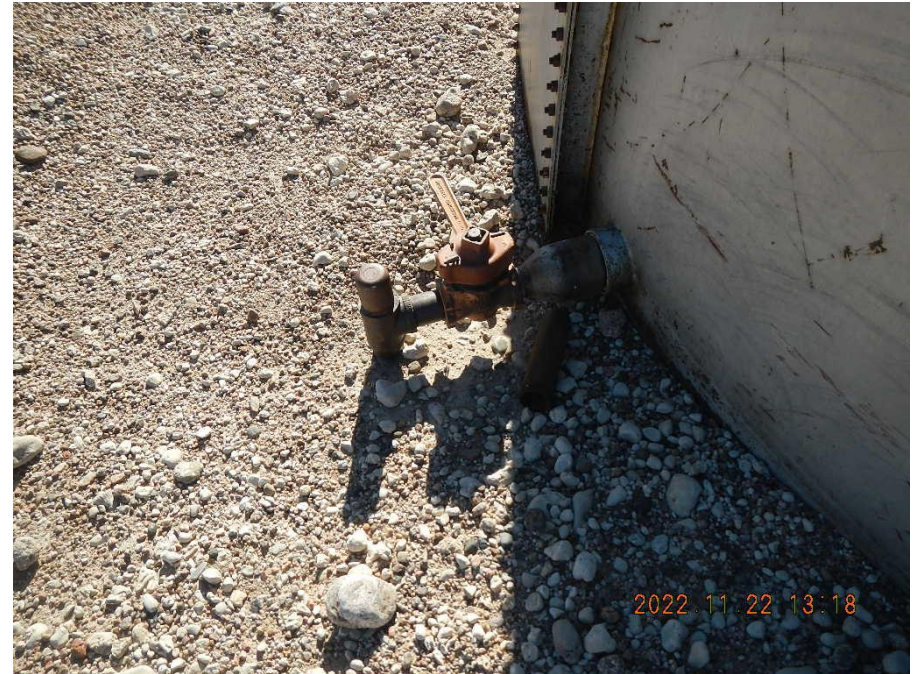
Photo 4. Valve in closed position with handle on valve. Note: evidence of livestock was observed in tank tank battery.

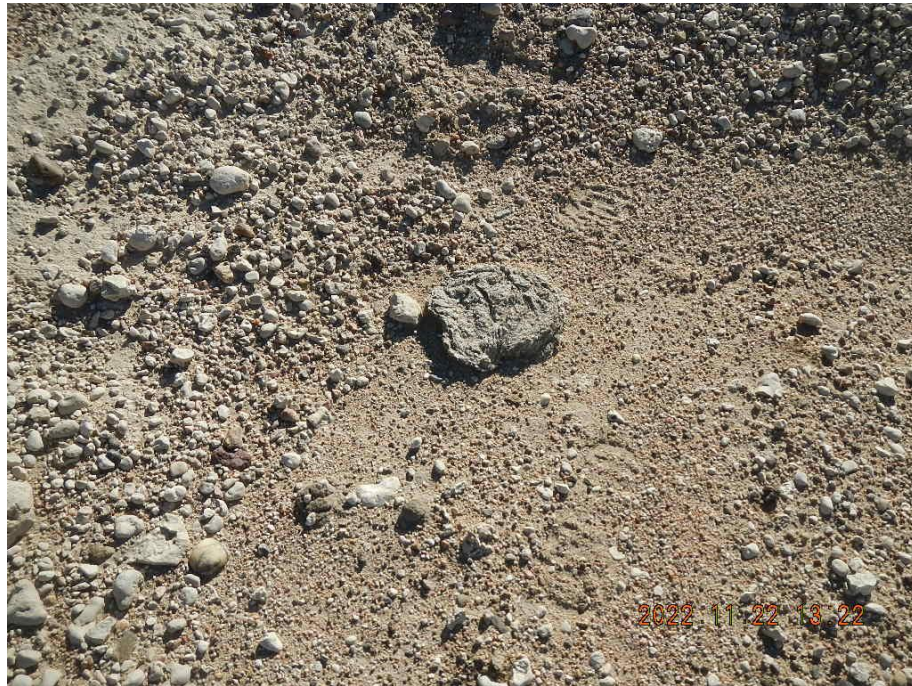
Photo 5. Evidence of livestock.

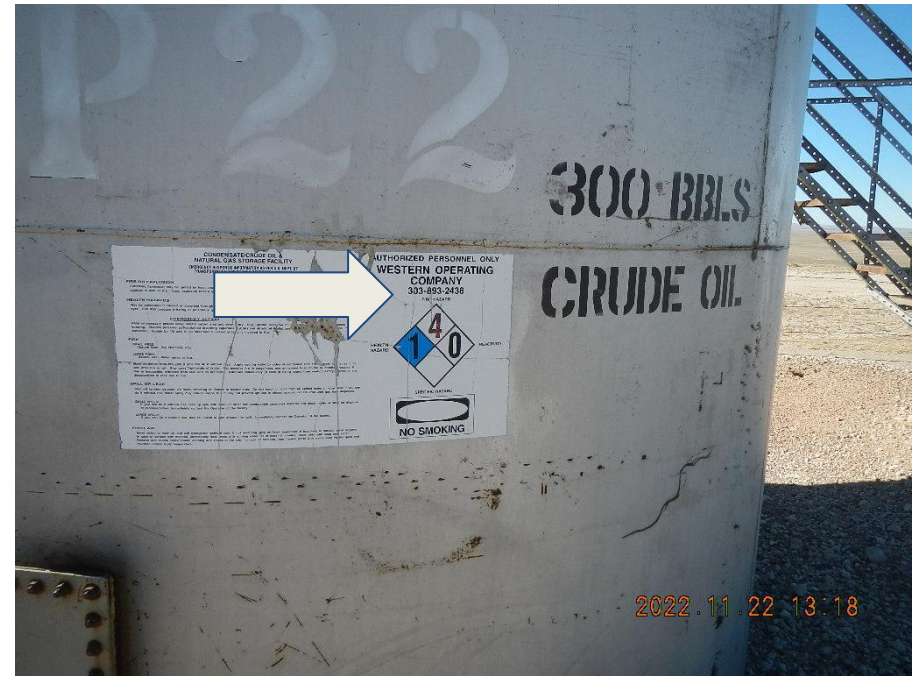
Photo 6. Tank label and placard. Note: Emergency Contact # illegible from a distance.

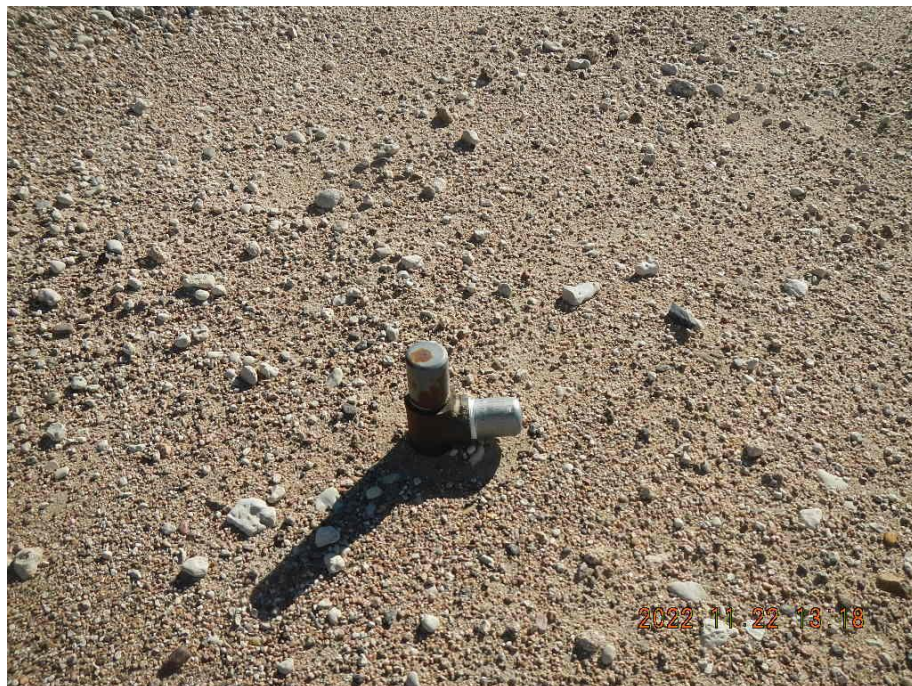
Photo 7. Un-marked riser at tank battery.

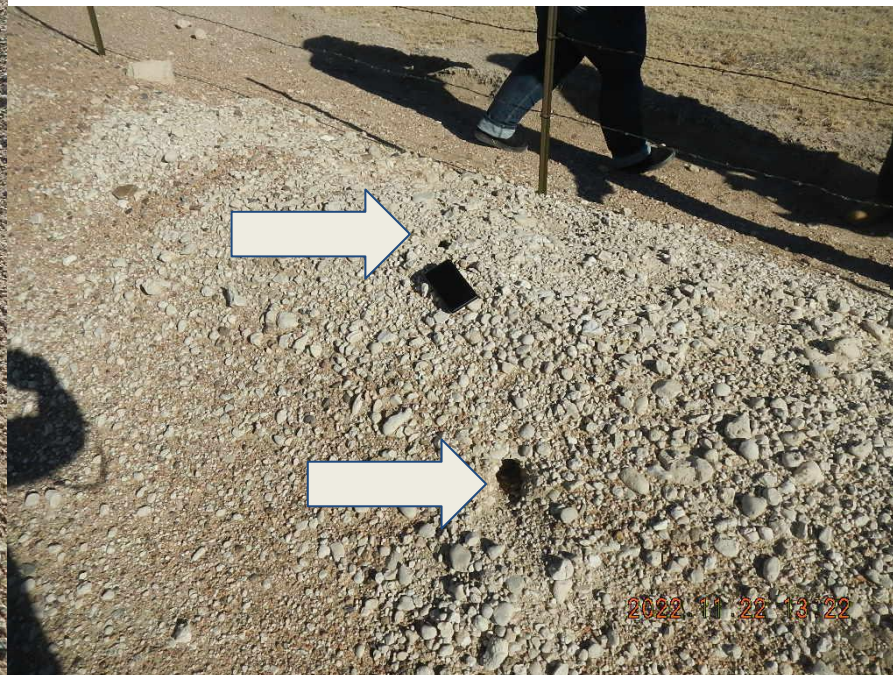
Photo 8. Burrows compromising secondary containment berm.

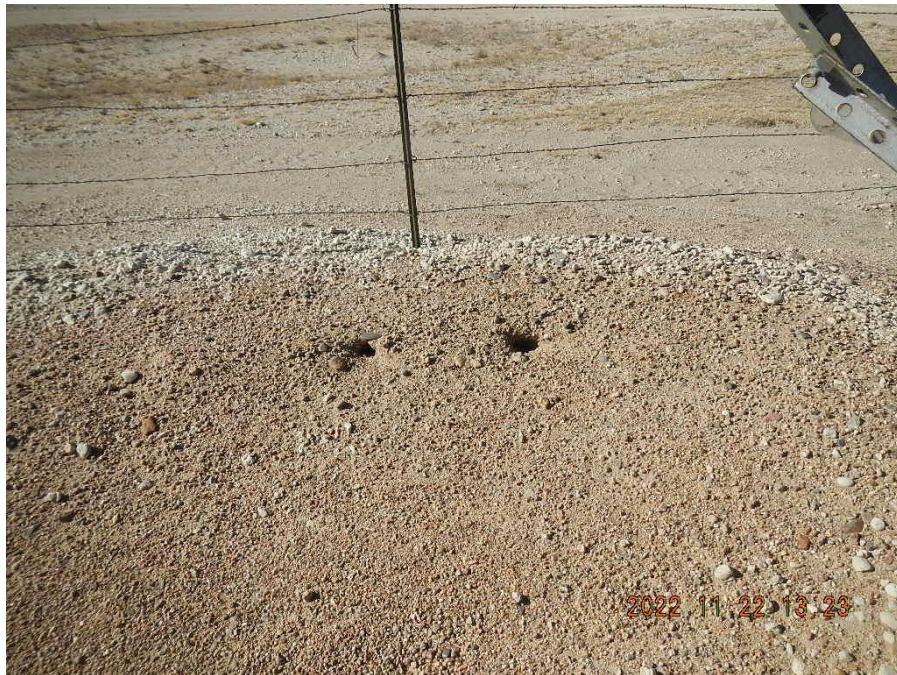
Photo 9. Burrows compromising secondary containment berm.

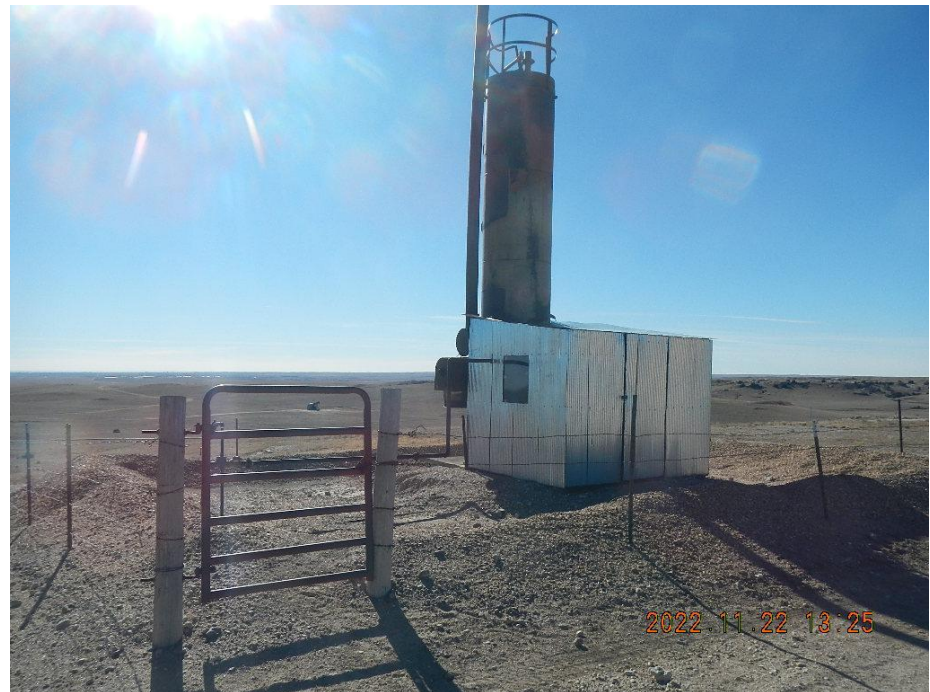
Photo 10. Vertical separator.

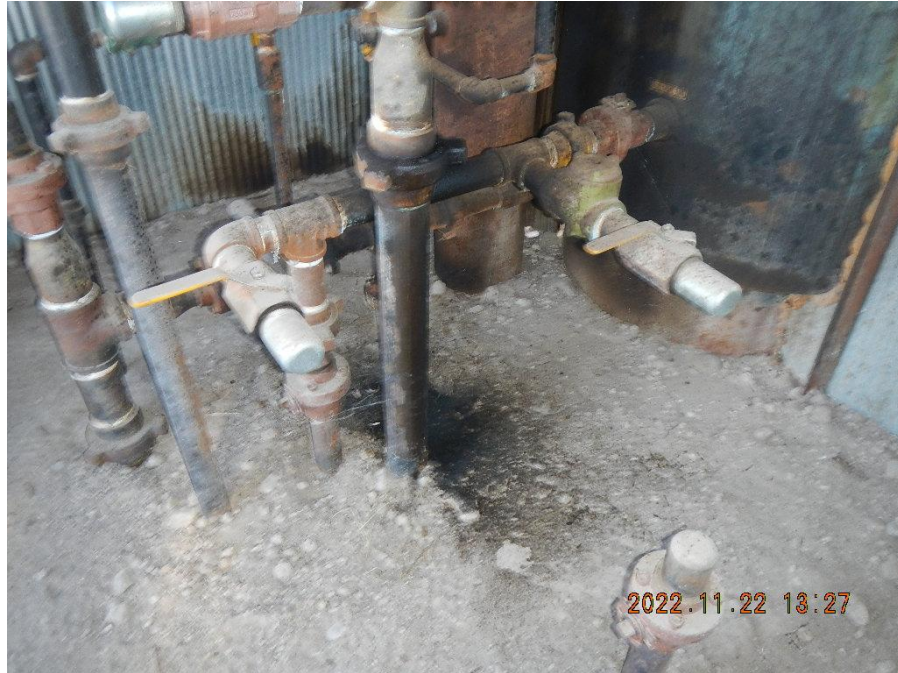
Photo 11. Hammer union weeping oil and oil staining on ground.

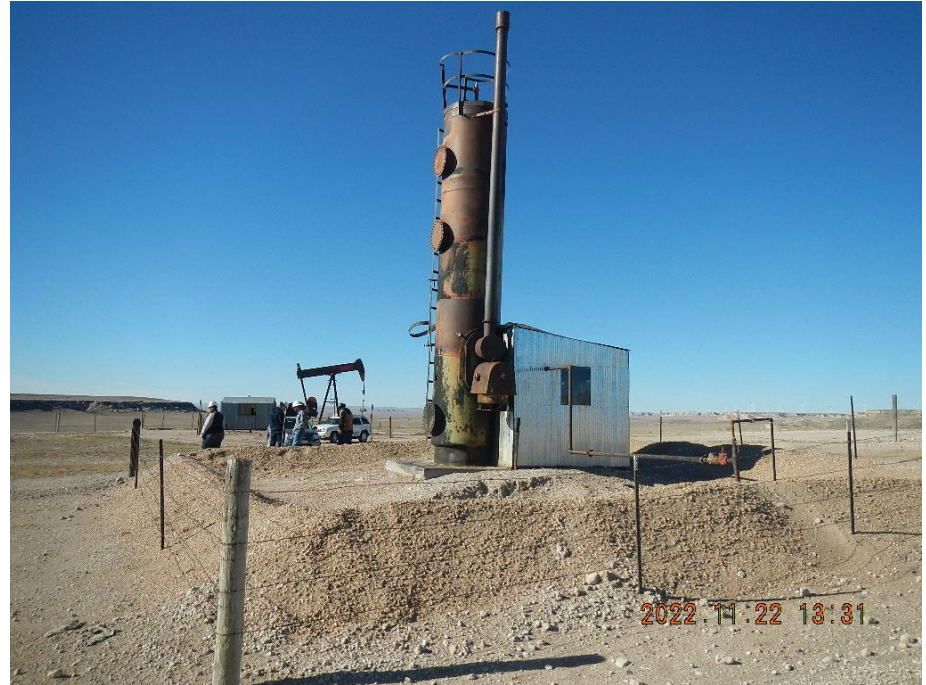
Photo 12. Vertical separator with apparent material removed on south side of concrete pad.

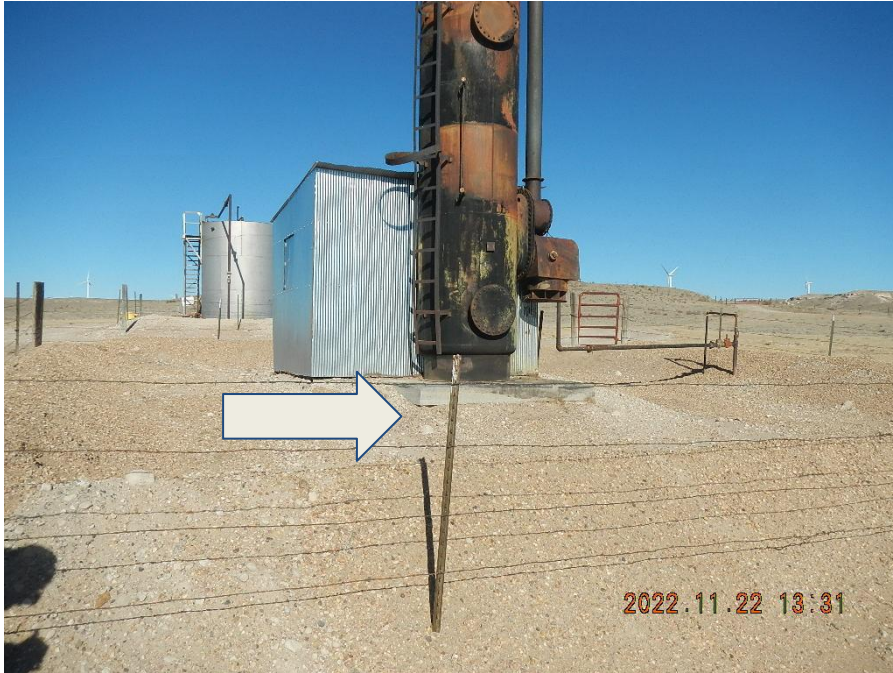
Photo 13. Vertical separator with apparent material removed on south side of concrete pad.

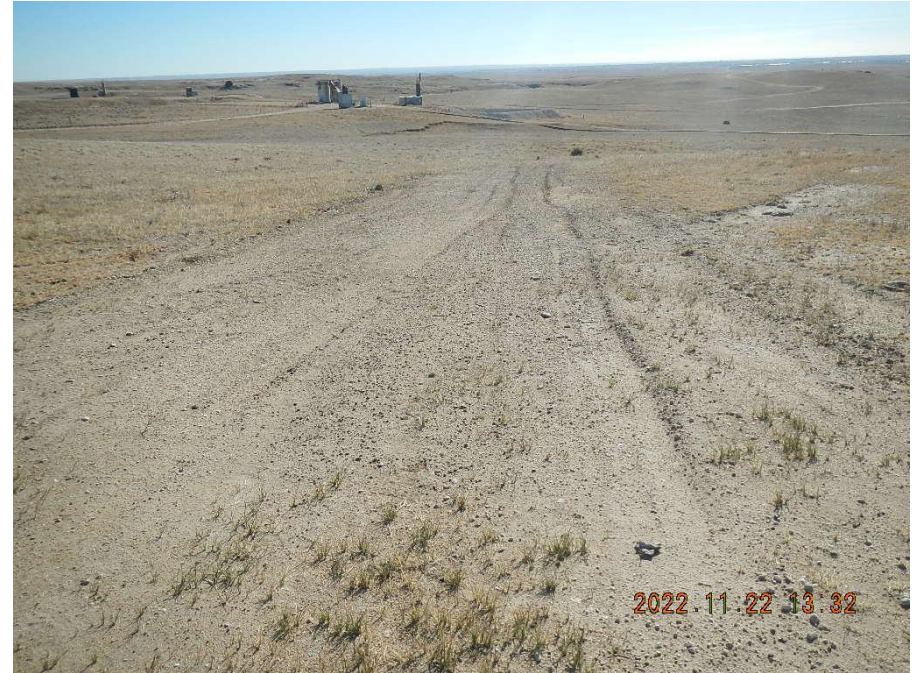
Photo 14. Surface disturbance south of separator approximately 150+ feet in length by 20 feet in width.

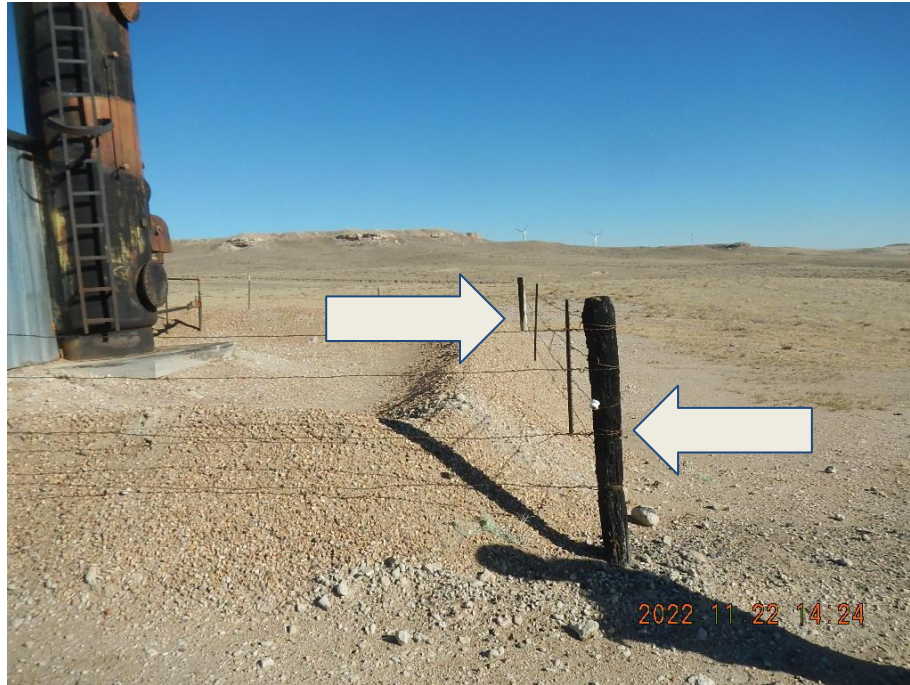
Photo 15. Charred fence posts from November 2019 fire (Insp Doc #680305948).

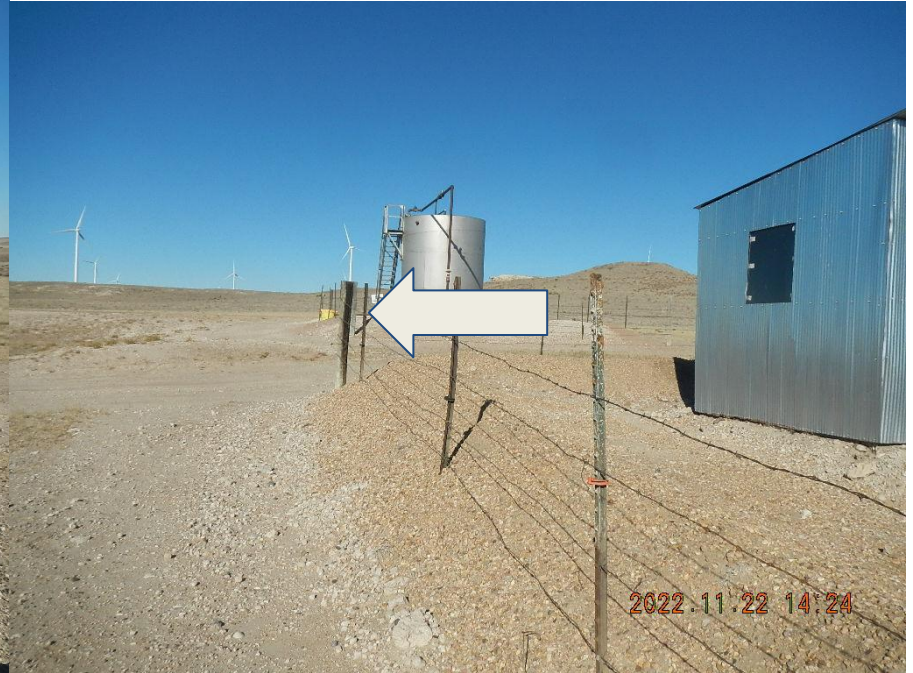
Photo 16. Charred fence posts from November 2019 fire (Insp Doc #680305948).

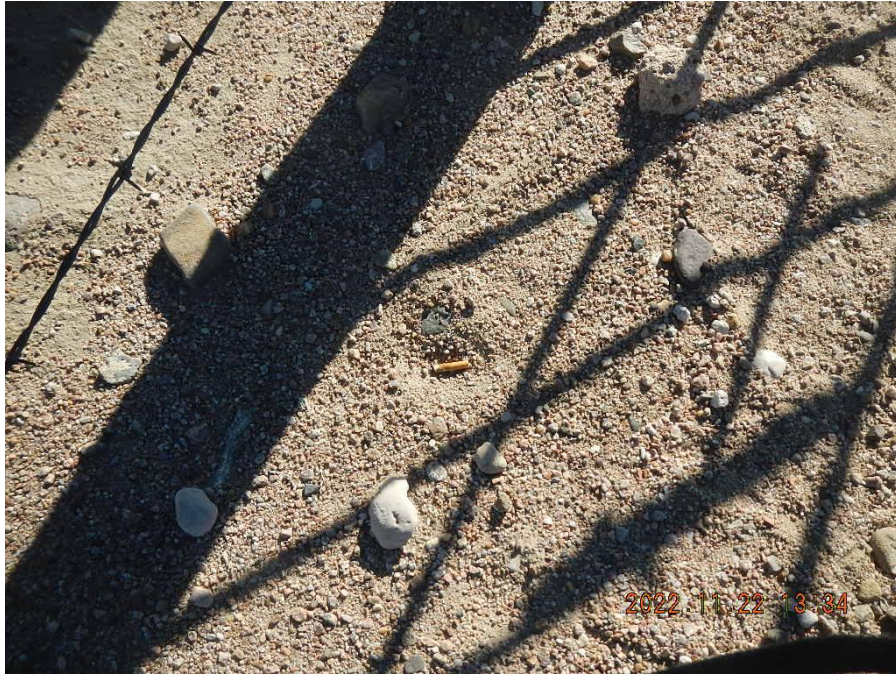
Photo 17. Trash/debris (cigarette butt) within well fence enclosure.

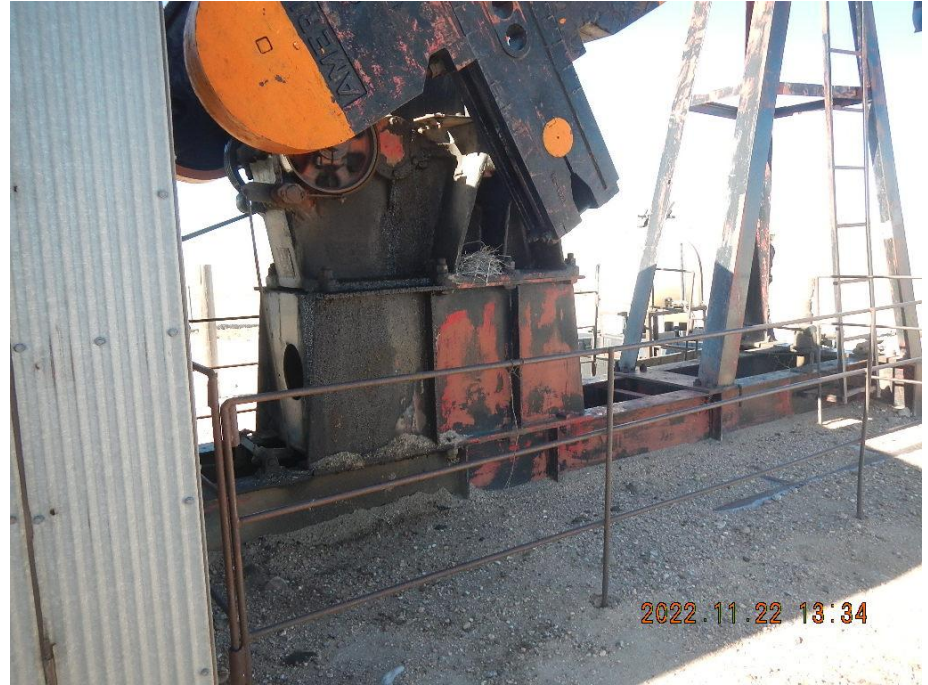
Photo 18. Bird nest on pumping unit.

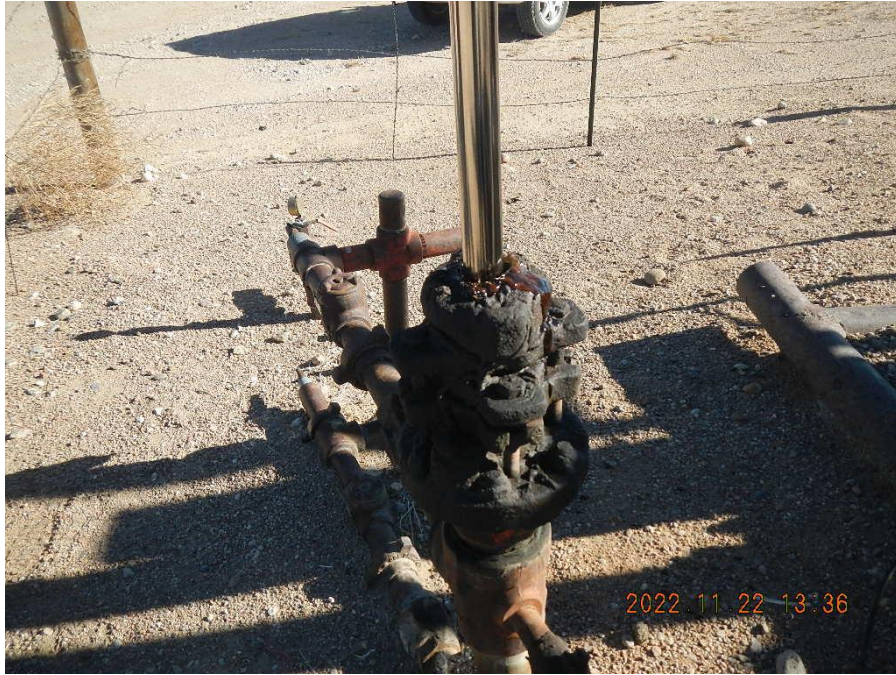
Photo 19. Paraffin and oil build up at stuffing box.

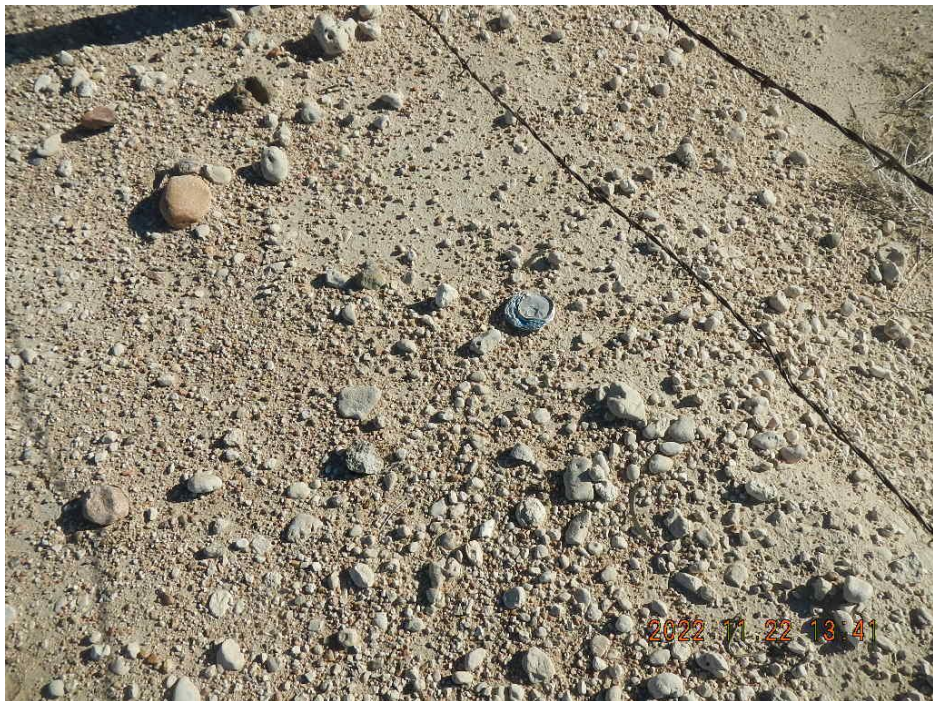
Photo 21. Trash near pit.

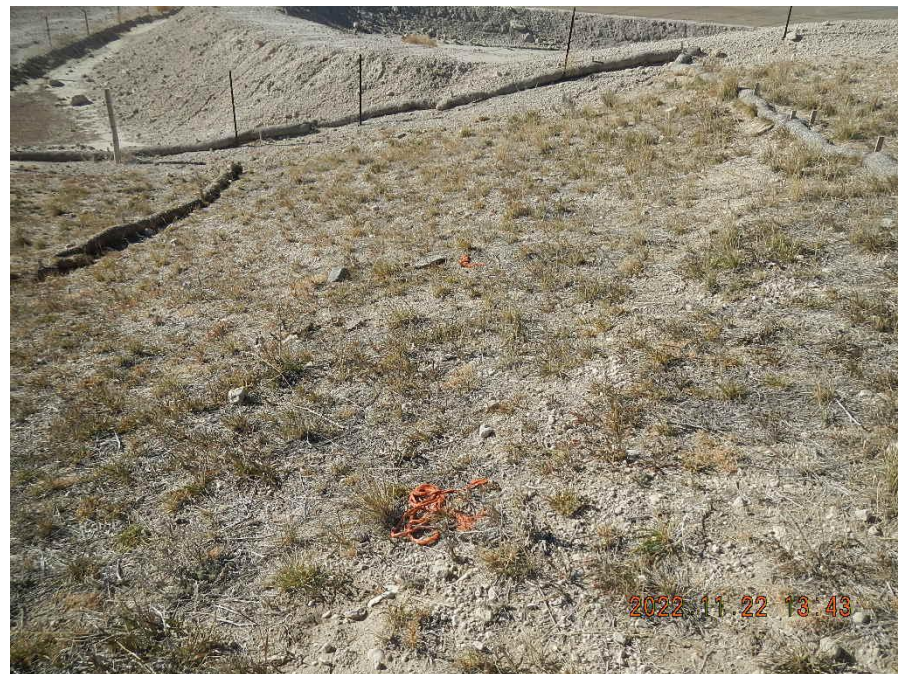
Photo 22. Trash near pit.

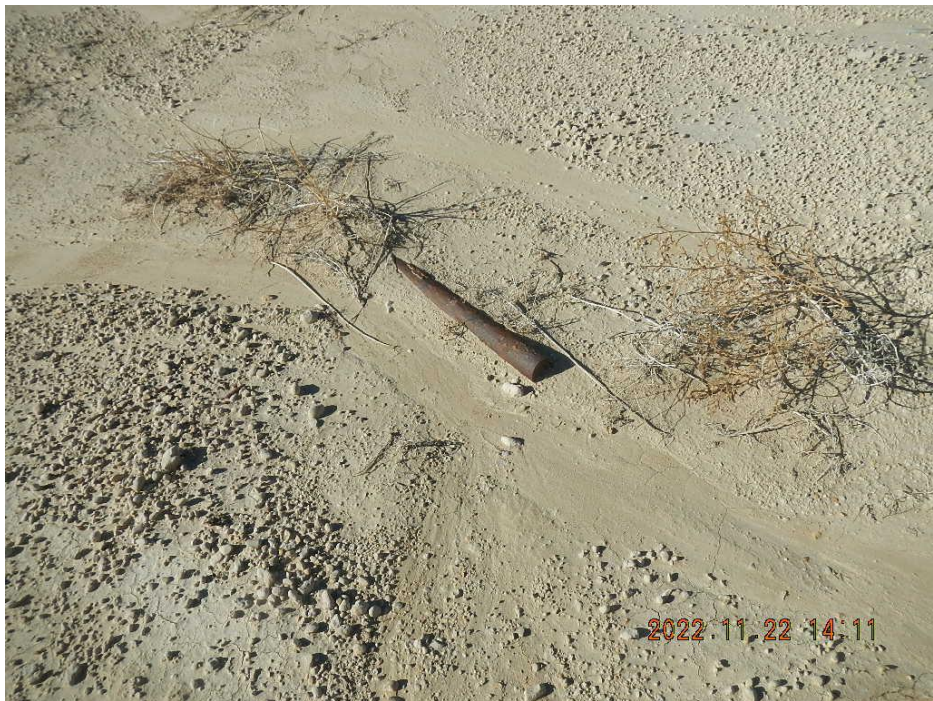
Photo 23. Trash/debris inside the pit.

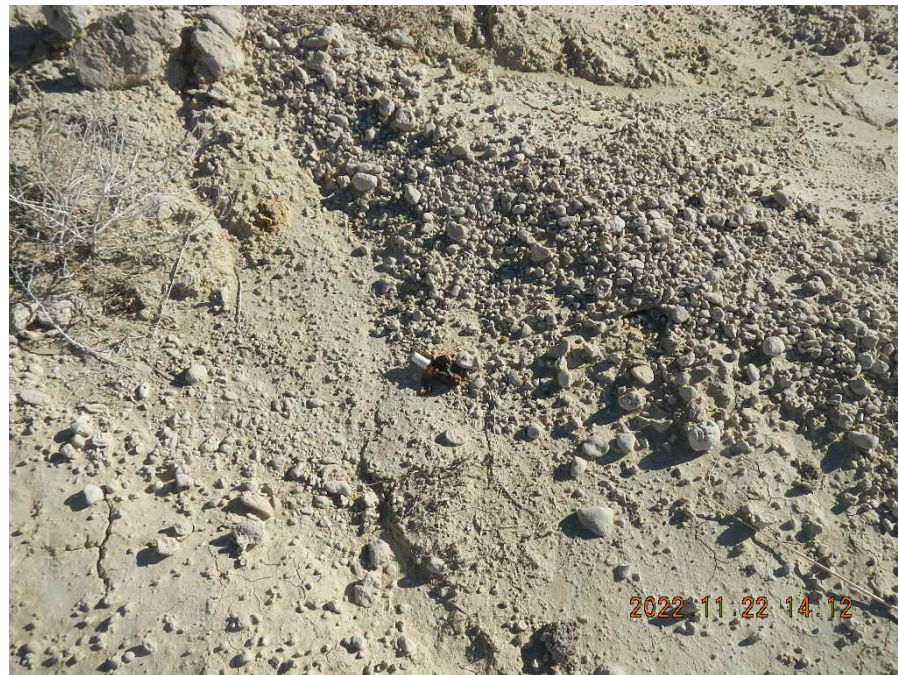
Photo 24. Trash/debris inside the pit.

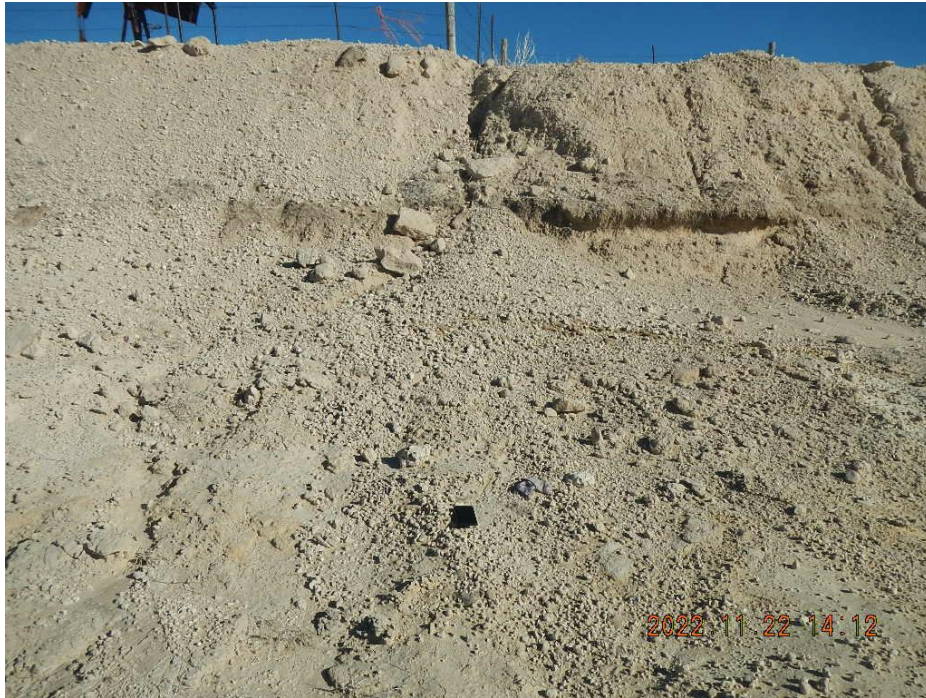
Photo 25. Signs of stormwater run on into the pit.

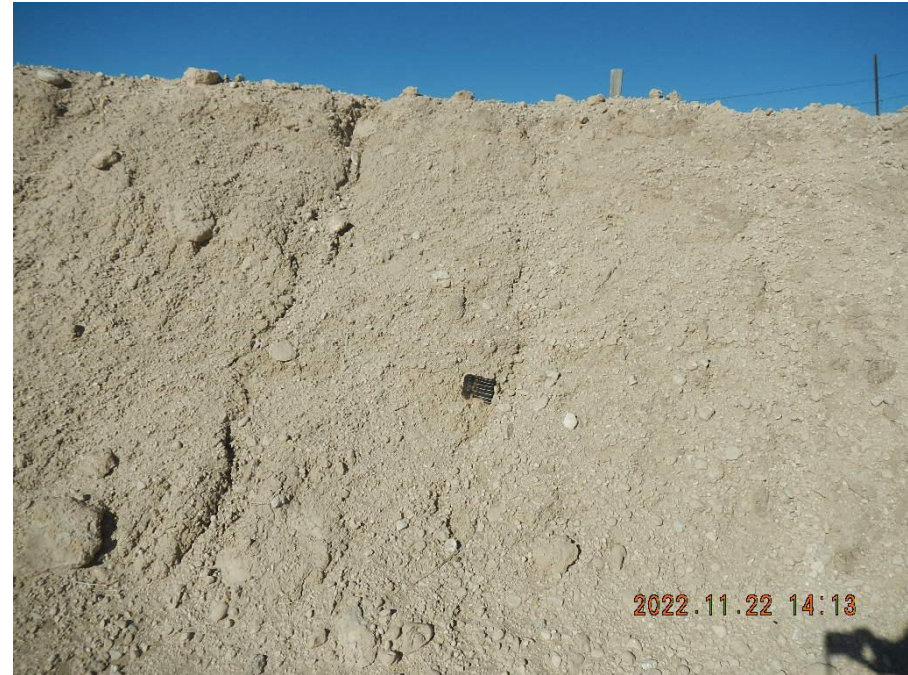
Photo 26. Trash/debris inside the pit along with stormwater run on into the pit.

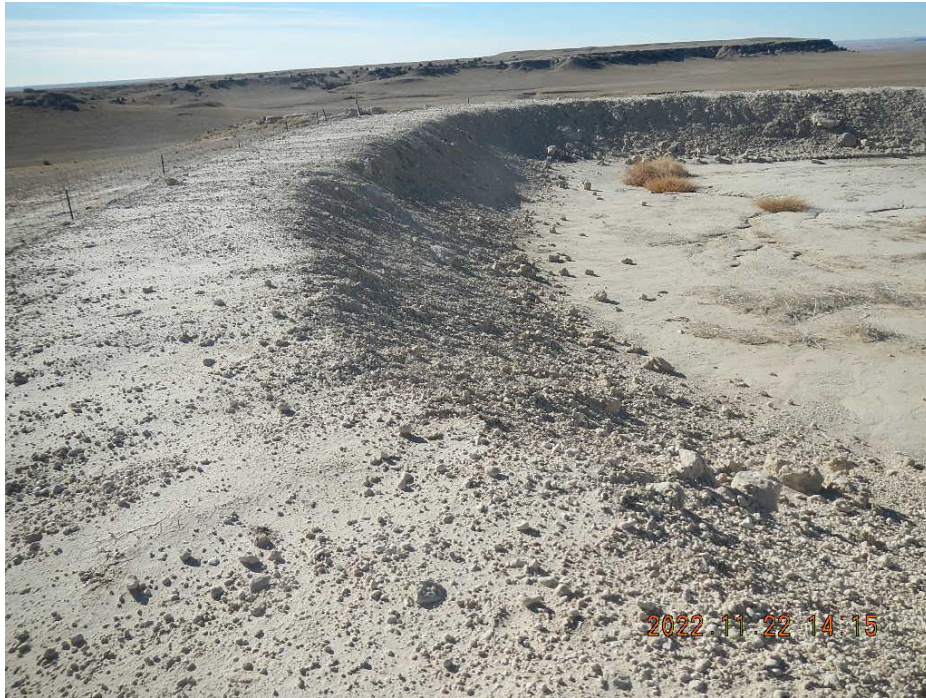
Photo 27. South side of pit looking west.

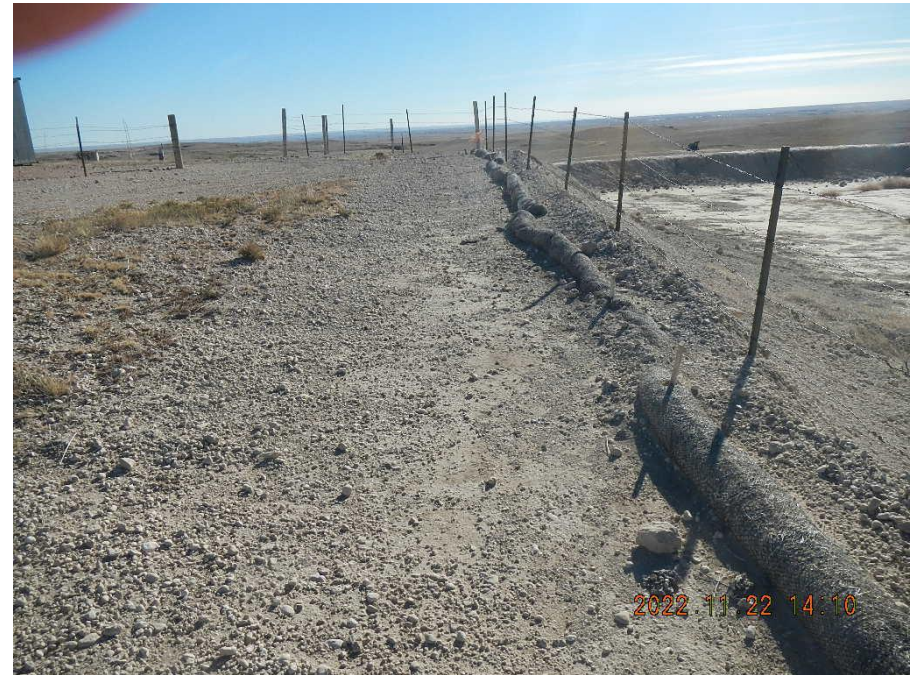
Photo 28. East side of pit looking south. Signs of run on into the pit with inadequate BMPs.

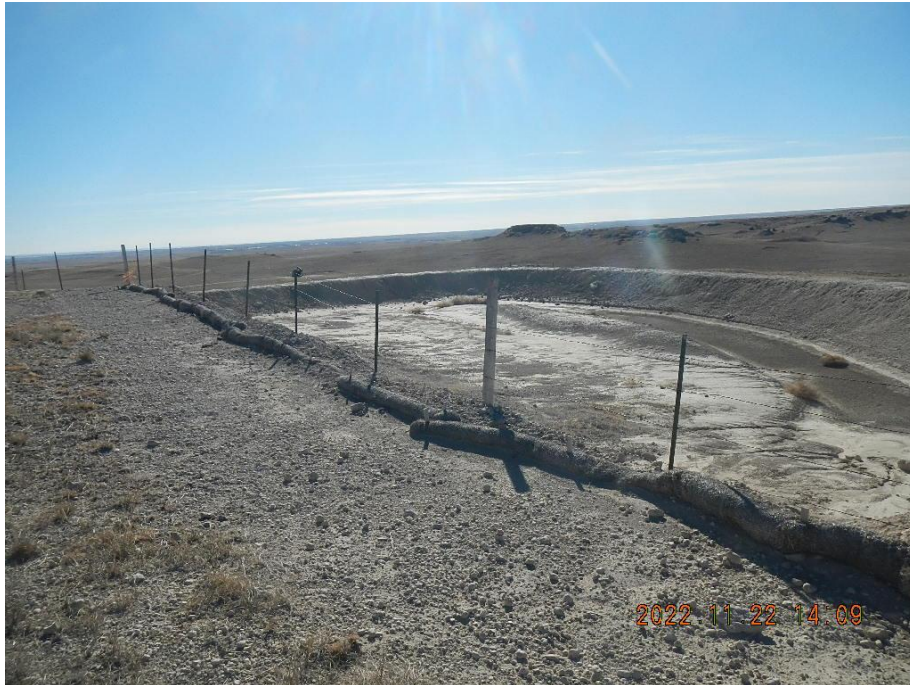
Photo 29. East side of pit looking south. Signs of run on into the pit with inadequate BMPs.

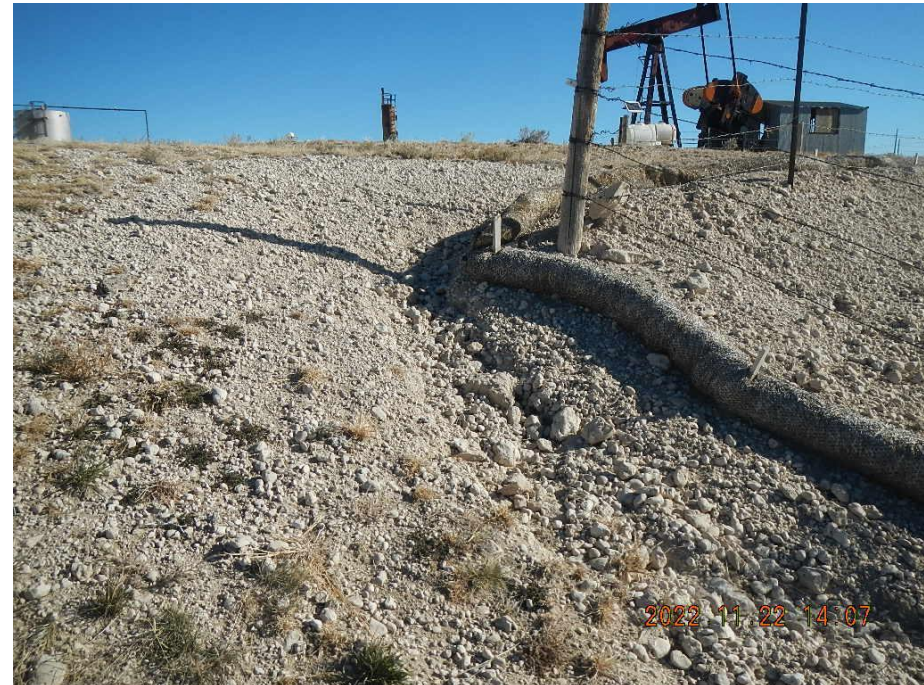
Photo 30. Erosion along the north side of the pit.

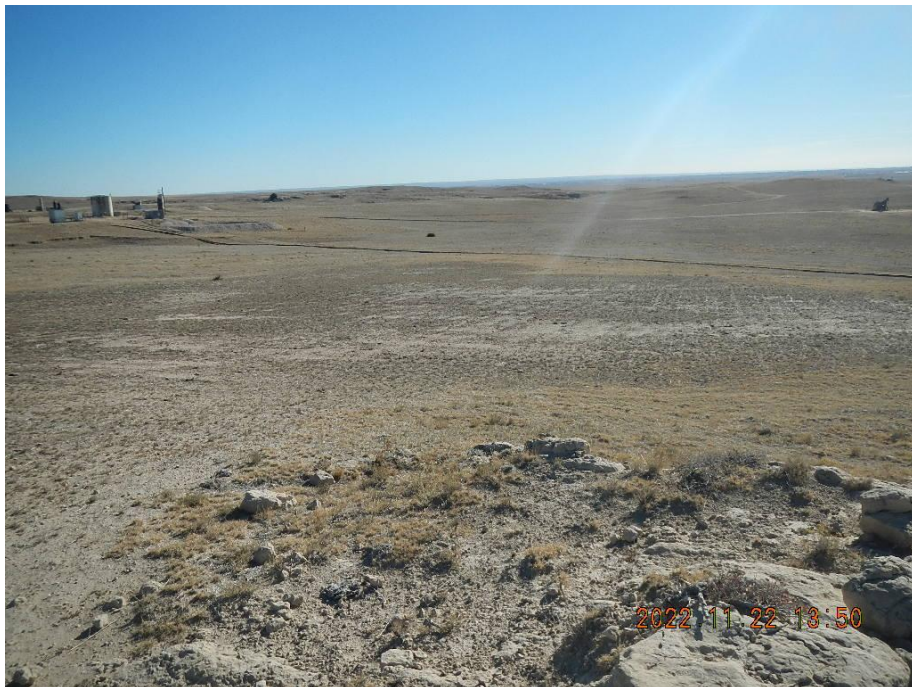
Photo 31. Stressed vegetation in center of photo.

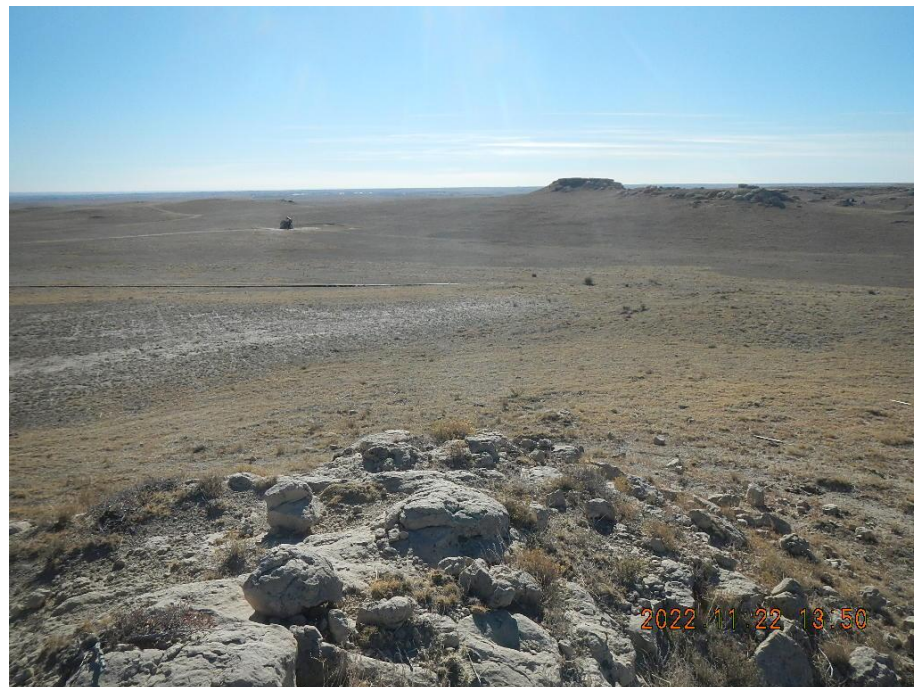
Photo 32. Stressed vegetation.
